# Pre Purchase Building And Pest Inspection 5 Napelle Crt

Property Address: 5 Napelle Court Ocean Shores 2483

Inspection Date: 10 Oct 2025

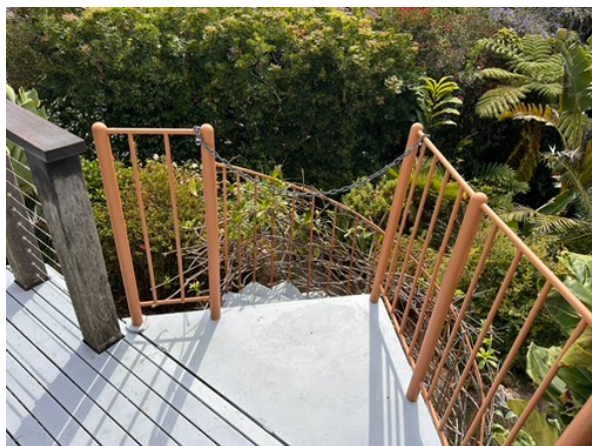
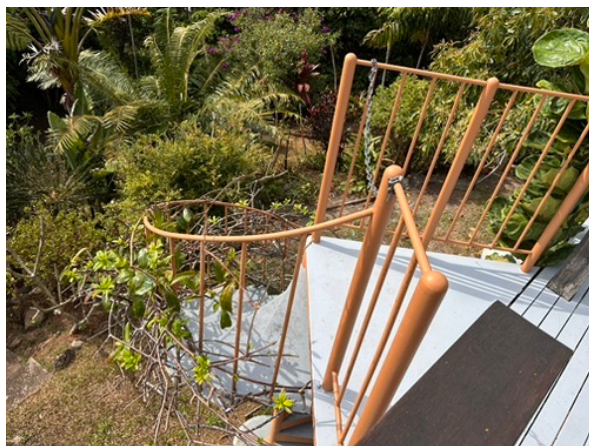
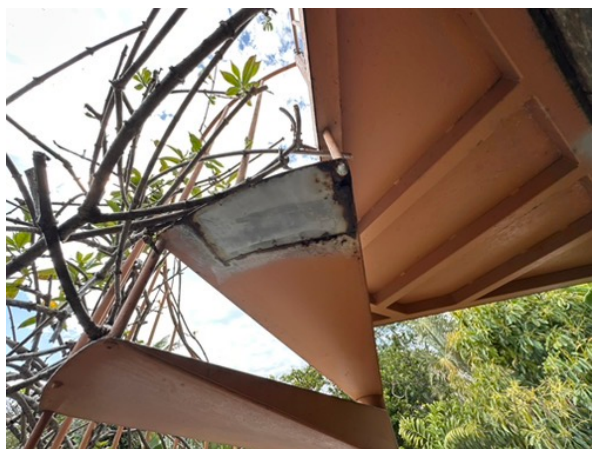
### Serious Safety Hazard 1.01

**Location:** External Spiral Stairs

**Finding:** The external spiral stairs, although visually appealing, are not designed for actual use and should not be walked on. This can be considered a significant safety risk if attempted. It appears they were intended solely for aesthetic purposes, rather than functional use. To address this issue, it's recommended that these stairs be clearly marked with appropriate signage to deter use, or alternatively, be modified by a qualified professional to ensure they meet safety standards for regular use. This will mitigate potential safety hazards and provide peace of mind.

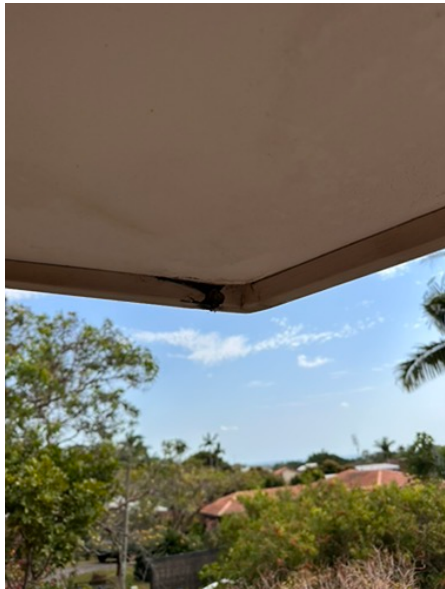
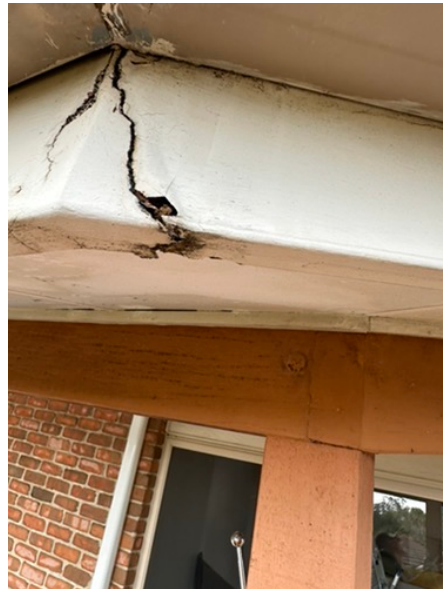
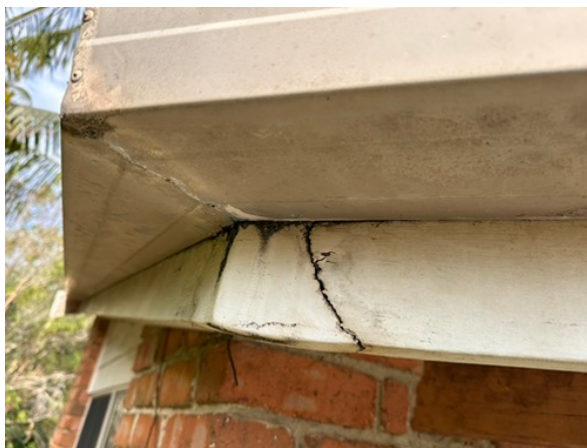
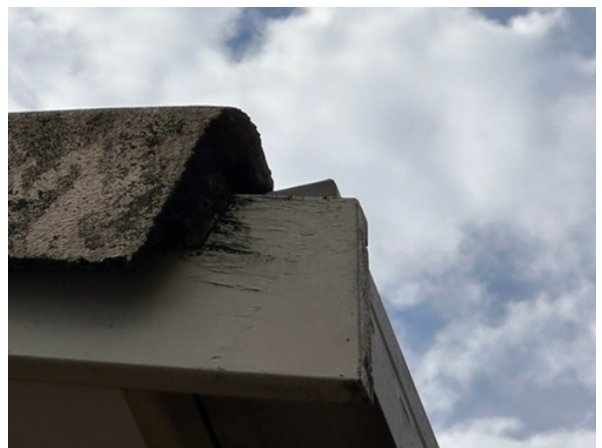
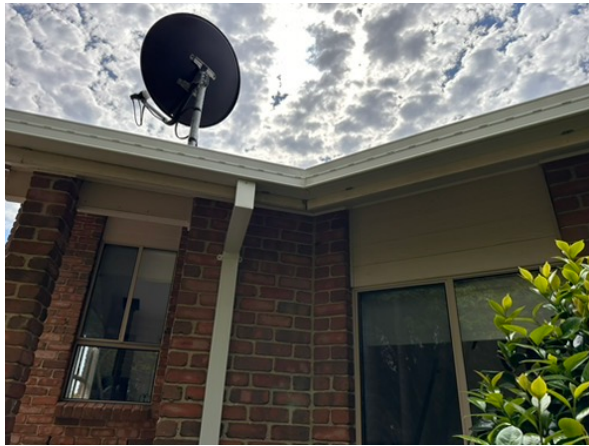
## Minor Defect 2.01

**Location:** External Timber Fascia

**Finding:** During the inspection of the external timber fascia, we noticed some areas showing early signs of deterioration. It's not urgent, but it could benefit from some attention. It might be a good idea to consider sanding it back and applying some bog in spots that need it. Whether you choose to address this now or later is entirely up to you, but keeping an eye on it could prevent bigger issues down the track. So, it's something to think about as you decide on your next steps.

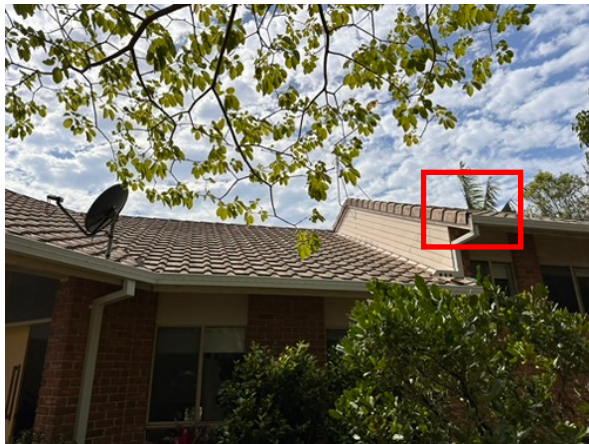
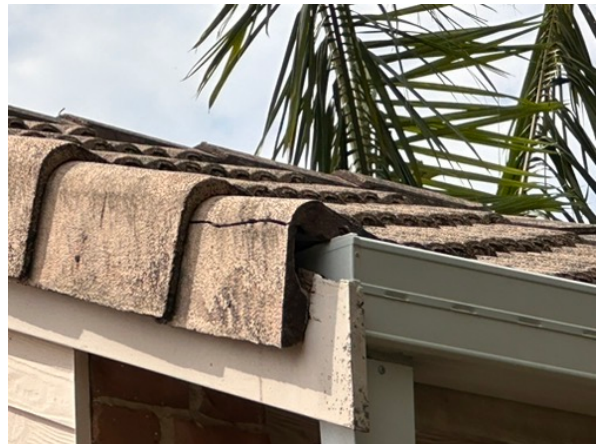
## Minor Defect 2.02

**Location:** Roof exterior

**Finding:** During the inspection of the roof exterior, a cracked roofing tile was identified. It's a good practice to address any broken tiles promptly to prevent potential water damage or other issues. Given that some tiles appeared aged and fragile, walking on them wasn't advisable, as additional tiles might crack underfoot. To ensure the integrity of the roof, it's recommended to engage a professional roofer to replace the damaged tile and assess the condition of the neighboring tiles. This proactive maintenance can help extend the lifespan of your roof.

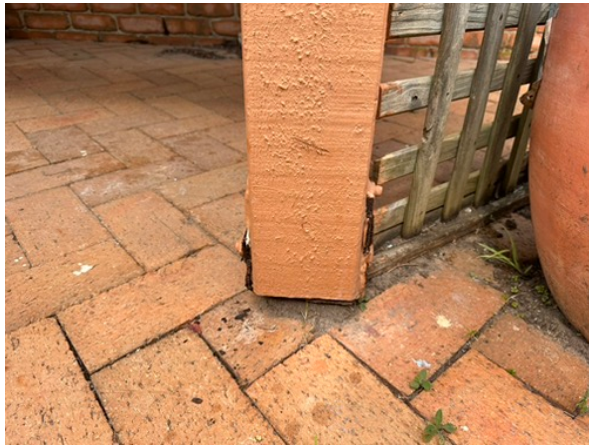
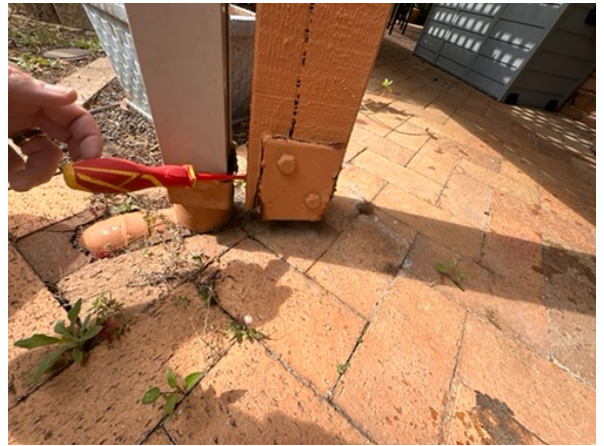
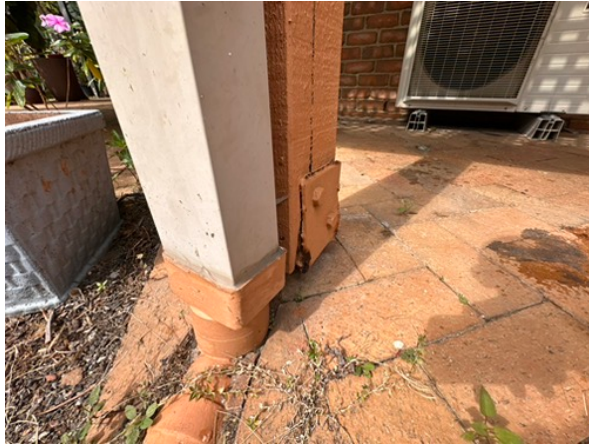
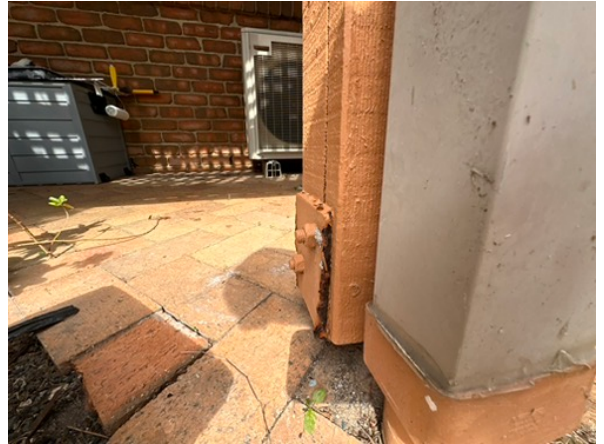
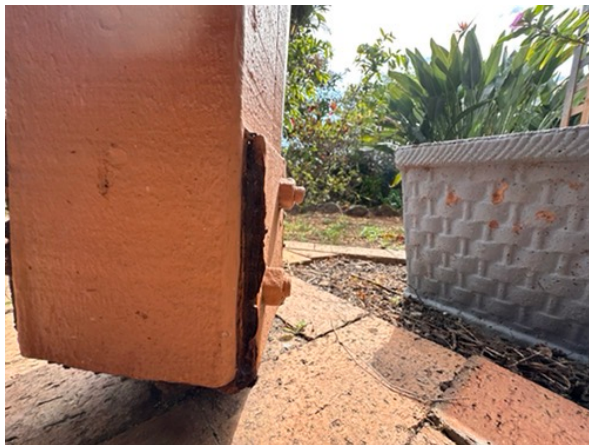
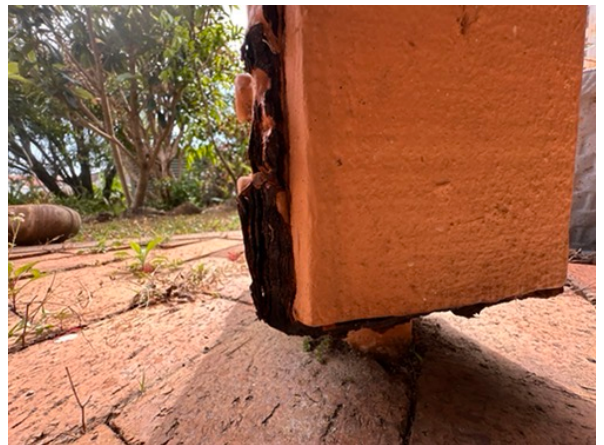
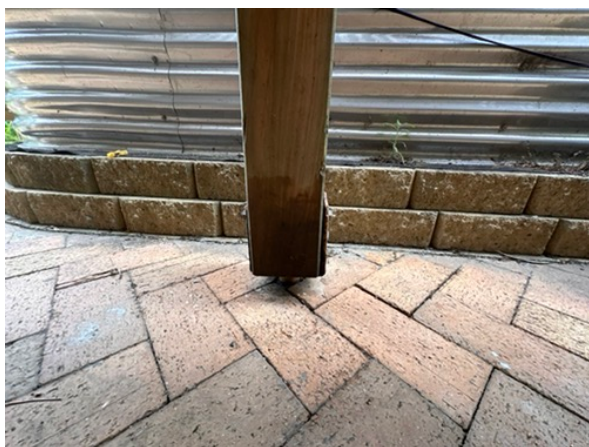
## Minor Defect 2.03

**Location:** Deck Post Brackets

**Finding:** During the inspection, it was observed that several deck post brackets are showing signs of steel delamination, which is a red flag for potential structural issues. One side of a particular post is beginning to deteriorate, indicating early signs of compromised integrity. It's important to address these issues promptly to prevent further damage. I recommend and consider replacing the affected brackets to ensure the deck remains safe and sturdy for use.

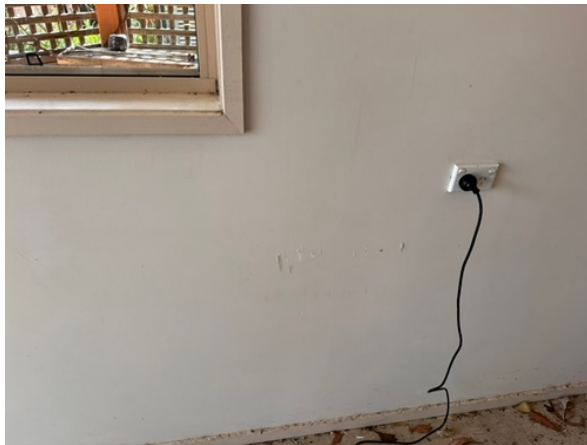
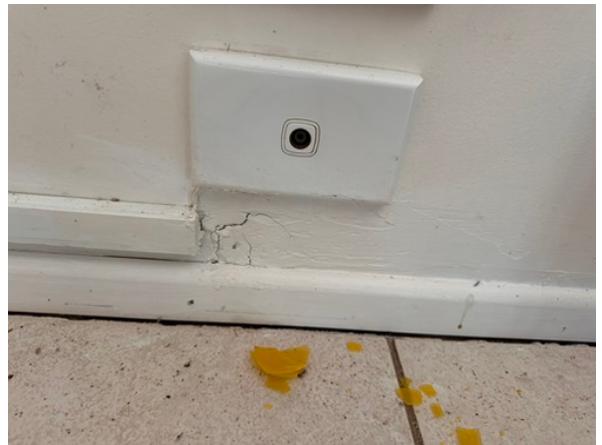
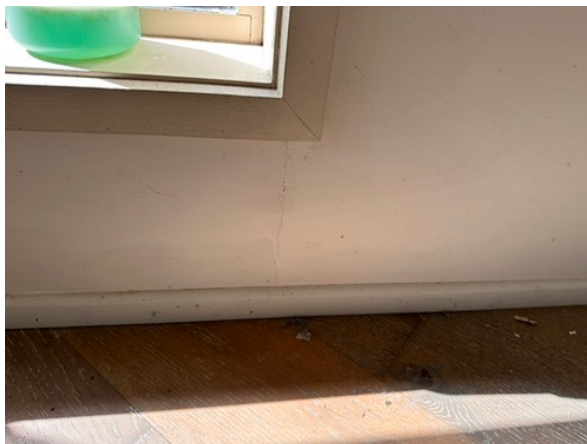
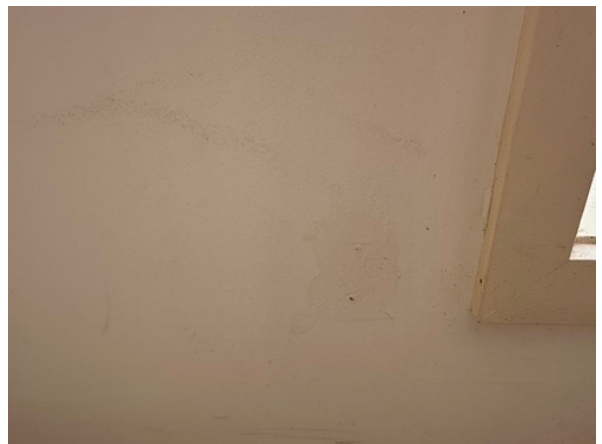
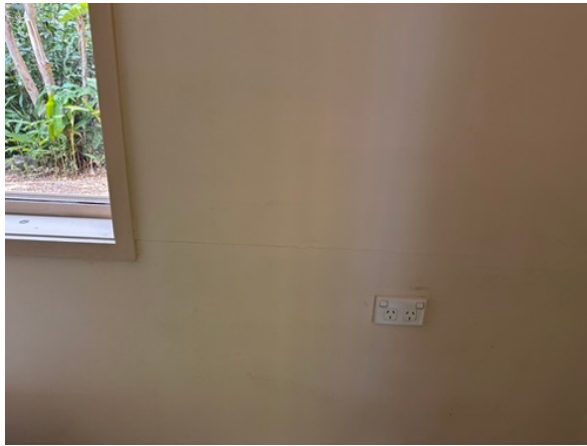
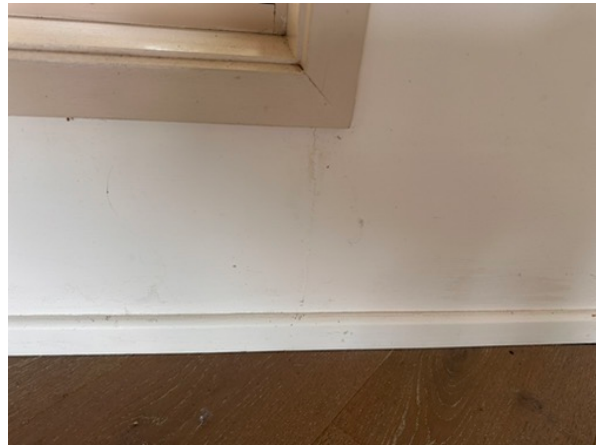
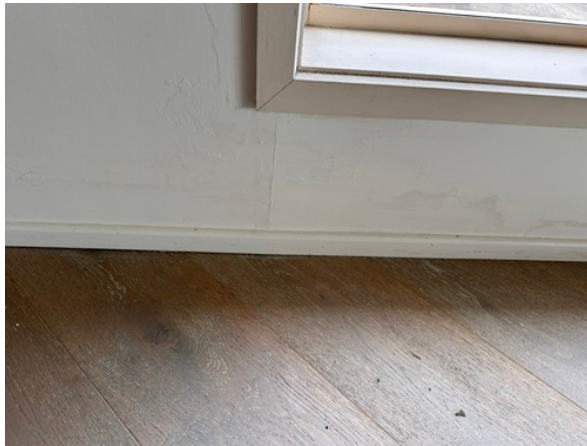
**Location:** Various Internal Areas

**Finding:** In various internal areas, there are noticeable cracks and marks on the walls where the Gyprock has settled. These imperfections, while common, can become more pronounced over time if left unaddressed. It's important to monitor these areas for any changes or worsening. For peace of mind and to ensure the durability of the wall finish, consider having a qualified professional assess the situation. They can apply a fresh coat of plaster or use filler to smooth out the surface, followed by repainting to restore the walls to their original condition.

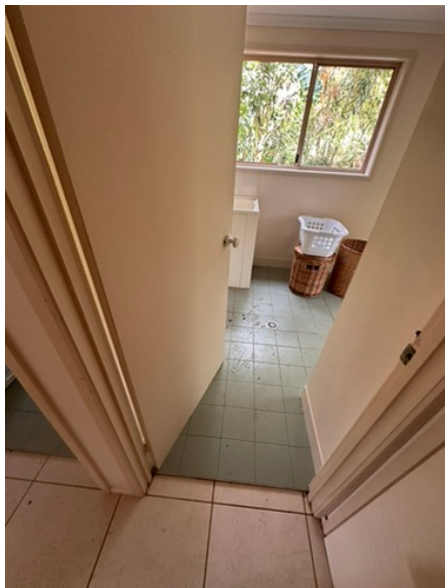
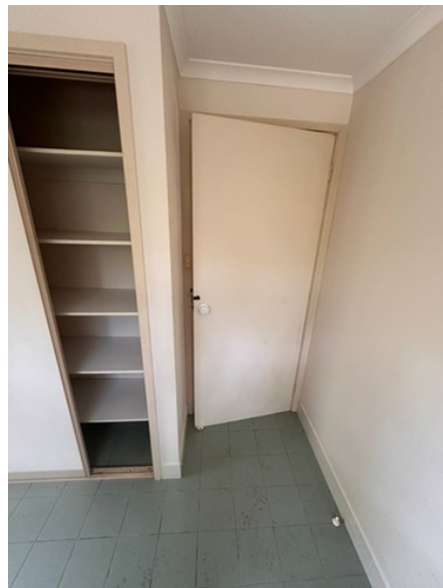
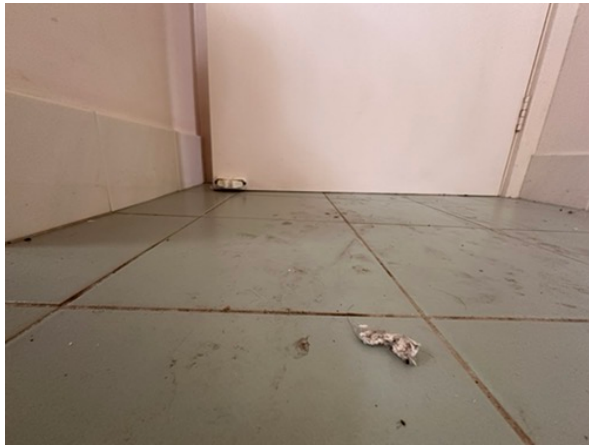
## For your information 3.02

In the laundry, the bottom of the door is making contact with the tiles, causing a noticeable scraping noise when opened or closed. This issue could be easily resolved by trimming approximately 5-10mm off the bottom of the door. By doing so, you'll allow the door to swing freely without any obstruction, enhancing the overall functionality and longevity of both the door and the tile surface. A straightforward maintenance task like this can prevent further wear and keep everything operating smoothly.

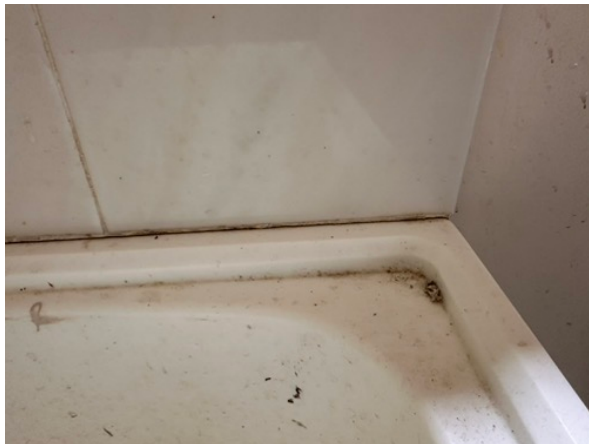
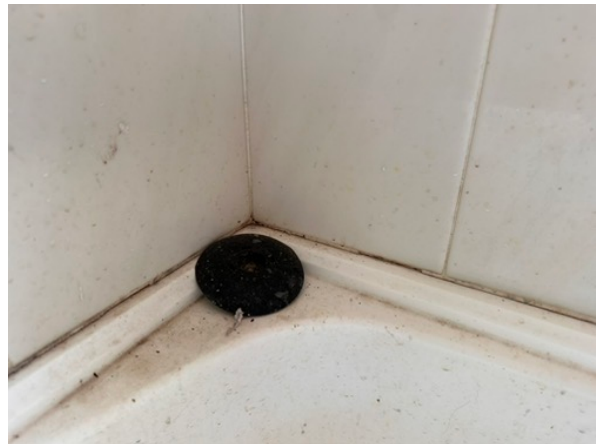
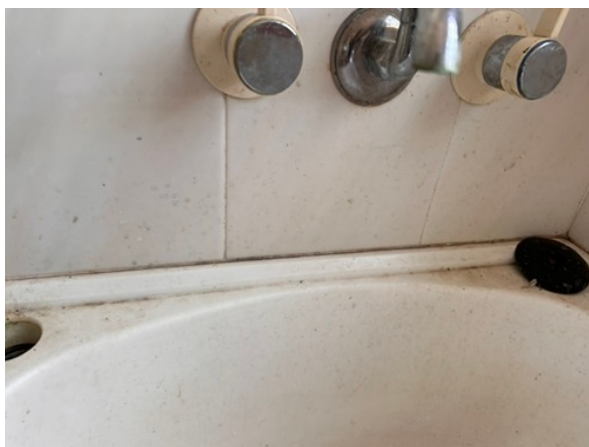
### For your information 3.03

**Location:** Laundry

**Finding:** In the laundry, it's been noted that the splashback around the tub is missing grout and could use some silicone maintenance. Over time, this absence in crucial areas can lead to water seeping into the wall, potentially causing damage. To address this, it's recommended to apply fresh grout and silicone in the affected areas. This not only helps prevent any water ingress but also keeps the laundry looking clean and well-maintained. Taking care of this now can save a lot of hassle later on!

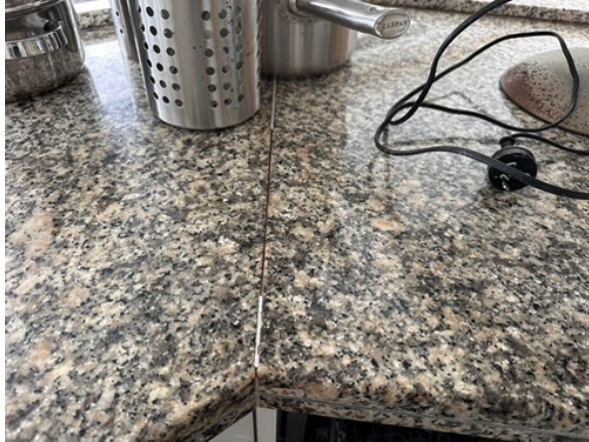
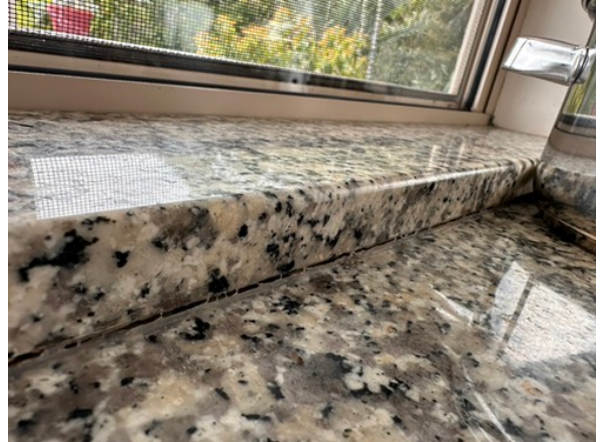
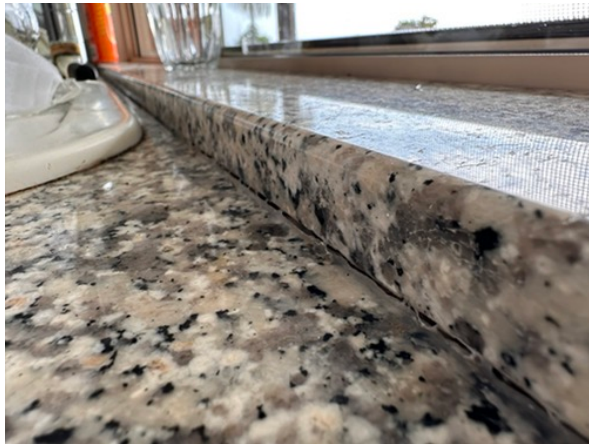
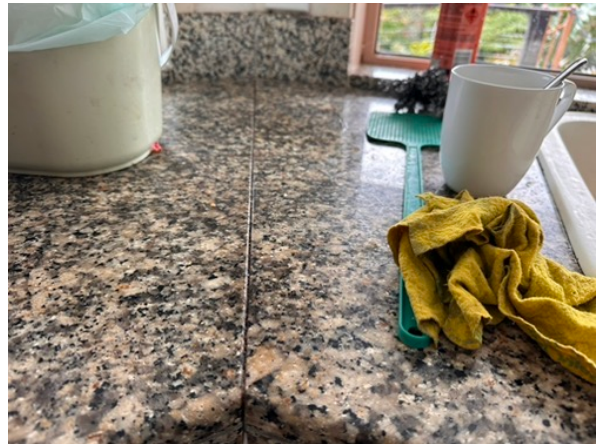
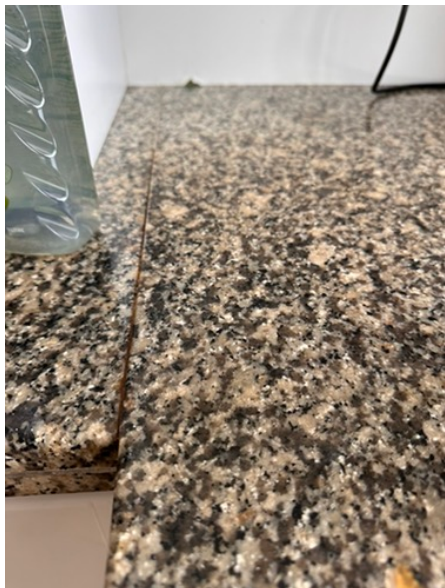
## For your information 3.04

**Location:** Kitchen

**Finding:** In the kitchen, we've noticed that some joints on the benchtop are missing grout or silicone, which could lead to moisture seeping into and damaging the underlying materials over time. Addressing this issue sooner rather than later is a good idea, as it can prevent potential water damage or mold growth. A simple fix would be to reapply grout or silicone to these joints to ensure they're well-sealed. This not only helps maintain the integrity of the benchtop but also keeps your kitchen looking its best.

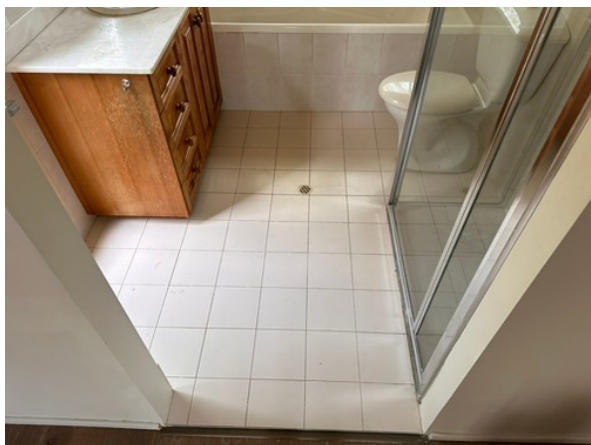
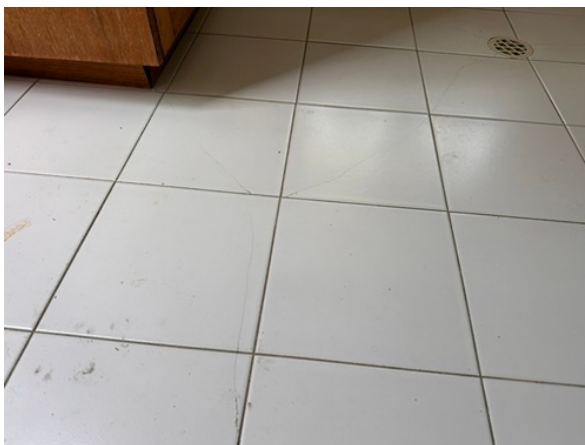
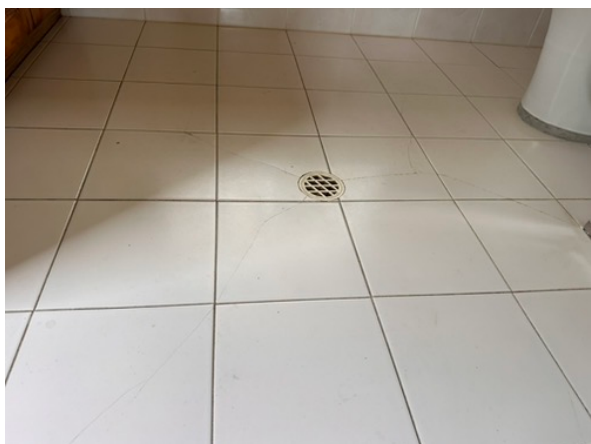
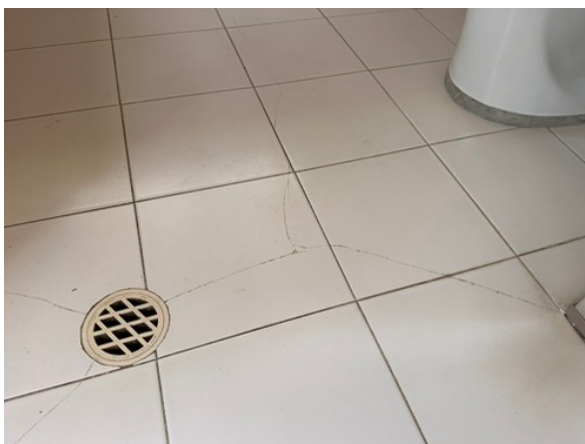
## For your information 3.05

**Location:** Ensuite

**Finding:** In the Ensuite, some tiles exhibit superficial cracks. While these imperfections don't pose any immediate risk or structural concern, they could become more noticeable over time or during property use. Replacement of the cracked tiles is at your discretion, based on your aesthetic preferences and any future plans regarding the property. For now, it's perfectly fine to leave them as they are. However, should you choose to address the issue, consulting a professional tiler would be advisable for a seamless finish.

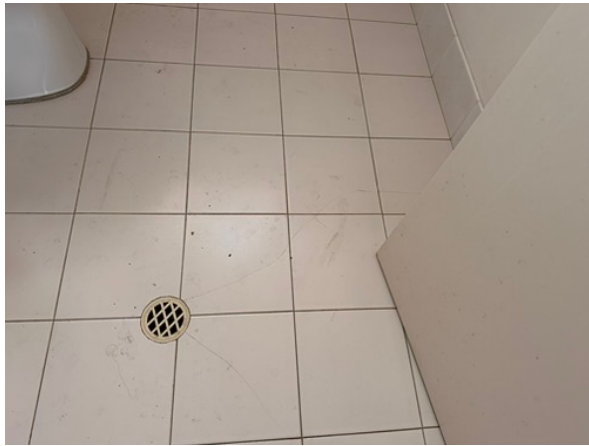
## For your information 3.06

**Location:** Toilet

**Finding:** In the toilet area, there are a few superficial cracks in the floor tiles. While these cracks currently pose no significant structural concern and the tiles remain functional, it's something worth keeping an eye on. Over time, normal wear and tear could potentially exacerbate the issue. To maintain the aesthetic and integrity of the floor, consider replacing the affected tiles as a future project. This proactive approach can help prevent any unexpected problems down the line and keep the space looking its best.

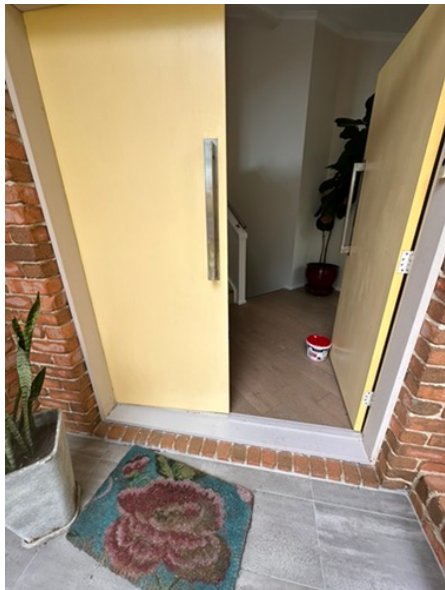
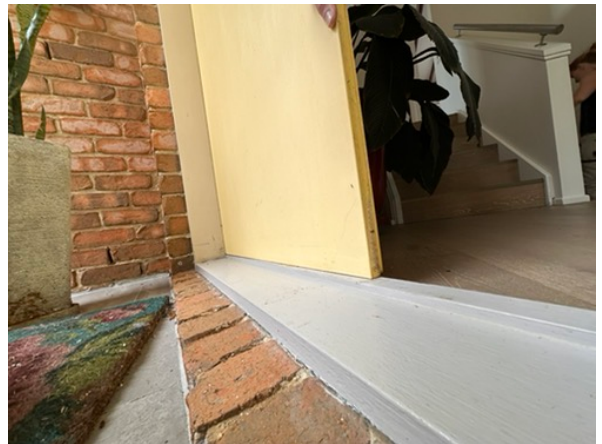
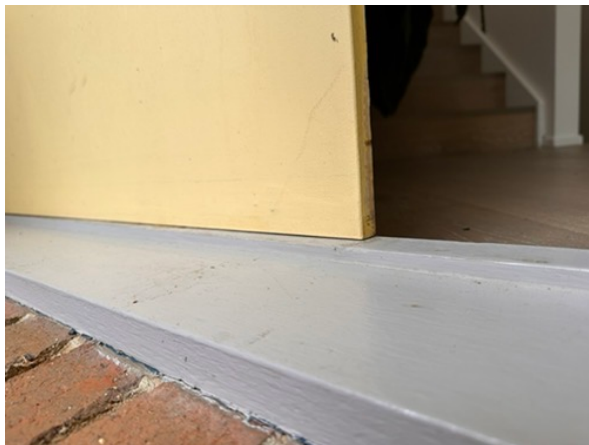
## For your information 3.07

**Location:** Front Door

**Finding:** During our inspection, we noticed that the left-hand bifold door at the front entrance scrapes along the bottom of the jamb. This minor issue likely requires only about 5mm to be trimmed off the bottom to ensure smooth operation. To prevent any potential damage or inconvenience, it's advisable for a professional carpenter to make this adjustment. This simple fix should restore proper clearance and allow the door to operate effortlessly.

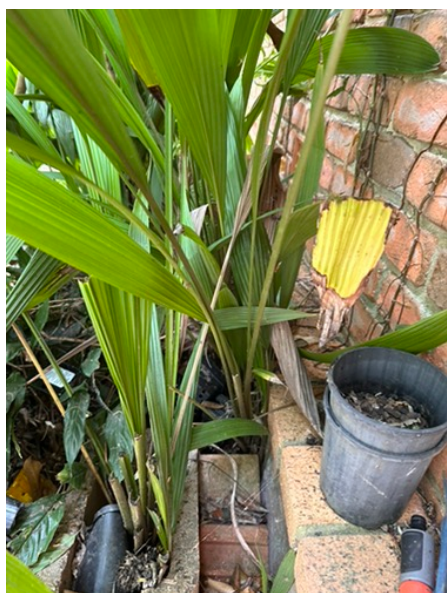
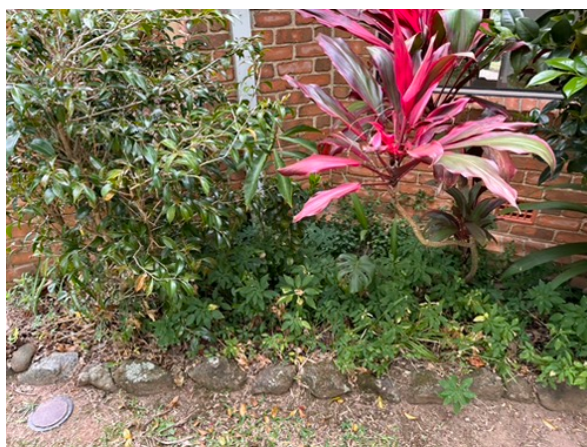
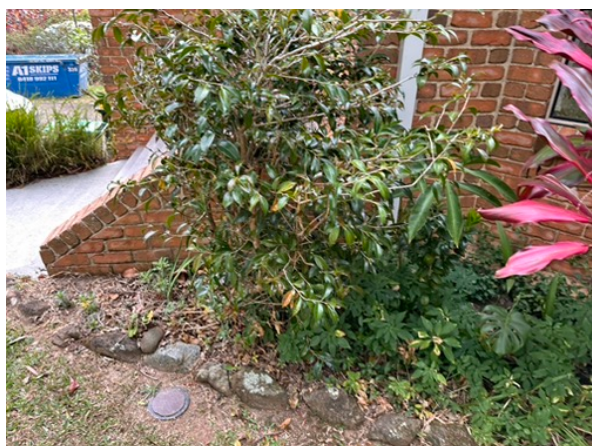
## Conditions conducive to timber pest attack 4.01

**Location:** Right Hand Side Of House

**Finding:** During the inspection, it was observed that all trees, rubs, and bushes on the right-hand side of the house are budding, creating an inviting environment for termites, which can use the house as a bridging point. This growth can potentially overshadow and compromise the property's structural integrity. To mitigate this risk, it's recommended to trim back the vegetation regularly, ensuring at least a one-meter clearance between the foliage and the building. This action will not only reduce termite access but also improve air circulation, which is beneficial for both the garden and the house.

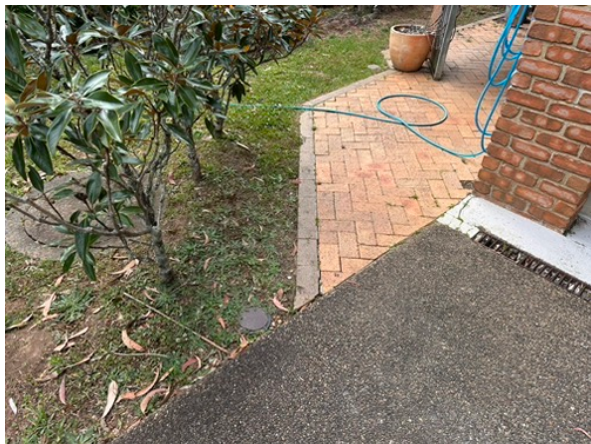
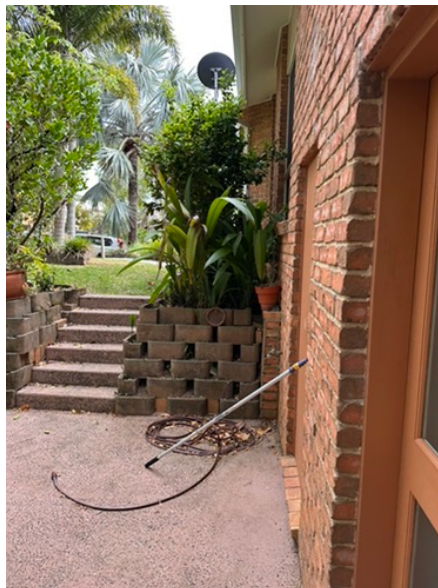
**Location:** All External Areas

**Finding:** During the inspection of all external areas, it was reassuring to find an effective termite management system in place, marked by the presence of 18 bait stations strategically positioned around the property. These stations are diligently checked every six weeks, demonstrating proactive pest control. However, for optimal protection, it's recommended that the new owner continues regular monitoring and maintenance of these stations. Additionally, consulting a pest management professional annually could enhance the effectiveness of the system and ensure early detection of any potential issues.
