Pre Purchase Building & Pest Inspection 78 Teak Crc

Property Address: 78 Teak Circuit Suffolk Park 2481

Inspection Date: 20 Apr 2026

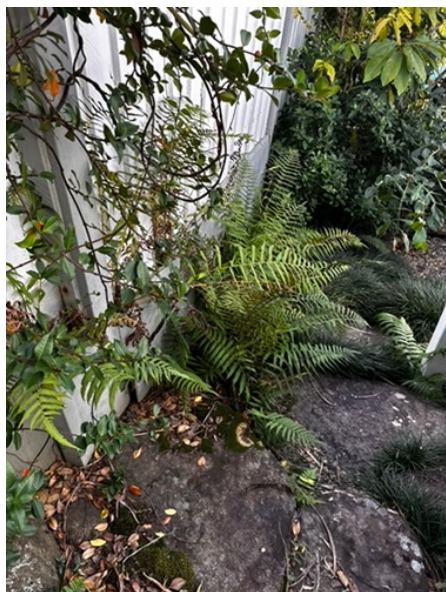
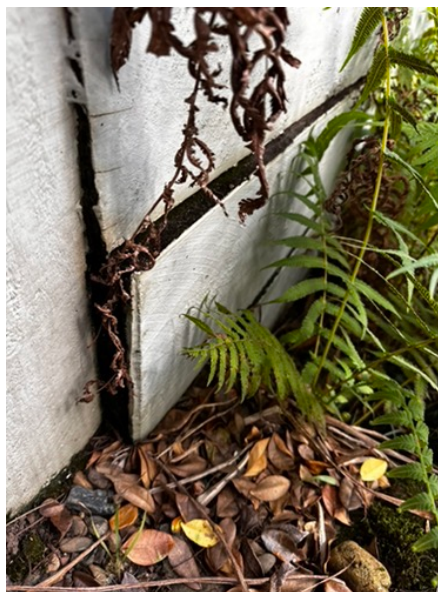
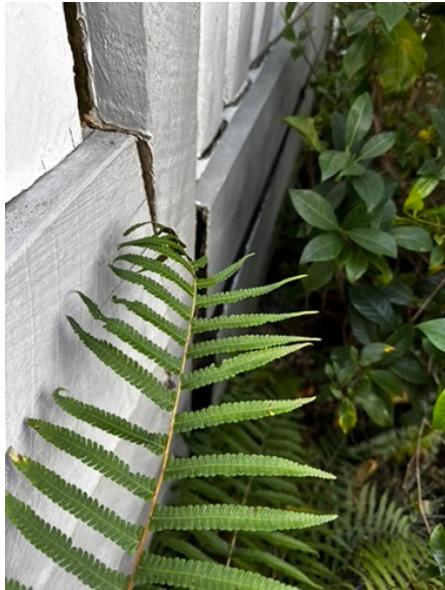
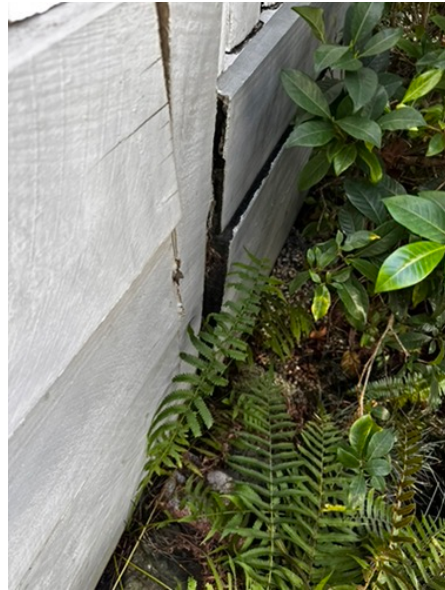
Minor Defect 1.01

Location: Right Hand Side Part Of Retaining Wall

Finding: The right-hand side of the retaining wall shows some noticeable bowing, which might become an issue if not addressed. It's a good idea to get a structural landscaper to have a look and sort it out before it escalates into a bigger problem. Reinforcement or potential rebuilding of the affected section might be necessary to ensure long-term stability. A professional can assess if corrective measures like additional support or drainage improvements might be needed to prevent further movement.

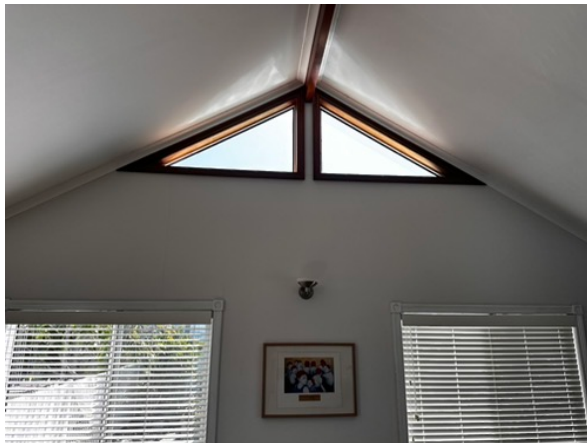
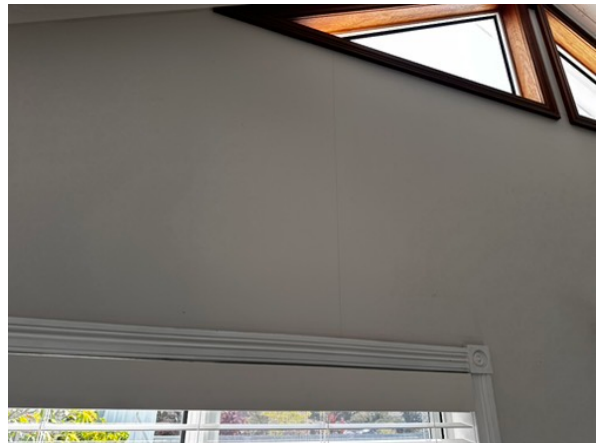
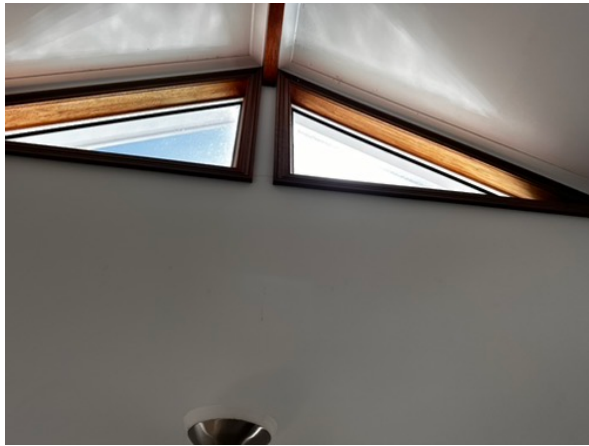
Location: Various Internal Areas

Finding: In various internal areas, there's some minor settlement cracking visible, which is quite common and not a structural concern, just a bit of an aesthetic issue. These types of cracks are usually due to normal settling of the building over time. To freshen things up, a cosmetic repair with a quality filler followed by a fresh coat of paint should do the trick. Keeping an eye out for any changes in the future is always a good idea, but right now, it's mainly about sprucing up the appearance.

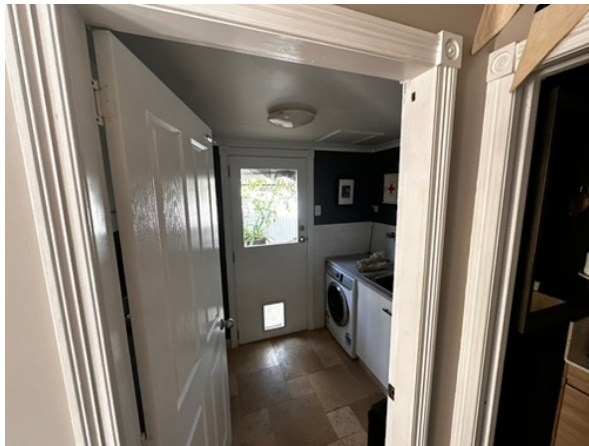
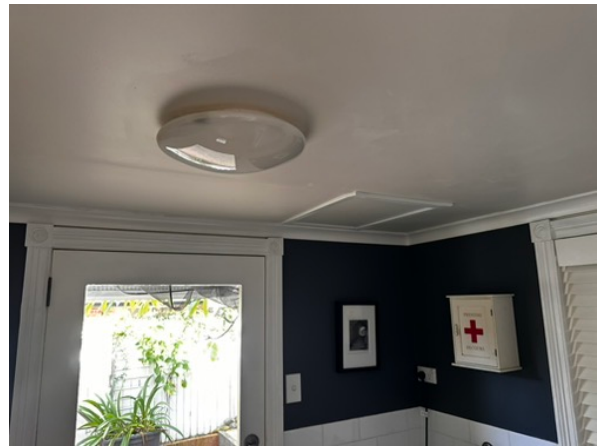
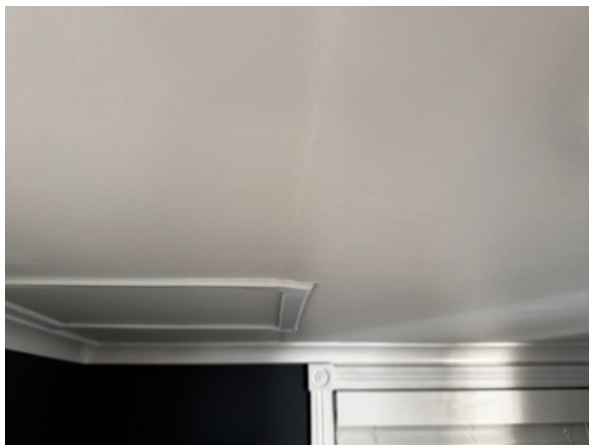
For your information 2.02

Location: Laundry

Finding: In the laundry area, there's a noticeable variation in the thickness of the gyprock sheets on the ceiling. Fortunately, it's not impacting the structure, but it does affect the smoothness and finish of the surface, which might be a bit of an eyesore. To fix this, consider having a qualified tradesperson skim the ceiling to create a more uniform appearance. This relatively simple solution will enhance the overall look and feel of the room.

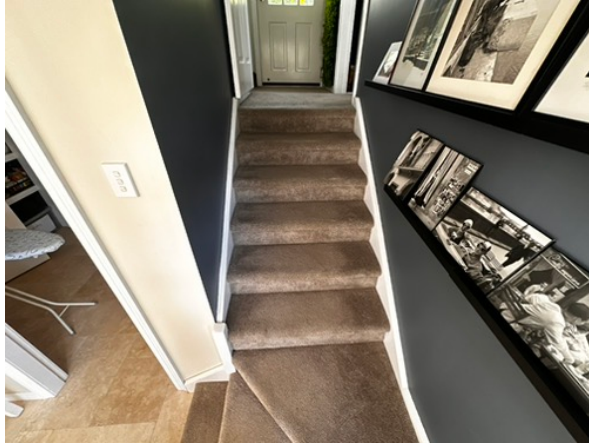
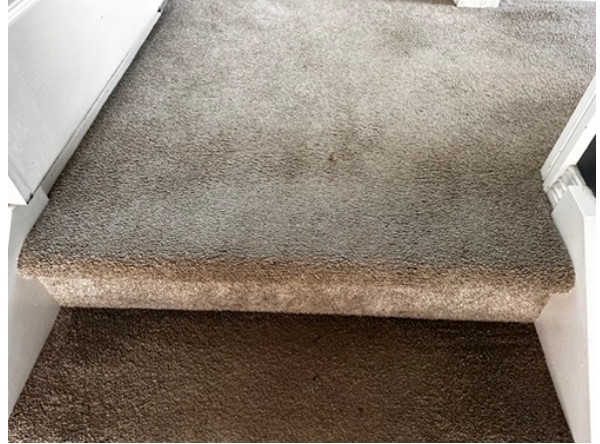
For your information 2.03

Location: Internal Stairs And Landing

Finding: There's a minor issue with the internal stairs and landing some squeaking as you go up. Nothing structural to worry about, but it might benefit from a bit of maintenance. Tightening the screws or applying some lubricant should help reduce the noise. It's an easy fix that can make your daily journey upstairs a little more peaceful.

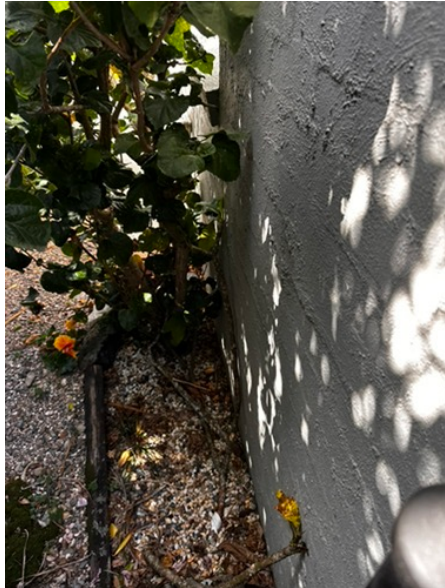
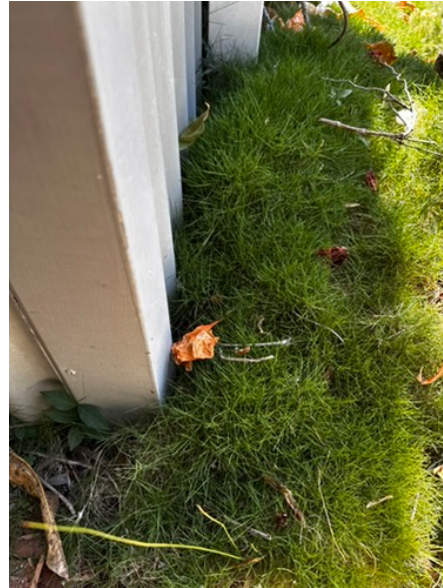
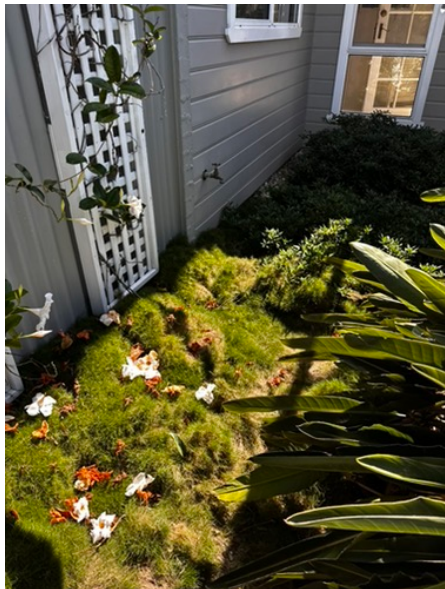
Conditions conducive to timber pest attack 3.01

Location: Various External Areas

Finding: The images indicate that shrubs and grass are in direct contact with the building, creating easy bridging points for termites. Although no termites were found currently, this setup poses a risk due to the lack of a visible barrier. To address this, it's advisable to trim the vegetation back and establish a gap between the plants and the building. This not only helps in monitoring but also acts as a preventive measure against potential termite intrusion.
