12/17 MAHOGANY DRIVE, BYRON BAY

BUILDING & PEST REPORT

Inspection Report

12/17 Mahogany Drive, Byron Bay, NSW, 2482

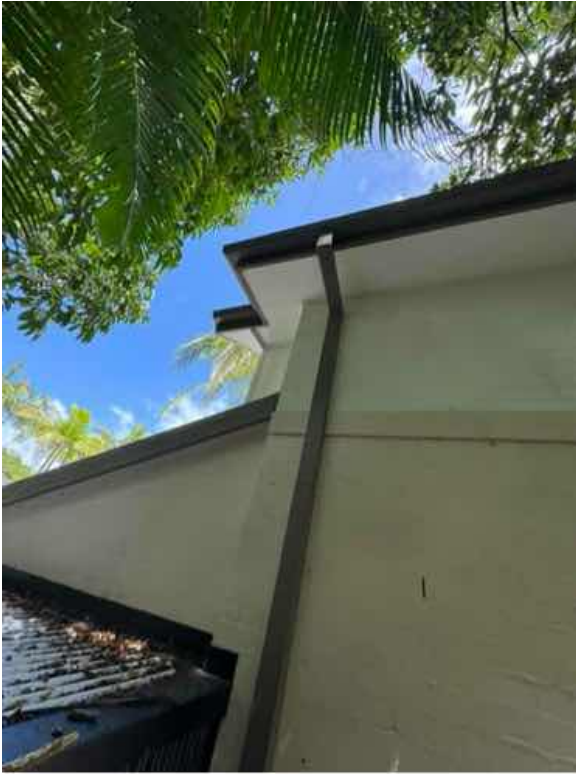
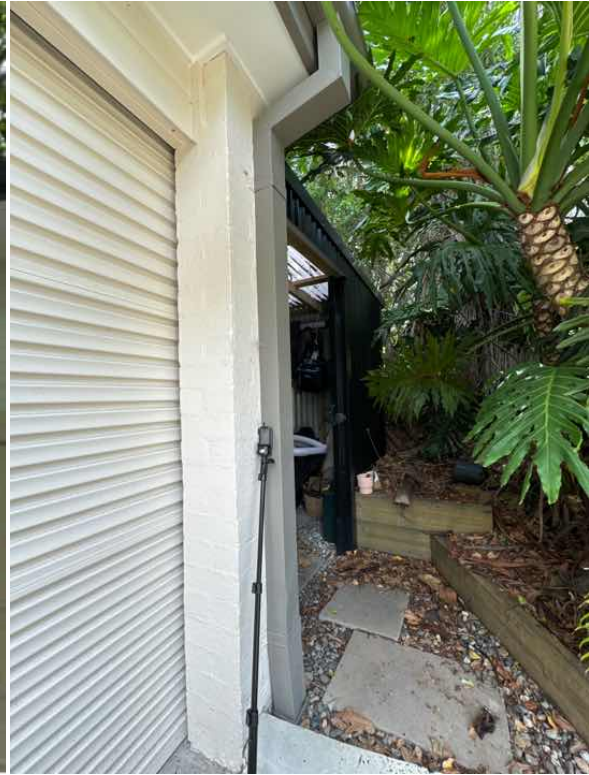
Impact damage noted to downpipe. Contact a roof plumber for replacement as required.

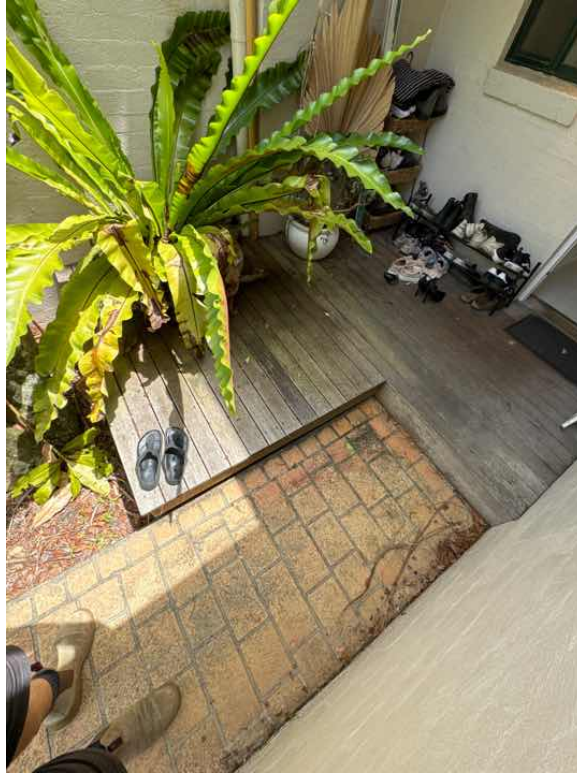
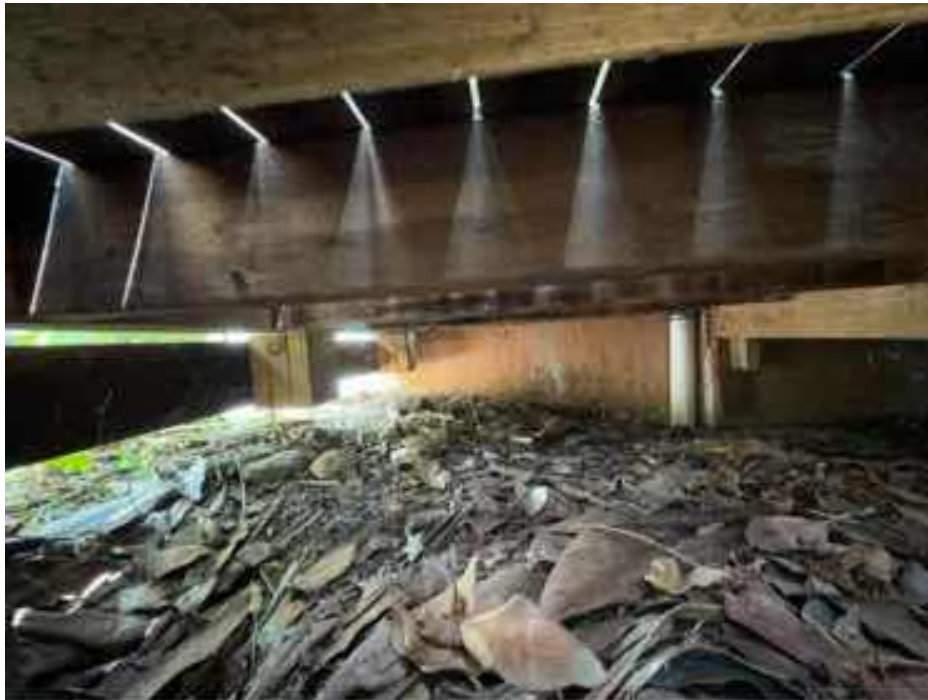
Of areas visible, minor defects and/or maintenance issues were visible. These will require assessment and subsequent repairs by a licensed tradesperson. Please read below for details. Please note that the inspector believes these to be of a minor nature relative to the age of the dwelling and or lack of proper and continual maintenance. Others, including other inspectors may differ in their opinions.

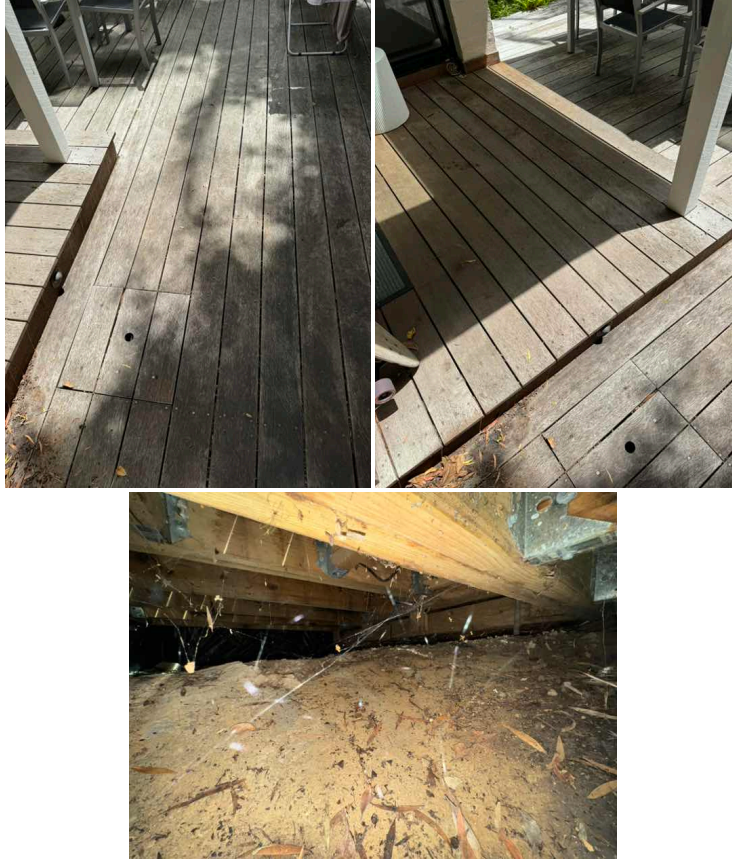
Of areas visible, minor defects and/or maintenance issues were visible. These will require assessment and subsequent repairs by a licensed tradesperson. Please read below for details. Please note that the inspector believes these to be of a minor nature relative to the age of the dwelling and or lack of proper and continual maintenance. Others, including other inspectors may differ in their opinions.

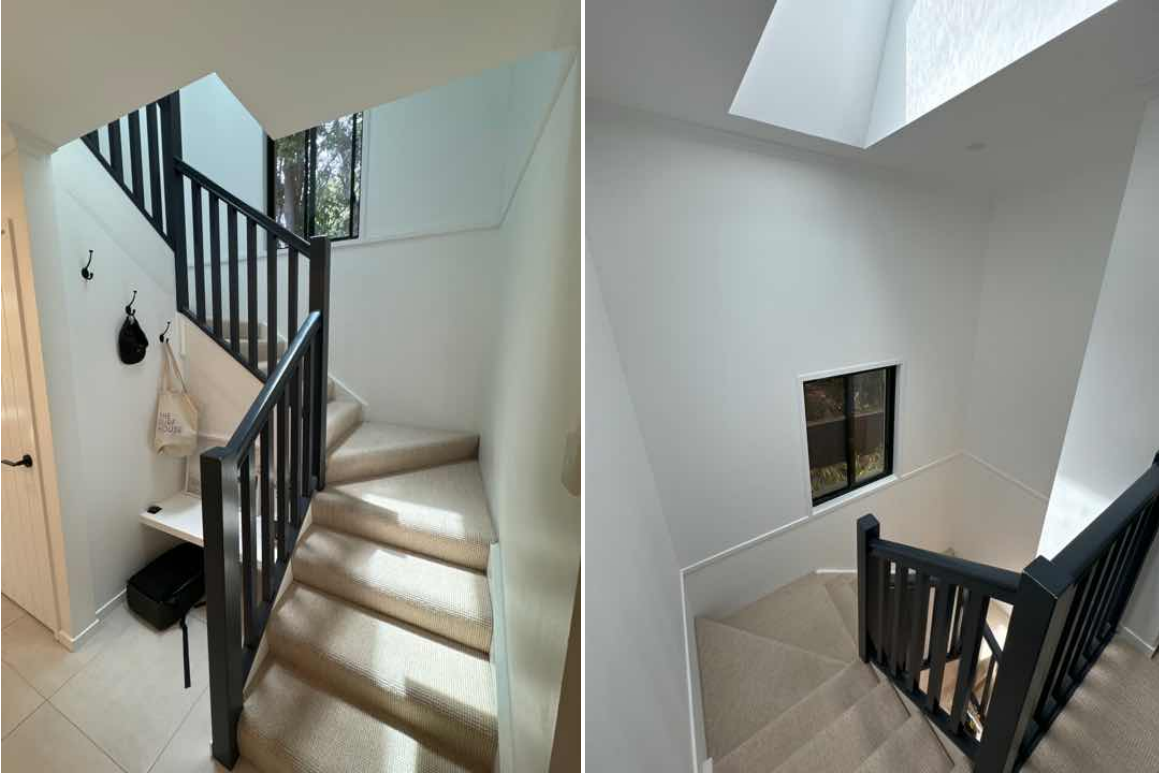
Settlement Cracks Noted. These are typical and generally patch and paint will suffice, however we recommend you monitor these cracks and if they become wider or longer, you will need to contact a structural engineers to assess.

The stair treads squeak and require maintenance.

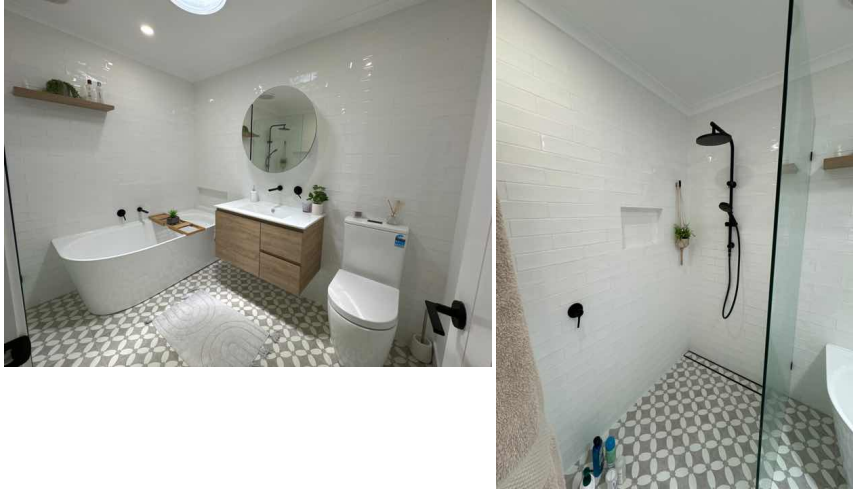
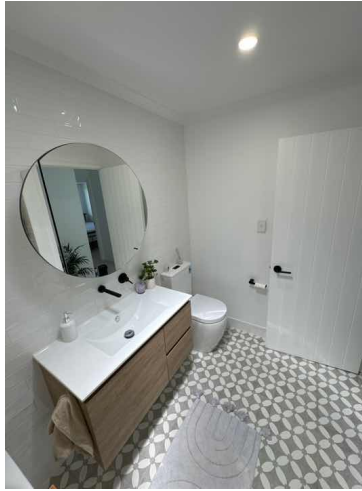
The vanity mirror is desilvering at edges. Replacement recommended.

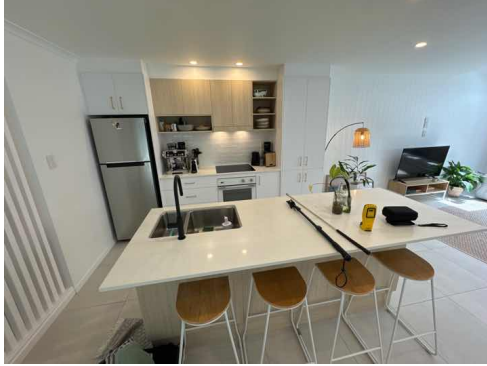
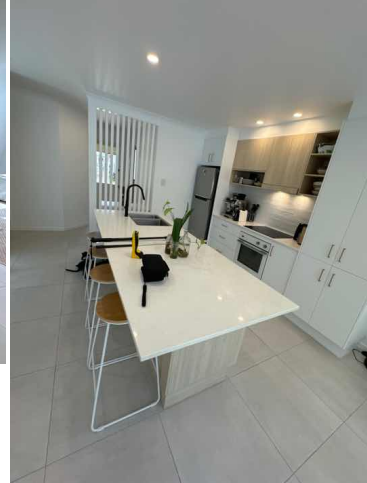
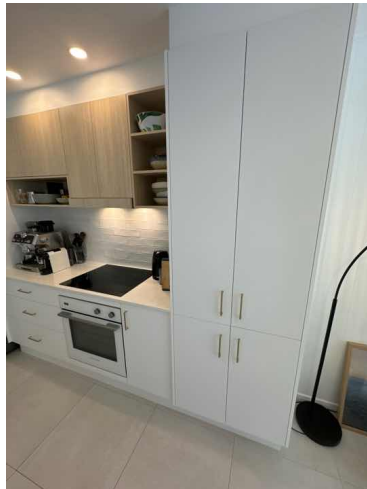
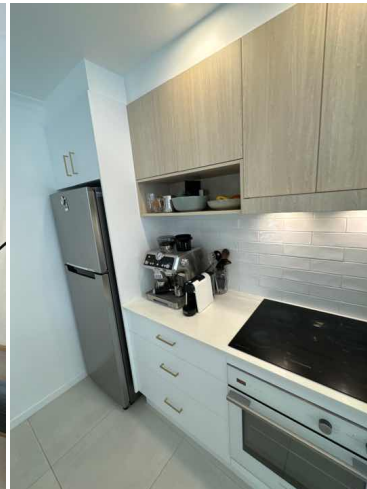
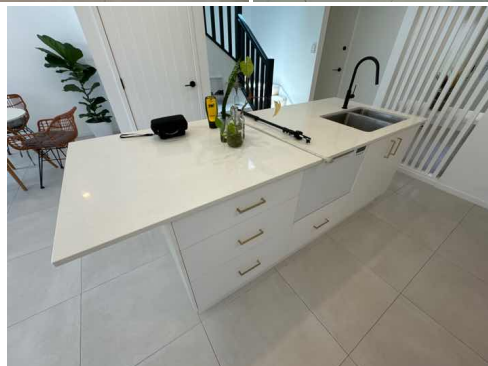
Adjustment to cabinet doors required, in some instance hinges may need to be replaced.

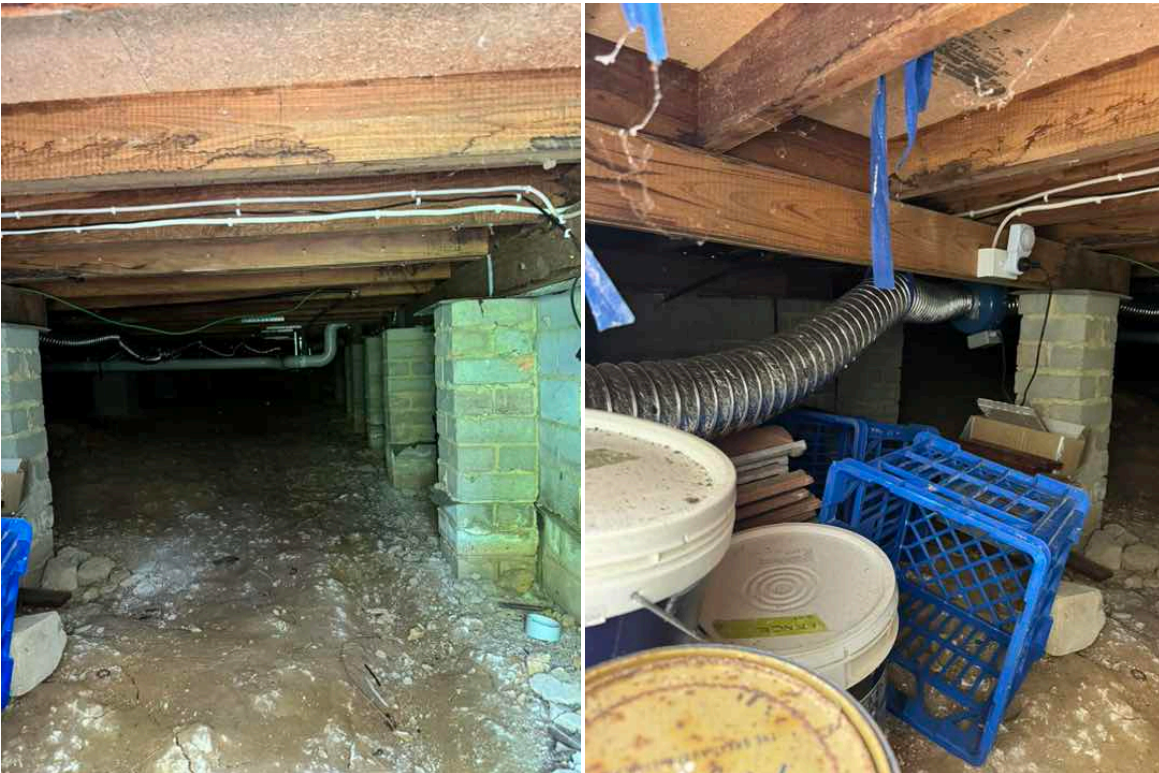
Rusted ant capping noted. Ant capping is not designed to prevent termite entry but to force the termites to reveal themselves by means of mud packing. Rusted, missing or defective ant capping will allow the termites to enter the building undetected. Contact a qualified brick layer for further advice
