Building and Pest Report

50A Ruskin Street Byron Bay

Pre-Purchase Building & Timber Pest Inspection Report

7a/21-25 Fletcher Street Byron Bay 2481 New South Wales Australia

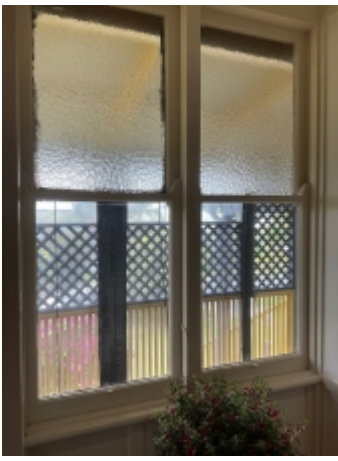
Defect Severity	Minor Defect
Defective Item	Windows
Defect	Painted Shut
Comment	The window sashes have been painted shut. Contact a licensed carpenter for repair.

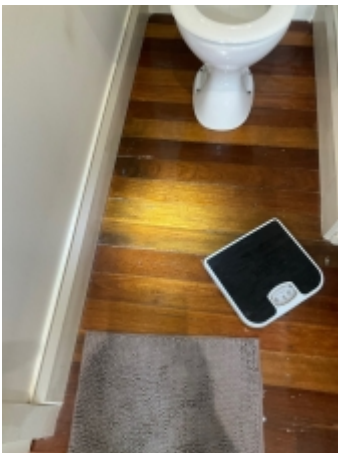
Defect Severity	Minor Defect
Defective Item	Flooring
Defect	Squeaky floor boards
Comment	An area of the floor boards is squeaky underfoot. Contact a licensed carpenter for repair.

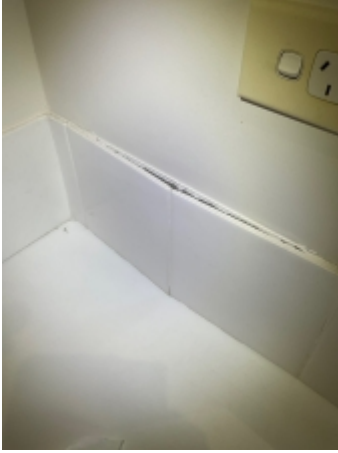
Defect Severity	Minor Defect
Defective Item	Tiled Walls
Defect	Loose
Comment	The tiles on the splashback are loose in areas/falling off. Contact a licensed tiler for assessment and repair.

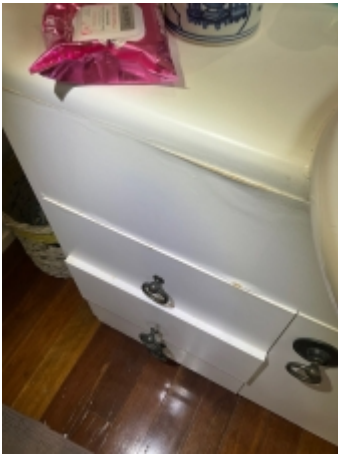
Defect Severity	Minor Defect
Defective Item	Vanity basin/cabinet
Defect	Moisture Damage
Comment	Moisture damage observed to the vanity cabinet. Contact a licensed cabinetmaker for repair or replacement.

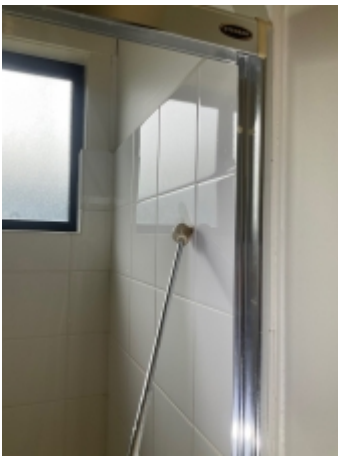
Defect Severity	Minor Defect
Defective Item	Shower
Defect	Loose tiles
Comment	The wall tiles are loose in areas/falling off. Contact a licensed tiler for immediate assessment and repair.

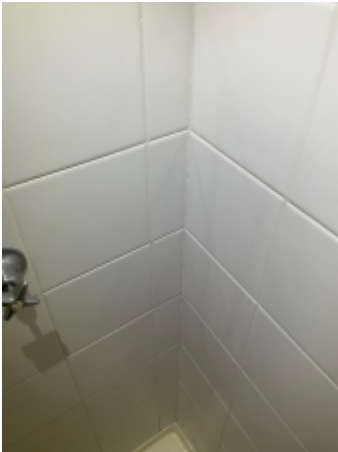
Defect Severity	Minor Defect
Defective Item	Shower
Defect	Reseal internal corners
Comment	The internal corners of the floor/wall tiles require re-sealing to prevent water ingress behind the tiles which can lead to leaking and popped tiles. Contact a licensed tiler or plumber for resealing.

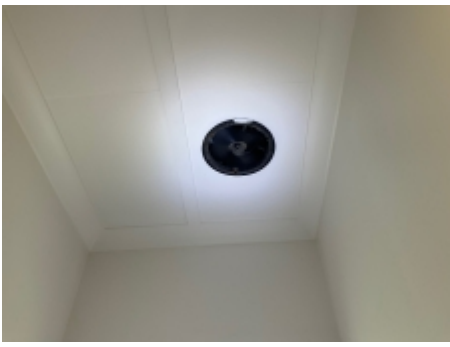
Defect Severity	Minor Defect
Defective Item	Bathroom Ventilation
Defect	Cover missing
Comment	The cover is missing from the exhaust fan. Contact a licensed electrician for replacement.

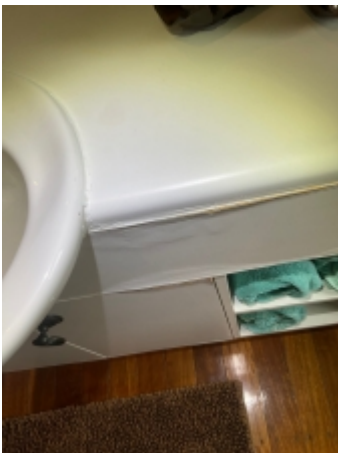
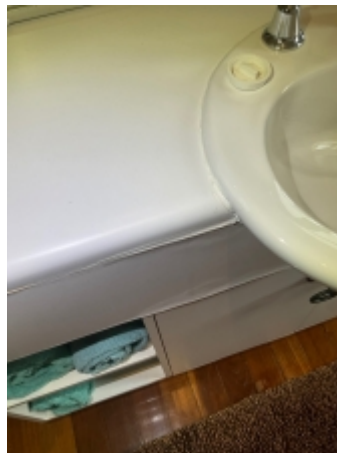
Defect Severity	Minor Defect
Defective Item	Vanity basin/cabinet
Defect	Moisture Damage
Comment	Moisture damage observed to the vanity cabinet. Contact a licensed cabinetmaker for repair or replacement.

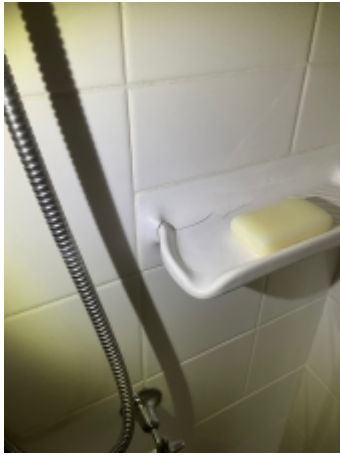
Defect Severity	Minor Defect
Defective Item	Shower
Defect	Soap dish broken
Comment	The soap dish is broken. Contact a licensed tiler for replacement.

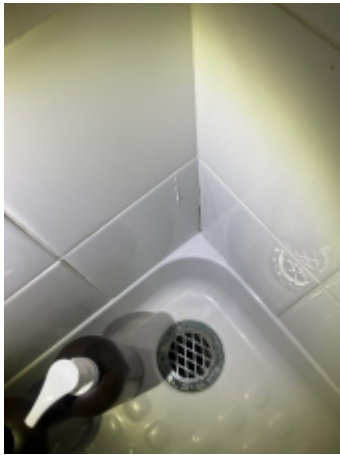
Defect Severity	Minor Defect
Defective Item	Shower
Defect	Reseal internal corners
Comment	The internal corners of the floor/wall tiles require re-sealing to prevent water ingress behind the tiles which can lead to leaking and popped tiles. Contact a licensed tiler or plumber for resealing.

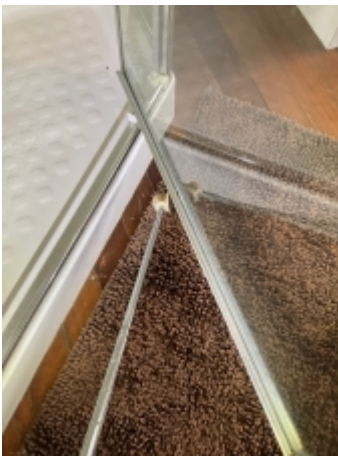
Defect Severity	Minor Defect
Defective Item	Shower
Defect	Loose trim
Comment	There is a loose trim at the base of the shower screen door. Contact a licensed glazier for repair.

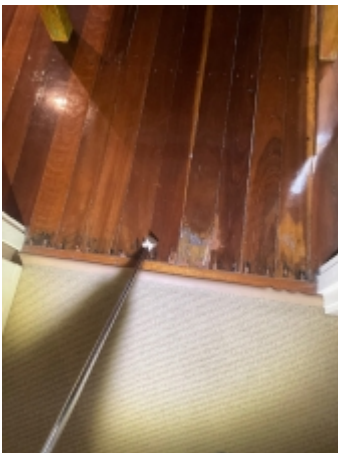
Defect Severity	Minor Defect
Defective Item	Flooring
Defect	Loose flooring
Comment	Movement was noted in a section of the floor boards. Contact a licensed carpenter for re-fixing.

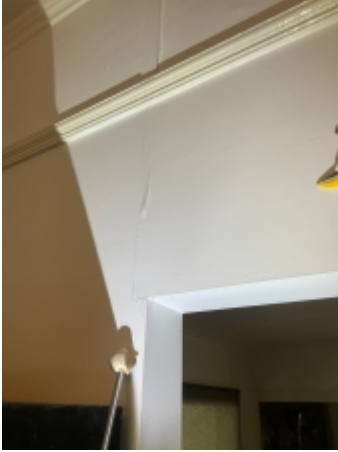
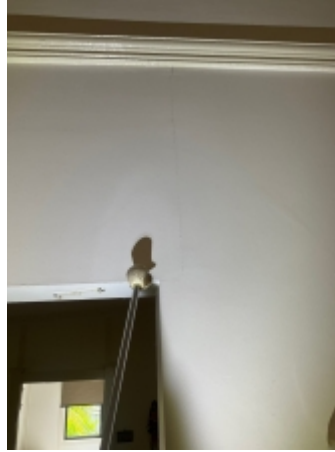
Defect Severity	Minor Defect
Defective Item	Walls
Defect	Cracks Settlement Minor

Settlement Cracking observed. These are typical, and generally, patch and paint will suffice, however, monitoring these cracks is advised and if they become wider or longer you should contact a qualified builder for assessment.

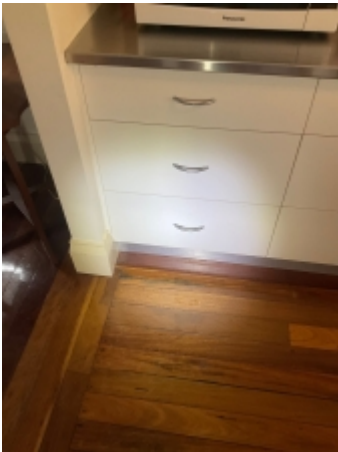
The drawers require adjustment. Contact a licensed cabinetmaker for repair.

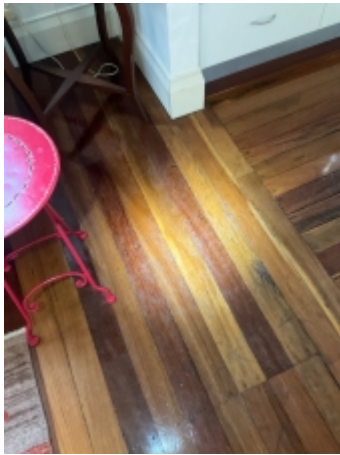
Defect Severity	Minor Defect
Defective Item	Flooring
Defect	Squeaky floor boards
Comment	An area of the floor boards is squeaky underfoot. Contact a licensed carpenter for repair.

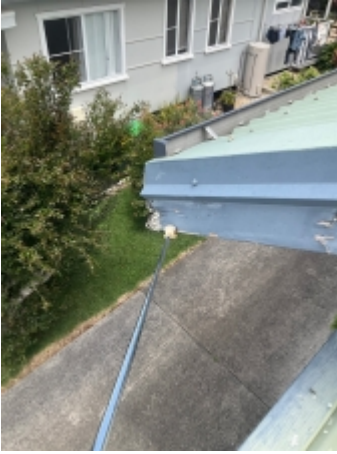
Defect Severity	Minor Defect
Defective Item	Fascia/barge boards
Defect	Timber Fungal Decay
Comment	Timber fungal decay/rot was observed in areas of the fascia/barge boards. Contact a licensed carpenter for repair.

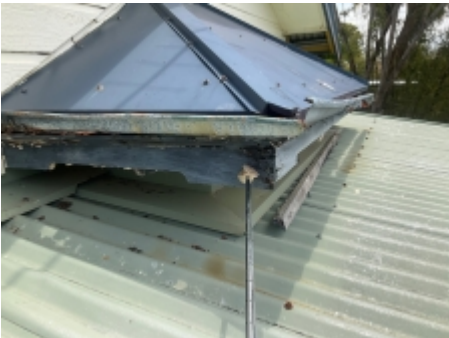
Defect Severity	Minor Defect
Defective Item	Window hood
Defect	Deteriorated fascia
Comment	The fascia boards around the window hood are deteriorated. Contact a licensed carpenter for repair.

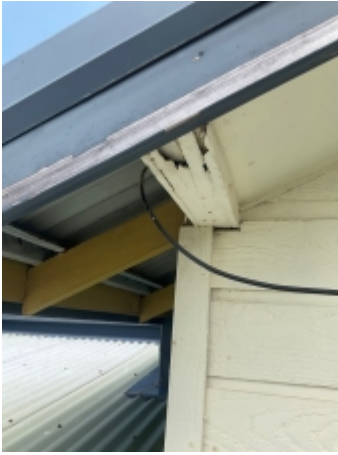
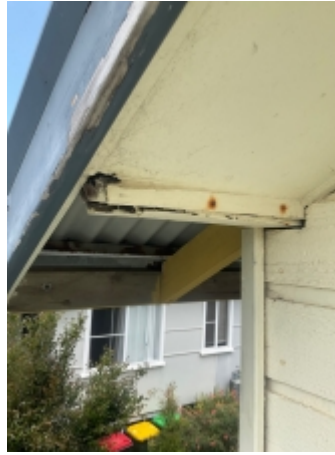
Defect Severity	Minor Defect
Defective Item	Eaves
Defect	Timber fungal decay/rot
Comment	Timber fungal decay/rot observed in sections of the eave trims. Contact a licensed carpenter for repair.

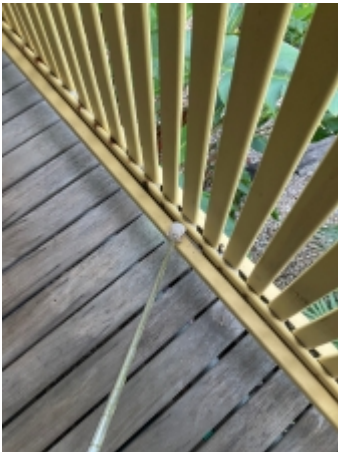
Defect Severity	Minor Defect
Defective Item	Balustrades
Defect	Balustrade rot
Comment	Timber fungal decay/rot observed in areas of the timber balustrade. Contact a licensed carpenter for repair.

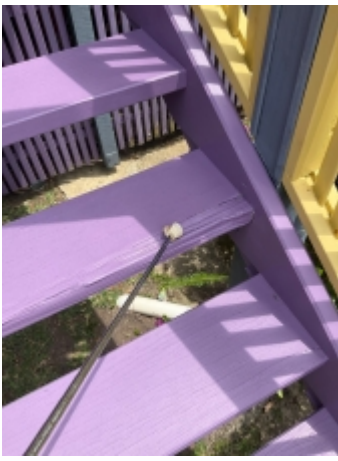
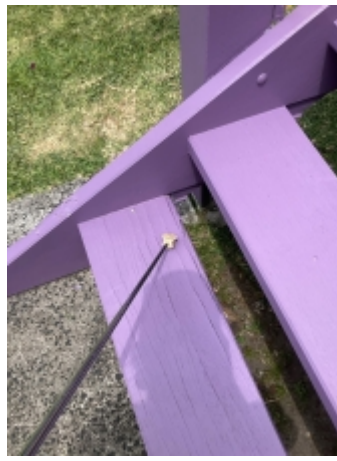
Defect Severity	Minor Defect
Defective Item	External Stairs
Defect	Tread Rot
Comment	Timber fungal decay/rot was observed in a number of the stair treads. Contact a licensed carpenter for repair to prevent unsafe conditions.

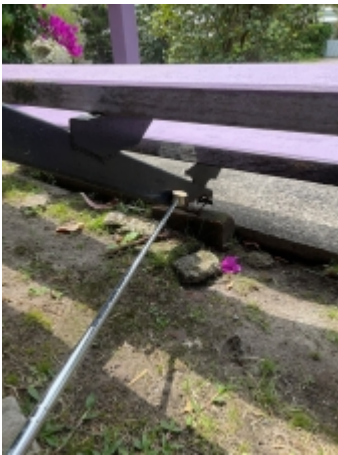
Defect Severity	Minor Defect
Defective Item	External Stairs
Defect	Rust to stringers/frame
Comment	Rust was observed to the central steel stair stringer at the base. Contact a licensed carpenter for further assessment and repair.

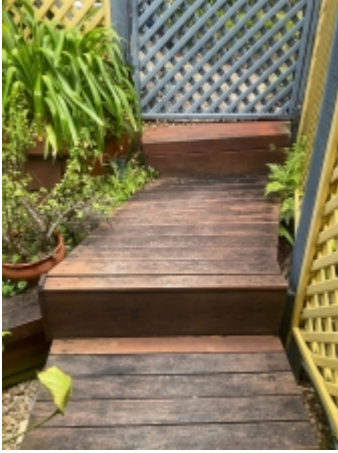
Defect Severity	Minor Defect
Defective Item	Steps
Defect	Dropped/out of level
Comment	The rear garden steps up tp the car park area have dropped and are out of level. Contact a licensed carpenter for further assessment and repair.

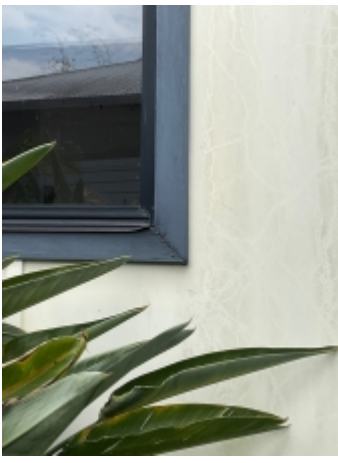
Defect Severity	Minor Defect
Defective Item	External windows
Defect	Rot To Window
Comment	Timber fungal decay/rot was observed in a section of the window architraves. Contact a licensed carpenter for repair.

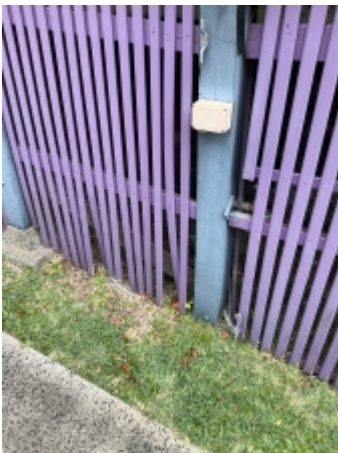
Defect Severity	Minor Defect
Defective Item	External Walls
Defect	Damage to subfloor slats
Comment	The slats enclosing the subfloor area are damaged in areas. Contact a licensed carpenter for repair.

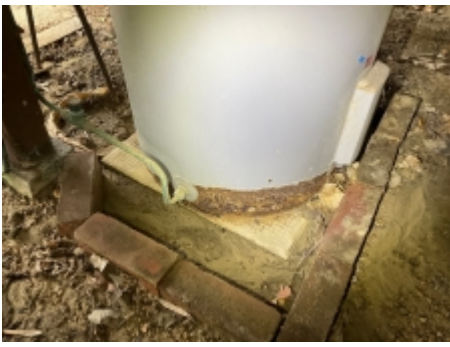
Rusted HWS

The HWS is rusted around the base. Contact a licensed plumber for assessment.

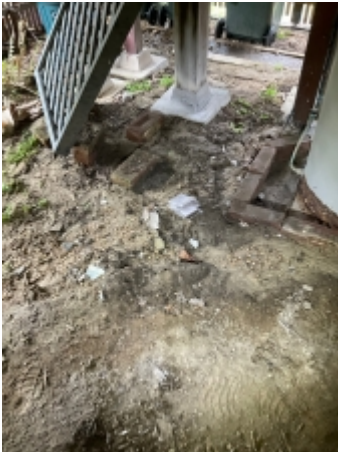
Defect Severity	Minor Defect
Defective Item	Dampness
Defect	Evidence of water entering subfloor
Comment	Although dry at the time of inspection, there is visible evidence of water having entered the subfloor space. This should be monitored during periods of prolonged rainfall and if water is entering the subfloor a licensed plumber must be engaged to assess the site drainage around the home.

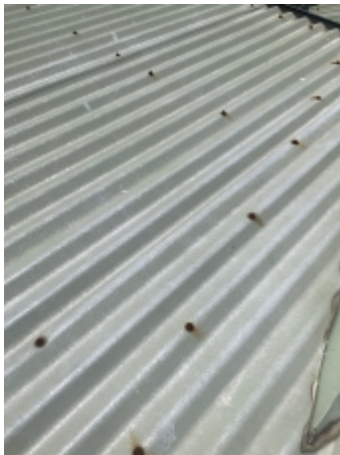
Defect Severity	Minor Defect
Defective Item	Roof cladding
Defect	Screw rust
Comment	Rusted roof screws were observed, this can lead to penetrating rust in the roof cladding and leaking. Contact a licensed roof plumber for replacement of affected areas.

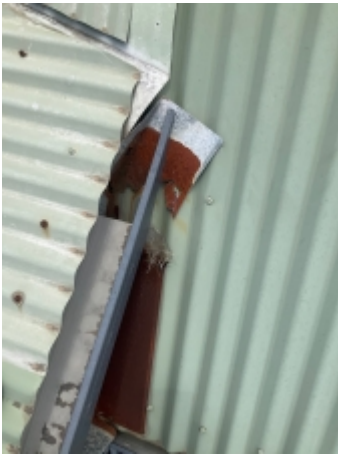
Defect Severity	Minor Defect
Defective Item	Flashings
Defect	Flashing rust
Comment	Rusted flashings were observed in areas over the front verandah roof. Contact a licensed roof plumber for assessment.

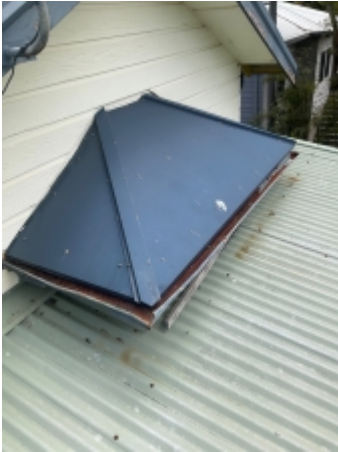
Defect Severity	Minor Defect
Defective Item	Guttering
Defect	Gutter rust
Comment	Rusted guttering was observed on the window hood. Contact a licensed plumber for assessment and repair.

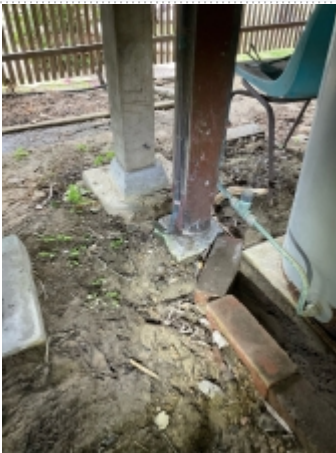
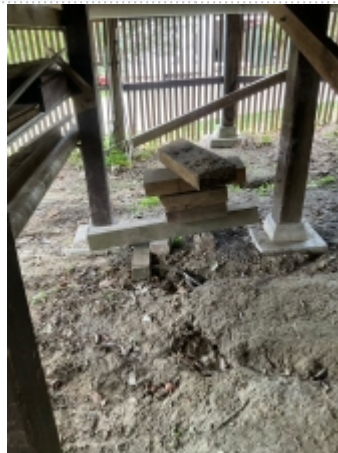
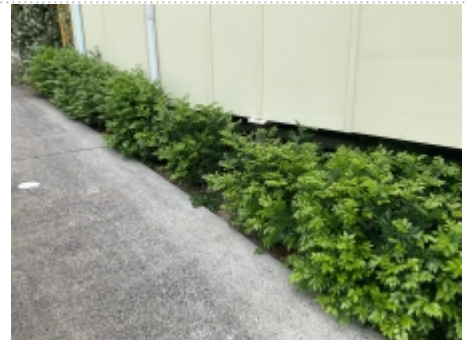
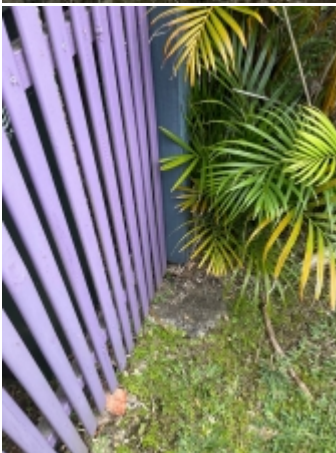
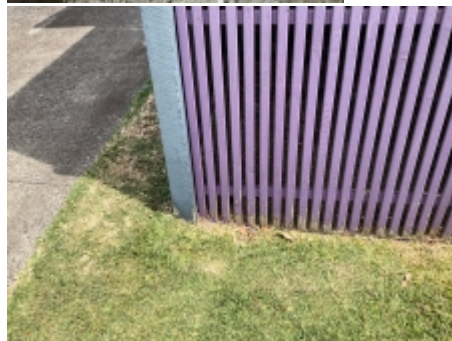
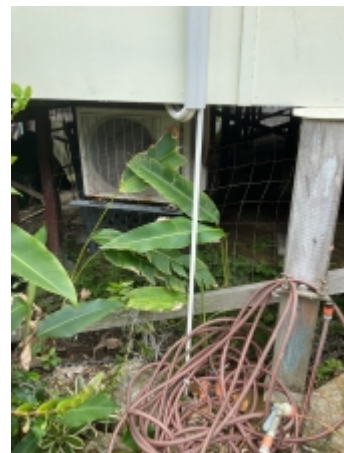
These provide conducive conditions and/or concealed entry for termite infestation and must be rectified to reduce risk.
