## Statement of Timber Repair Works

| Property | 18 Learmouth Street, Belmont VIC 3216 |
| Works completed | 15 October 2026 |
| Carried out by | Hugh Hunter, HHBuilt |

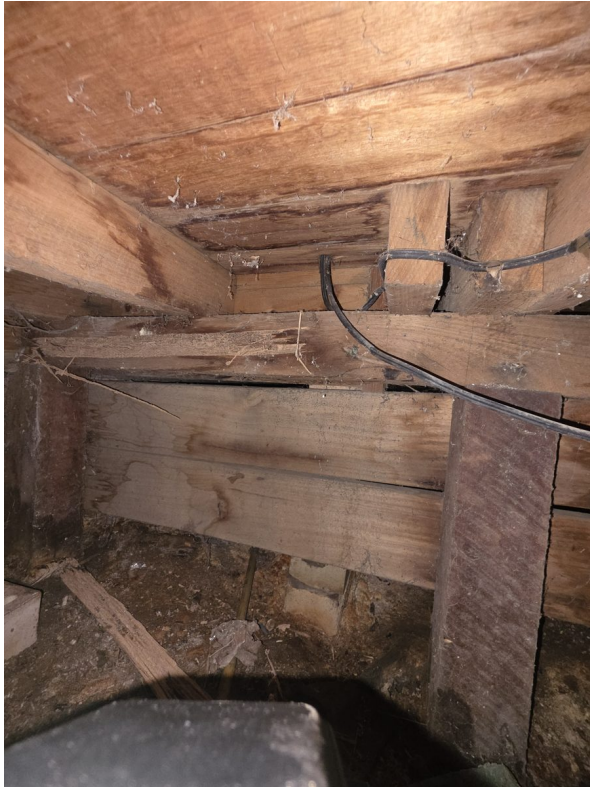
1. Before: original bearer where termite activity may have been present

- 1. Replacement of affected timber.** The subfloor bearer at the rear of the laundry and toilet, where past termite activity may have been present, was removed and replaced with new timber.
- 2. Subfloor inspection.** The full subfloor was inspected, including bearers, joists and stumps, for signs of termite activity.
- 3. Wall frame inspection.** A camera was used behind power points throughout the home to inspect the internal wall framing. Weatherboards were also removed in selected areas so the wall frame and the back of the cladding could be inspected directly.

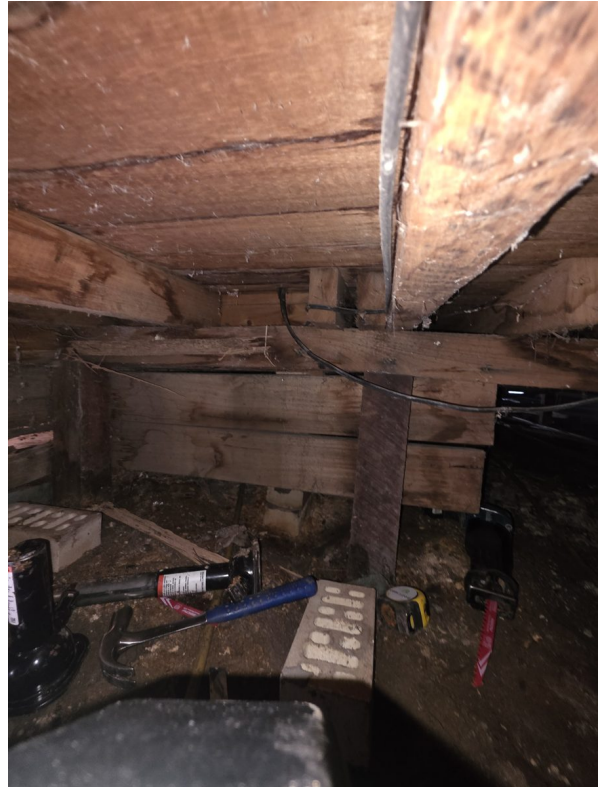
2. During works: floor propped and affected timber removed

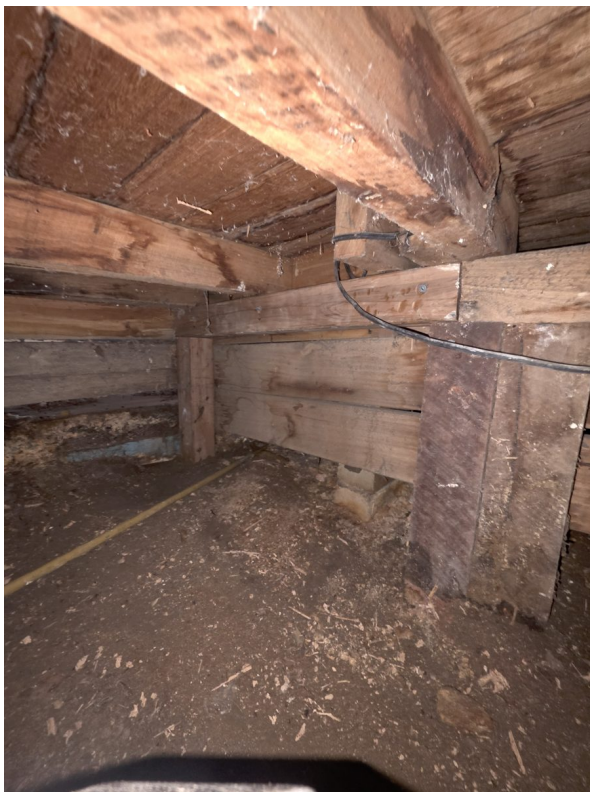
3. After: new bearer timber installed

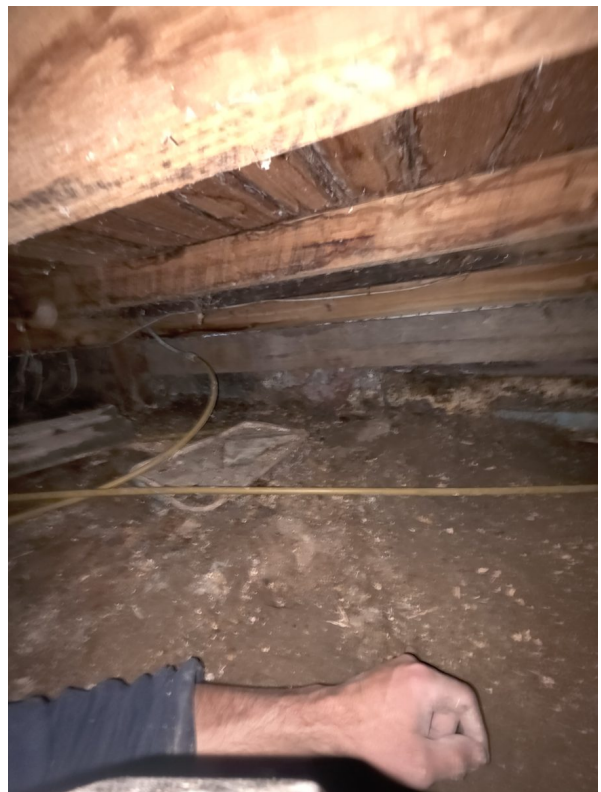
4. Subfloor inspection of surrounding bearers, joists and stumps

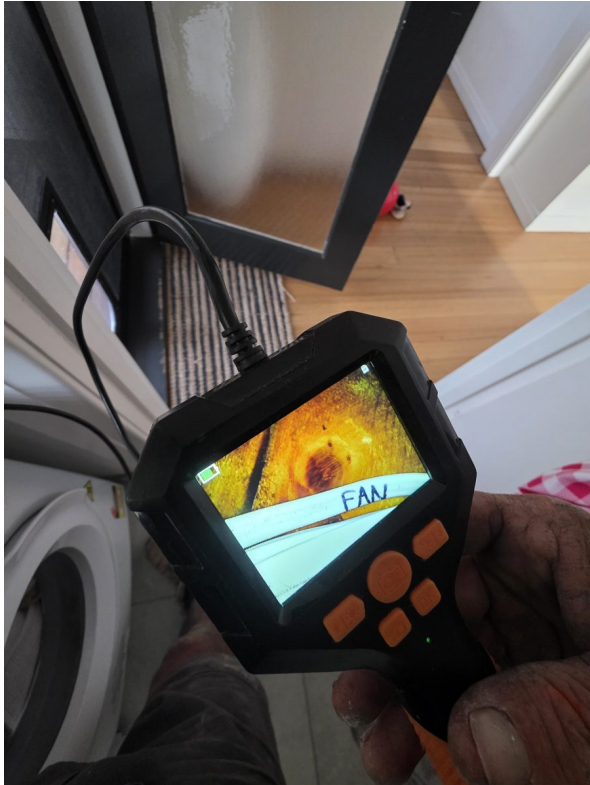
5. Camera inspection of internal wall framing (laundry)

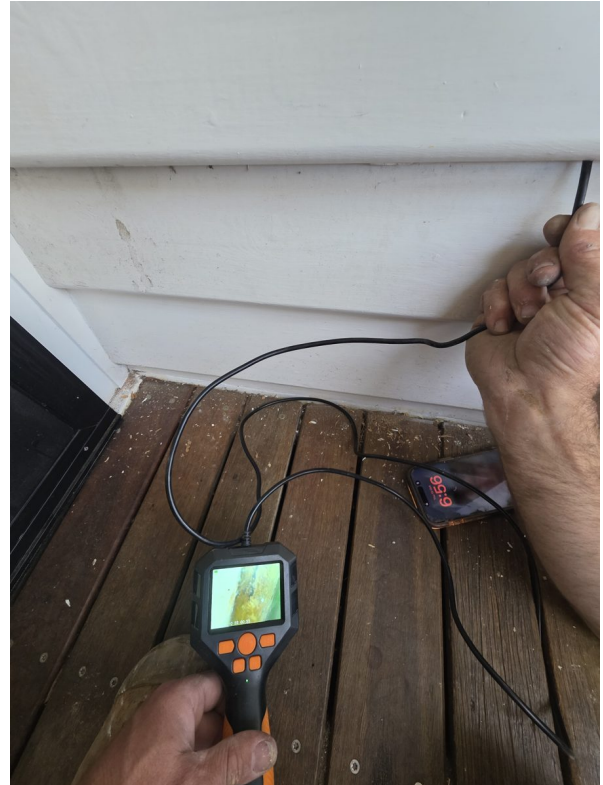
6. Camera inserted behind weatherboards

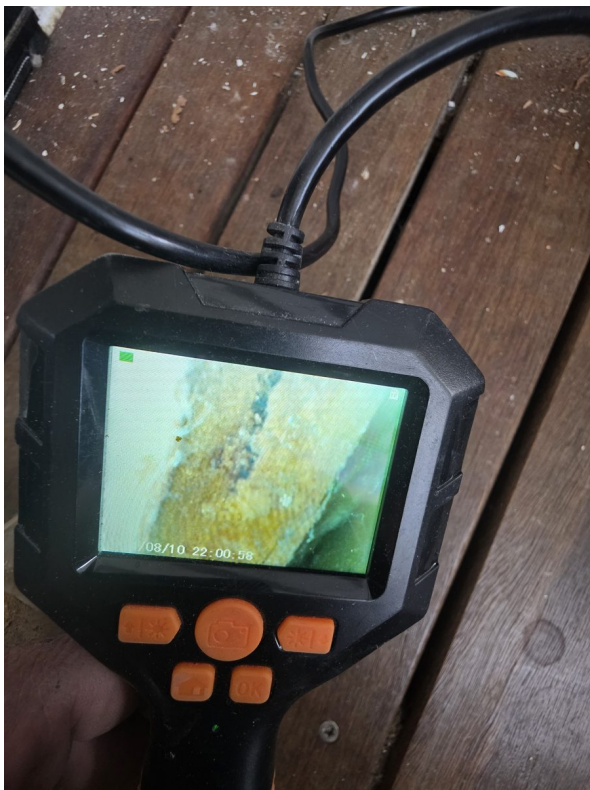
7. Camera view of wall frame timber

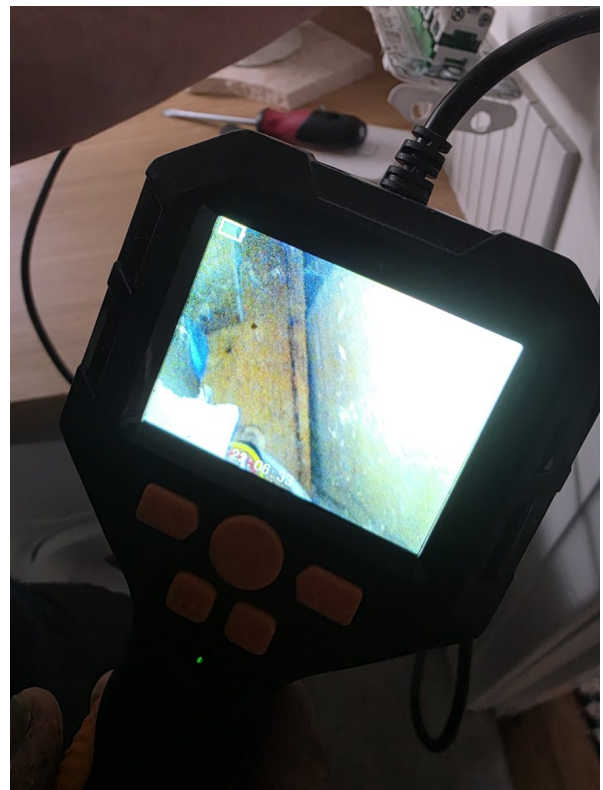
8. Camera inspection through power point opening
