# Inspection Report

## Bloom Inspections

**18 Learmouth Street , Belmont, VIC, 3216**

Inspection Date: 01 Oct 2026

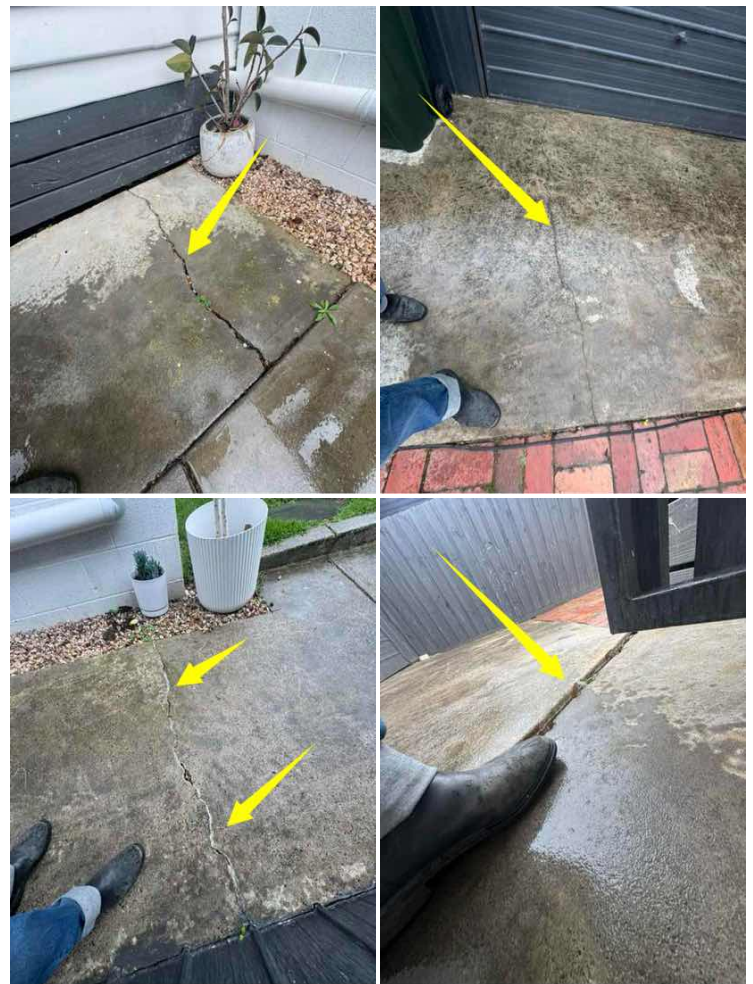
| Section | Location | Name | Comment |
|---|---|---|---|
| THE SITE | Pathways | Pathway Observations | #2. Moderate cracks were observed in sections of the concrete surfaces. Cracks are generally an unavoidable part of the process of concrete construction. Excessive water content or rapid drying of concrete can increase the likelihood of shrinkage curing cracks occurring. Low cement mix ratios, ground movements, heavy traffic, site drainage issues, insufficient control cuts can contribute to cracks. Some of these cracks require monitoring and where raised edges occurs grinding lippage is recommended. |

#2. Moderate cracks were observed in sections of the concrete surfaces. Cracks are generally an unavoidable part of the process of concrete construction. Excessive water content or rapid drying of concrete can increase the likelihood of shrinkage curing cracks occurring. Low cement mix ratios, ground movements, heavy traffic, site drainage issues, insufficient control cuts can contribute to cracks. Some of these cracks require monitoring and where raised edges occurs grinding lippage is recommended.

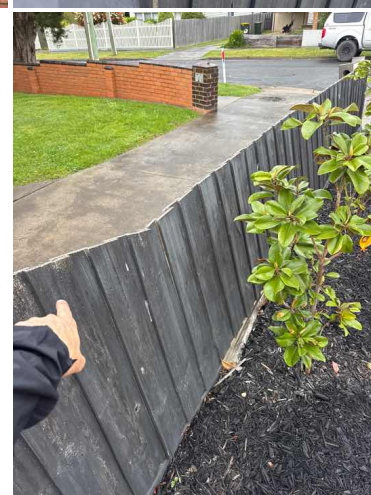
| Section | Location | Name | Comment |
|---|---|---|---|
| THE SITE | Fencing and Gateways | Observations | #3. Fencing is ageing and shows deterioration with some sections unstable and leaning out of alignment, likely due to general wear, obstructions, decayed or rotting posts and movement around post foundations which reduces overall stability and serviceability. We recommend a suitably competent and qualified fencing contractor further assess the fencing and provide advice and quotations for any required straightening, reinforcement repair or replacement works to restore stability. |

#3. Fencing is ageing and shows deterioration with some sections unstable and leaning out of alignment, likely due to general wear, obstructions, decayed or rotting posts and movement around post foundations which reduces overall stability and serviceability. We recommend a suitably competent and qualified fencing contractor further assess the fencing and provide advice and quotations for any required straightening, reinforcement repair or replacement works to restore stability.

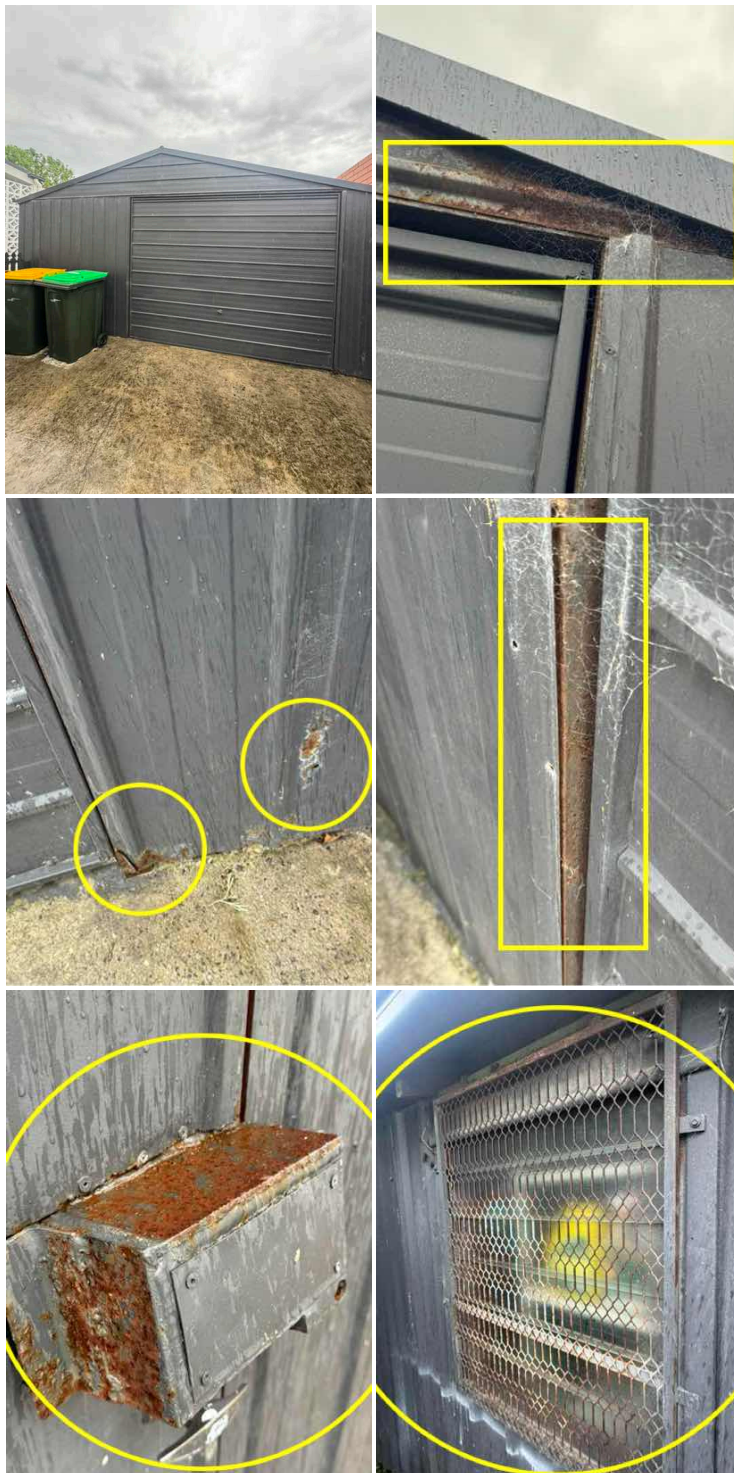
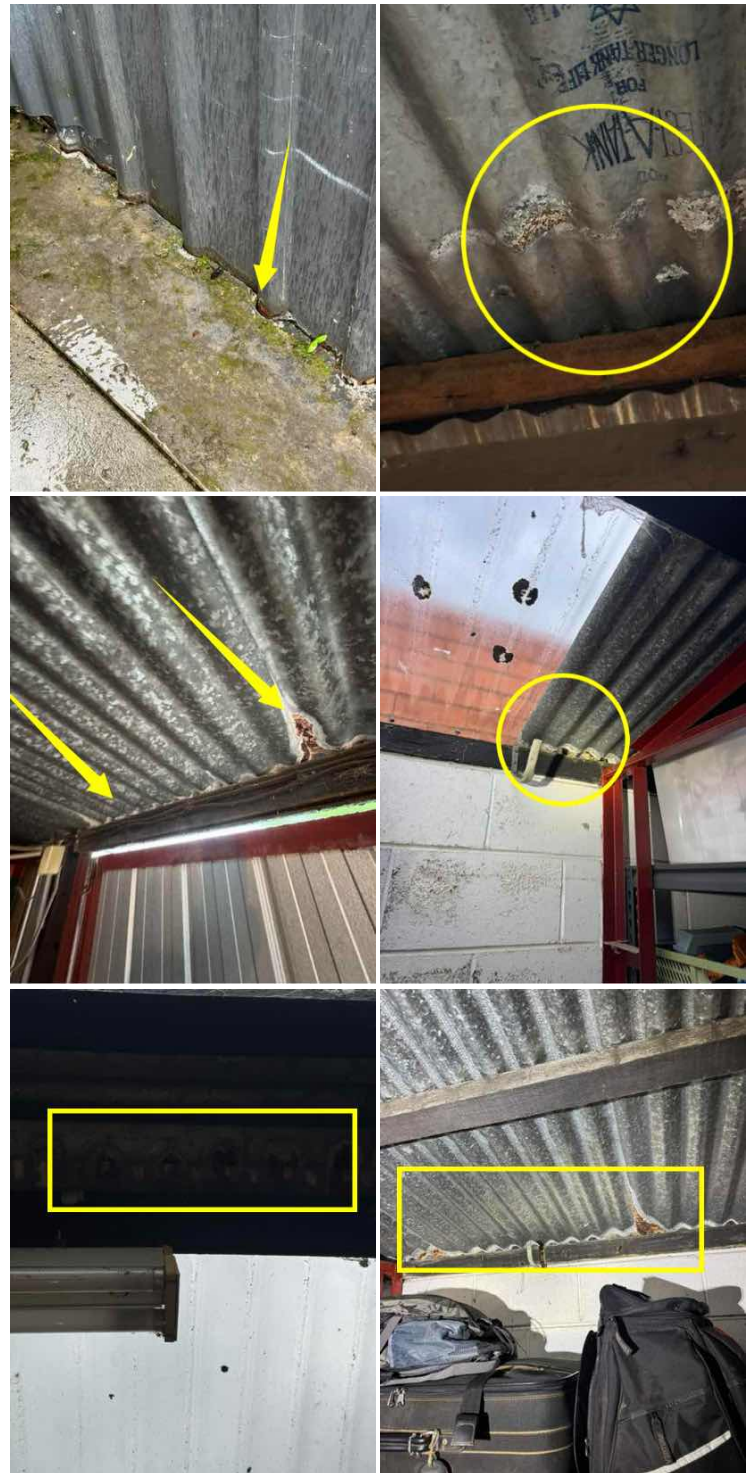
| CARPORTS AND GARAGES | Garage | Overall Condition | #5. Ageing is evident particularly to external steelwork, with rust observed, indicating corrosion to metal components exposed to the weather; if not addressed, this condition may progress, leading to accelerated corrosion, loss of protective coatings, and potential weakening of the affected elements over time. It is recommended that a suitably competent and qualified tradesperson or painter further assess the condition, remove loose rust, apply appropriate corrosion treatment, prepare the surfaces, reseal and recoat affected components, provide quotations, and carry out the necessary maintenance works to preserve the steelwork and prevent further deterioration. |

#5. Ageing is evident particularly to external steelwork, with rust observed, indicating corrosion to metal components exposed to the weather; if not addressed, this condition may progress, leading to accelerated corrosion, loss of protective coatings, and potential weakening of the affected elements over time. It is recommended that a suitably competent and qualified tradesperson or painter further assess the condition, remove loose rust, apply appropriate corrosion treatment, prepare the surfaces, reseal and recoat affected components, provide quotations, and carry out the necessary maintenance works to preserve the steelwork and prevent further deterioration.

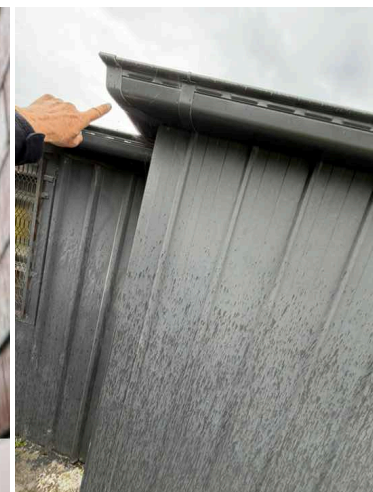
Joint leakage

| CARPORTS AND GARAGES | Garage | Roofing and Guttering Components | #6. Evidence of gutter joint leakage was observed. We recommend further assessment during rainfall and engaging a plumber for repairs as required. |

#6. Evidence of gutter joint leakage was observed. We recommend further assessment during rainfall and engaging a plumber for repairs as required.

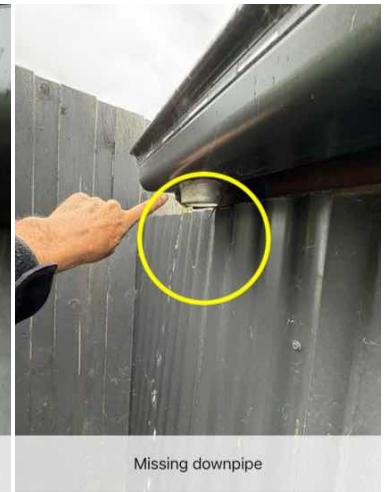
Missing downpipe

| CARPORTS AND GARAGES | Garage | Roofing and Guttering Components | #8. Down pipe missing and therefore not connected to the storm water discharge system. This has the potential to cause serious problems such as; flooding, differential movement of structure footings, issues relating to rising damp, fungal timber decay (wood rot) and also provides for a conducive environment for timber pest activity. Neighbouring properties can also be adversely affected. We recommend that a qualified plumber should be engaged to rectify as a matter of importance. |

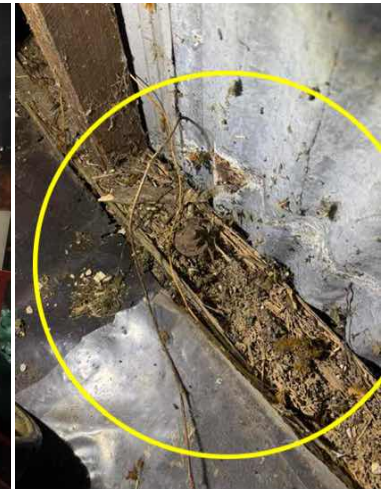
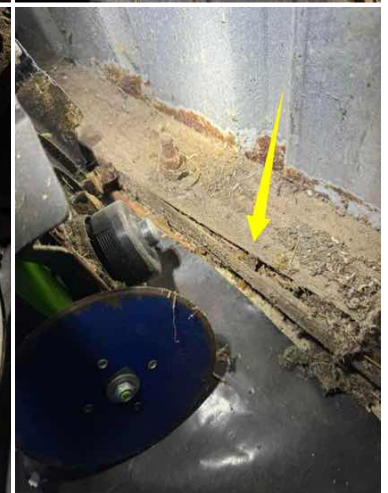
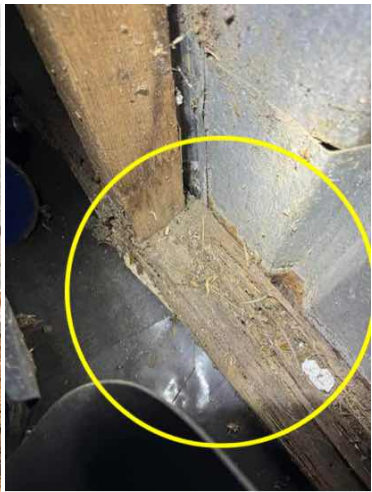
| Section | Location | Name | Comment |
|---|---|---|---|
| CARPORTS AND GARAGES | Garage | Framing | #9. Termite workings/damage were observed to rear of garage/shed to bottom plates and studs. This requires further invasive assessment by a registered builder to remove building components to determine the degree of termite damage present. The damage requires tracing back to the point(s) of entry to the furthest points of termite workings. We also strongly recommend engaging a licensed pest controller immediately to further invasively assess, treat and eradicate if required in accordance with AS3660.2 |

#9. Termite workings/damage were observed to rear of garage/shed to bottom plates and studs. This requires further invasive assessment by a registered builder to remove building components to determine the degree of termite damage present. The damage requires tracing back to the point(s) of entry to the furthest points of termite workings. We also strongly recommend engaging a licensed pest controller immediately to further invasively assess, treat and eradicate if required in accordance with AS3660.2

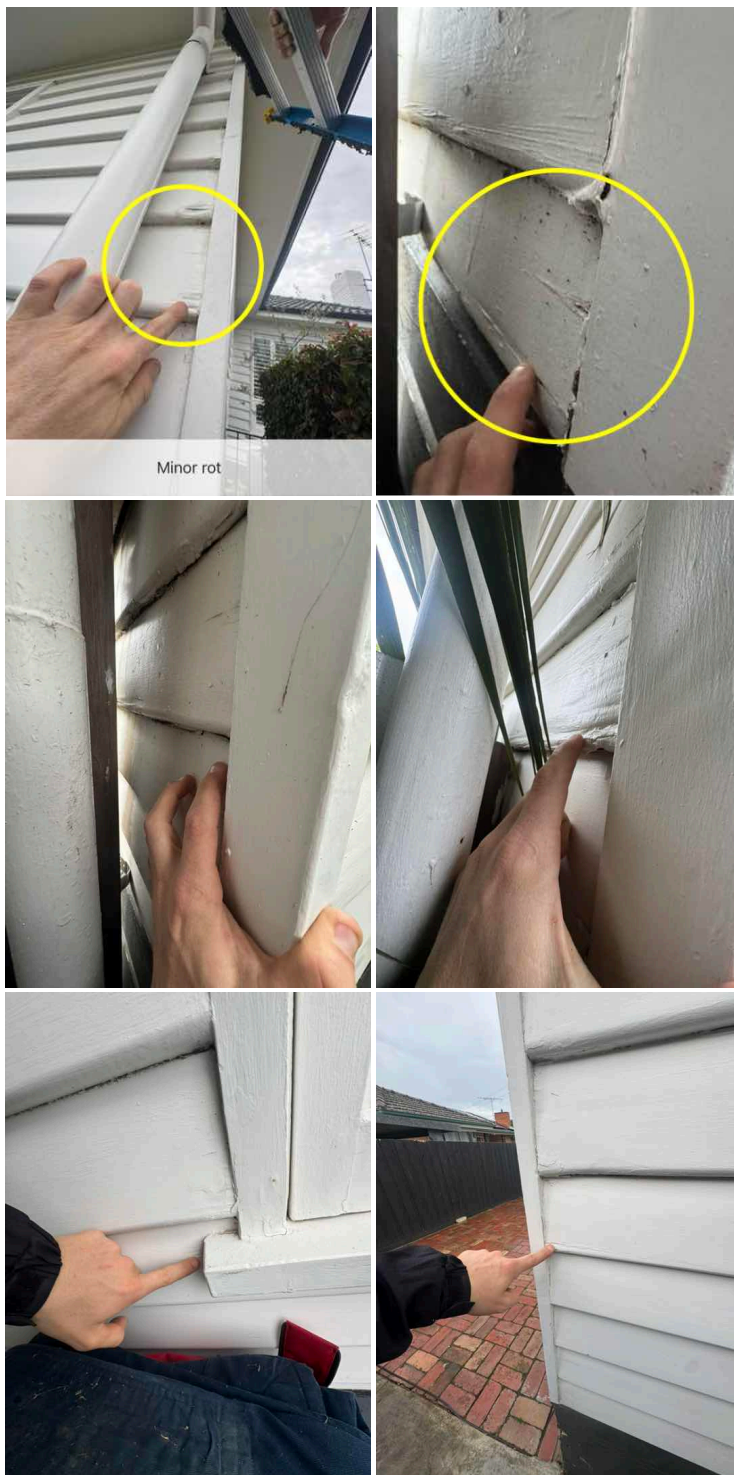
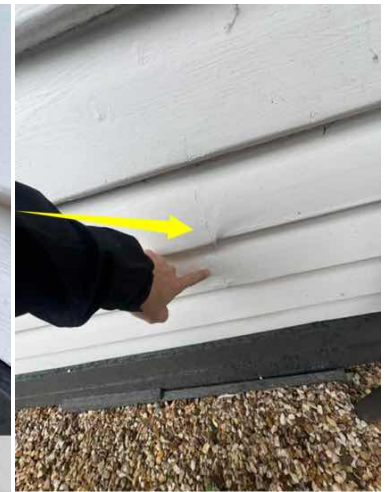
| DWELLING EXTERIOR | Walls | Cladding Observations | #10. Some wood rot/timber fungal decay was observed to timber components, which if left untreated can weaken the structural integrity of the affected elements and allow further deterioration; appropriate rectification requires removal and replacement of all rotten timber, treatment of remaining affected areas with a suitable fungicide, thorough drying and reinstatement of protective sealing or paint finishes to prevent recurrence. We recommend engaging a suitably qualified registered builder or carpenter and a qualified painter to further assess the extent of decay, provide quotations and carry out the necessary rectification and protective works. |

#10. Some wood rot/timber fungal decay was observed to timber components, which if left untreated can weaken the structural integrity of the affected elements and allow further deterioration; appropriate rectification requires removal and replacement of all rotten timber, treatment of remaining affected areas with a suitable fungicide, thorough drying and reinstatement of protective sealing or paint finishes to prevent recurrence. We recommend engaging a suitably qualified registered builder or carpenter and a qualified painter to further assess the extent of decay, provide quotations and carry out the necessary rectification and protective works.

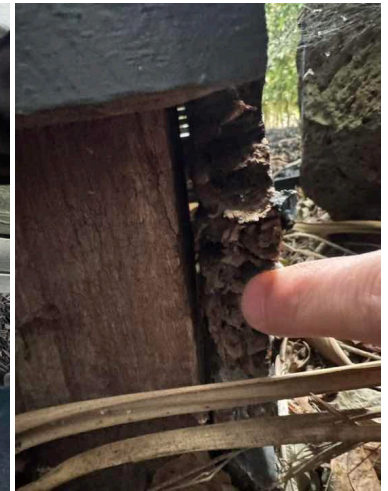
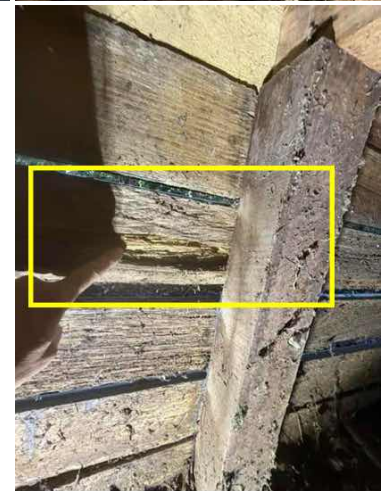
| DWELLING EXTERIOR | Walls | Baseboard Observations | #11. Some base boards are affected with timber fungal decay (wood rot). We recommend to replace any deteriorating boards with a more durable material or treated timber, installed with appropriate gaps to allow for adequate subfloor ventilation. |

#11. Some base boards are affected with timber fungal decay (wood rot). We recommend to replace any deteriorating boards with a more durable material or treated timber, installed with appropriate gaps to allow for adequate subfloor ventilation.

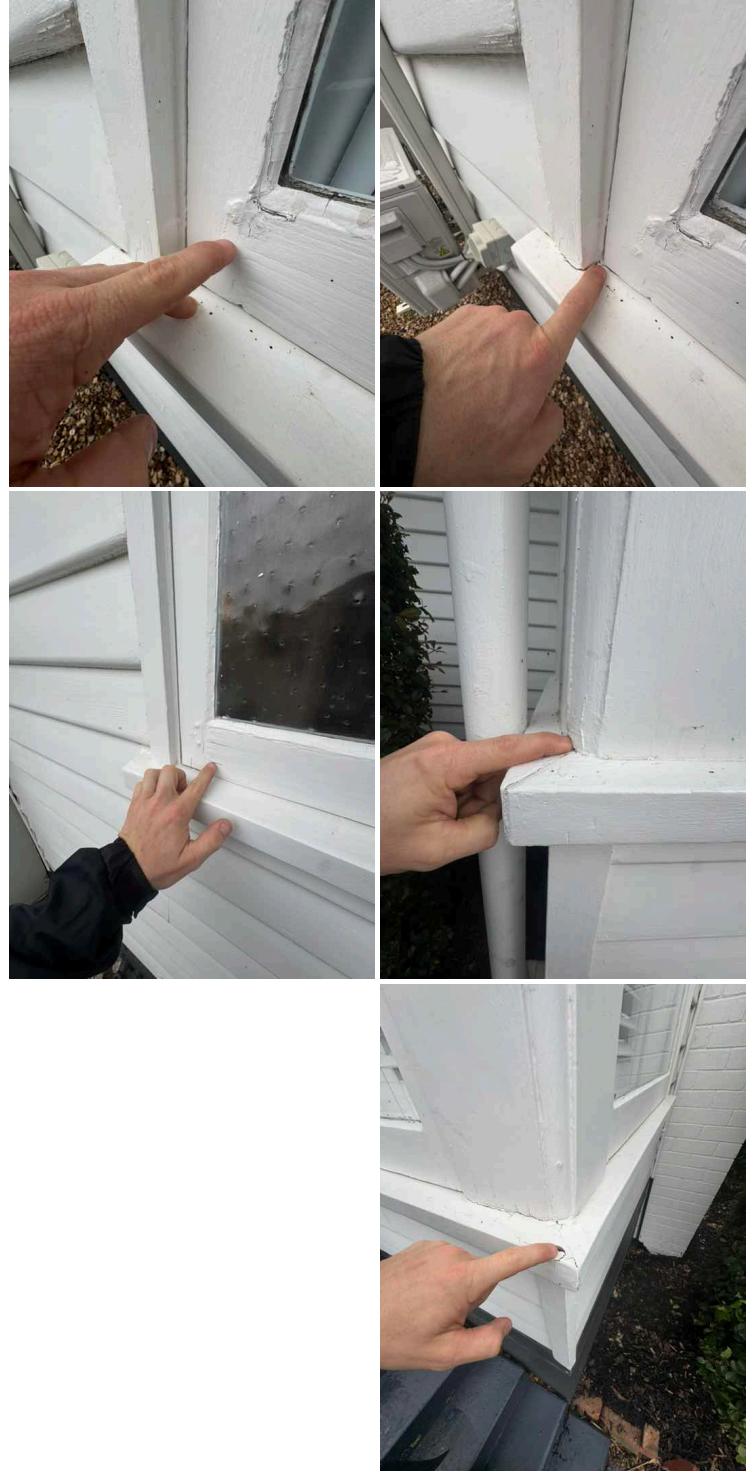
| DWELLING EXTERIOR | Windows | Observations | #12. Minor timber rot and decay were observed to sections of the timber window assembly. Localised deterioration of window components has occurred and may continue to worsen if not addressed, potentially resulting in progressive timber damage, reduced weather resistance, deterioration of adjoining building elements, and increased repair requirements over time. Rectification generally includes removal and replacement of affected timber sections, treatment of surrounding areas with an appropriate fungicidal product, correction of contributing moisture sources where required, and application of a suitable protective coating or paint system. It is recommended that a suitably qualified carpenter further assess the extent of deterioration, provide quotations, and undertake rectification works as required. |

#12. Minor timber rot and decay were observed to sections of the timber window assembly. Localised deterioration of window components has occurred and may continue to worsen if not addressed, potentially resulting in progressive timber damage, reduced weather resistance, deterioration of adjoining building elements, and increased repair requirements over time. Rectification generally includes removal and replacement of affected timber sections, treatment of surrounding areas with an appropriate fungicidal product, correction of contributing moisture sources where required, and application of a suitable protective coating or paint system. It is recommended that a suitably qualified carpenter further assess the extent of deterioration, provide quotations, and undertake rectification works as required.

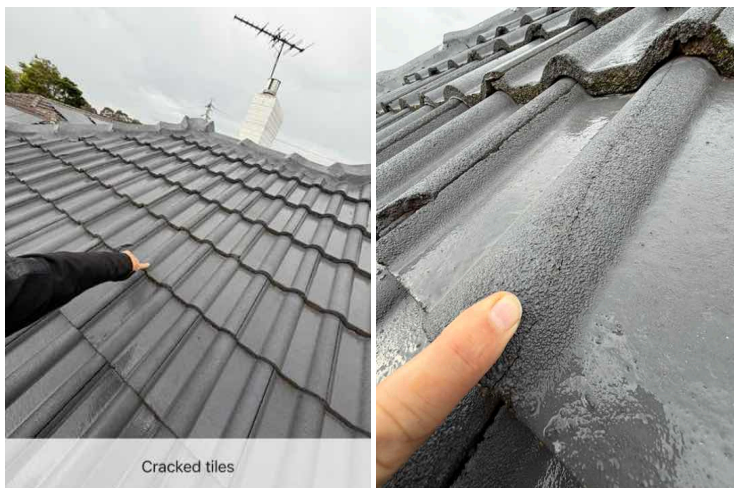
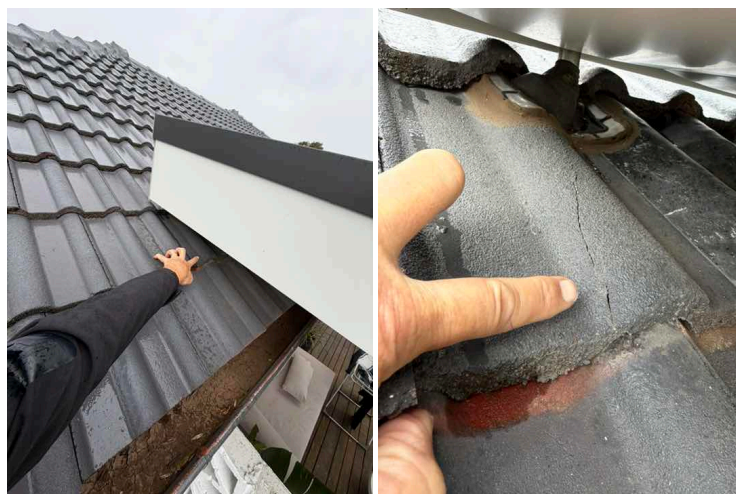
Cracked tiles

| ROOFING AND PLUMBING COMPONENTS | Roofing | Roof Tiling | #13. A cracked roof tile was observed, which can allow water ingress into the roof cavity and lead to deterioration of roof components and potential internal damage if not rectified. It is recommended that a suitably competent and qualified roof plumber or tile roof restoration contractor further assess the roof, replace any cracked, damaged, or sealant-repaired tiles, and provide quotations for the required rectification works.. |

#13. A cracked roof tile was observed, which can allow water ingress into the roof cavity and lead to deterioration of roof components and potential internal damage if not rectified. It is recommended that a suitably competent and qualified roof plumber or tile roof restoration contractor further assess the roof, replace any cracked, damaged, or sealant-repaired tiles, and provide quotations for the required rectification works..

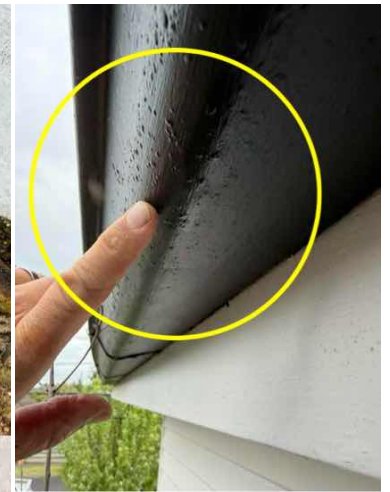
| ROOFING AND PLUMBING COMPONENTS | Guttering | Guttering Observations | #16. Significant corrosion and rust were observed in sections of guttering. While repairs or treatment may be a temporary fix for surface rust, we recommend replacement for more severely rust-affected components as a safer long-term solution. In the near future, we recommend engaging a qualified roof plumber to further assess, repair or replace any affected guttering components. |

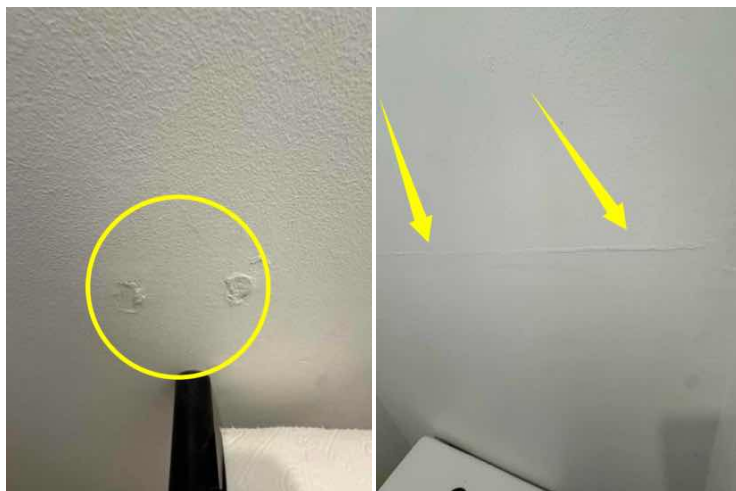
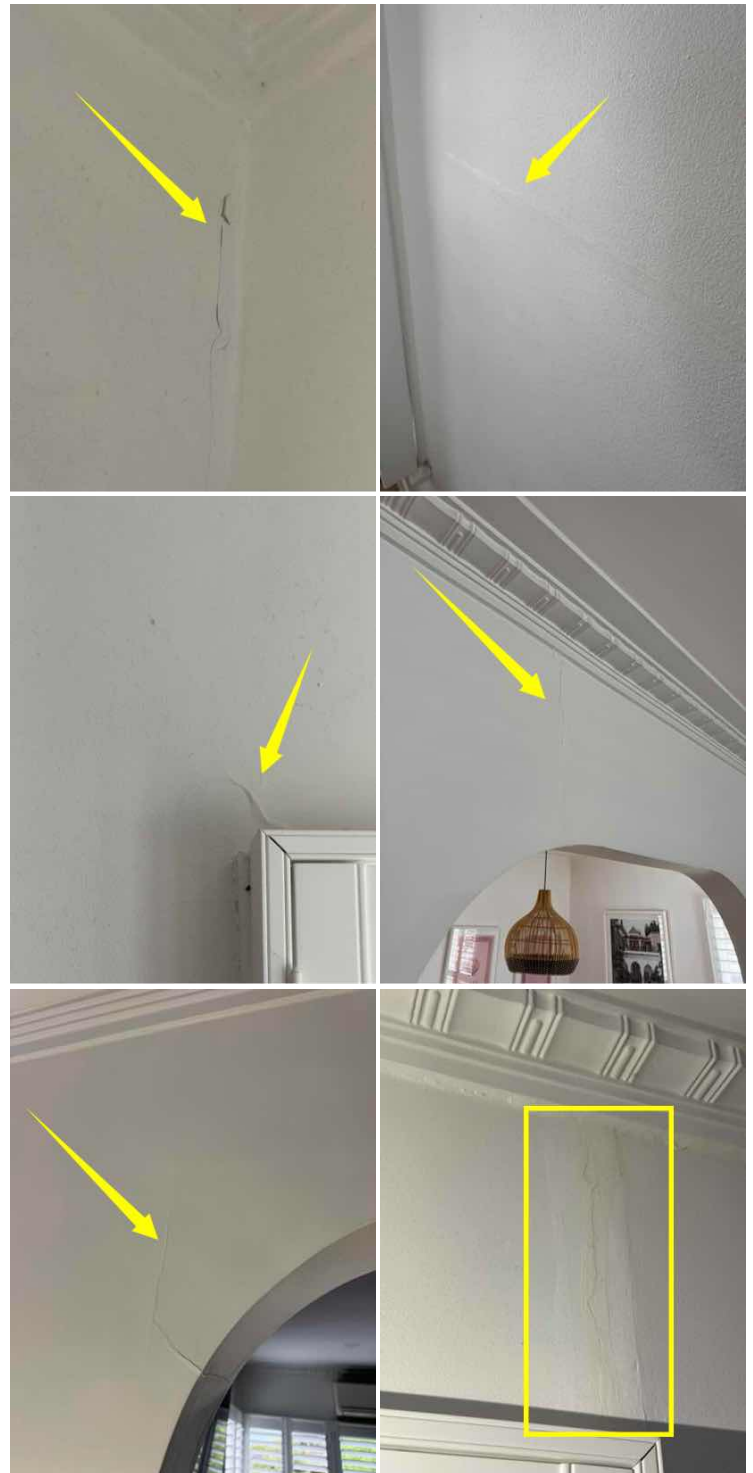
#20. Some minor settlement cracking and plastering and painting imperfections were observed to wall and ceiling linings. These conditions are generally consistent with normal ageing and typical building movement and appear within an expected range for a structure of this type and age. Minor cracking to internal linings is common where buildings experience movement, as plaster is a rigid material with limited flexibility and can crack when stresses from normal structural movement are released. In most cases, localised patching and repainting is sufficient to maintain appearance. Monitoring of crack locations is recommended and if cracking becomes wider, more pronounced or progressive over time, a suitably qualified building professional should be engaged to further assess and provide advice on any necessary repairs.

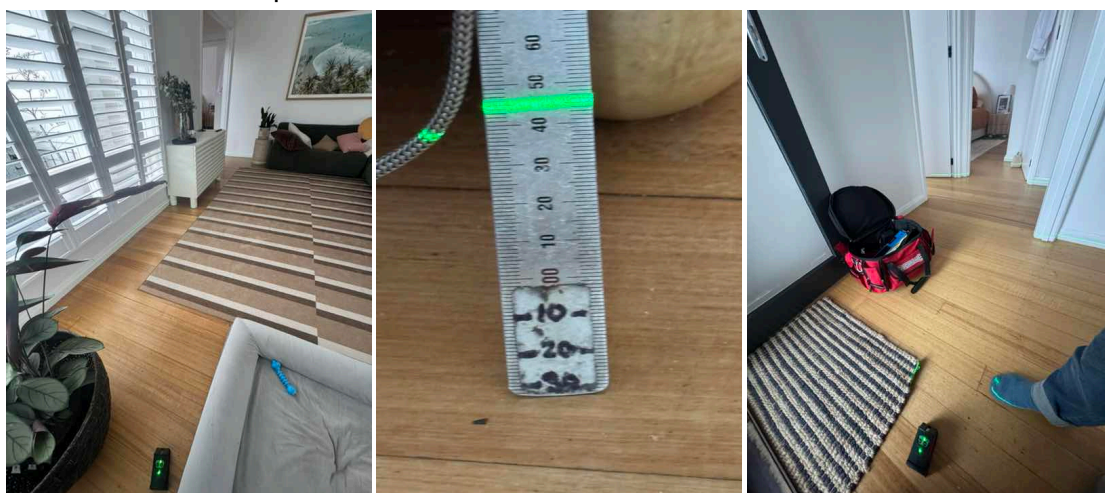
#21. Floor levels were measured to accessible areas and recorded a variance of approximately 40-45mm high to the fireplace area at the time of inspection. Variance of this magnitude is typically indicative of moderate building movement and should be regarded as a cautionary finding as it may reflect past or ongoing foundation movement, noting that observations are limited to conditions present at the time of inspection only. Contributing factors may include site drainage issues, moisture variation within foundation soils or leaking plumbing services, and if movement continues this may result in further distortion, cracking and reduced serviceability of the structure. It is recommended that site drainage is improved where required, all gutters and downpipes are checked to ensure adequate fall and discharge, and a licensed plumber is engaged to inspect for leaks including underground or subsoil services. Ongoing annual monitoring of floor levels is recommended and if increased variance, additional cracking or further movement becomes evident a suitably qualified structural engineer should be engaged to carry out further assessment and provide advice.

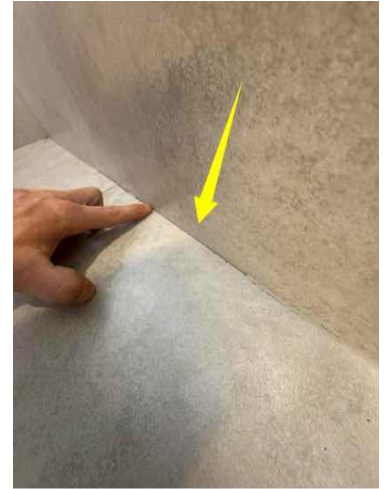
#22. Flexible sealant is in deteriorating condition. Flexible water proof sealant is critical and must be applied to all internal junctions to prevent water ingress and associated moisture related defects. We recommend engaging a wet area or caulking specialist to rectify.

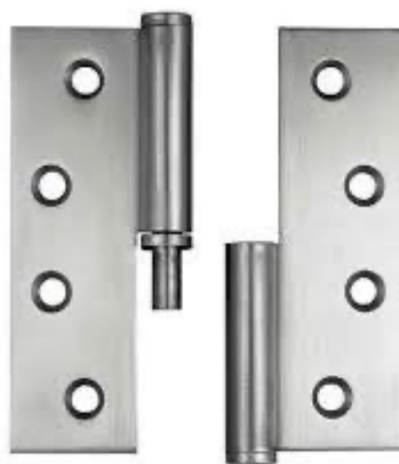
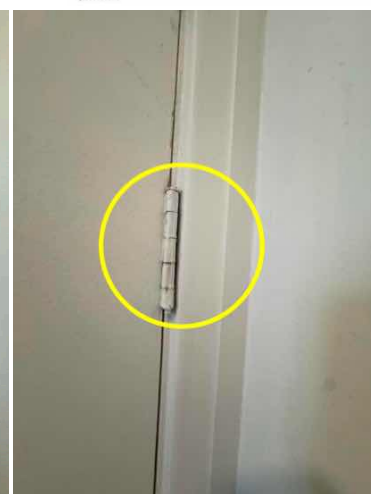
| Section | Location | Name | Comment |
|---|---|---|---|
| BATHROOMS AND TOILETS | Toilets | Doors | #23. SAFETY HAZARD. Safety hinges should be installed for safety reasons. The toilet is too close to the in-swinging door for regular hinges to be used. In rectifying, the top of the door may need to be trimmed to accommodate lift-off hinge operation. We recommend engaging a carpenter to rectify. |

#23. SAFETY HAZARD. Safety hinges should be installed for safety reasons. The toilet is too close to the in-swinging door for regular hinges to be used. In rectifying, the top of the door may need to be trimmed to accommodate lift-off hinge operation. We recommend engaging a carpenter to rectify.

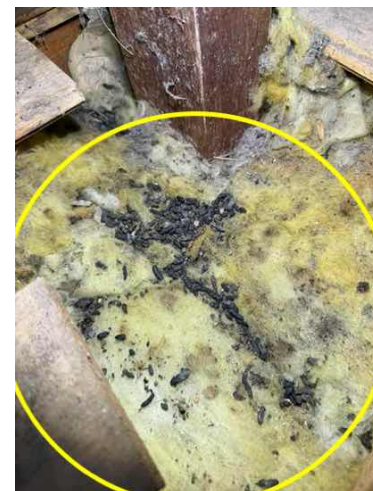
#25. We observed a high incidence of rodent droppings within the roof void. Rats and mice are common pests that can cause damage, contaminate insulation and spread diseases. To prevent further infestation and potential damage, we recommend taking appropriate measures to clean, treat and bait affected areas.

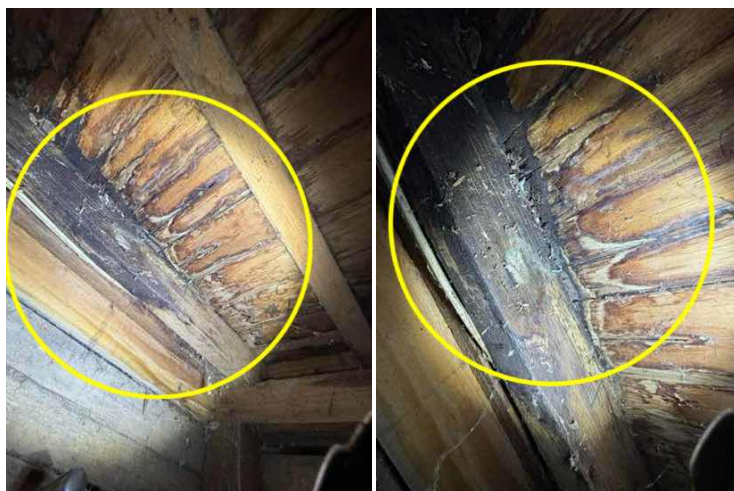
#26. Dry water stains were present to subfloor timbers beneath laundry wet areas. Probable causes are; general wet area spills and splashing, previous leaks or overflowed components. At this point in time there is no evidence of current leakage. However, due to uncertainty regarding frequency of wet areas usage before our inspection, ongoing monitoring and assessment by a qualified professional are recommended.

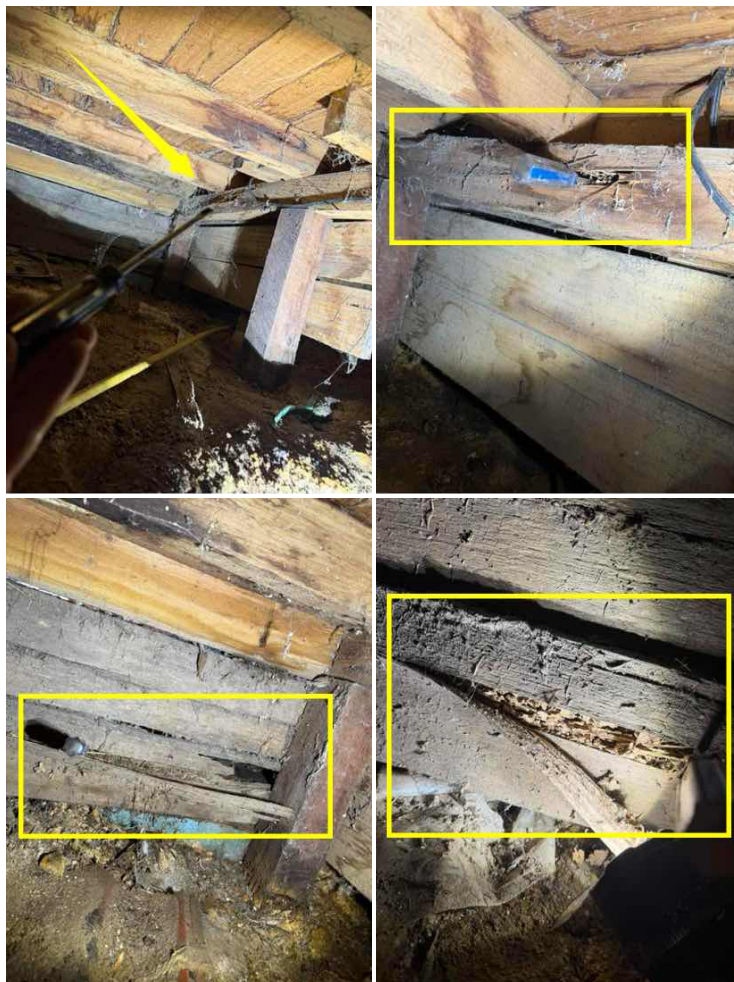
| Section | Location | Name | Comment |
|---|---|---|---|
| SUBFLOOR AREA | Subfloor Observations | Bearers | #27. Termite workings/damage were observed to a timber bearer and baseboards to the rear north west corner. This requires further invasive assessment by a registered builder to remove building components to determine the degree of termite damage present. The damage requires tracing back to the point(s) of entry to the furthest points of termite workings. We also strongly recommend engaging a licensed pest controller immediately to further invasively assess, treat and eradicate if required in accordance with AS3660.2 |

#27. Termite workings/damage were observed to a timber bearer and baseboards to the rear north west corner. This requires further invasive assessment by a registered builder to remove building components to determine the degree of termite damage present. The damage requires tracing back to the point(s) of entry to the furtherest points of termite workings. We also strongly recommend engaging a licensed pest controller immediately to further invasively assess, treat and eradicate if required in accordance with AS3660.2

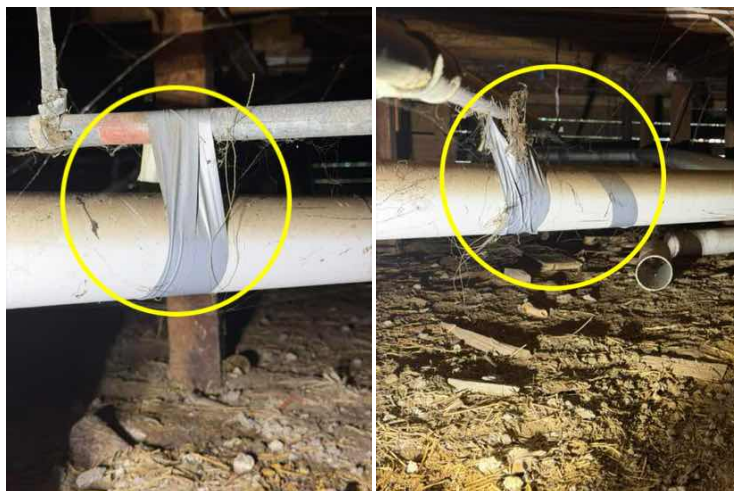
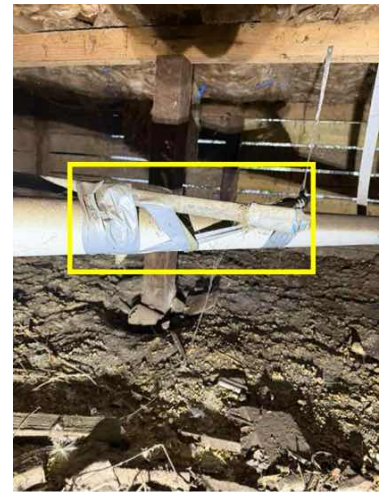
#28. Plumbing components beneath the dwelling were observed to be poorly supported, with pipes and services in contact with or close to the ground, which can lead to sagging, joint failure, blockages, and increased risk of leakage and damage if not rectified. It is recommended that a suitably competent and qualified licensed plumber further assess the installation, provide appropriate supports to lift services clear of the ground, and supply quotations for the necessary rectification works.

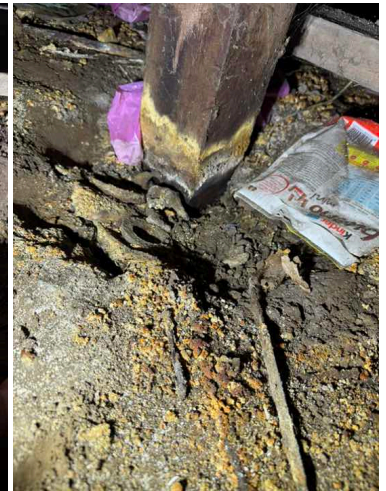
#29. Dampness was observed in the subfloor soil, which if not minimised can negatively impact the structural integrity of the building by weakening masonry components, footings and foundations, and by creating conditions conducive to timber pest activity and fungal timber decay (wood rot) in timber elements. It is recommended that a suitably competent and qualified builder, drainage contractor, or licensed plumber further assess contributing factors such as surface water drainage, plumbing leaks, and subfloor ventilation, implement appropriate moisture management measures, and provide quotations for the required rectification works.
