## Termite and Timber Pest Inspection V4

| Job ID | 70255249 |
| Site Address | 18 LEARMOUTH ST, BELMONT VIC 3216 |

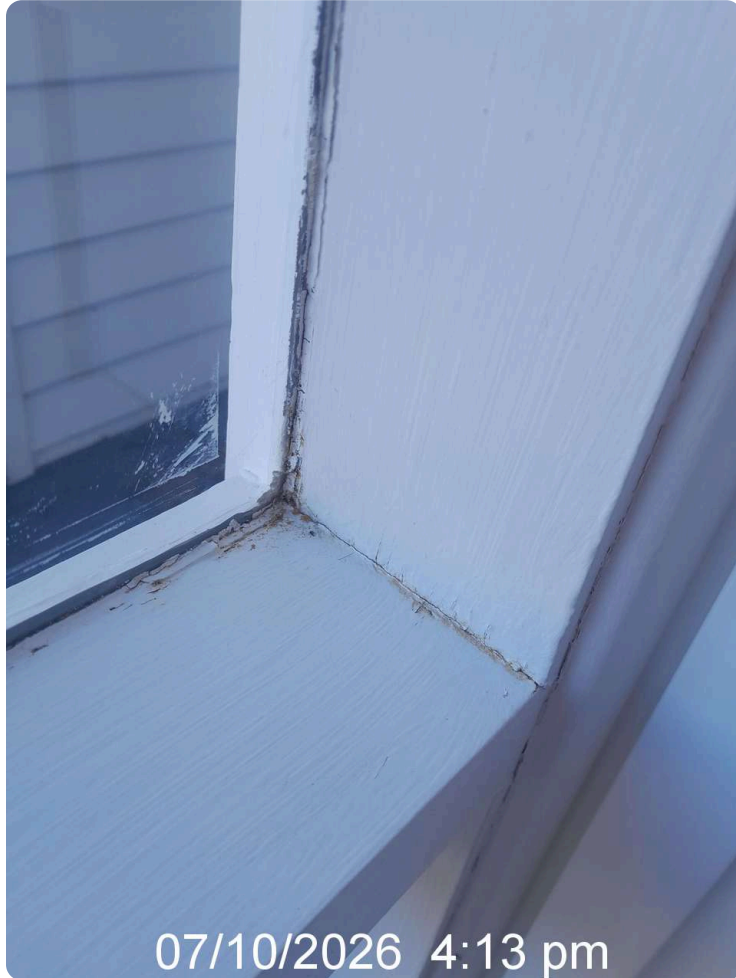
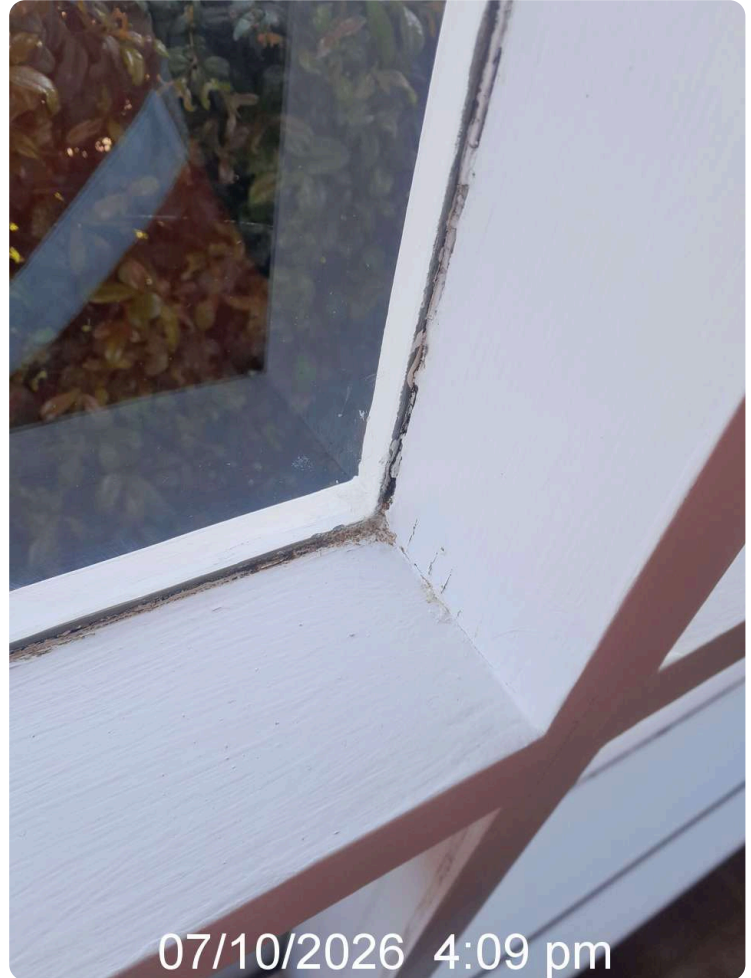
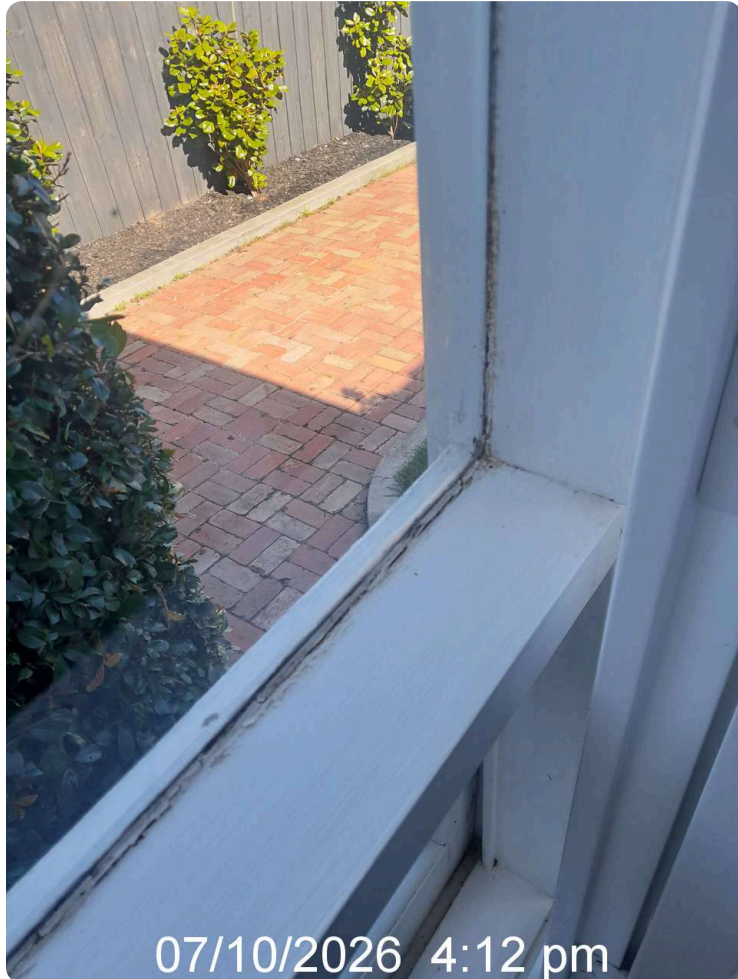
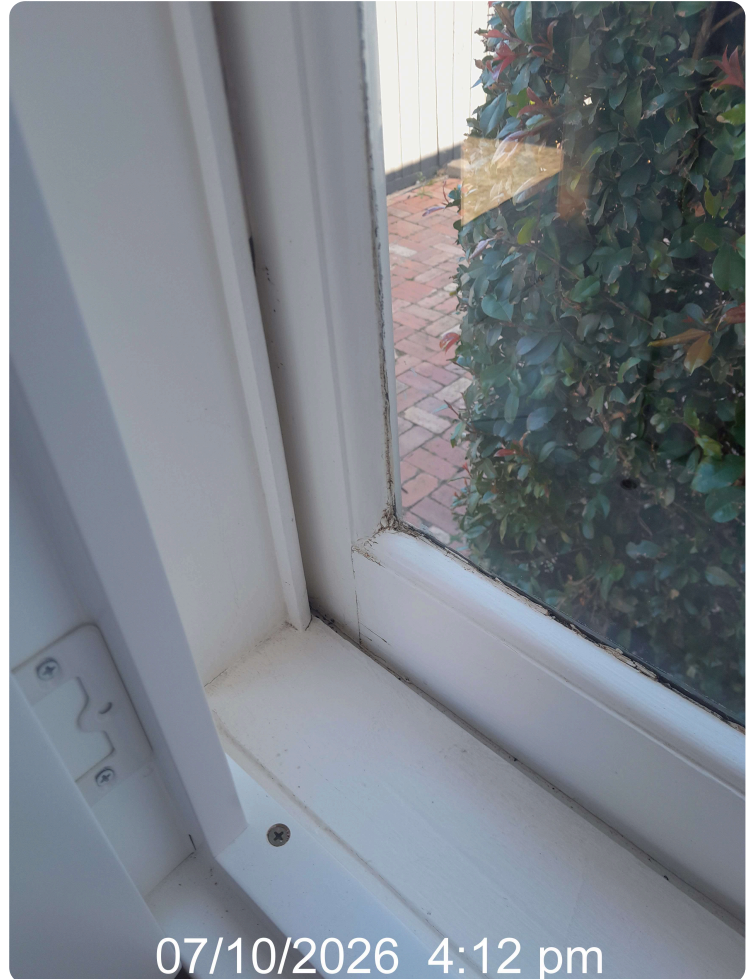
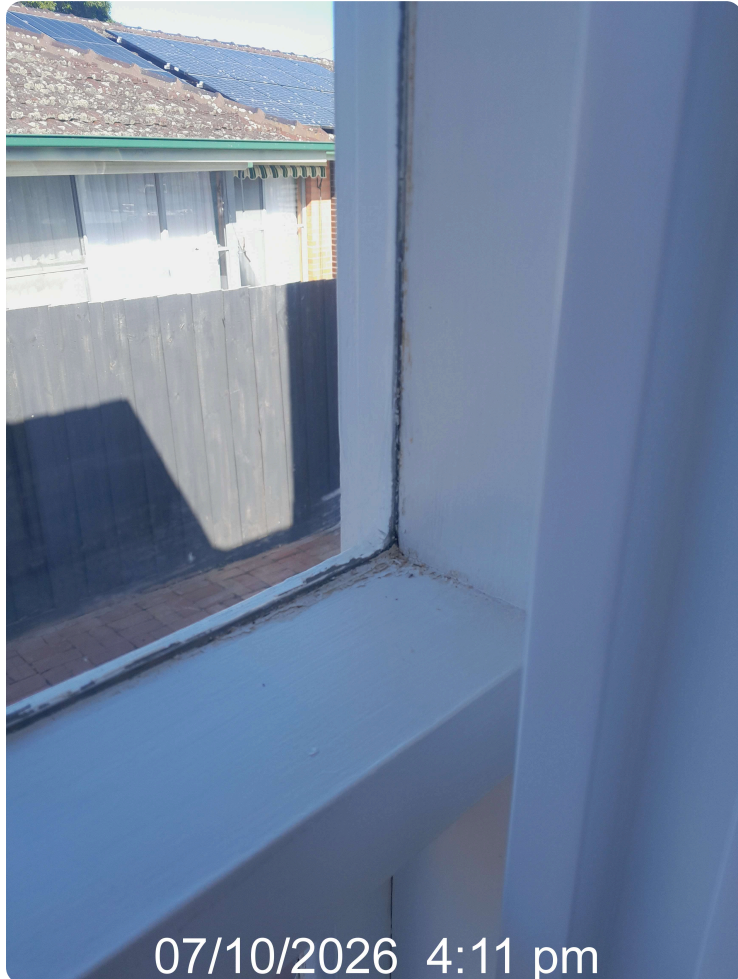
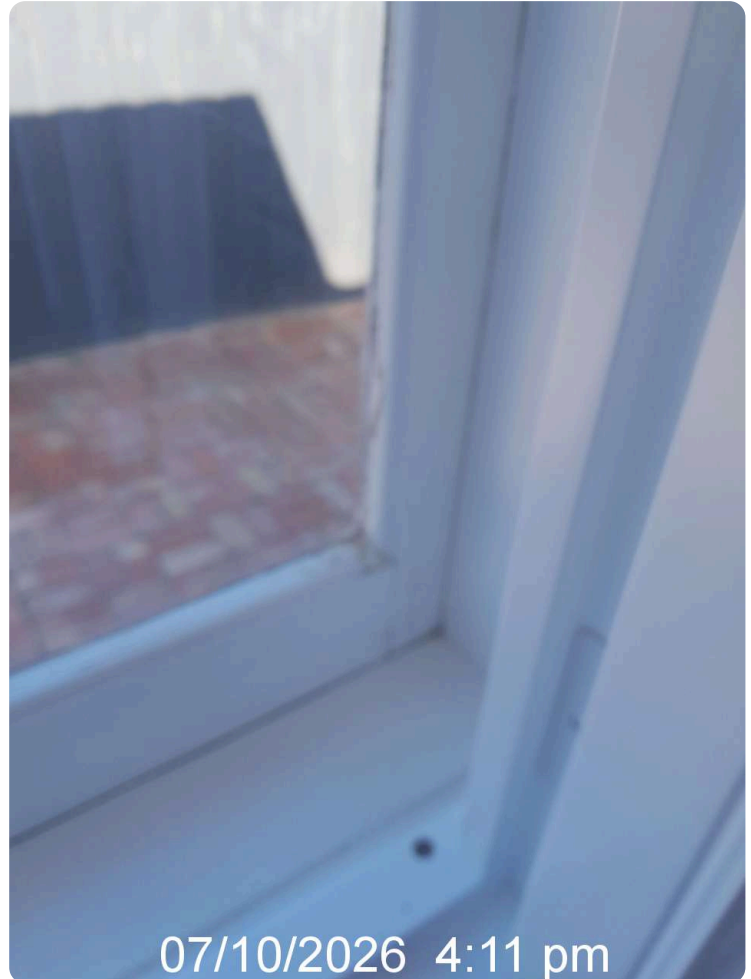
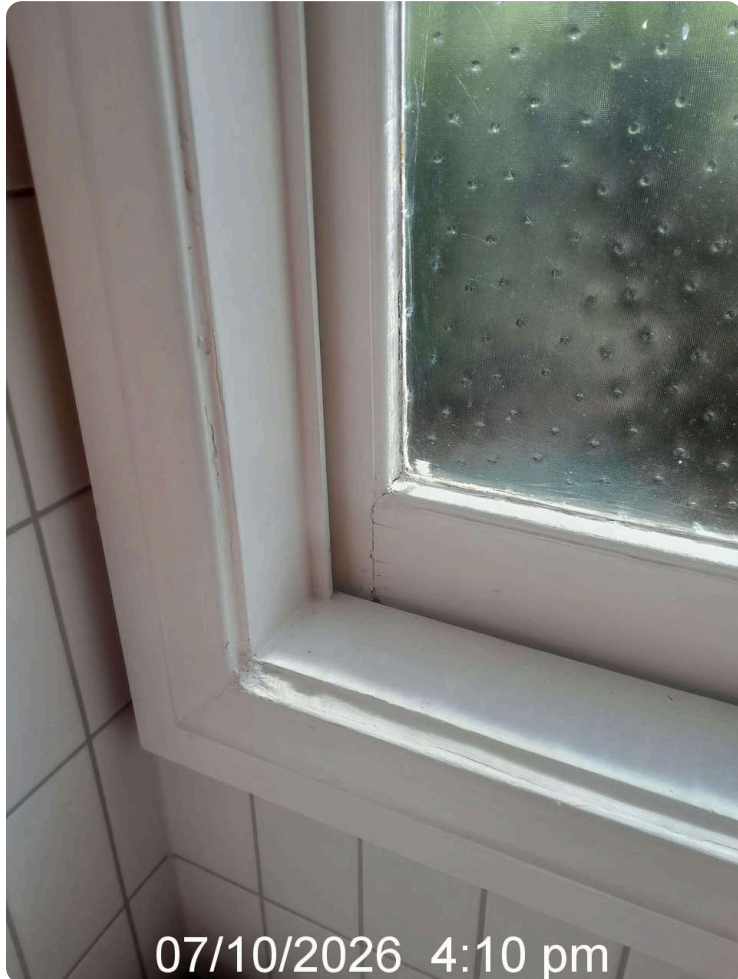
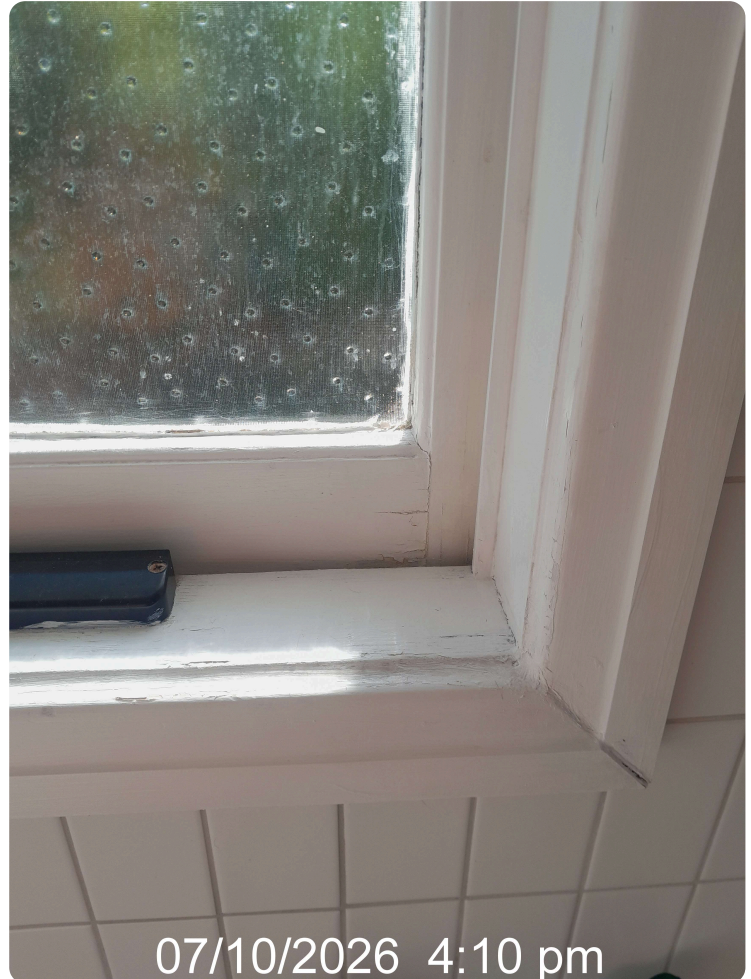
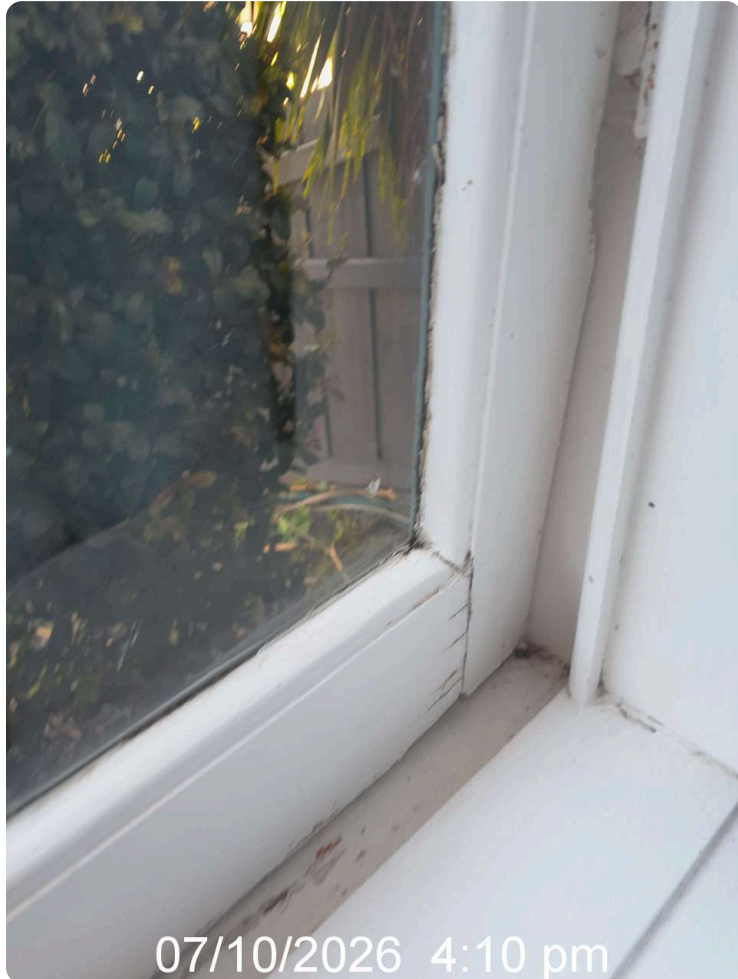
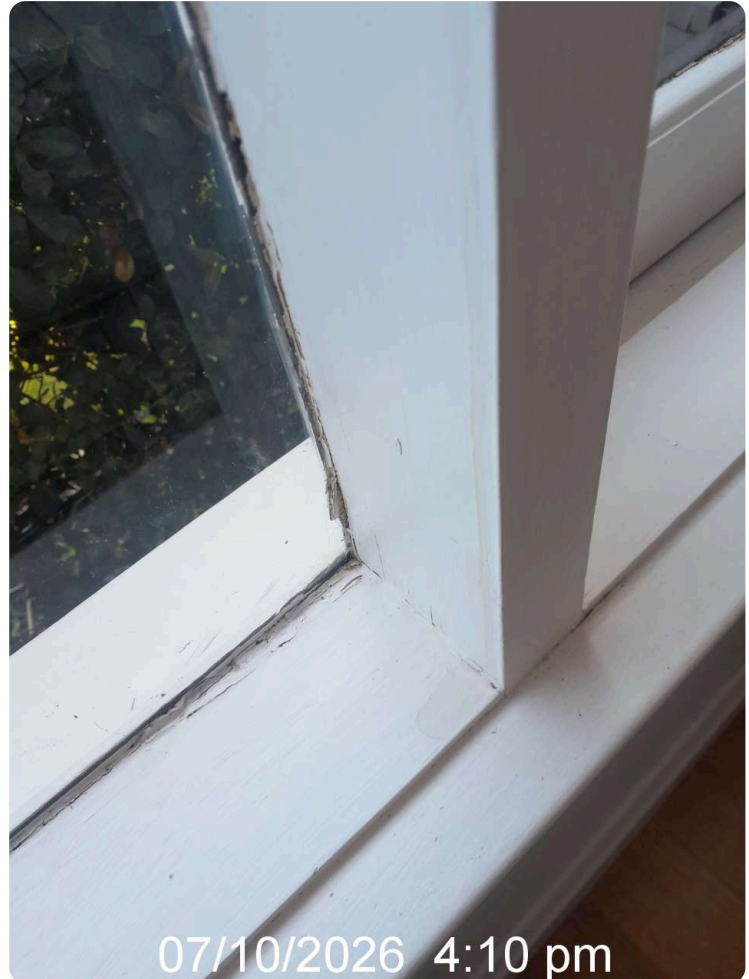
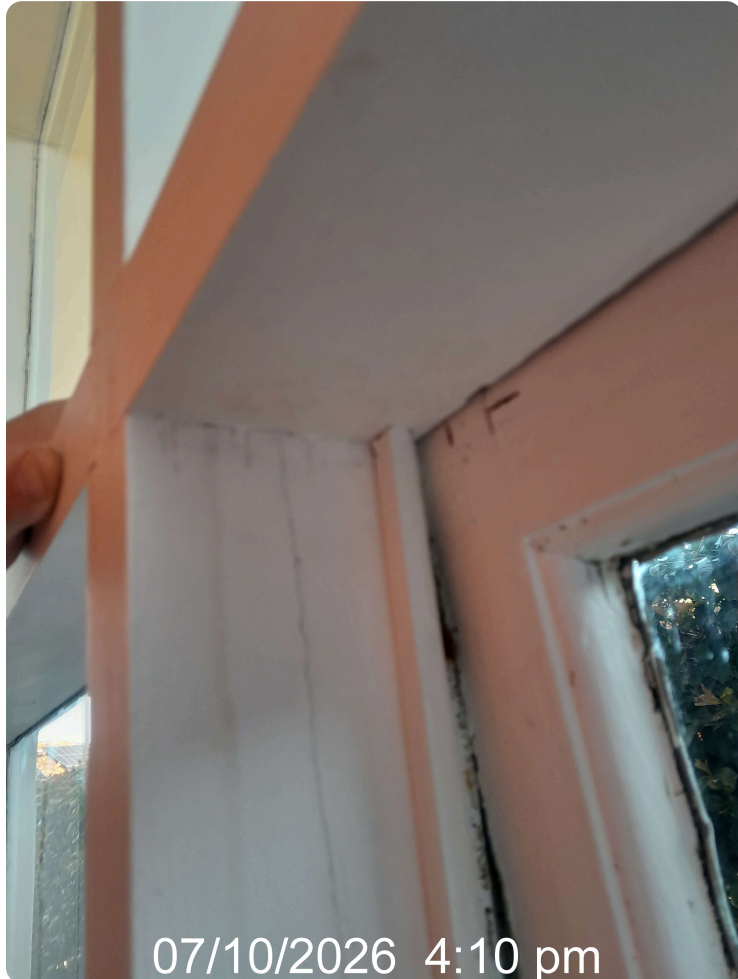
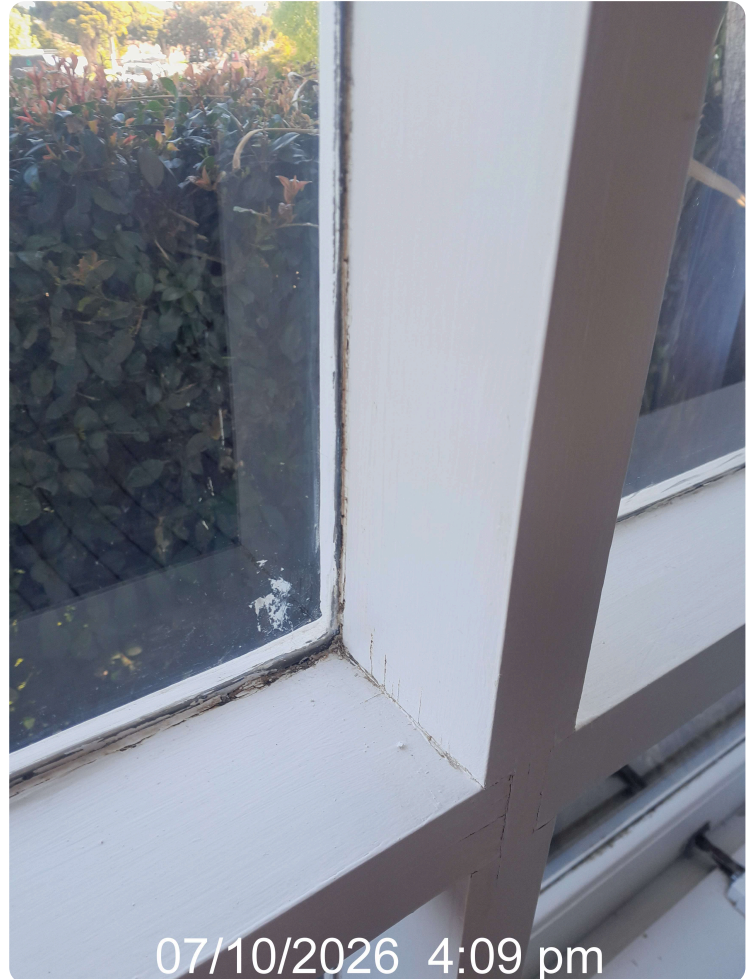
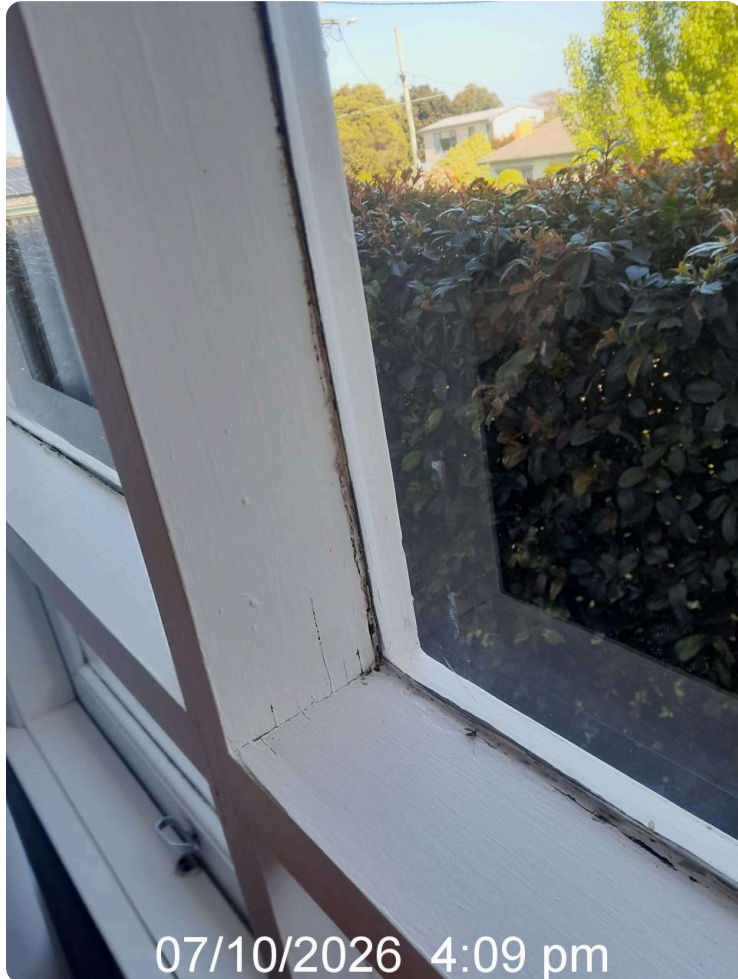
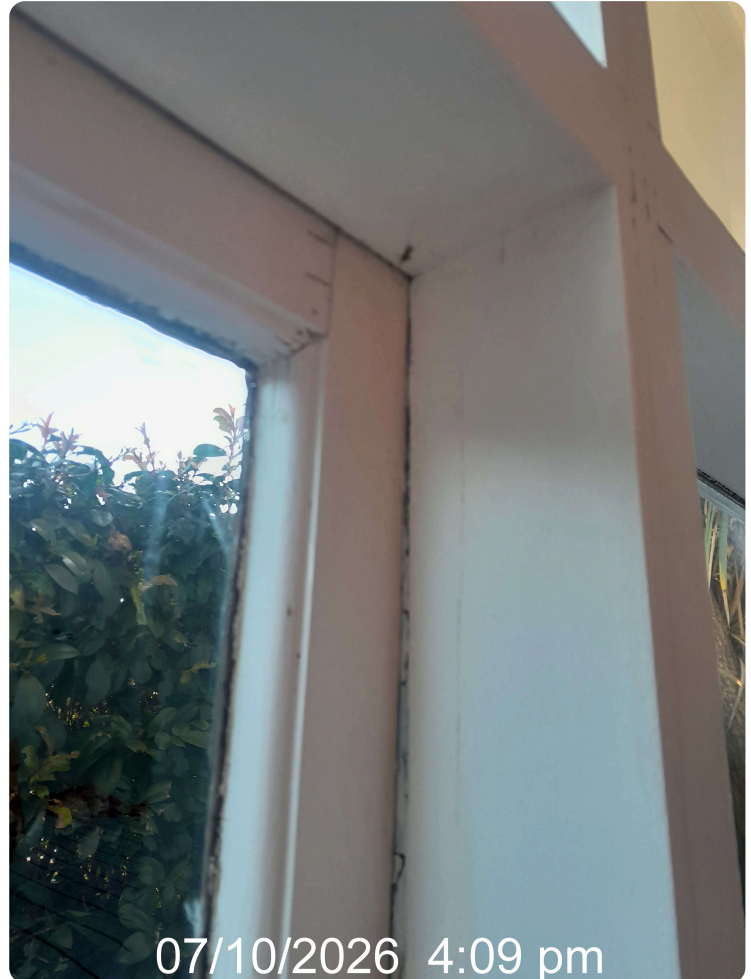
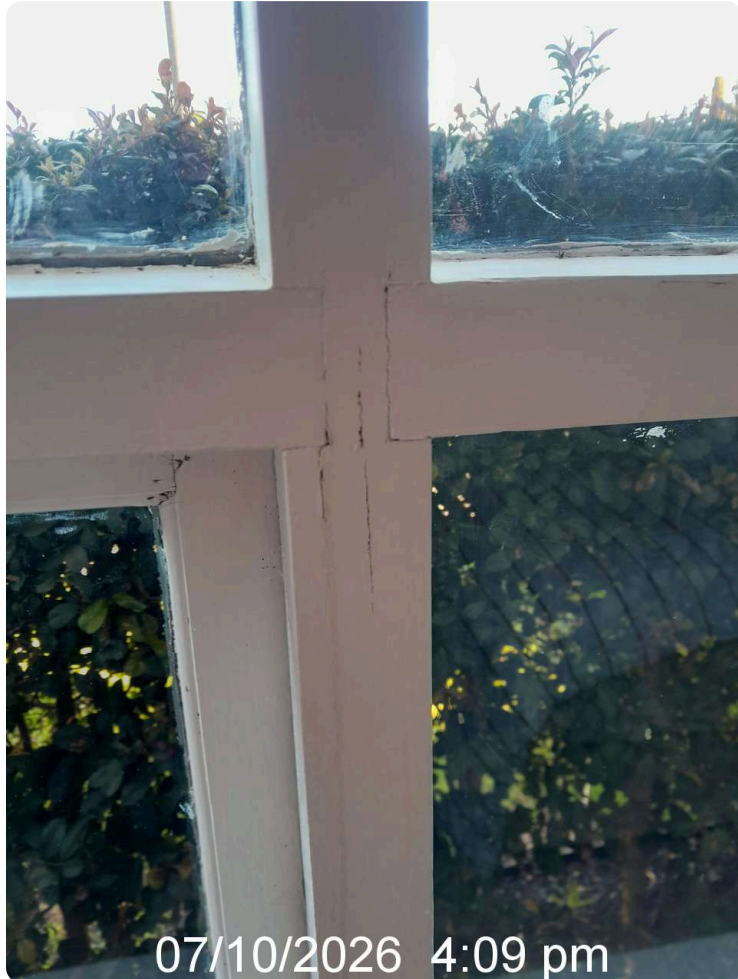
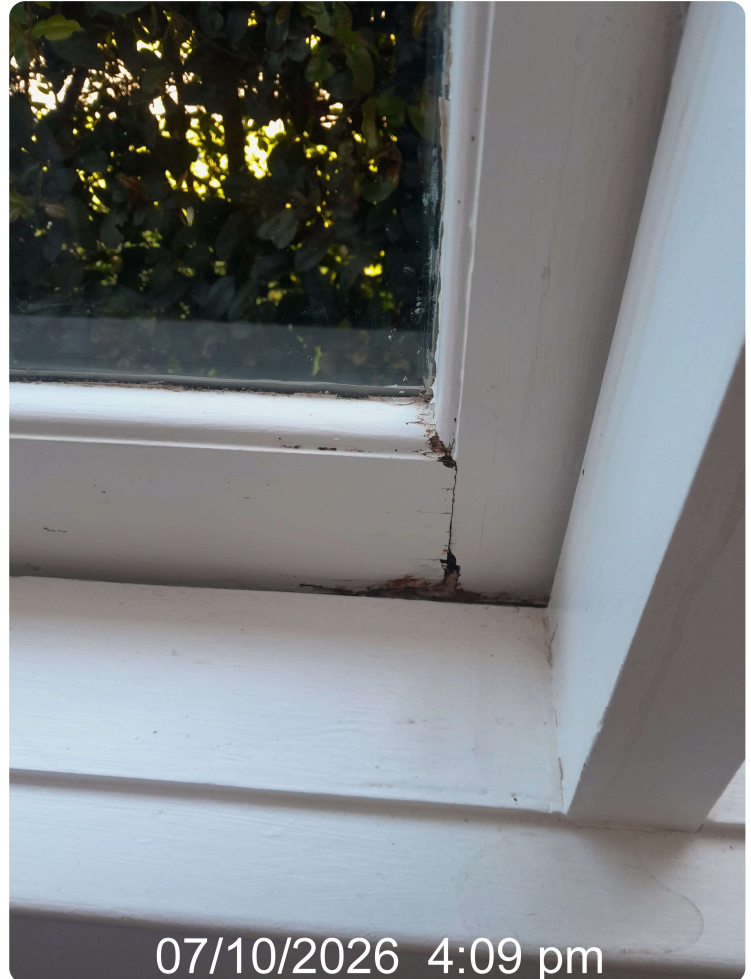
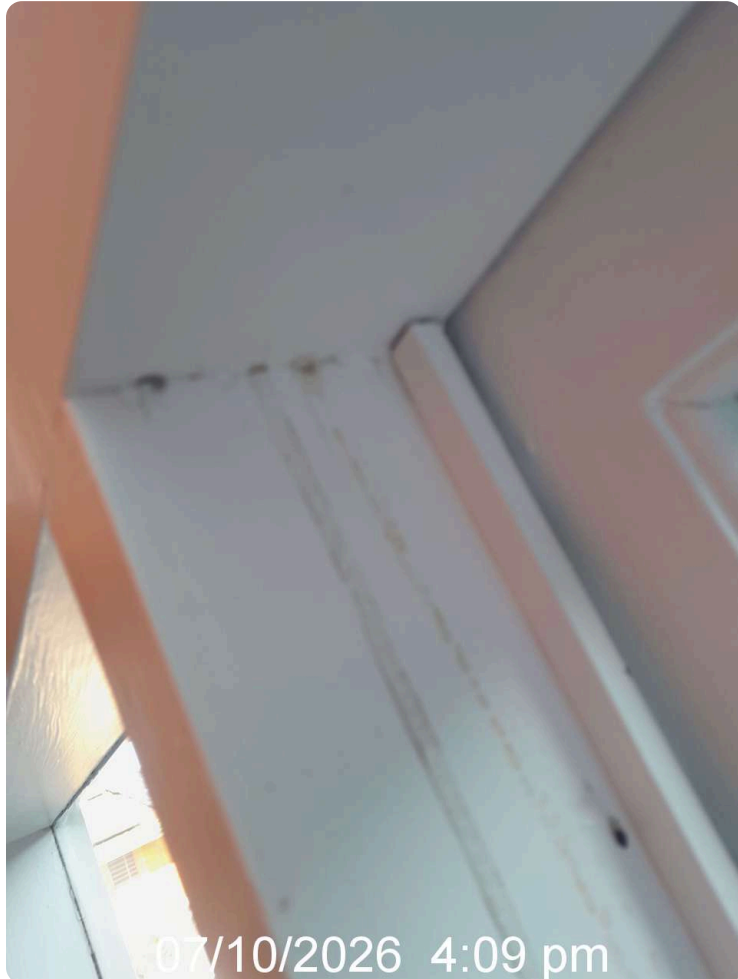
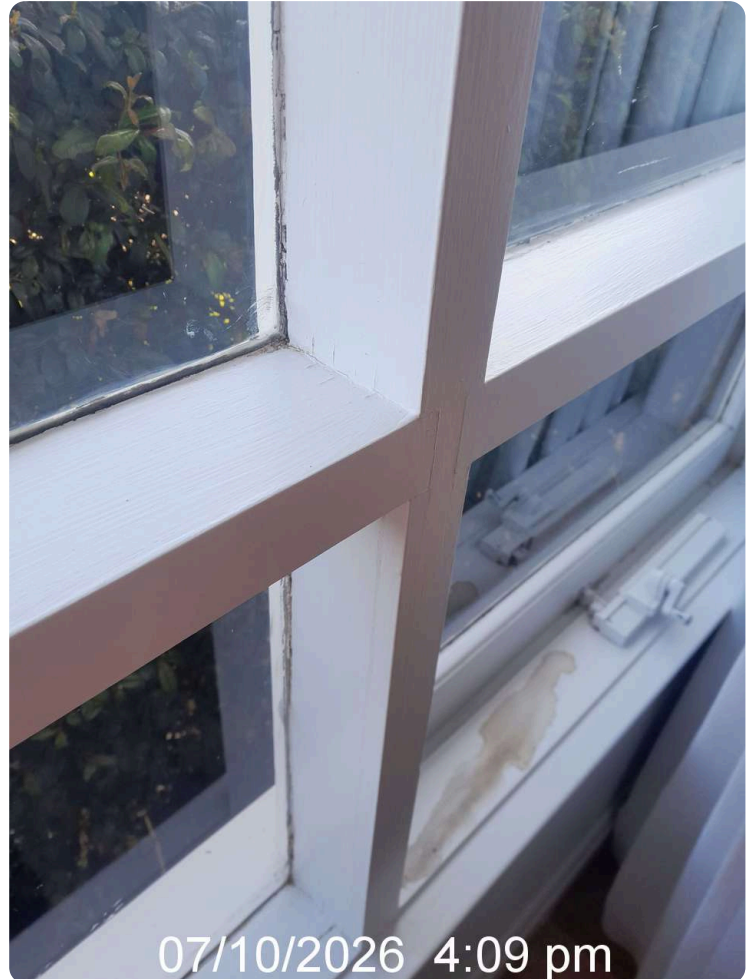
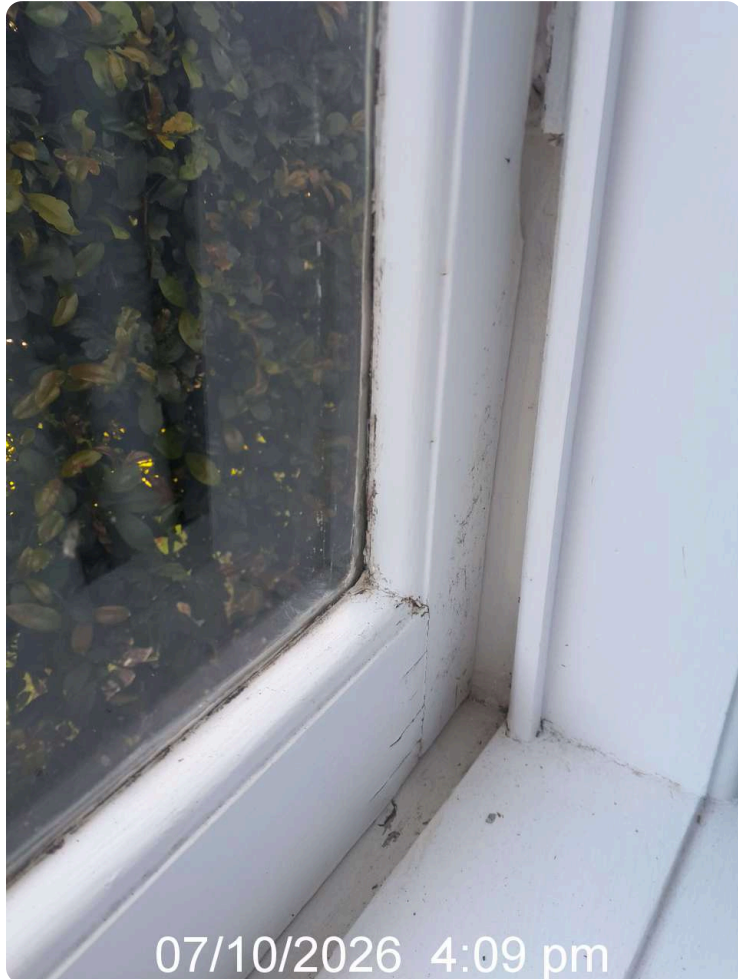
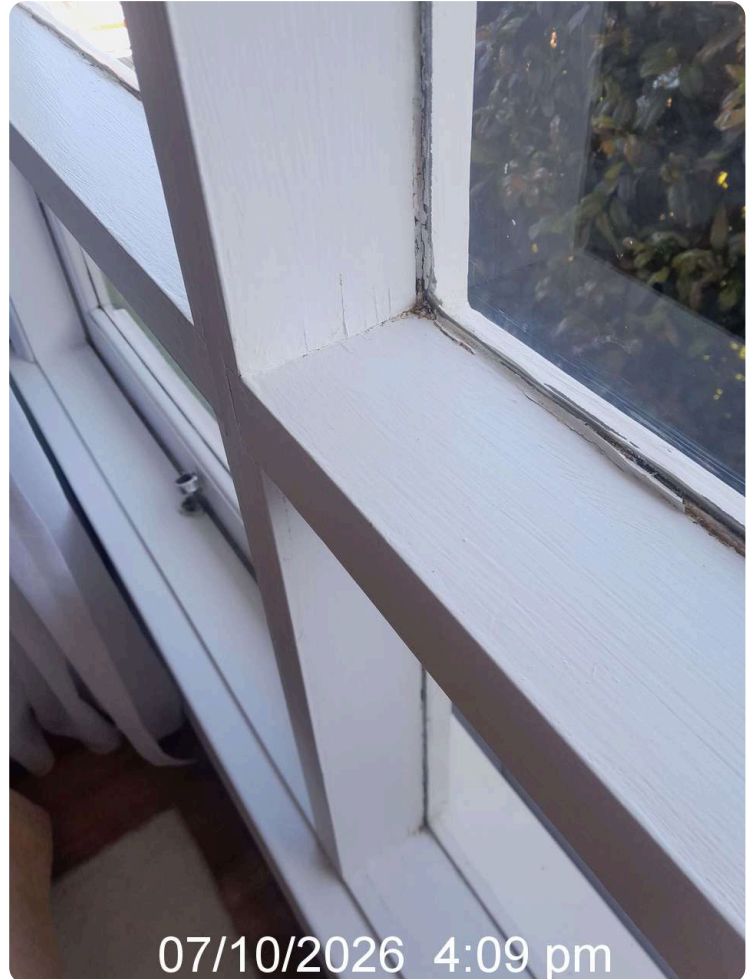
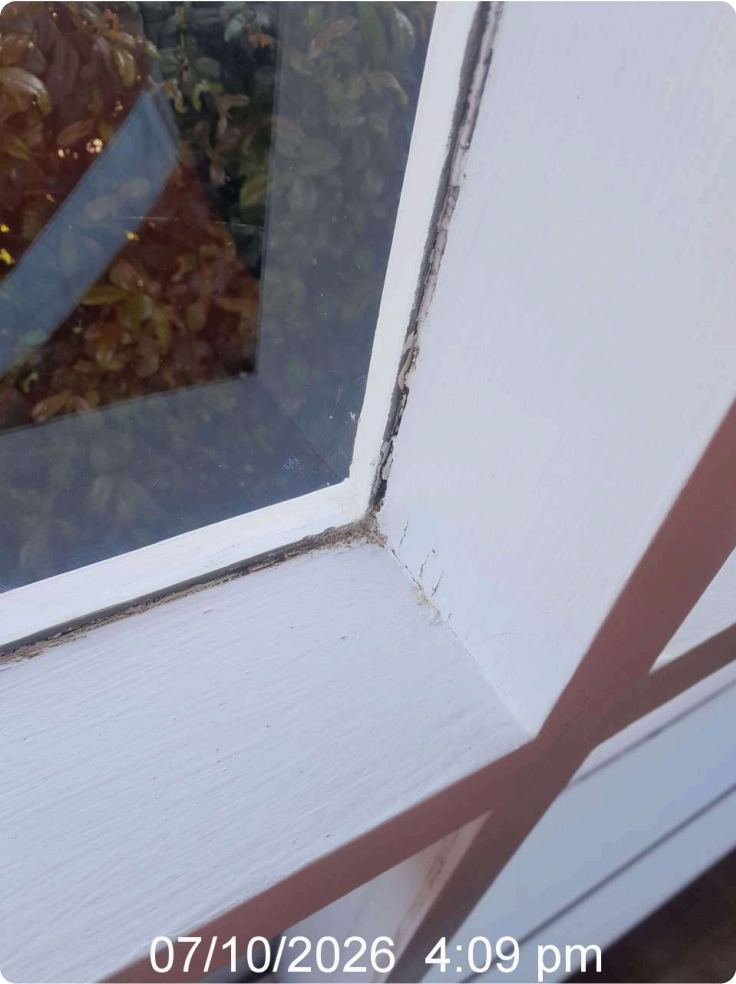
EVIDENCE OF FUNGAL DECAY TO THE INTERIOR ROOMS/AREAS:: ITEM 1

Fungal decay found

| Affected items: | Window frames |
| Extent of visible damage: | Minimal |
| Comments: | Potentail causes weathering due to seepage, sun damage, deteriorating seals: window sills, frames, rails, stiles, mullions, (bedroom 1, bedroom 2, bathroom, dining, lounge). |

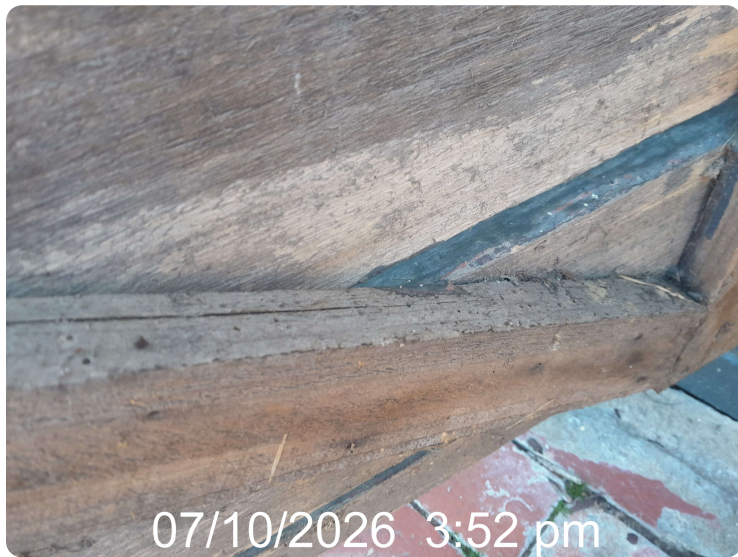
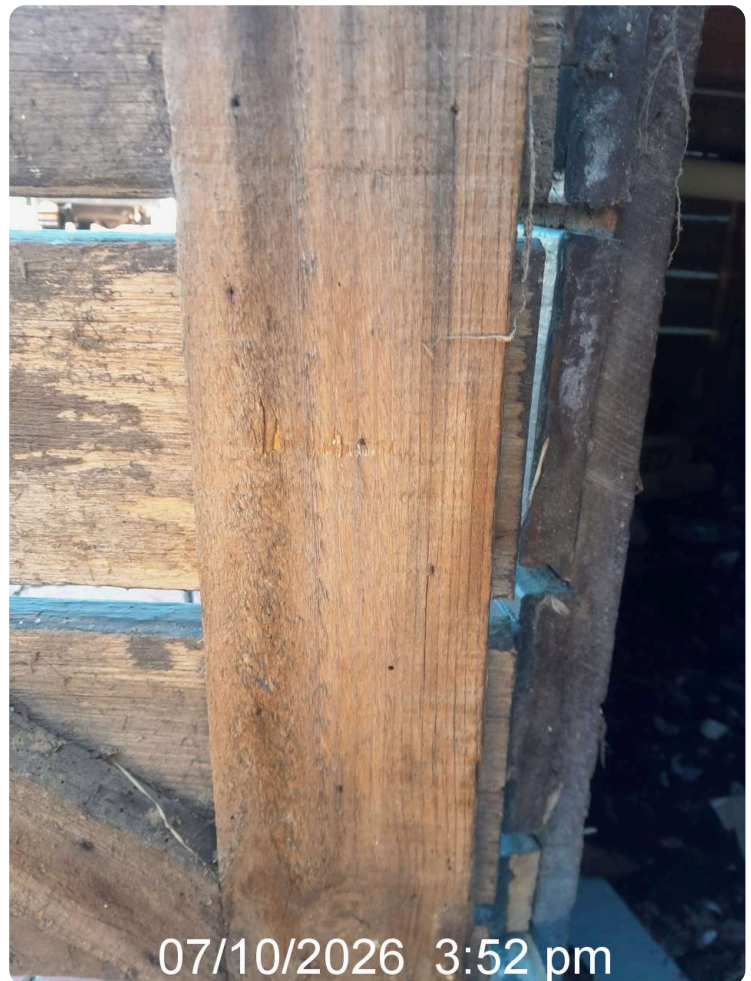
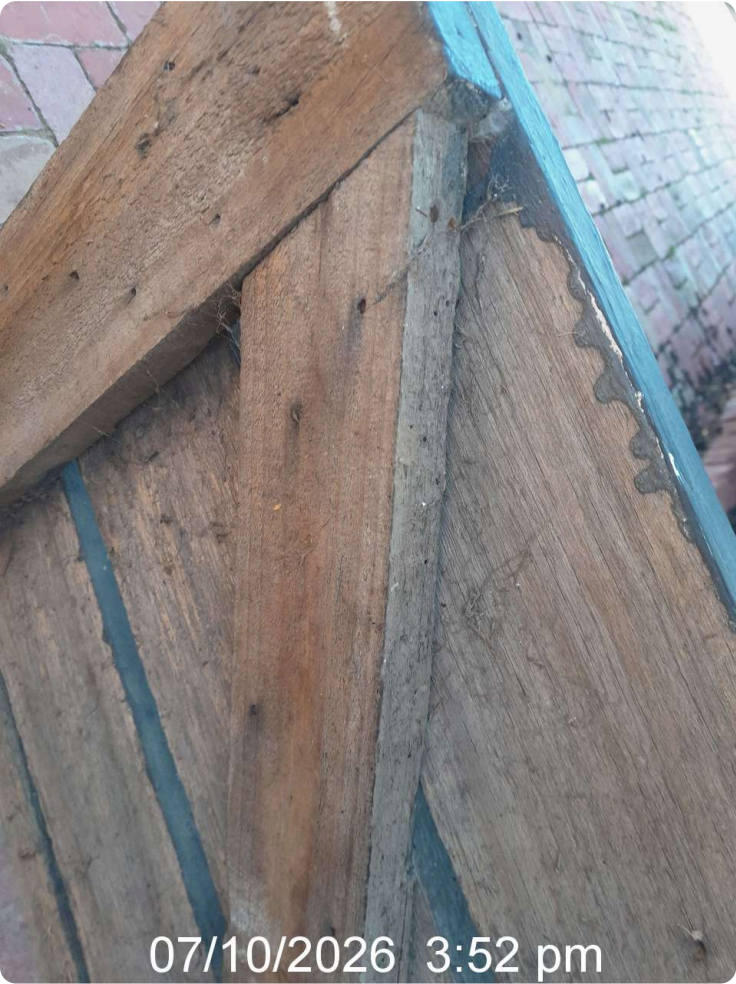
EVIDENCE OF BORER ACTIVITY / DAMAGE TO THE SUBFLOOR SPACE:: ITEM 1

Evidence of previous borer activity (damage/visible signs)

| Affected items: | Stored items |
| Extent of visible damage: | Moderate |
| Comments: | Damage to east entry hatch under dining room, base boards south of lounge, base boards south of bedroom 1 and 2, base boards west and north side of laundry, base boards under north side of kitchen and dining, timber debris under bedroom 2, laundry, kitchen and potentially throughout, |

Customer to engage a qualified builder to determine the extent of damage and replace any timbers as required .

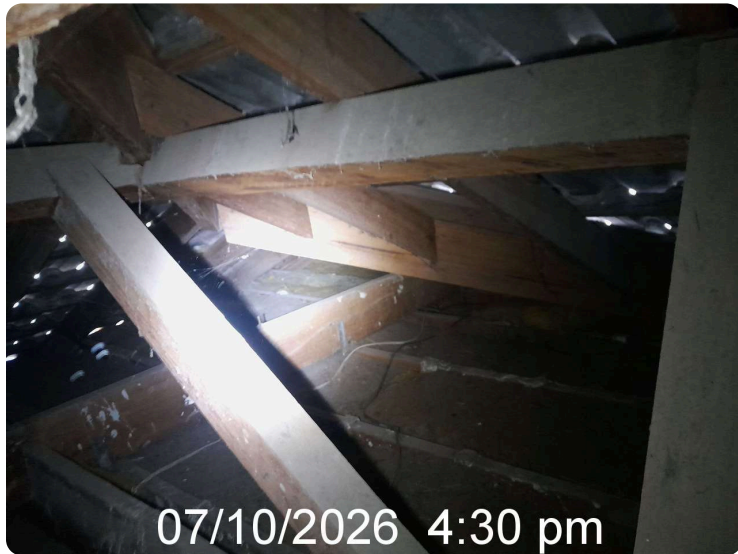
### ACCESS RESTRICTIONS TO THE ROOF VOID SPACE:: ITEM 2

| Reason for non access: | Items blocking access |

| Comments: | Stored timber preventing visual access to joists, old water heater, low access under 600mm above dining room, low eave points, |

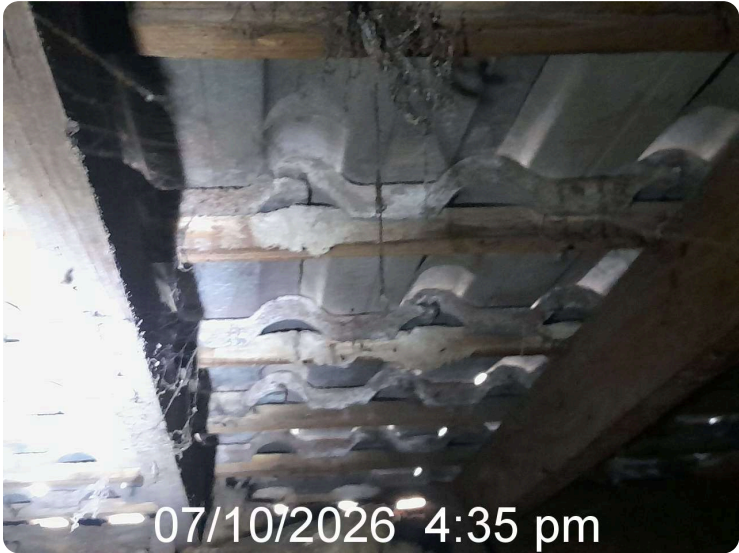
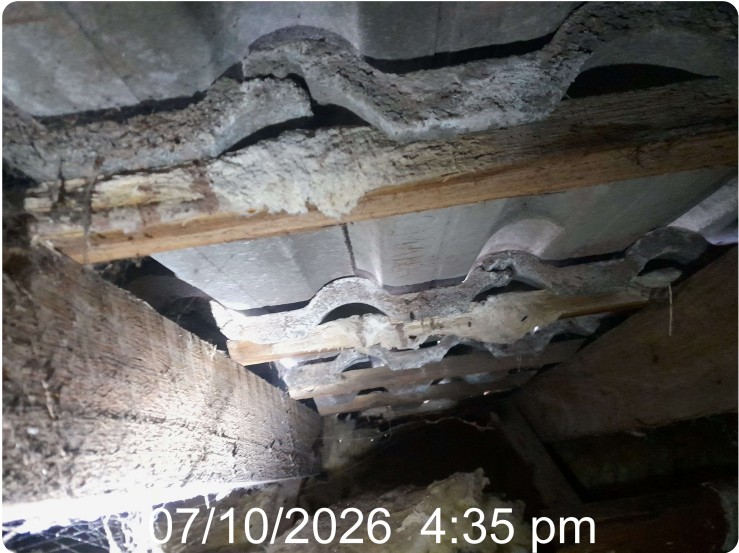
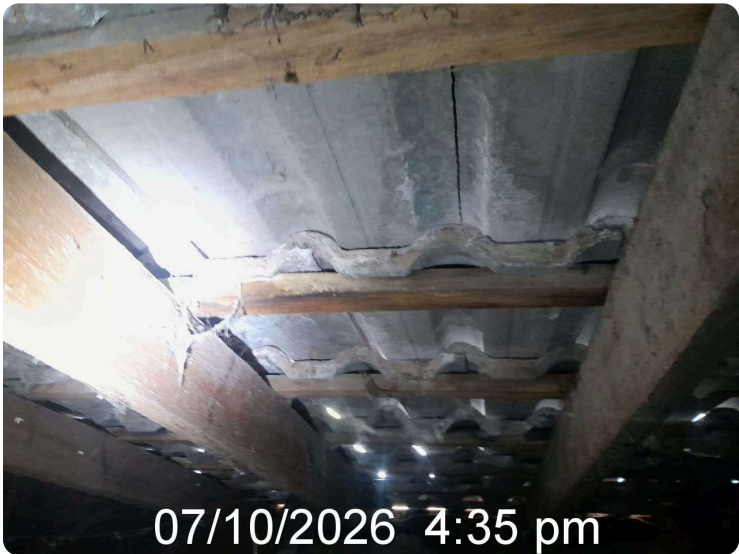
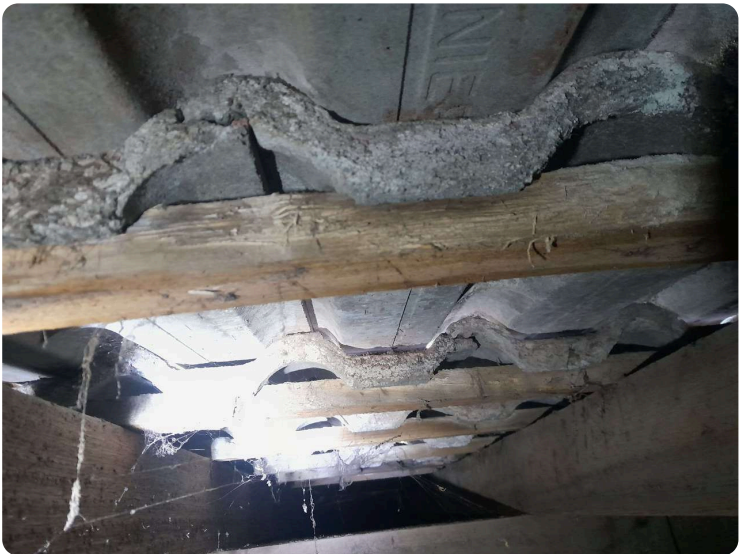
### EVIDENCE OF FUNGAL DECAY TO THE ROOF VOID SPACE:: ITEM 1

| Findings: | Fungal decay found |

| Affected items: | Battens |
| Extent of visible damage: | Moderate |
| Comments: | Delignification to Battens above bedroom 1, |

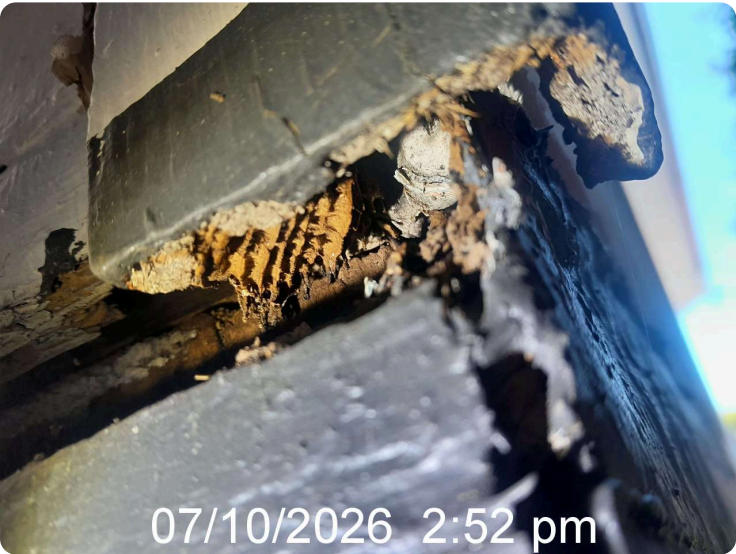
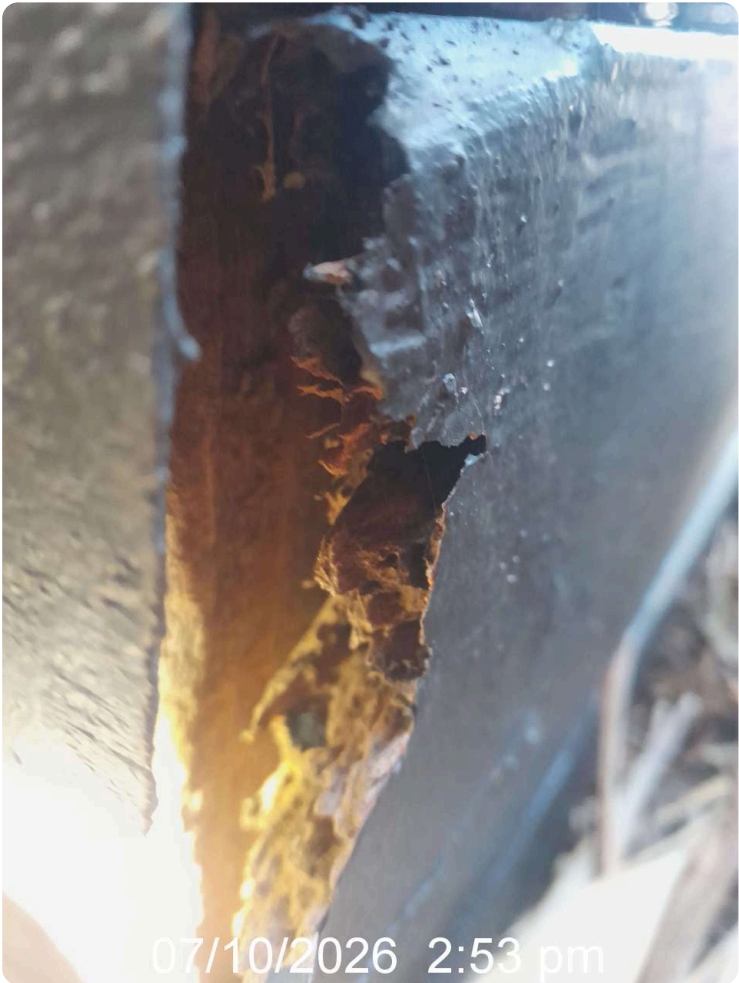
| EVIDENCE OF BORER ACTIVITY / DAMAGE TO THE EXTERNAL AREAS:: ITEM 1 | |

| Finding: | Evidence of previous borer activity (damage/visible signs) |

| Affected items: | Wall cladding |
| Extent of visible damage: | Minimal |
| Comments: | Corner trims |
