## Termite and Timber Pest Inspection V4

| Job ID | 70255249 |
| Site Address | 18 LEARMOUTH ST, BELMONT VIC 3216 |

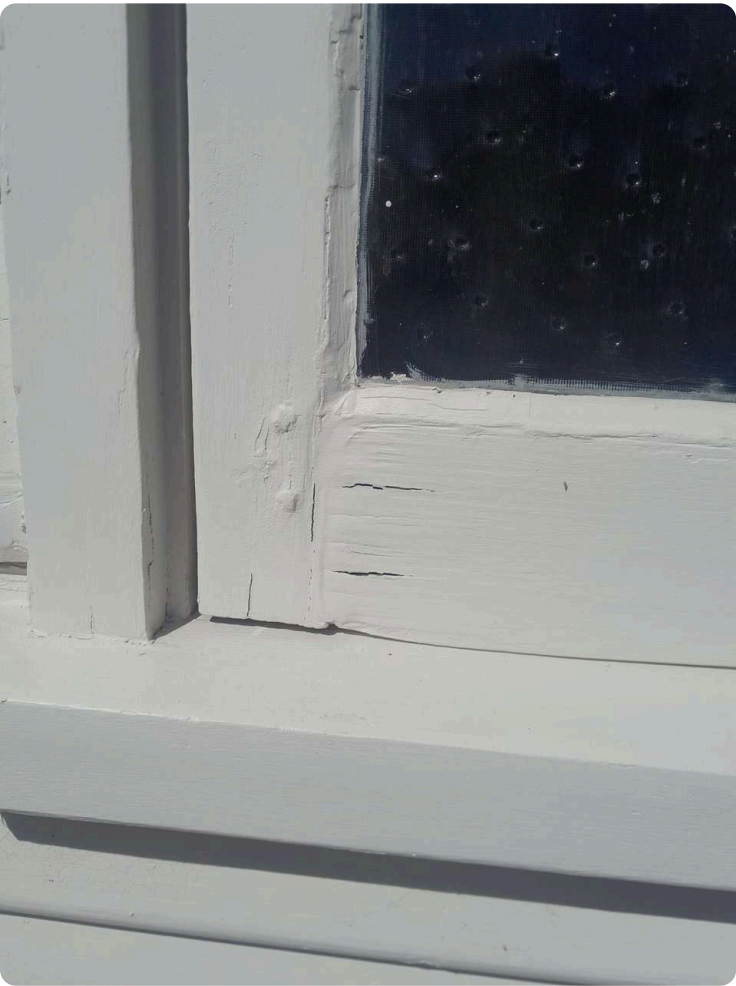
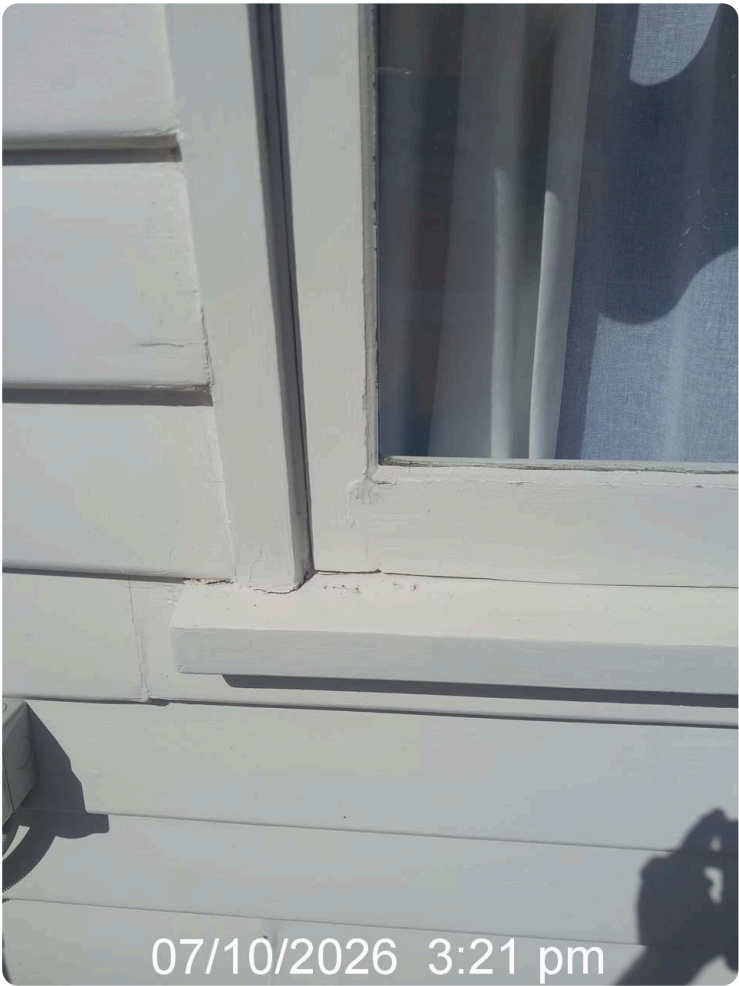
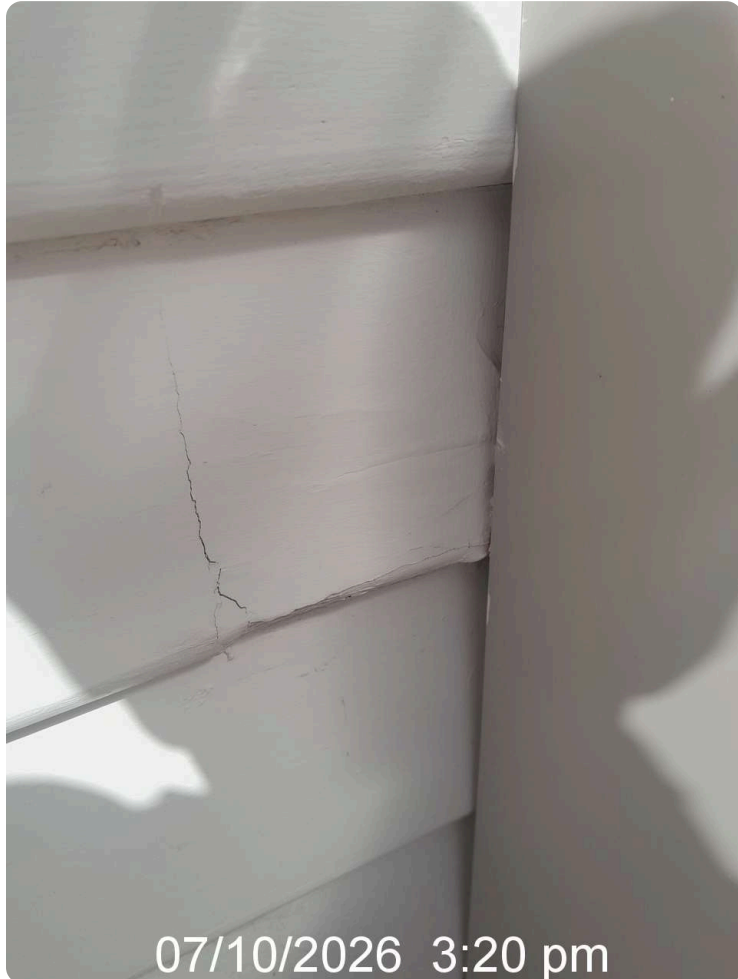
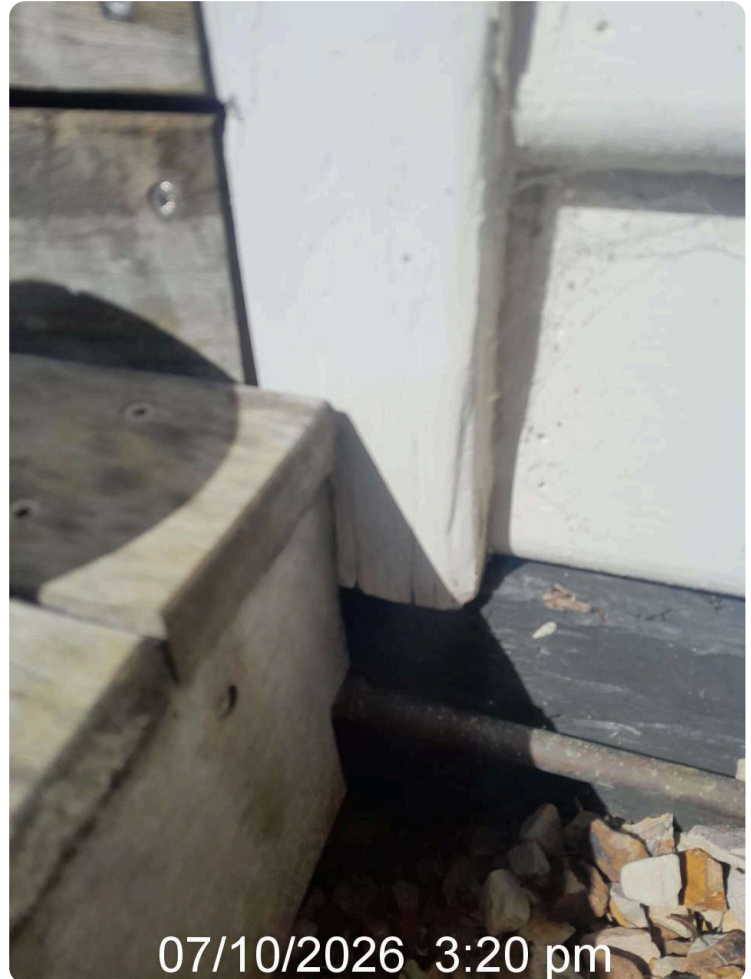
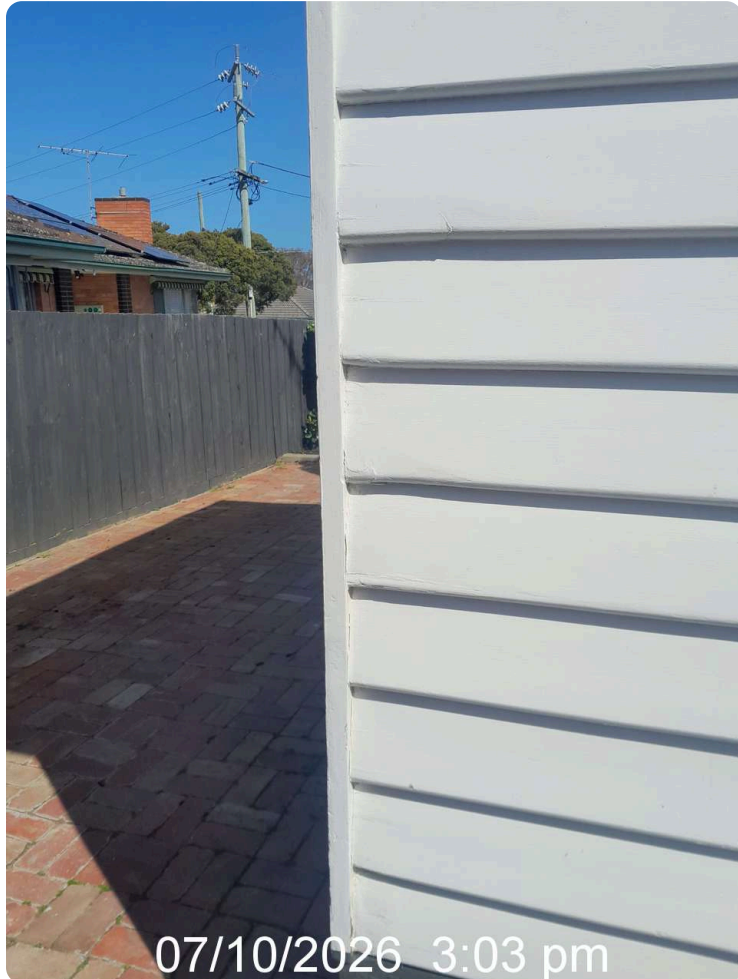
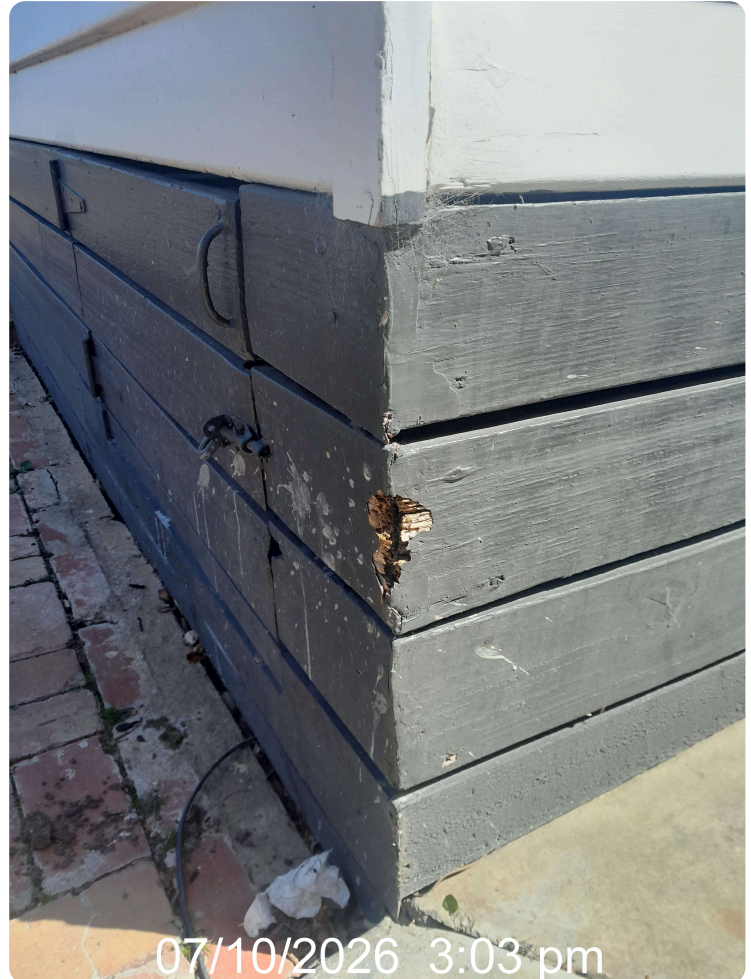
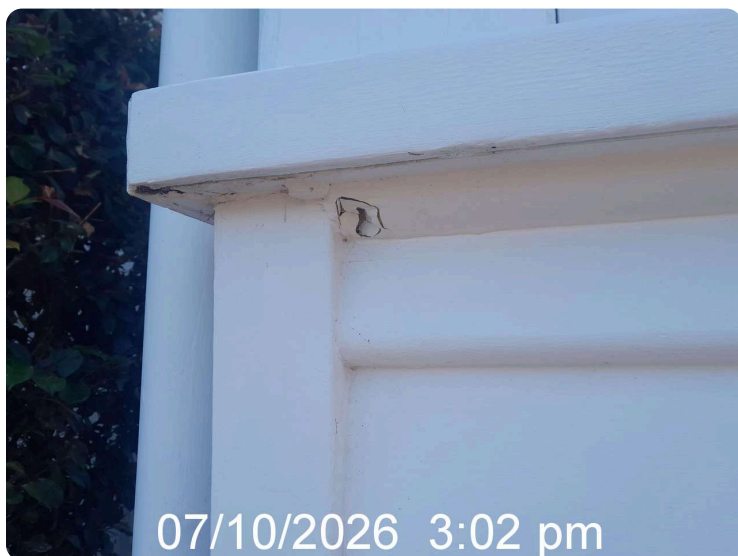
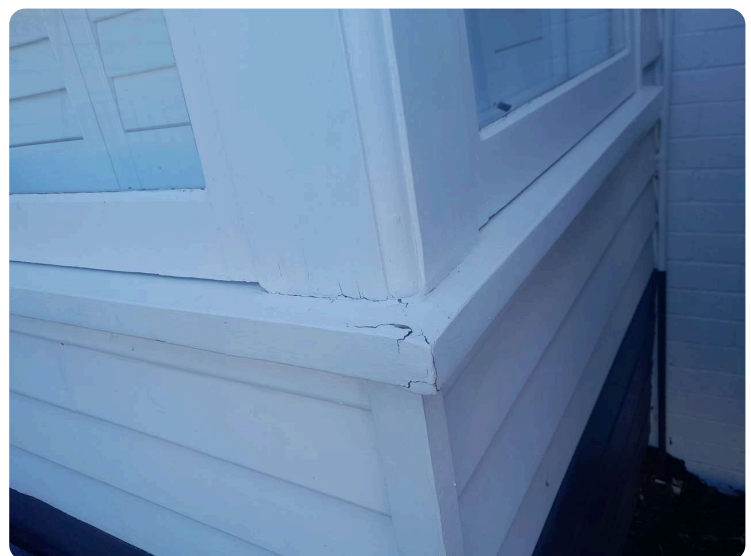
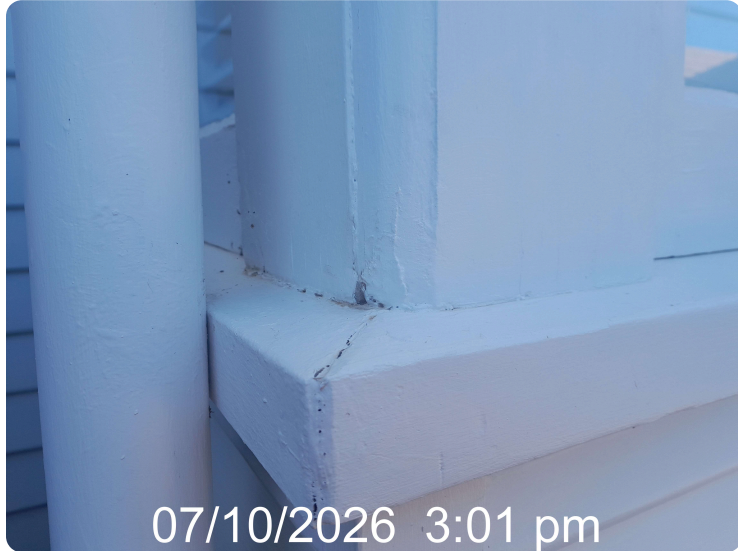
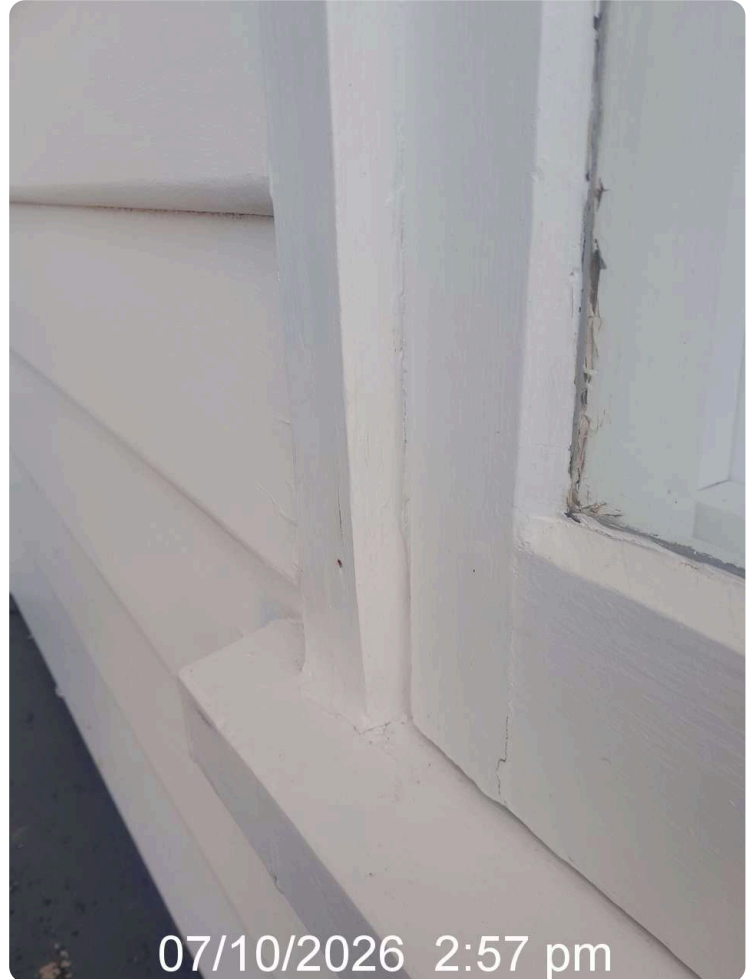
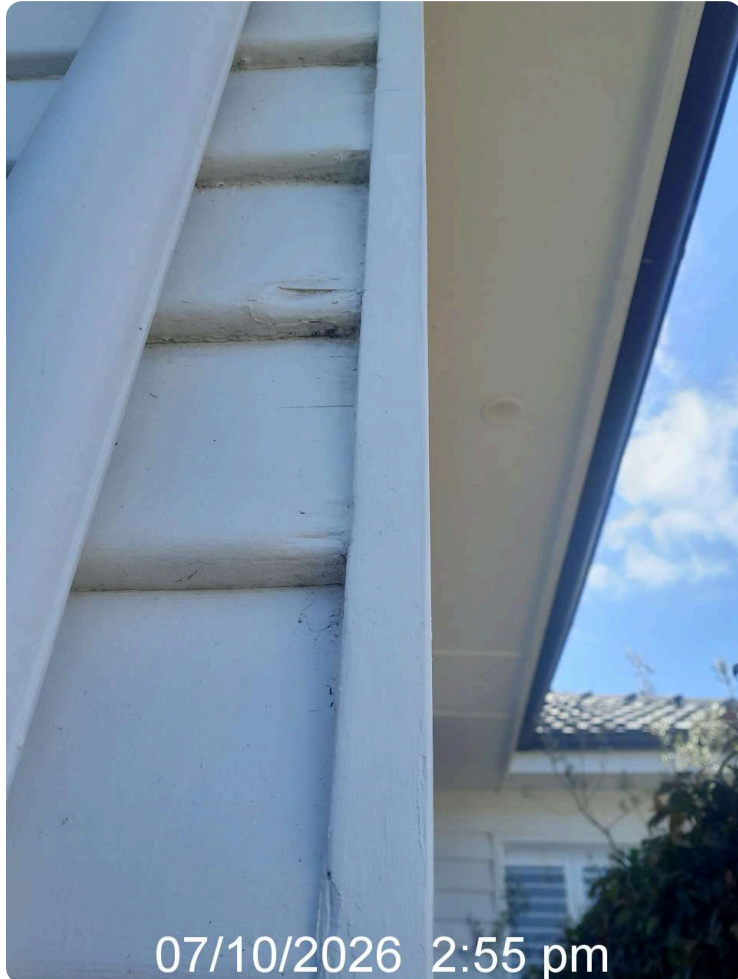
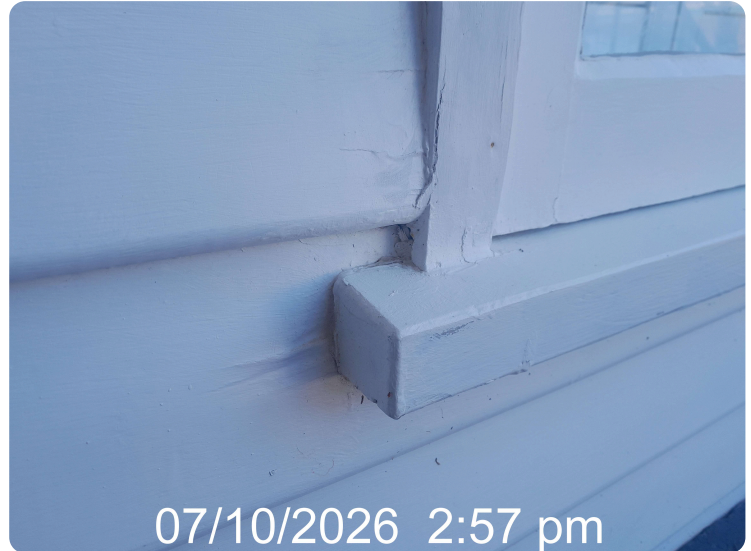
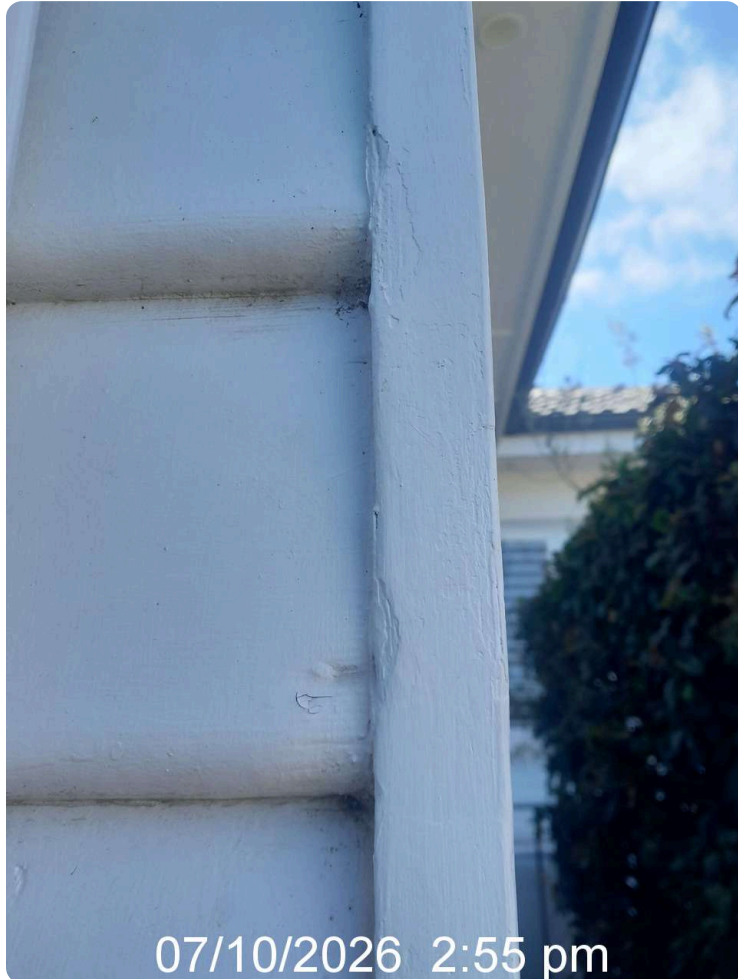
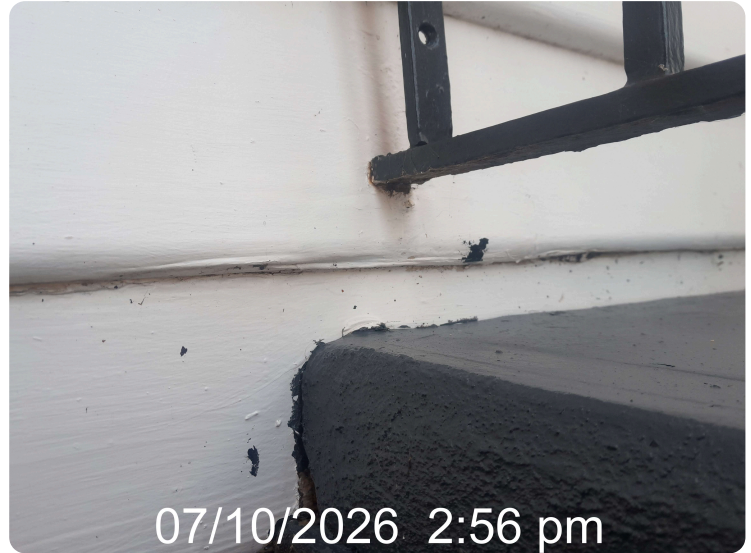
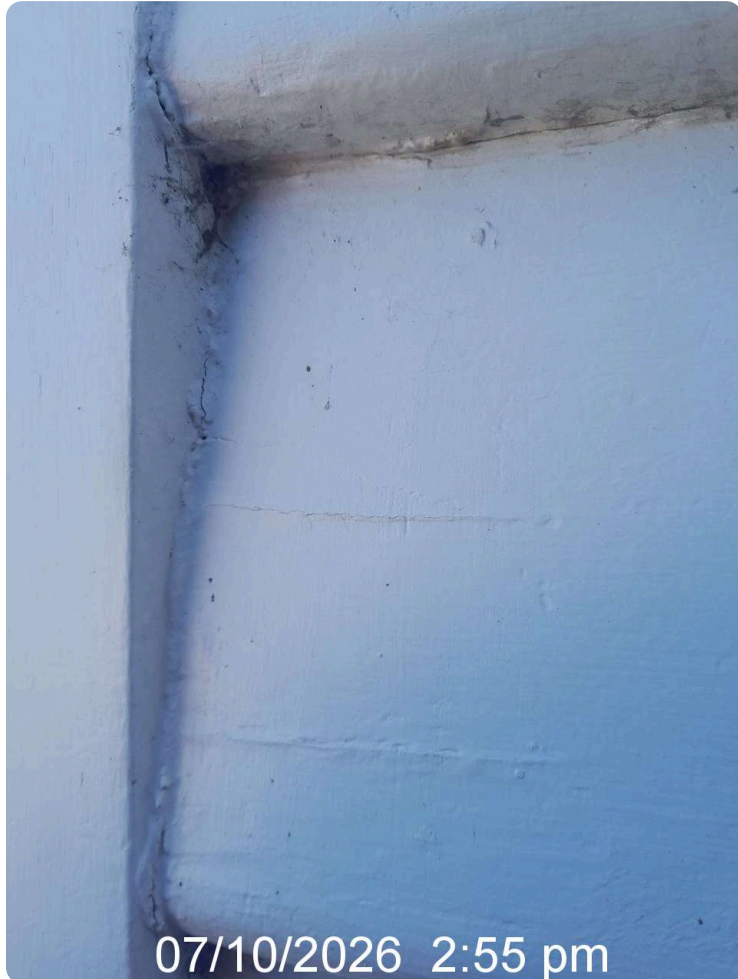
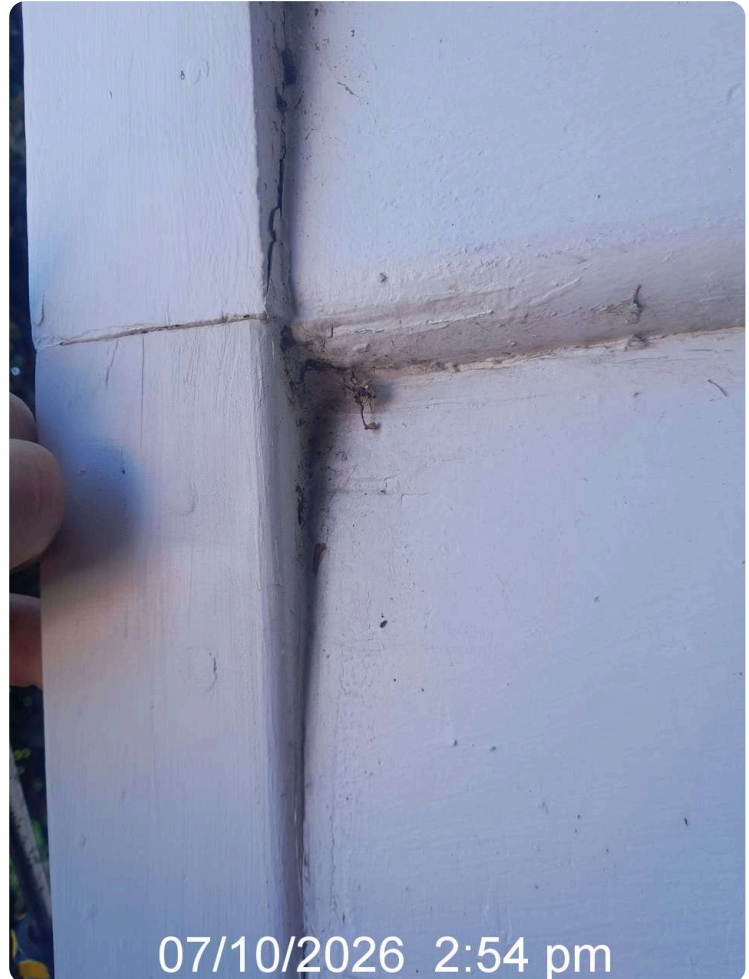
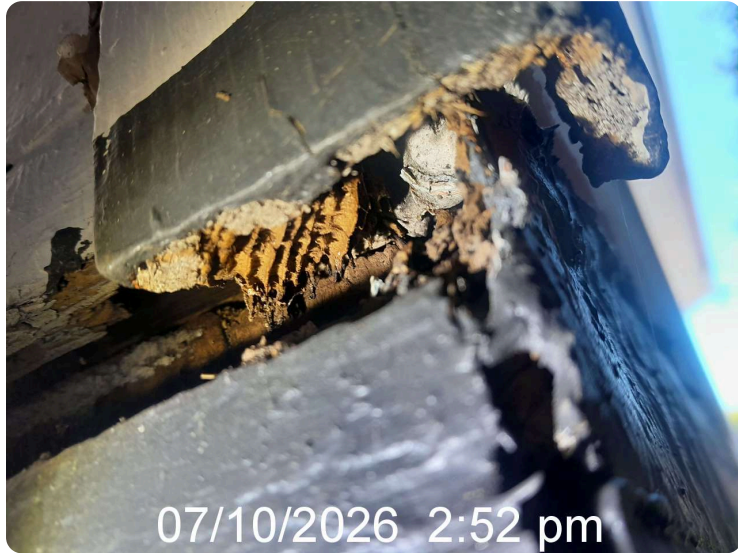
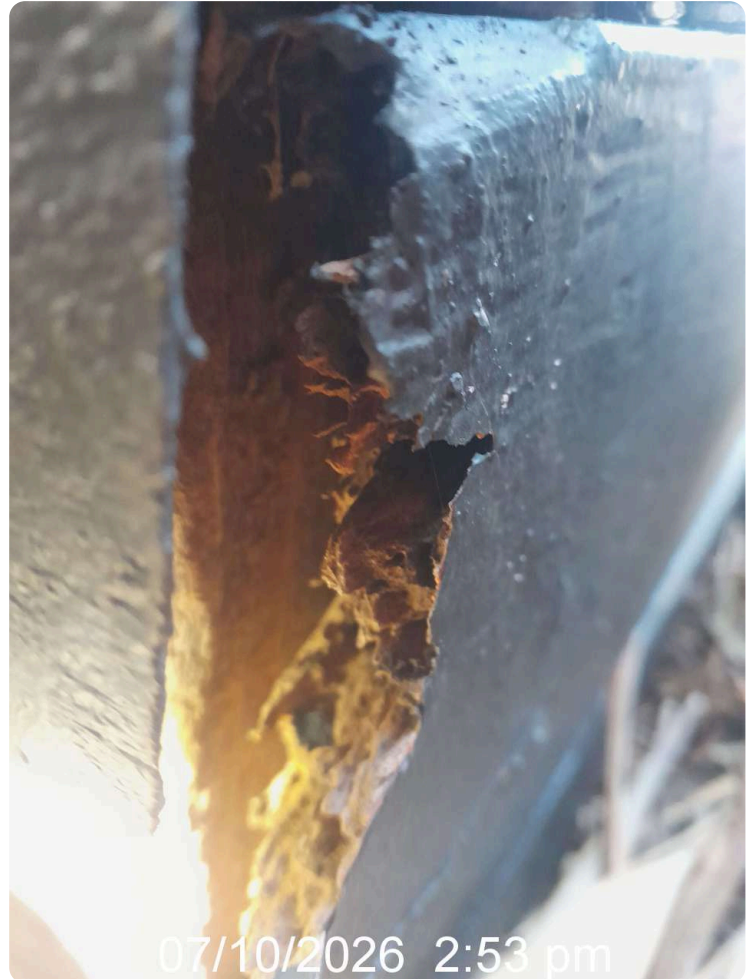
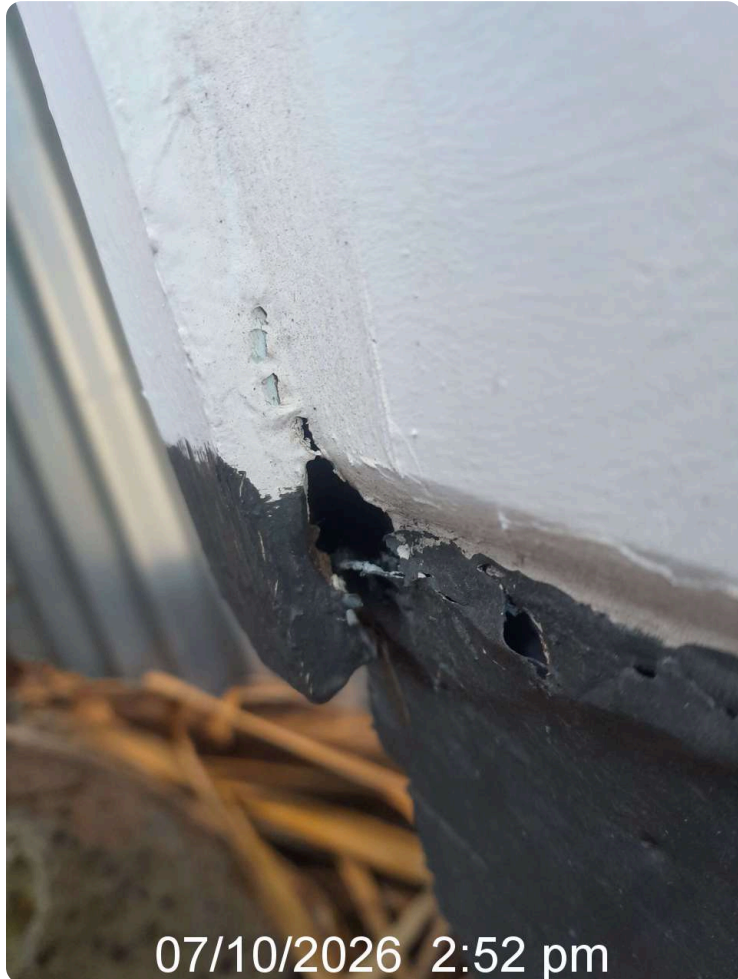
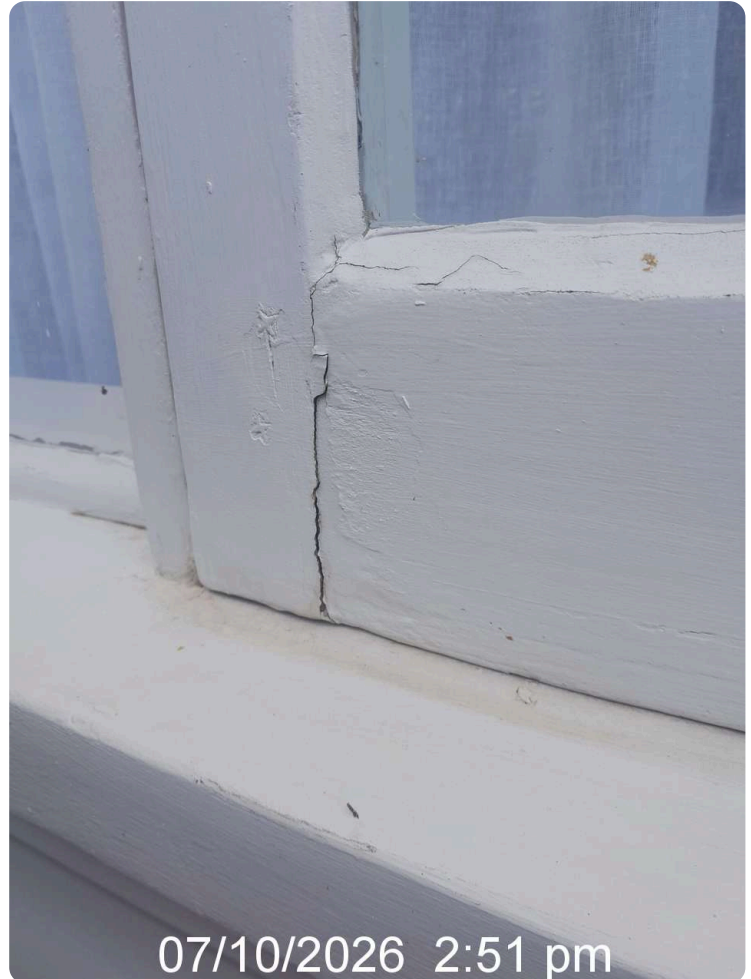
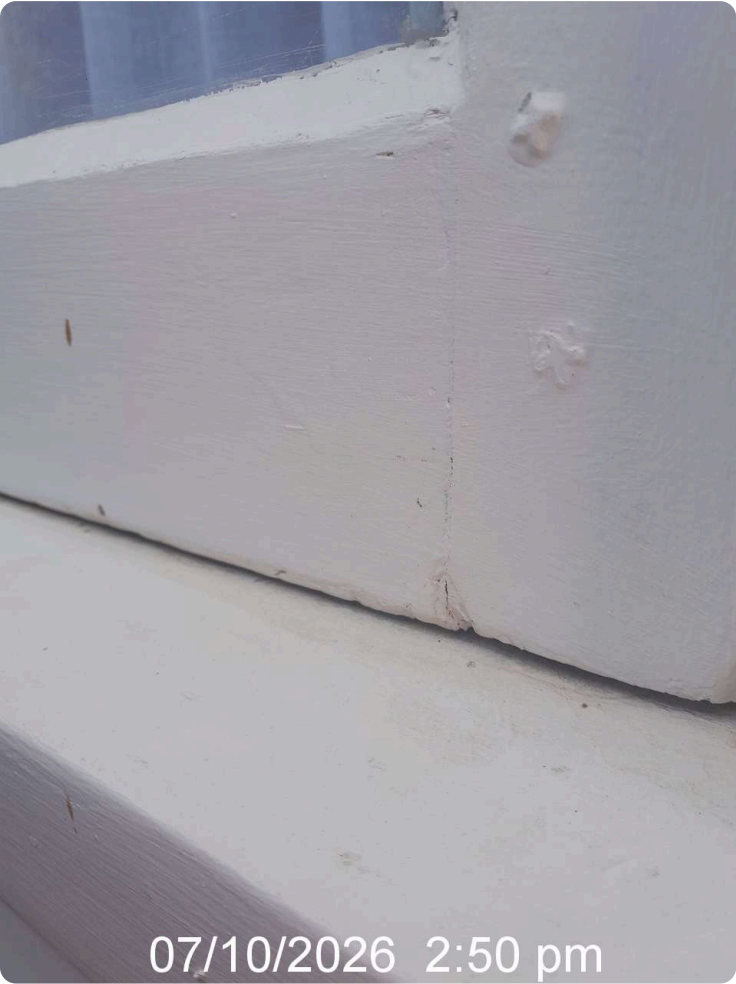
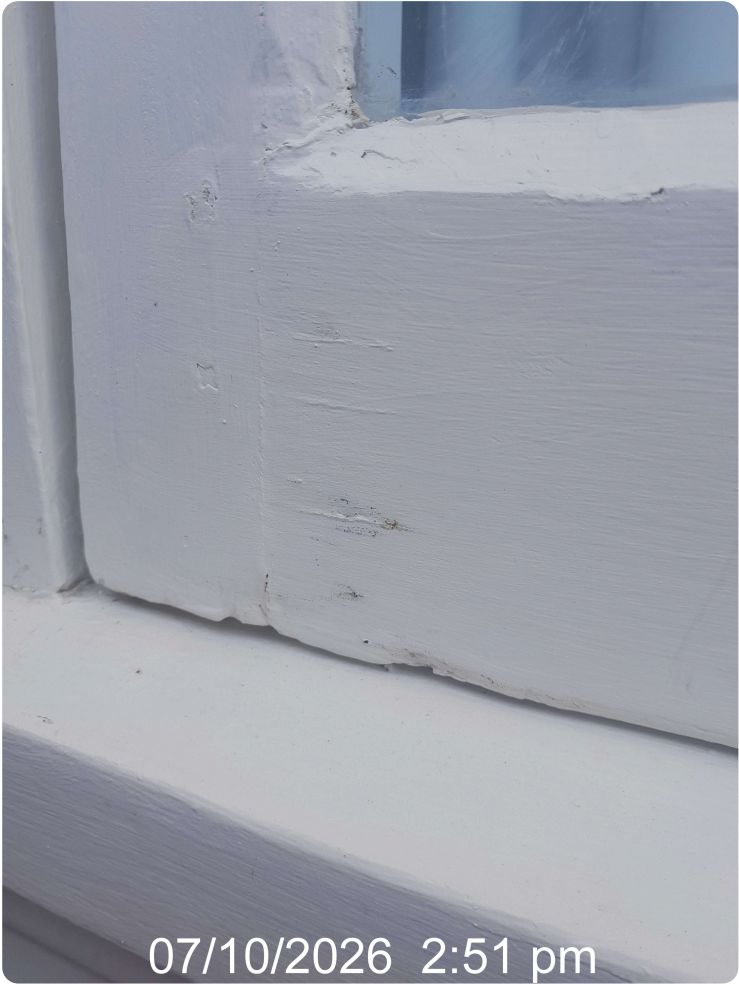
EVIDENCE OF FUNGAL DECAY TO THE EXTERNAL AREAS:: ITEM 1

| Findings: | Fungal decay found |

| Affected items: | Wall cladding<br>Window frames |
| Extent of visible damage: | Moderate |
| Comments: | Base boards, corner capping/trims, east weatherboards external to: bedroom 2, lounge, north side of dining, laundry toilet (beside Hot water unit), bedroom 3, window frames(external to: bedroom 2, lounge, bathroom, bedroom 3, dining: rails, stiles, sills, sill seat/quads, corner capping, |

Recommend replacing weathered timber to internal, external and subfloor spaces where applicable. Additionally all previously termite damaged areas to be excavated and replaced where necessary with adequate protection completed to surrounding concrete slab and penetrations.

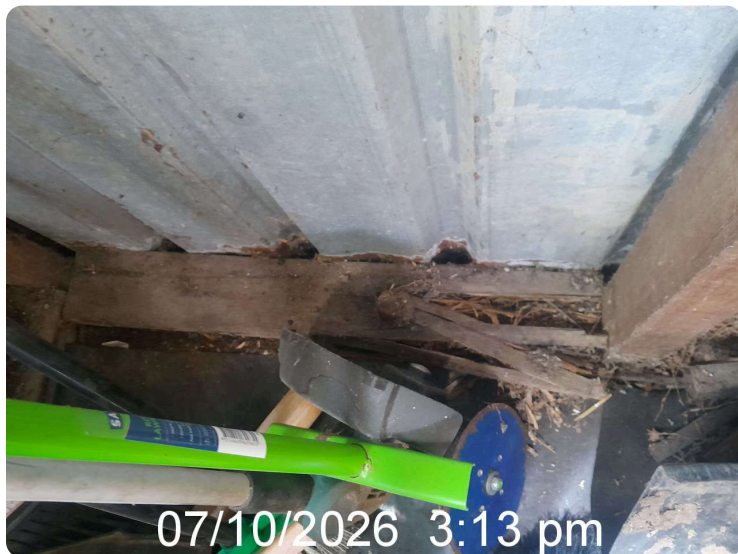
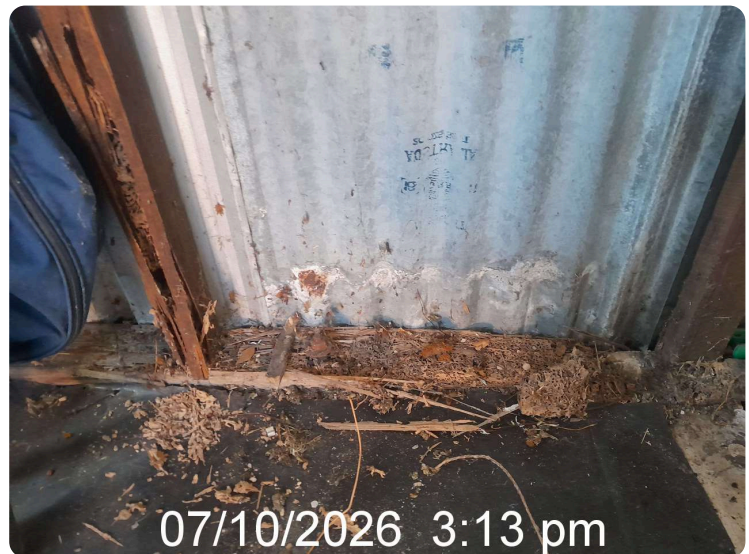
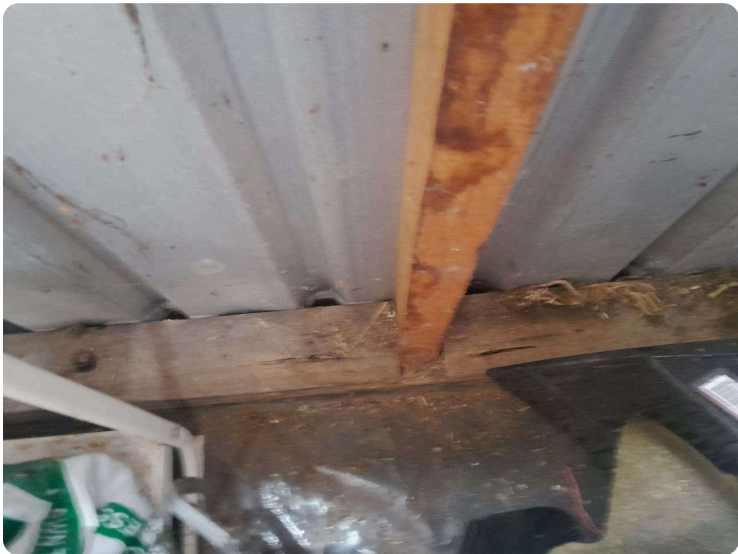
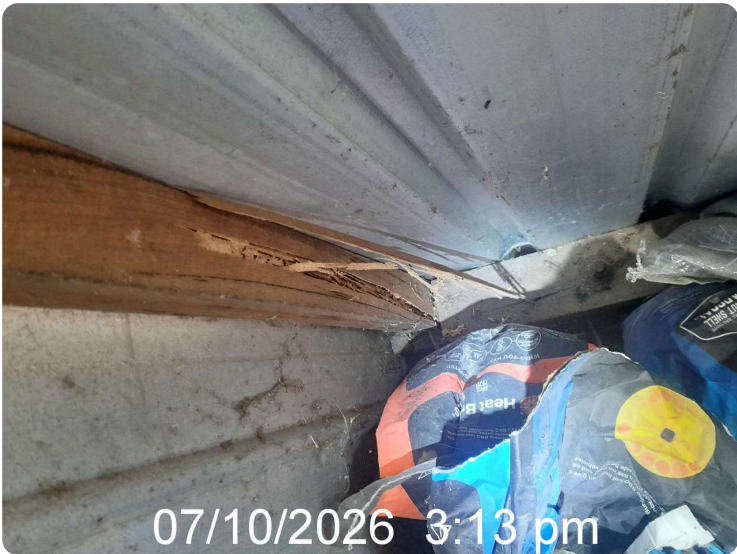
### EVIDENCE OF TERMITE ACTIVITY / DAMAGE TO THE OUTBUILDING(S):: ITEM 1

Evidence of previous termite activity (damage/visible signs)

| Affected items: | Stored items |
| Extent of visible damage: | Severe |
| Comments: | North bottom plates, north frame studs west bottom plates, west frame studs, |

| | Customer to engage a qualified builder to determine the extent of damage and replace any timbers as required |

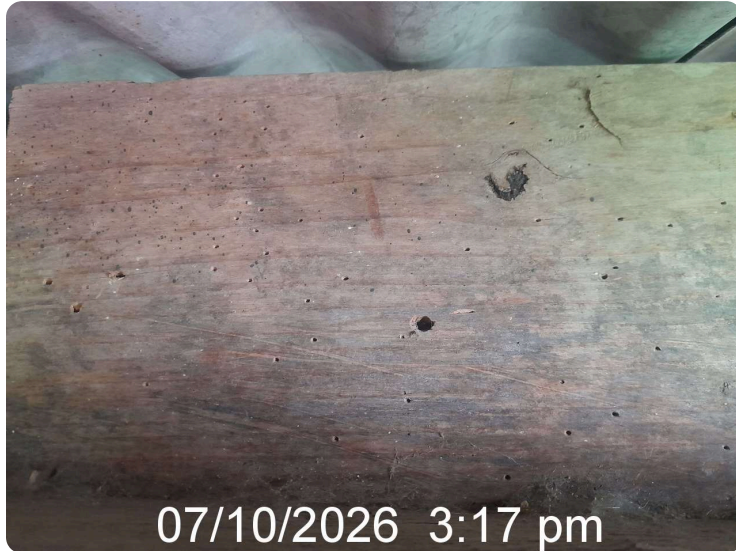
| EVIDENCE OF BORER ACTIVITY / DAMAGE TO THE OUTBUILDING(S):: ITEM 1 | |

| Findings: | Evidence of previous borer activity (damage/visible signs) |

| Affected items: | Roof timbers |
| Extent of visible damage: | Minimal |
| Comments: | North extension: west wall timber panels partially blocking roof to top plate, |
