**THE  
BUILDING  
AGENCY NSW**

# **Pre Inspection Building And Timber Pest Report**

**Inspection Date: 17 Jun 2026**

Property Address: 8 Coringle Place Woodcroft 2767

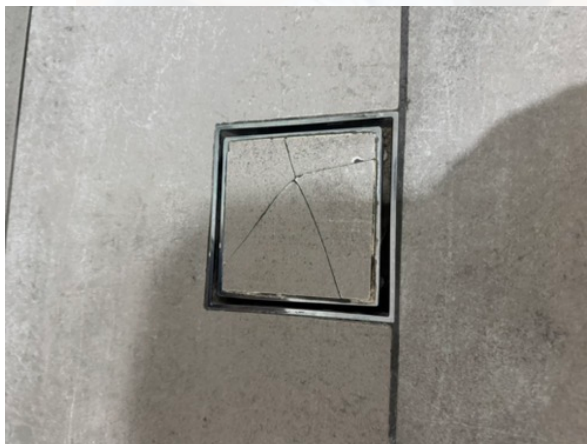
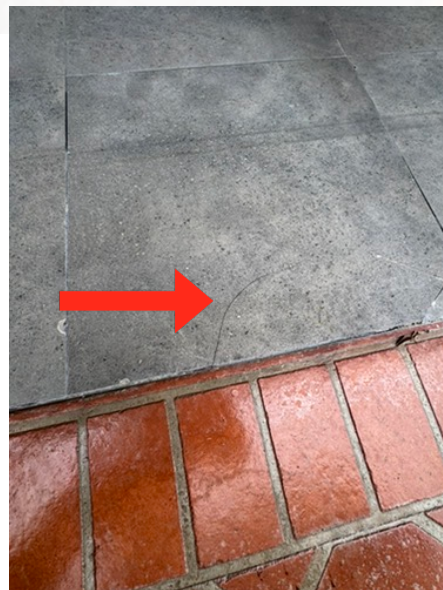
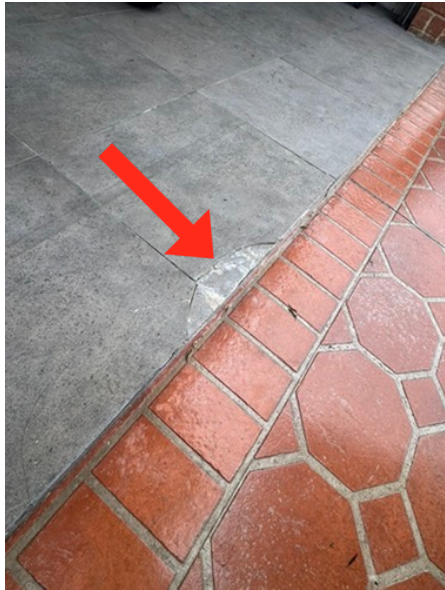
### Minor Defect 1.01

**Finding:** Cracked tiles

During the inspection, cracked tiles were observed on the garage floor, which may result from settling, impact, or other underlying issues. Additionally, while assessing the ensuite bathroom, it was noted that the floor waste tile is correctly installed. It is advisable to engage a professional tiler to assess and replace the damaged tiles in the garage to prevent further deterioration and potential safety hazards. This remedial action will ensure the integrity and aesthetic appeal of the property are maintained.

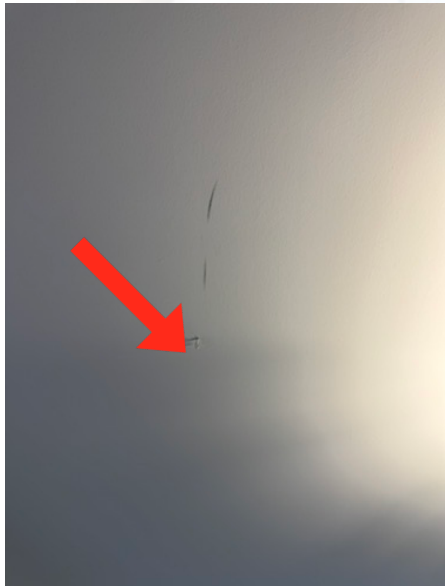
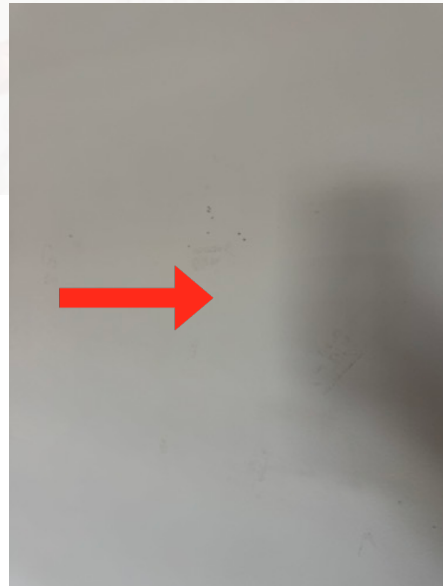
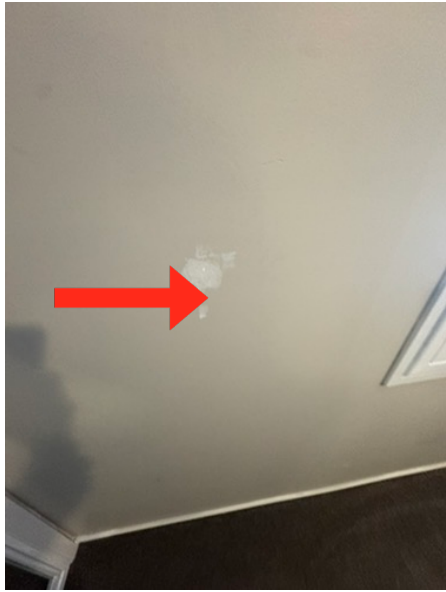
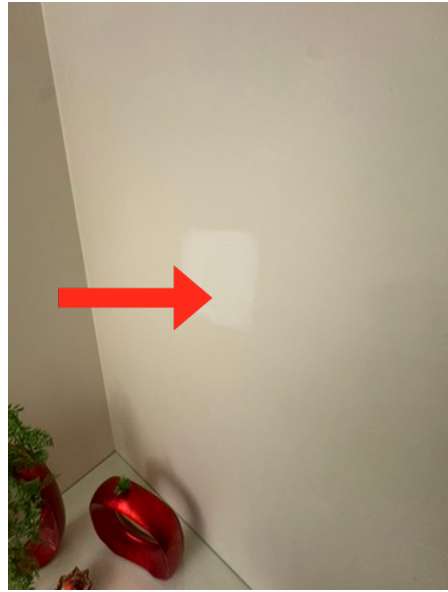
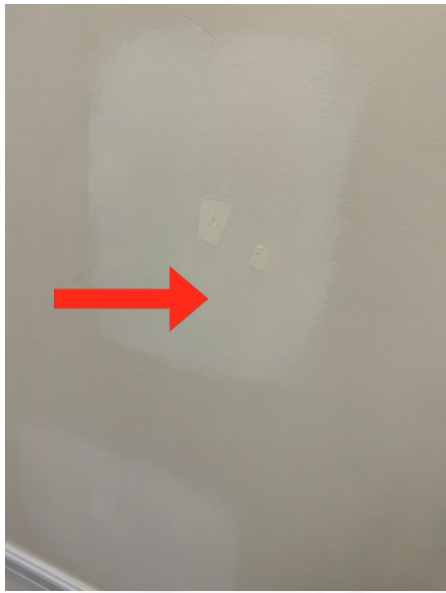
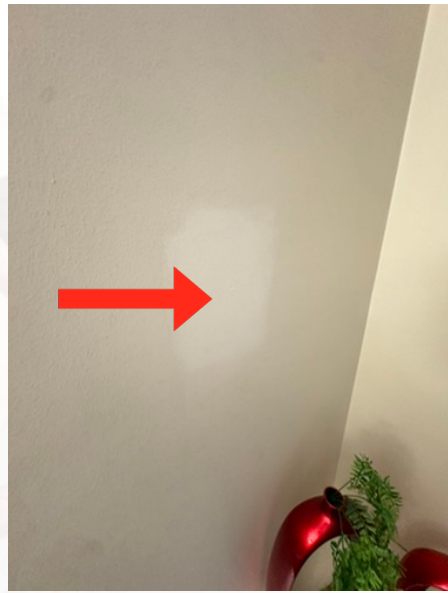
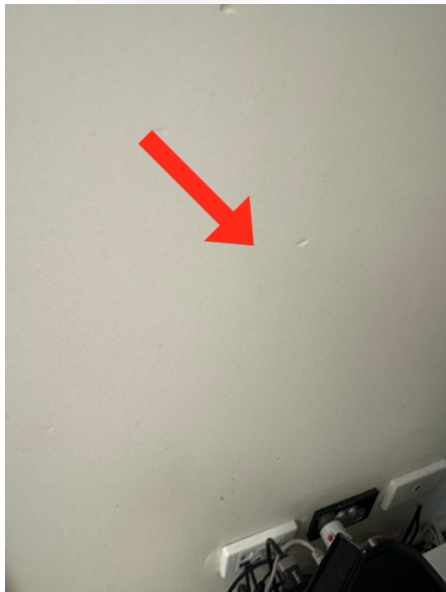
## Minor Defect 1.02

Scuff Marks

During the inspection, scuff marks were observed on numerous internal walls throughout the property. This cosmetic issue is consistent with normal wear and tear for a dwelling of this age. To address this aesthetic concern, it is recommended that the affected areas be cleaned and repainted. Engaging a professional painter will ensure a high-quality finish, restoring the walls' appearance and enhancing the property's overall presentation. Regular maintenance and care can help prevent the recurrence of such marks, preserving the interior condition of the home.

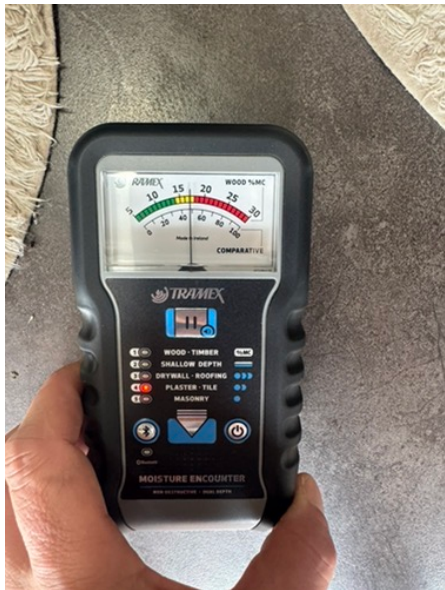
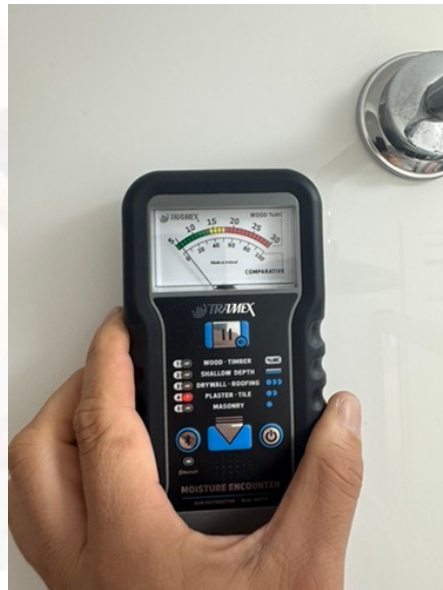
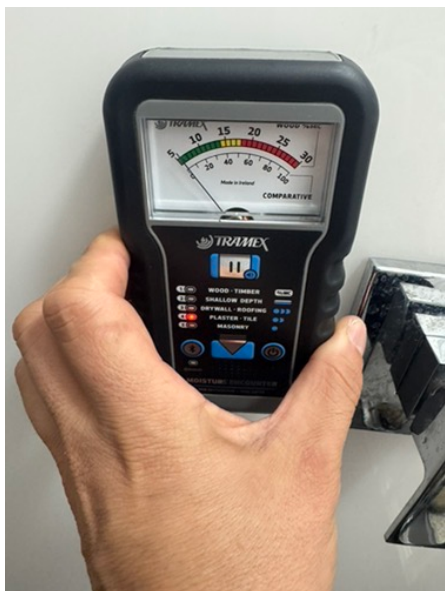
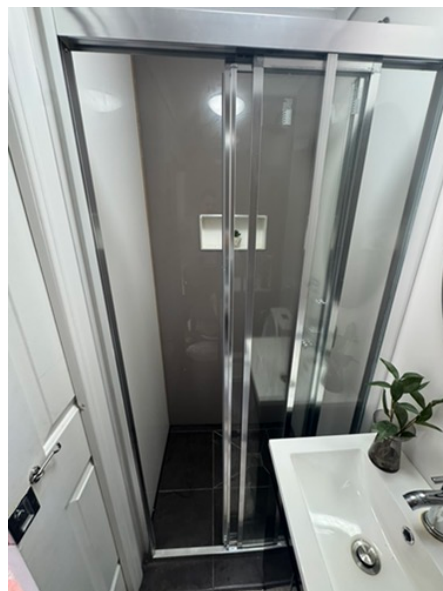
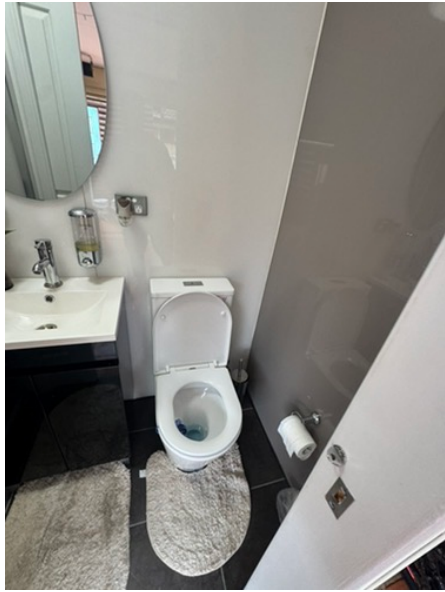
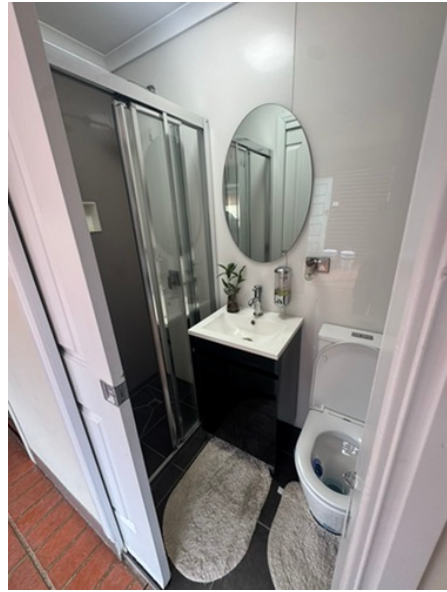
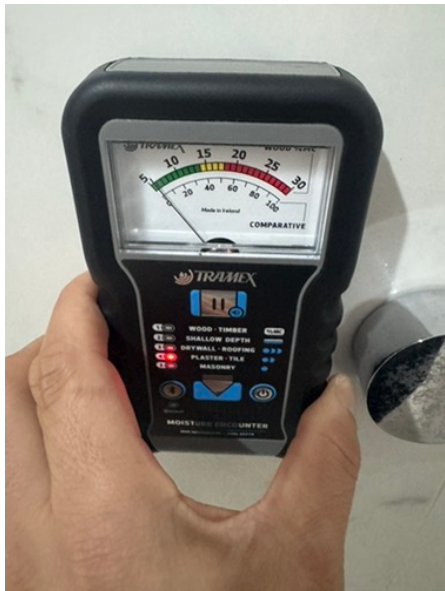
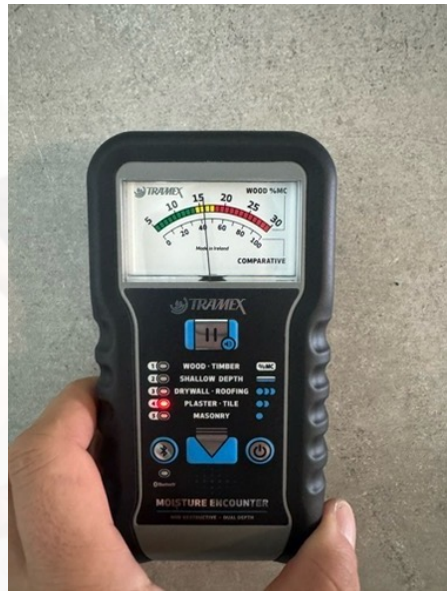
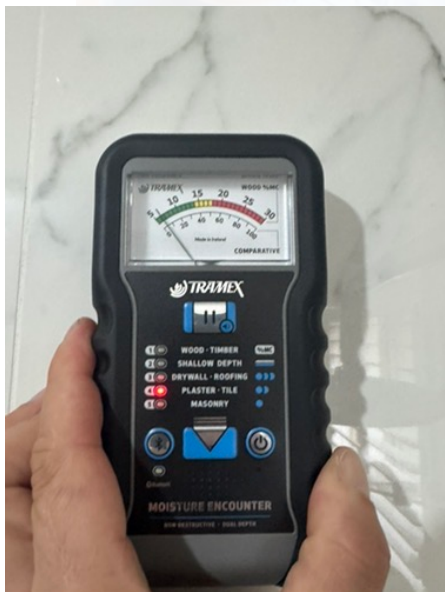
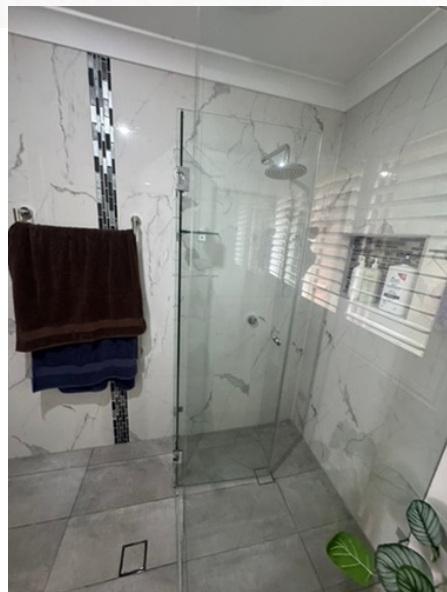
## For your information 2.03

**Finding:** Additional Photos-low moisture readings

During the inspection, moisture readings were taken in the bathrooms to assess the presence of dampness or water intrusion. The following observations were made:

- Moisture Reading: A moisture meter reading was taken in the bathrooms and ensuites and indicated a low level of dampness.
- Note/Description: The areas showed no visible signs of water leaks or water-related issues. The low moisture reading suggests that the bathroom area is adequately dry, and no immediate concerns are identified.

It is important to note that low moisture readings in bathrooms are positive indicators, suggesting that there are no immediate water-related problems. However, regular maintenance and monitoring of these areas are still recommended to prevent potential issues in the future.

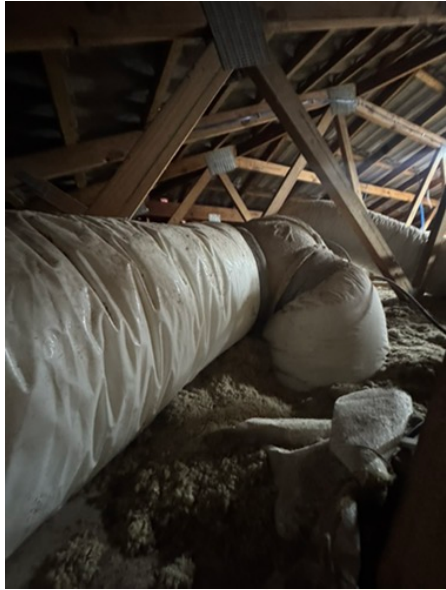
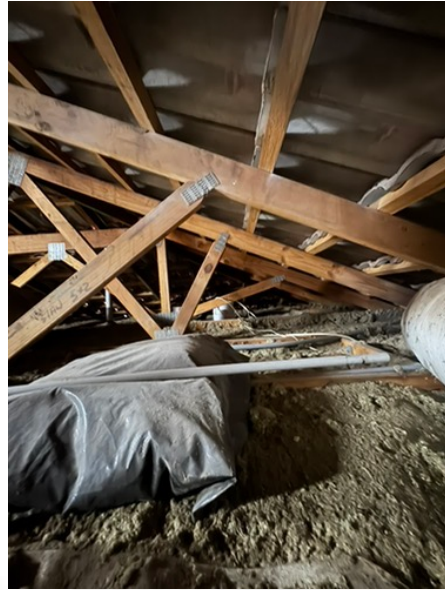
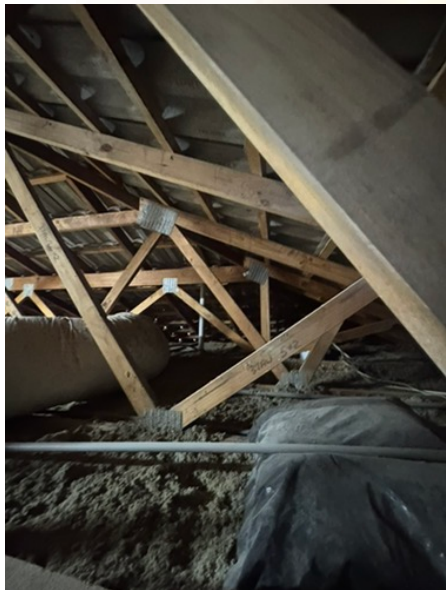
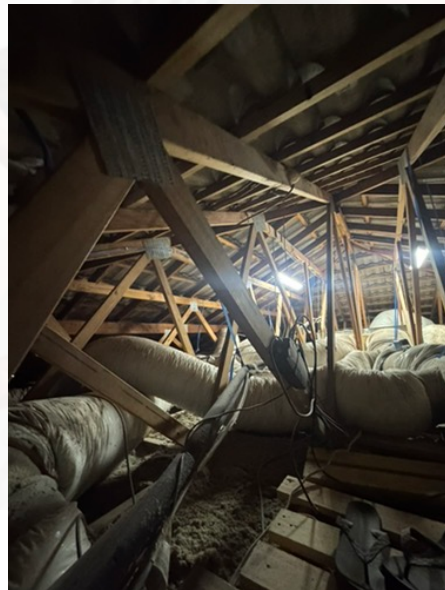
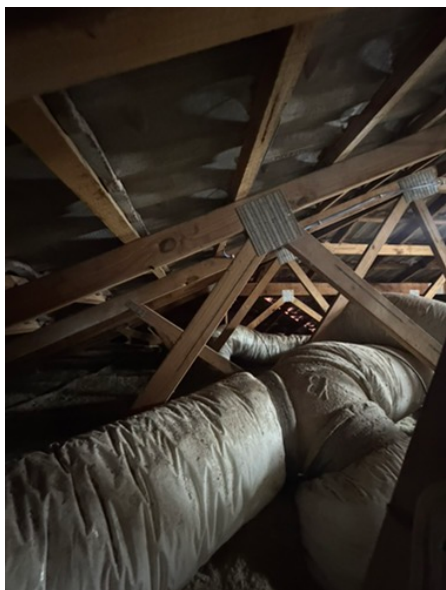
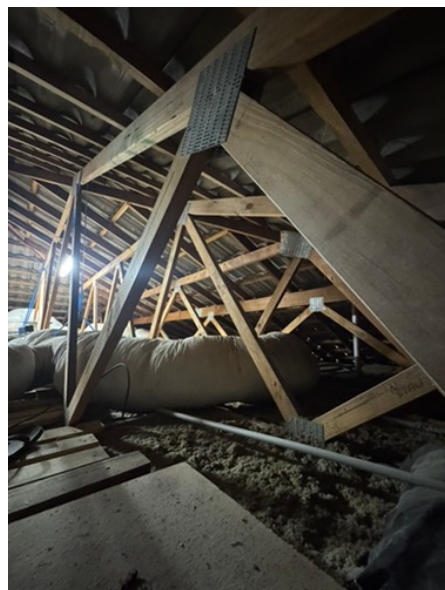
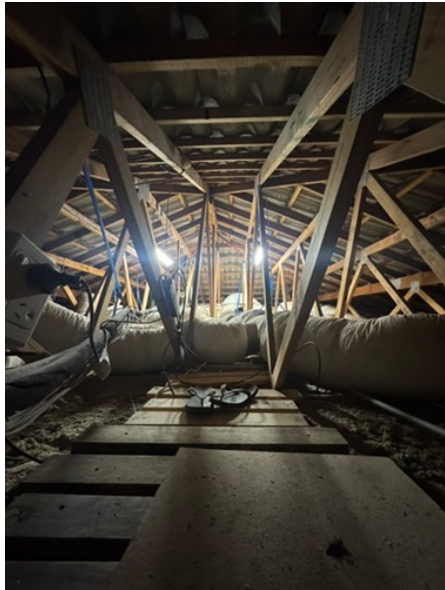
Note/Description: Roof sarking is a crucial layer of protection that is typically installed under the roof tiles or metal sheets. Its absence may lead to potential issues such as reduced thermal insulation, increased risk of water leaks during heavy rain, and decreased protection against dust and debris.

Possible risks: Without roof sarking, the dwelling may experience higher heating and cooling costs due to reduced insulation properties. In heavy rain or severe weather conditions, water leaks may occur, potentially leading to water damage and deterioration of building materials.

Recommendations: It is recommended to consider installing roof sarking to enhance the dwelling's thermal efficiency and protect against water infiltration. A qualified roofing specialist should be contacted to assess the roof's current condition and provide suitable options for the installation of roof sarking only at the owners discretion.

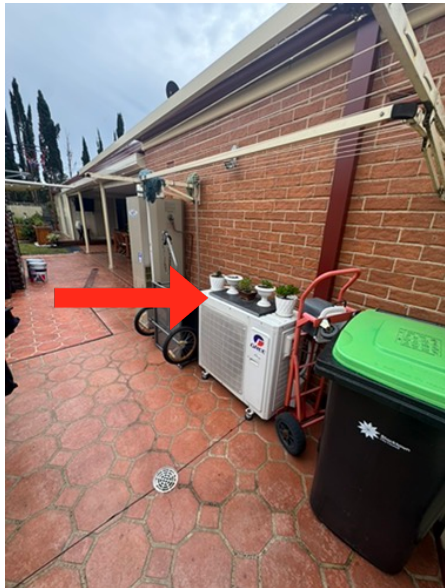
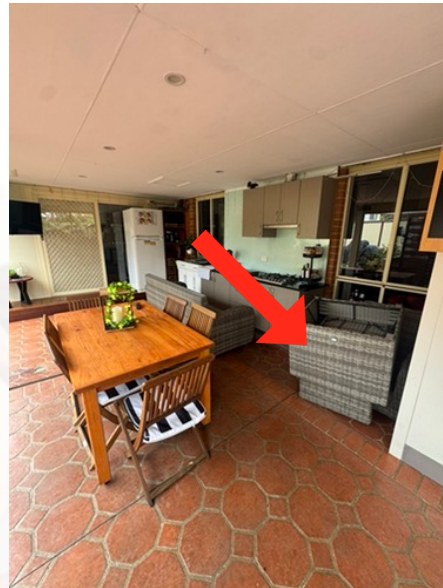
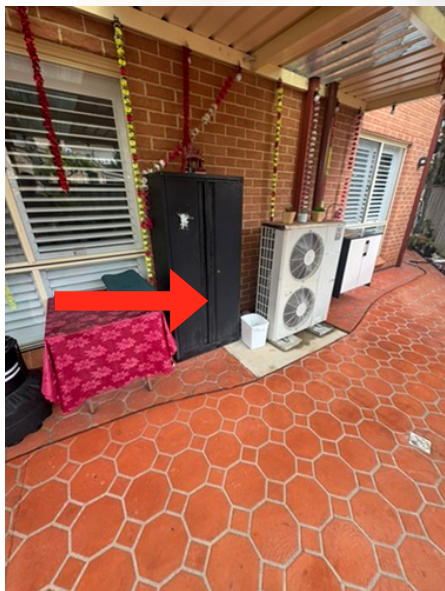
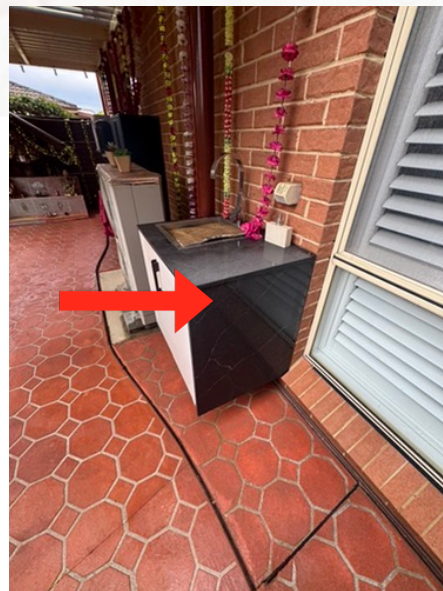
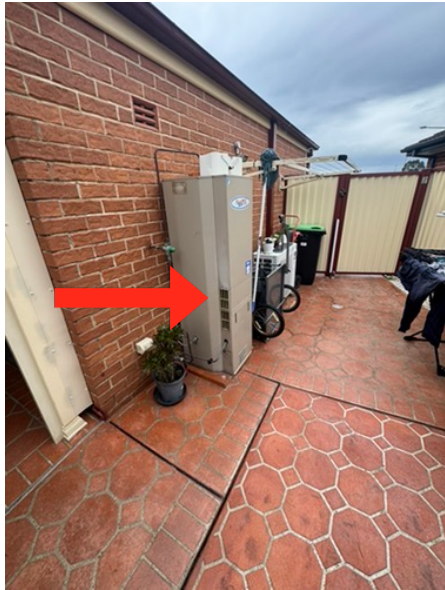
### Conditions conducive to timber pest attack 3.01

**Finding:** Bridging or Obstruction of inspection zones

Bridging of termite barriers occurs when termites bridge (usually by building a mud tunnel) a termite barrier or inspection zone or where termites have a passage allowing them to bridge the barrier. Either the A/C Unit, Hot Water unit, storage shed, garden beds or stored goods obstructed a clear visual inspection to the wall(s) and weep holes in this area. Where bridging has occurred full inspection is prevented and termites may enter a property in a concealed or undetectable manner. Recommend moving obstructions away from the external walls for further and future inspections.

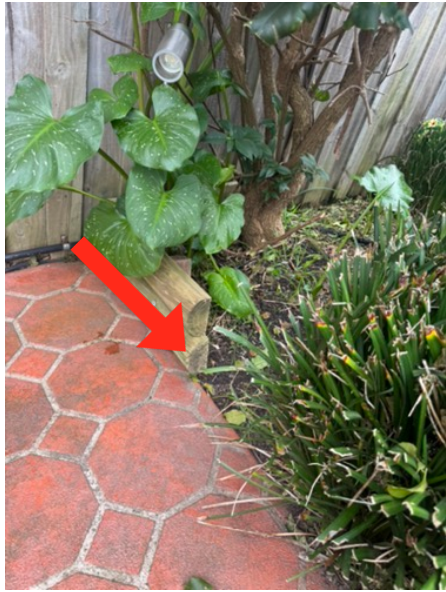
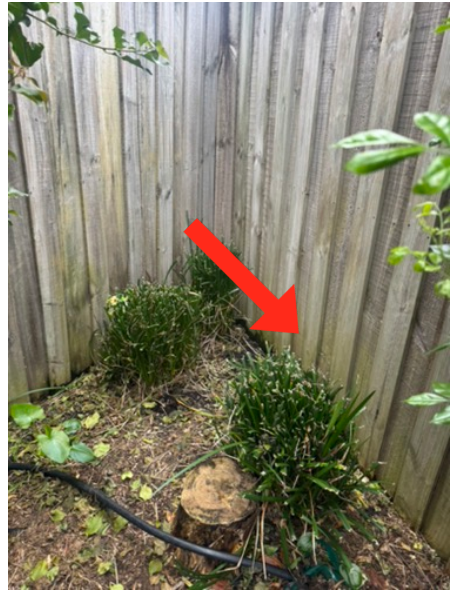
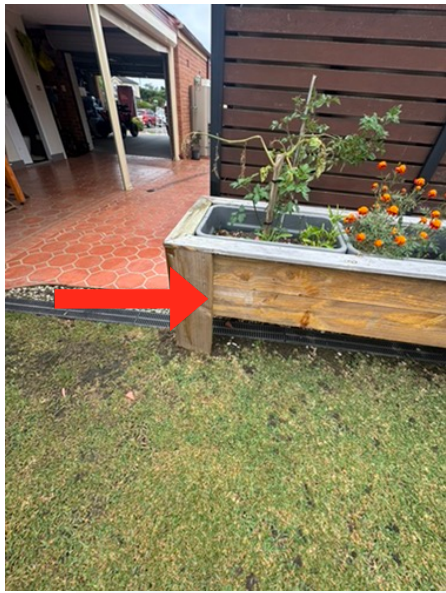
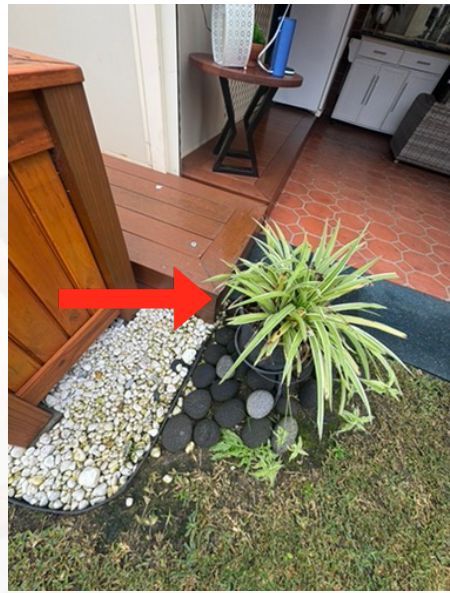
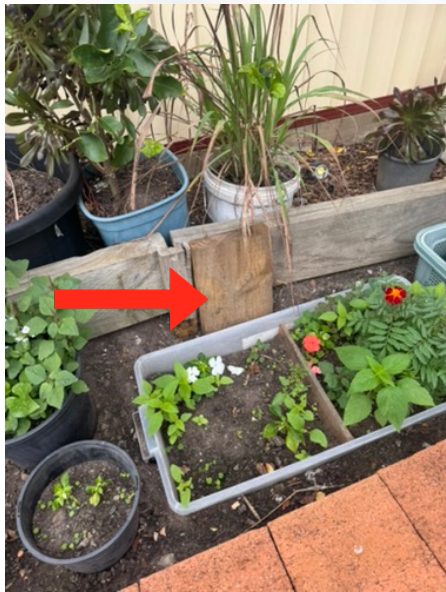
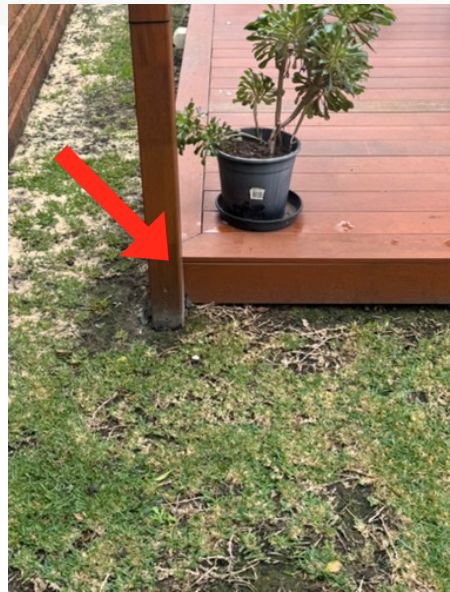
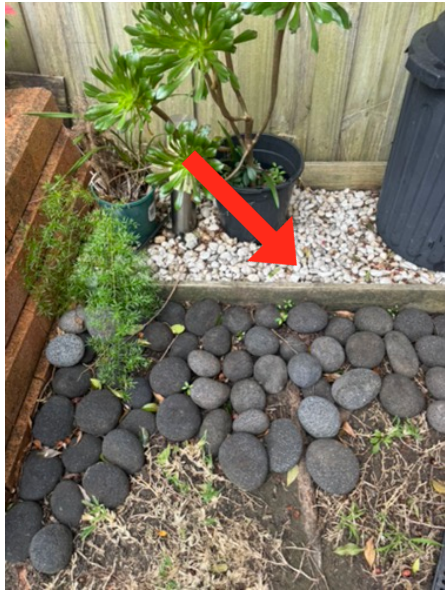
### Conditions conducive to timber pest attack 3.02

**Finding:** Timbers on Ground

Timbers throughout the property were found to be in contact with the ground. Where timber elements are in direct contact with the ground and consequently there is moisture or dampness they become conducive to termite activity. Whether timber is used as a building element part of a fencing structure or stored as an unused item they can provide an environment that is attractive to termite infestation. When met with excessive moisture timber begins to decay and develop wood decay. Any timbers that are in direct contact with external grounds especially if left untreated or non-durable also provide ingress for subterranean termites into that particular element. Any such materials that may be conducive to termite activity should be monitored frequently for any changes to minimise the risk of termite attack.

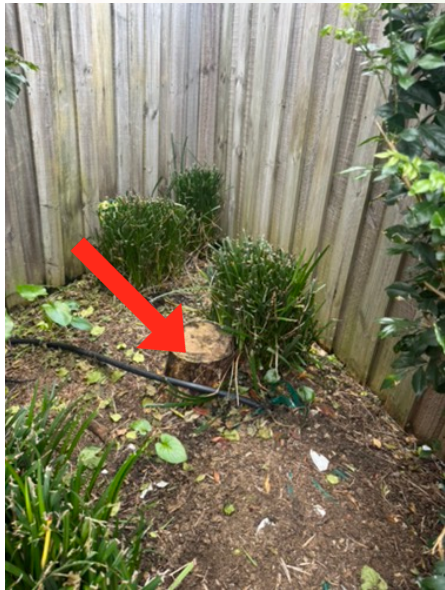
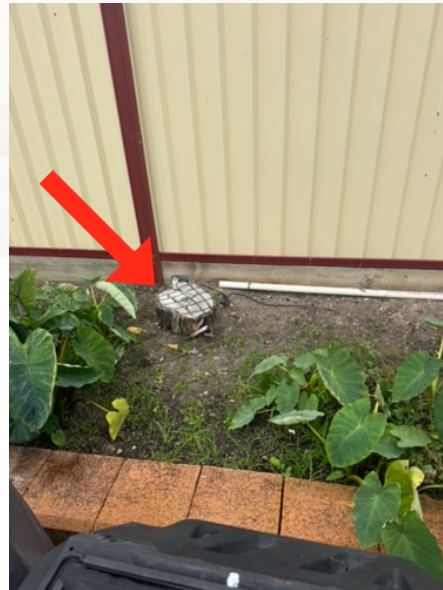
### Conditions conducive to timber pest attack 3.04

**Finding:** Old tree stumps

Tree stumps exposed and left in soil perimeters cause conducive conditions for termites to explore and enter through as colonies, a tree arborist is highly recommended to remove all tree stumps throughout the property and individually test and treat each stump. Left in such conditions is a high risk of termite activity.

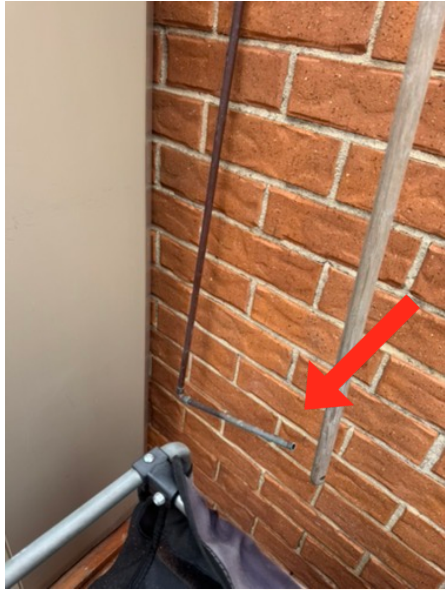
**Location:** Exterior Wall

The hot water unit is not properly connected to the stormwater system, creating a potential termite attraction. This defect poses a significant risk as termites are drawn to moisture, and the absence of proper drainage may lead to water accumulation near the property's foundation. To rectify this issue, it is recommended to engage a qualified plumber to connect the outlet to the stormwater system, ensuring proper drainage and minimizing the risk of

the outlet to the stormwater system, ensuring proper drainage and minimizing the risk of termite infestation.

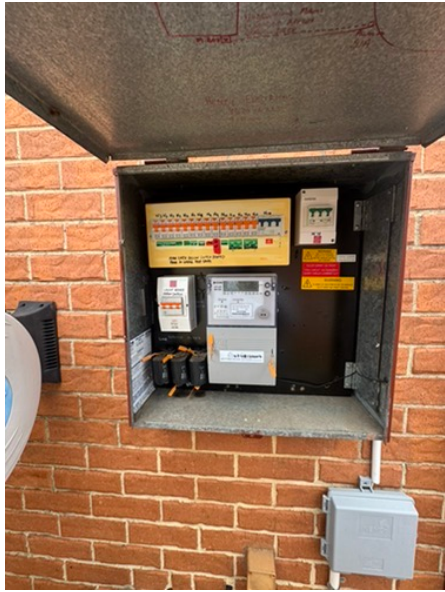
**Finding:** Durable Notice - Missing

A durable notice is missing from the meterbox. The application of a post-construction chemical termite barrier is highly recommended for all properties with timber building elements. Such barriers are highly effective in preventing termite attack on any timber building elements throughout the property. A durable notice should be placed in the meter board to indicate current termite barriers. At the time of inspection, it appeared as though no termite management system has been installed, with no evidence to suggest preventative works taking place which puts this property at very high risk. The client should consider gaining further advice from a licensed termite/timber pest technician as to the costs and procedures involved with implementing and maintaining a pest management system for this

Recommendations: Engage a qualified pest control expert with experience in termite management for older properties. They can assess the specific risk factors of the property, recommend appropriate treatments, and provide ongoing guidance to ensure effective termite prevention. Additionally, refer to local regulations and guidelines related to termite management for your area.
