RESIDENTIAL BUILDING REPORT

Complies with Australian Standard AS 4349.1-2007- Inspection of Buildings
Part 1: Pre-Purchase Inspections - Residential Buildings

Property Address: 12 TANTANGARA PL - WOODCROFT

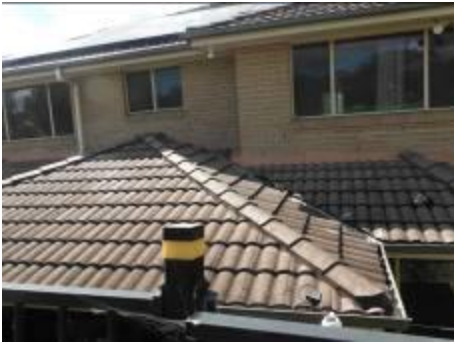
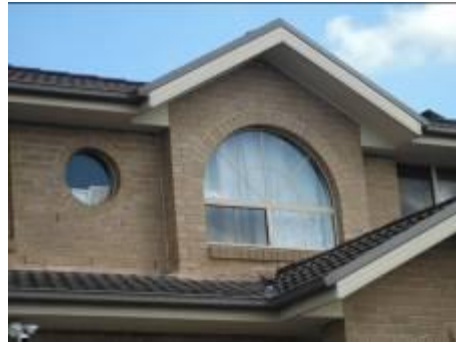
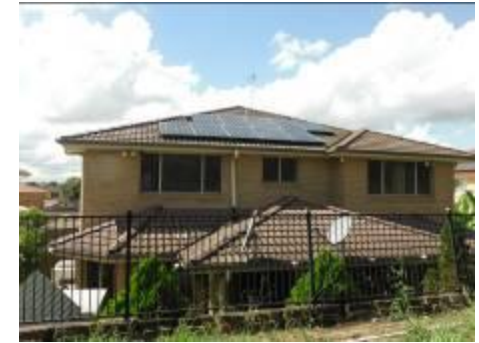
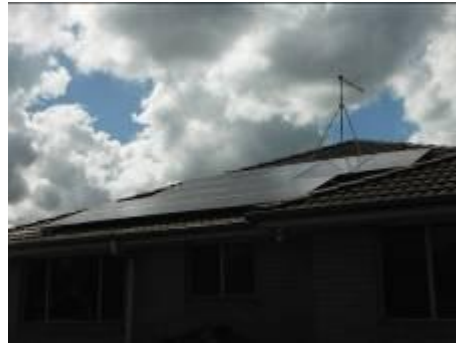
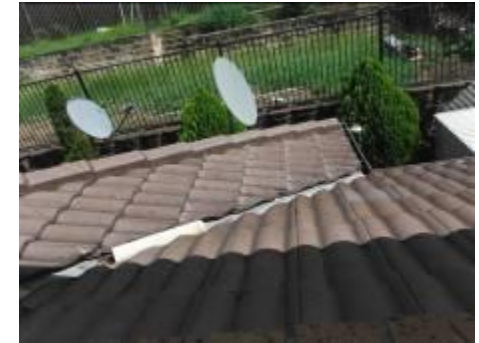
3.1 Roof		<p>Of the visible areas, the roof covers are generally watertight but require attention. Fig 1-9</p> <p>The cracked/sealed roof tile should be replaced.</p> <p>Refix the ill-fitting roof tiles along the valley gutters to prevent rainwater ingress.</p> <p>The roof flashings should always be properly sealed/dressed down.</p> <p>This is usual maintenance work common to most old houses.</p> <p>* Undertake any spot maintenance to include re-point/reseal if/as necessary.</p>	<p>The roof covers/flashings require attention to ensure the waterproof condition of the roof surface.</p> <p>* Water leaks can develop at any time.</p> <p>Monitor roof for any water leaks during periods of heavy rain.</p> <p>Note: A qualified roofer should be engaged for advice and recommendation.</p>

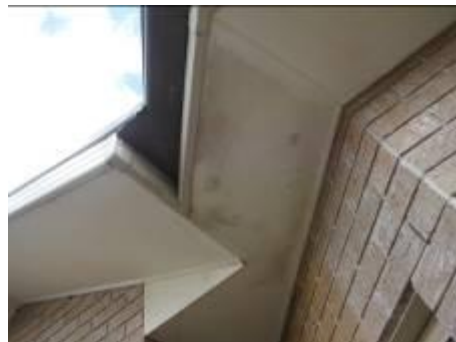
Fig 10

3.6 Eaves, Fascias and Barges		<p>Of the visible areas, the eaves/fascias are in a still serviceable condition with no notable defects for age of dwelling..</p> <p>Maintenance/general cleaning is recommended. Fig 10</p>	<p>The soffit lining/fascias should be kept well painted to prevent such deterioration.</p>

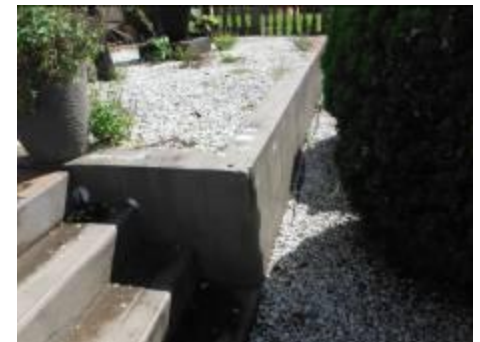
6.6 Paths/paving		Cracking is evident on the paving/flowerbeds. Fig 24 Repatching is considered.	(See section 7.0 of this report).
6.7 Driveway		Cracking/separating gaps is evident on the driveway slab.	(See section 7.0 of this report).

6.8 Steps		Tolerable.	* Handrails are required were a person has the potential to fall one meter or more.
6.9 General Fencing Gate		The front render fence and columns are chipped/spalling. The rear fences are wobbling/leaning due to movement in the retaining wall. Repairing/re-rendering/securing is required. Fig 22-24 The boundary timber fences are in tolerable condition The gates are still in service.	Recommendation: A qualified tradesperson should be engaged for advice and remedial work. Allow a budget for this. Fig 22-24

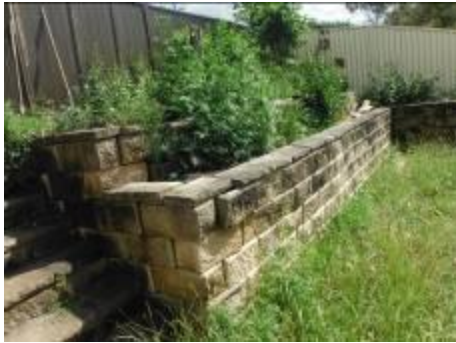
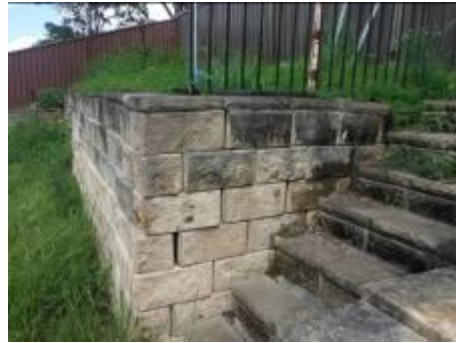
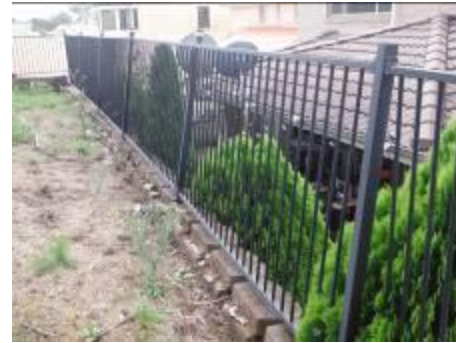
6.5 Retaining Walls/ Flowerbed		The retaining walls require attention/rectification. The rear concrete block retaining walls are leaning/crooked. Fig 25-27 The timber retaining walls besides the shed are crooked. Fig 28 Repairing/re-enforcing is required. * Retaining walls supporting other structures. Landscaping retaining walls more than 700mm high.	Recommendation: A qualified tradesperson should be engaged for advice and remedial work. Allow a budget for this. * Where a major defect is identified in any retaining wall regardless of height it is essential that an engineer's report be obtained.

7.4 Pier			
7.5 Retaining Walls		Structural / Serviceability Defects. Evident of leaning/crooked/separating gaps	Securing/re-enforcing/refixing is required.

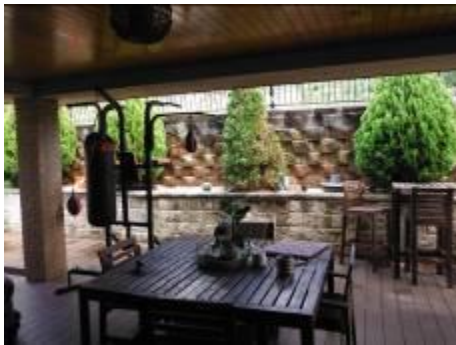
2.6 Steps		Tolerable.	* Handrails are required were a person has the potential to fall one meter or more.
2.7 Balconies, Verandah, Patios, Decks, suspended concrete floors, balustrades.	Verandah Alfresco	Repatch the damaged ceiling hole most likely due to the relocated camera. No significant defects were noted at the time of the inspection.	Fig 11. Fig 29

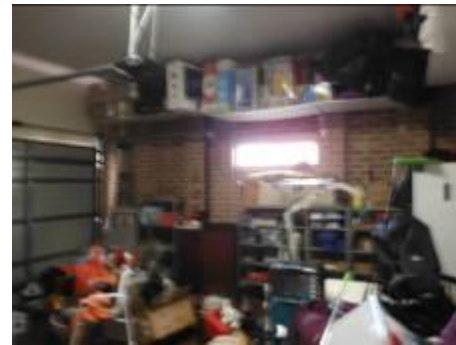
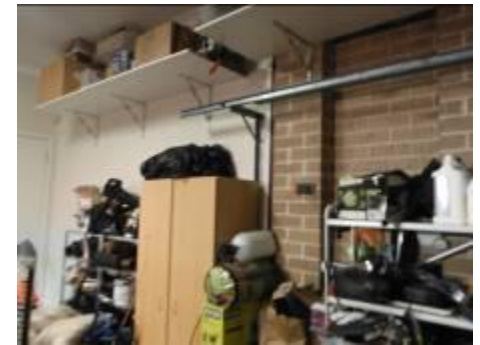
1.08 Skirting and Architrave Fittings		The garage shelving requires proper securing for safety reasons. Fig 31-32.	The standard of the joinery/fittings are in average condition.

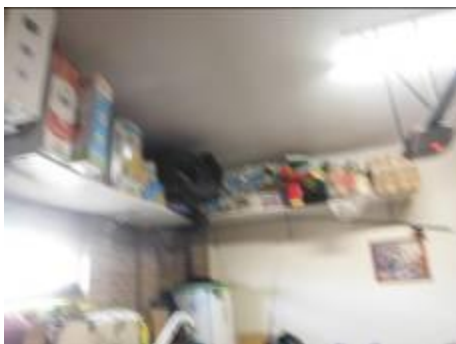
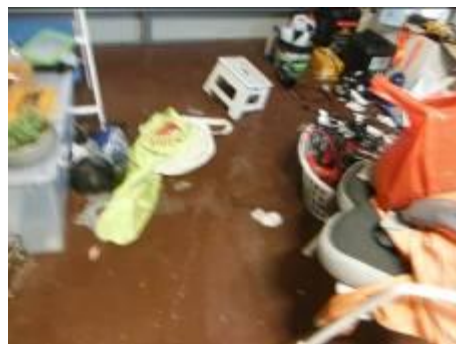
1.03 Timber Floors		The timber/floorboards show no visible surface irregularities.	
1.04 Concrete Floors		The concrete slab is in serviceable condition with no notable structural defects sighted.	Stored items/goods/floor covering etc... restricted access/visibility to garage at the time of the inspection. Fig 31-34. Reassess when clear/vacant prior to settlement.

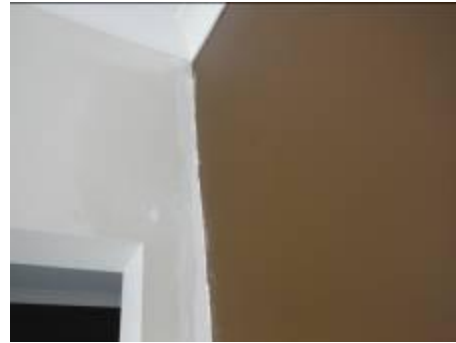
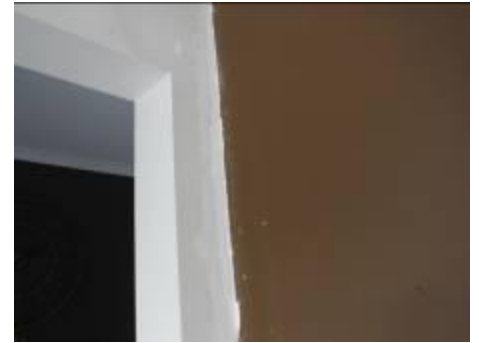
1.02 Walls	Lounge Bedroom Entrance Garage	Rough patches were located at the lounge/front bedroom partition wall due to poor workmanship. These should be smoothed out. A joint crack was noted on the front bedroom wall lining above the door. Noticeable patches were noted on the entrance wall lining due to door impact. Some wall linings are peeling paint. The garage wall lining requires cleaning. Normal wear and tear is evident. These should be sealed/patched/touch up painted. Allow satisfactory re-decoration to restore the appearance.. * Any general cracking/settlement/movement etc.... can be considered a normal occurrence and appears within acceptable tolerances at this time. Note: Part of the front lounge has been enclosed/converted into a bedroom.	The wall/linings appear to be fixed in an acceptable manner but require attention. This is considered a cosmetic issue although related to tolerable movement of the internal walls. (See section 7.0 of this report). Recommendations: Engage a qualified plasterer/painter for advice. Fig 39-40

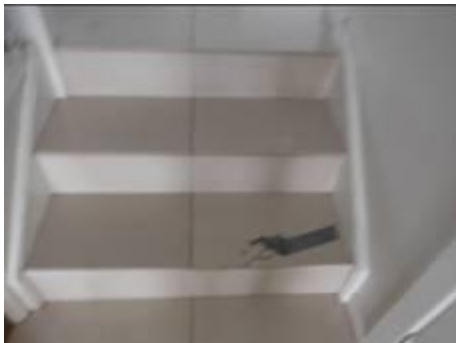
Fig 41

<p>1.17 Hard Floor Coverings e.g. Ceramic Tiles, Slate, Parquetry Soft Floor Coverings</p>		<p>Varnished floorboards and most floor tiles show no visible surface irregularities. There is a cracked floor tile at the hallway step. Fig 41. This should be replaced.</p>	<p>* Monitor floor areas for any evidence of tile growth/creep and provide expansion joints if required. * The perimeter is not visible and the surface is obscured from view by floor coverings and finishes.</p>
<p>1.18 Other</p>

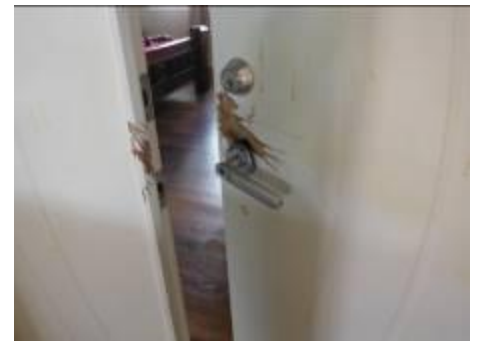
Fig 60

1.07 Doors and Frames		Replace the damaged main bedroom door/lock. Fig 60. Adjust the binding front bedroom door for proper closing The sliding bathroom door is out of square. Adjust/refix this for free operating.. Touch up paint some doors/frames as these are peeling paint * Adjust individual doors and install additional doorstoppers as required to avoid further damage to wall lining.	Ensure the door locks/keys/controlled garage doors are properly functioning. Refer to vendor for working condition.
