# PRE-PURCHASE PROPERTY INSPECTION BUILDING REPORT

Inspector Paul Cavallo.

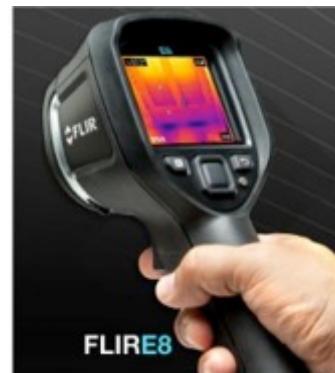
**1.0 CLIENT DETAILS:**

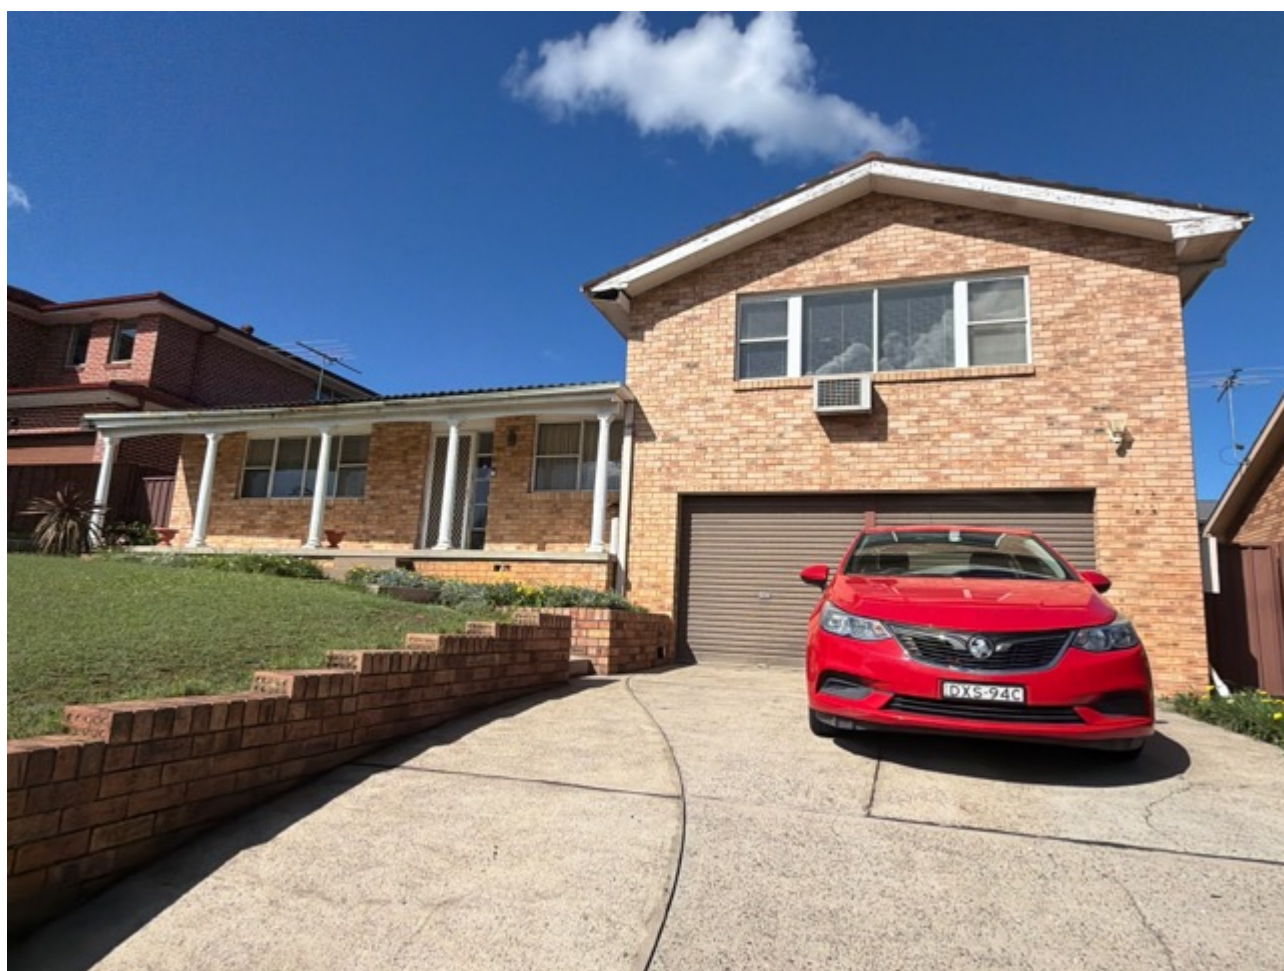
**5 PARKINSON STREET KINGS LANGLEY.**

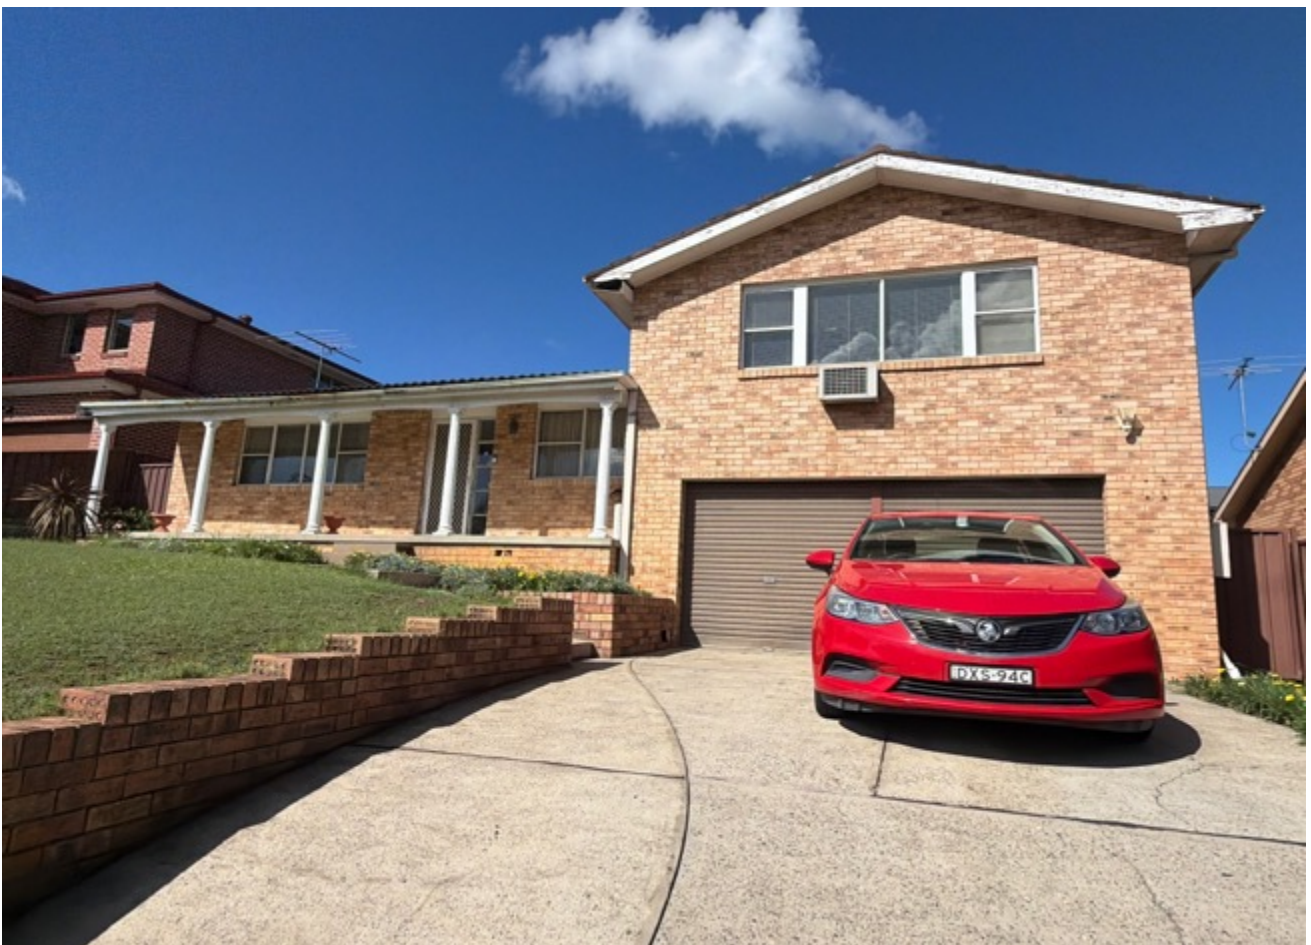
The exterior of the house presents in serviceable condition, renovations are required due to the age.

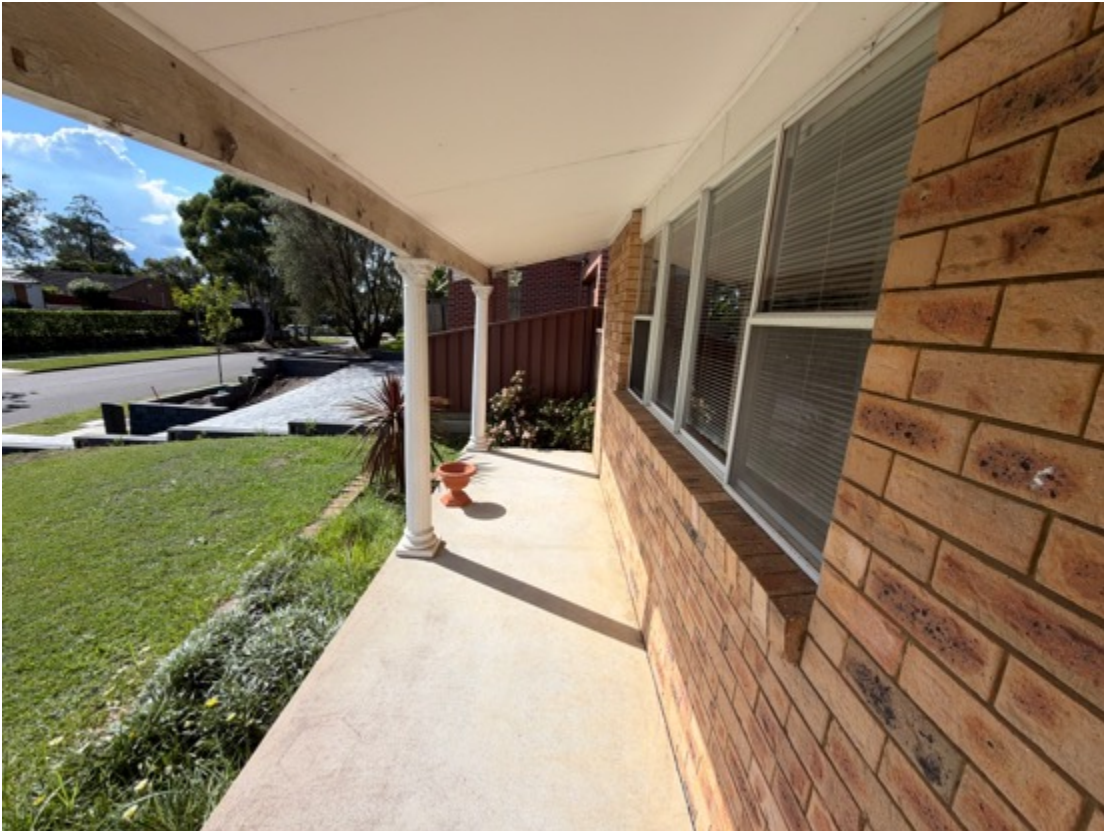
Exterior surfaces are moderately paint blemished, a fresh coat of paint is recommended on each elevation.

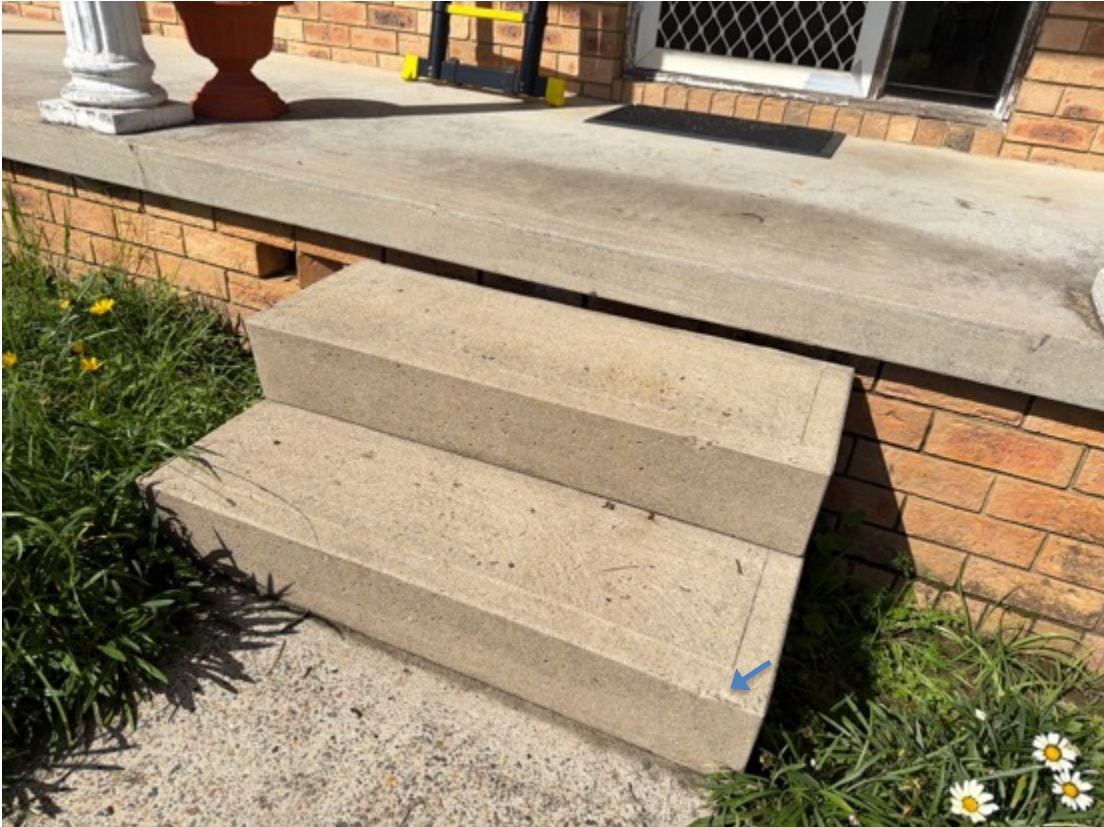
Front patio steps require remedial works.

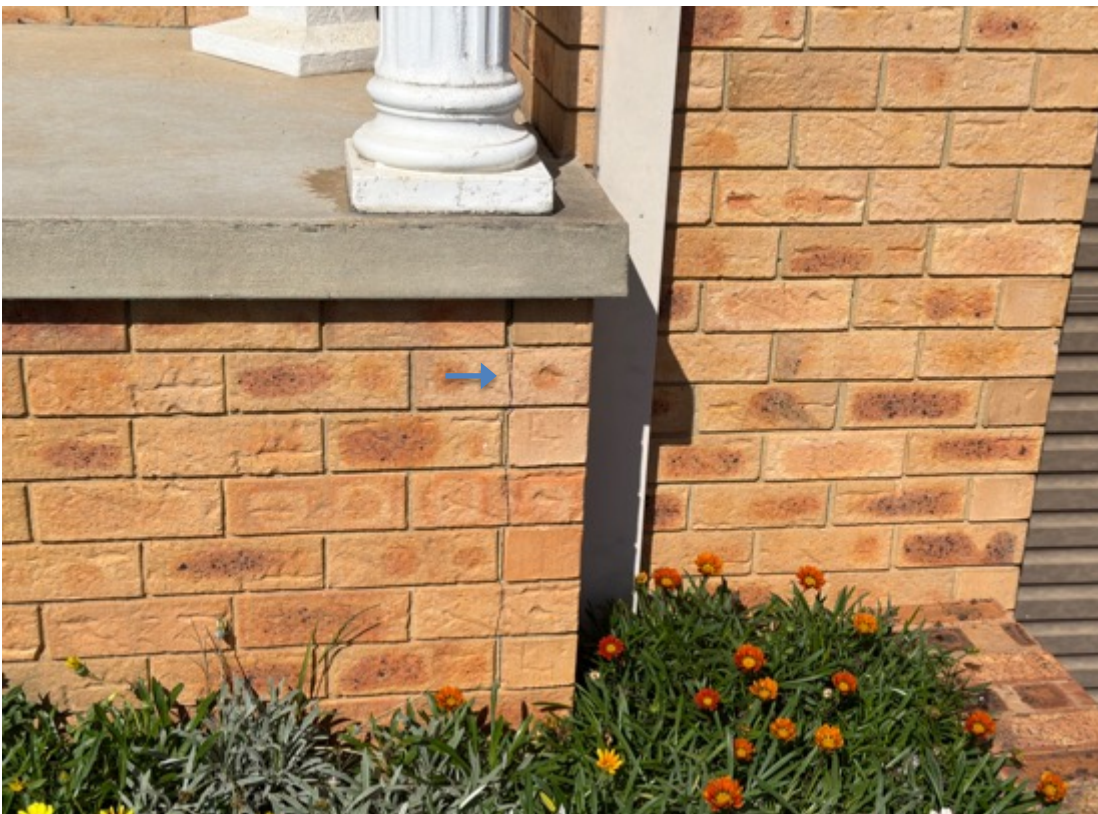
Exterior brickwork displays category one - two cracking (front mid section example above.)

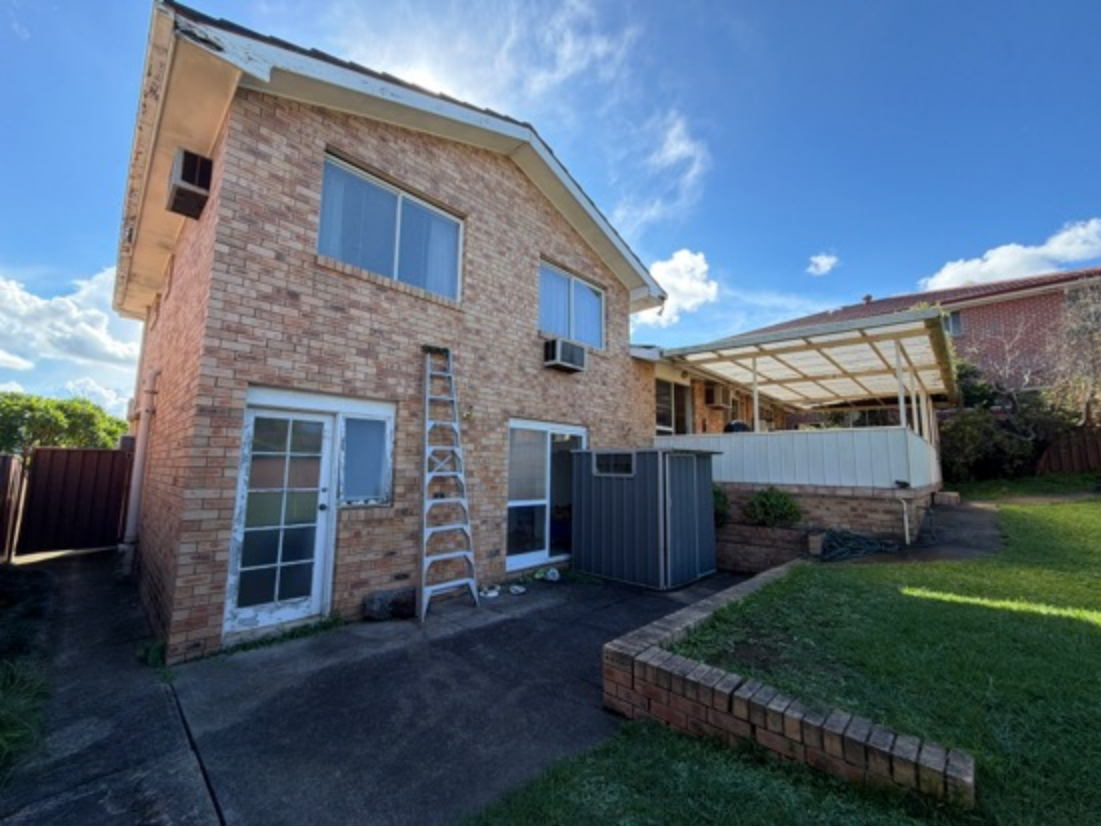
Exterior windows and doors present in serviceable condition for the age.

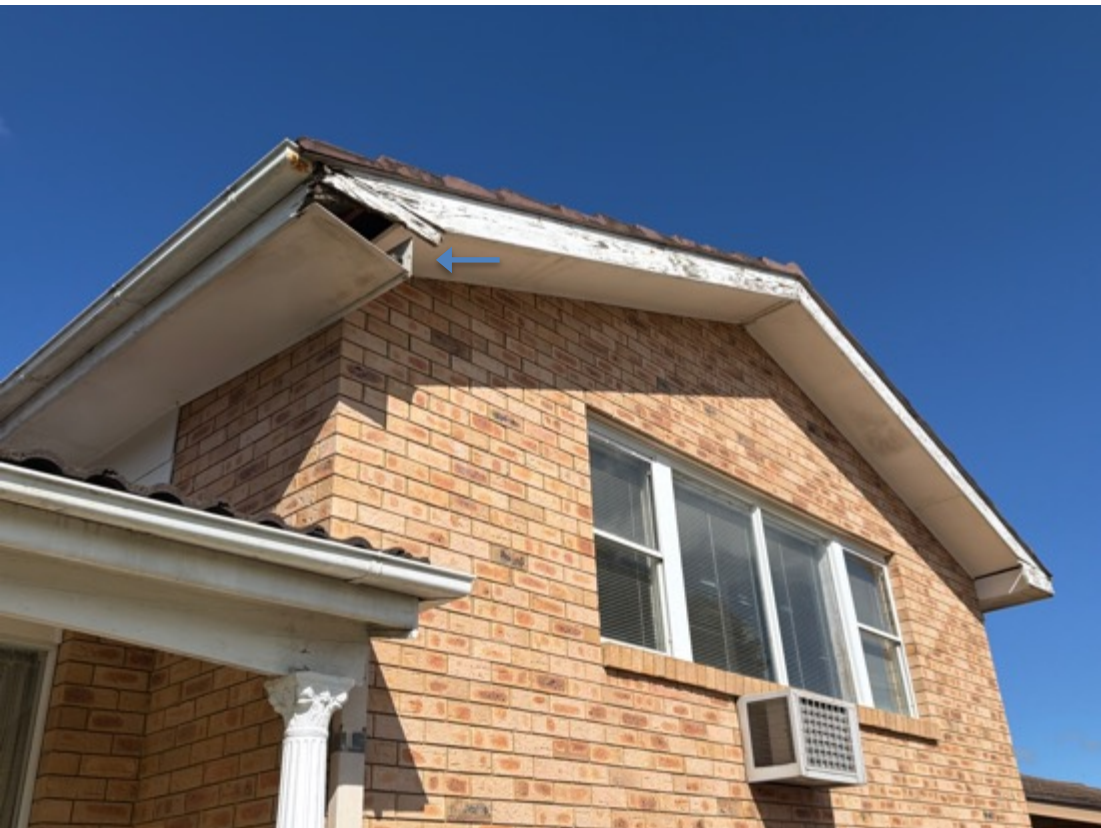
Exterior timber displays heavy level weathering - rotten, consistent with age.

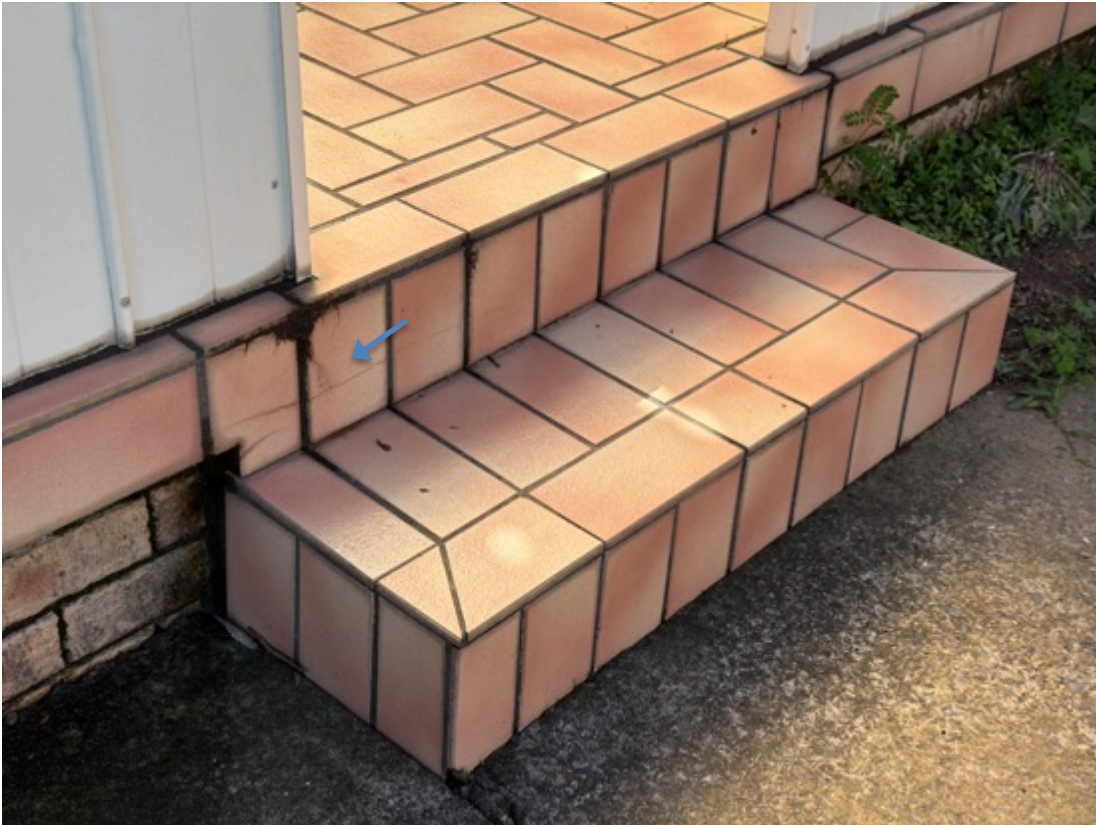
Isolated sections of tiles are cracked, consistent with age.

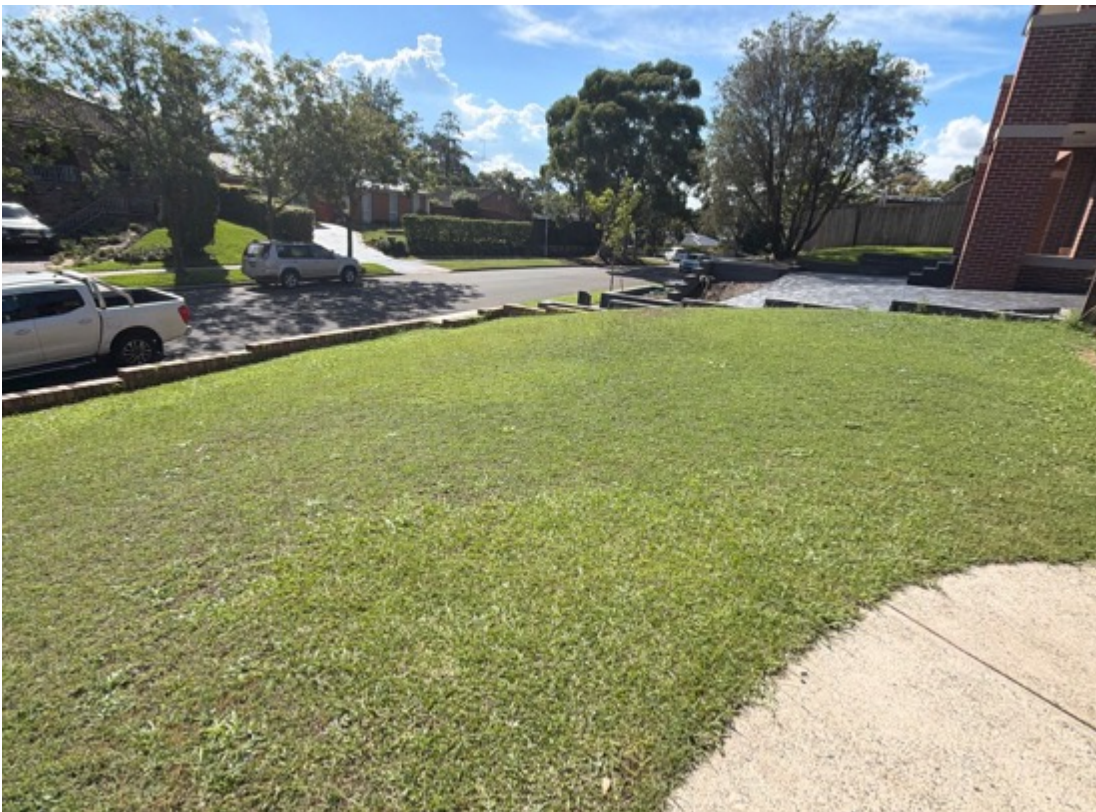
Site drainage / land overflow appears to function adequately with no signs of water laying at the time of inspection.

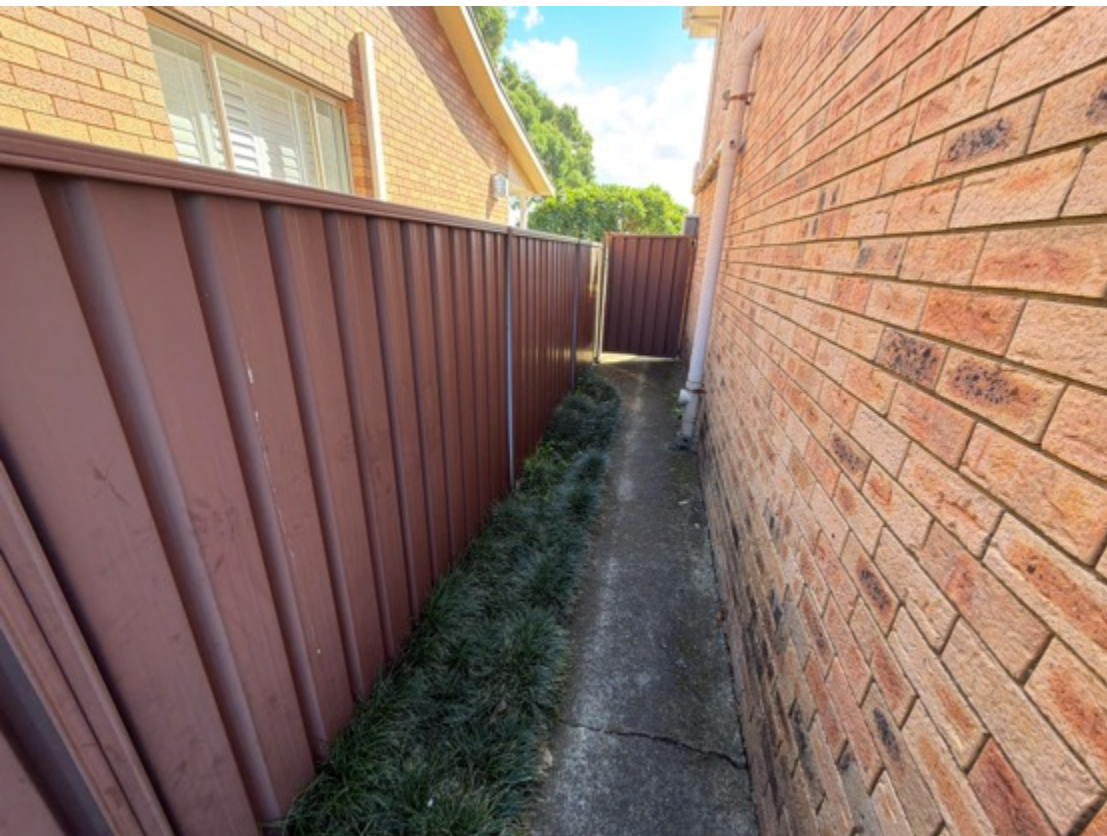
Site fences are in serviceable condition, have sections of damage and are leaning.

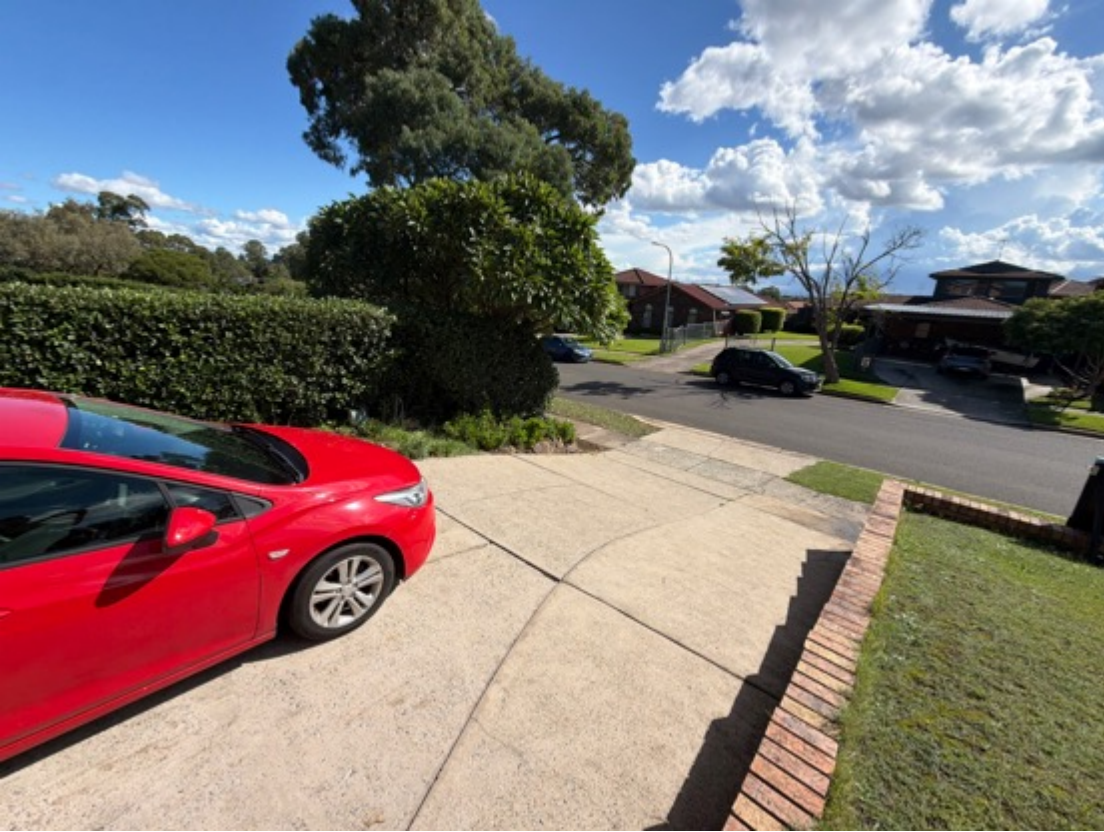
Isolated sections of exterior concrete displays typical shrinkage cracks and undulations - consistent with age.

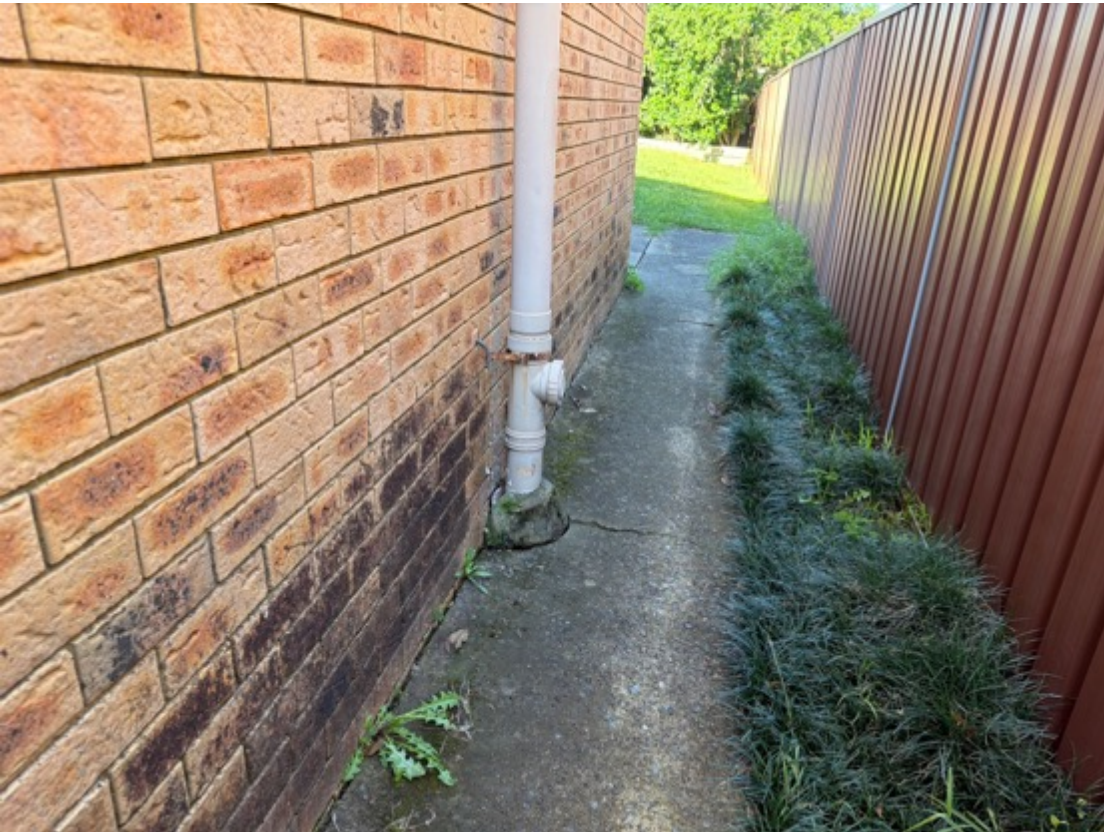
Right side footpath has subsidence.

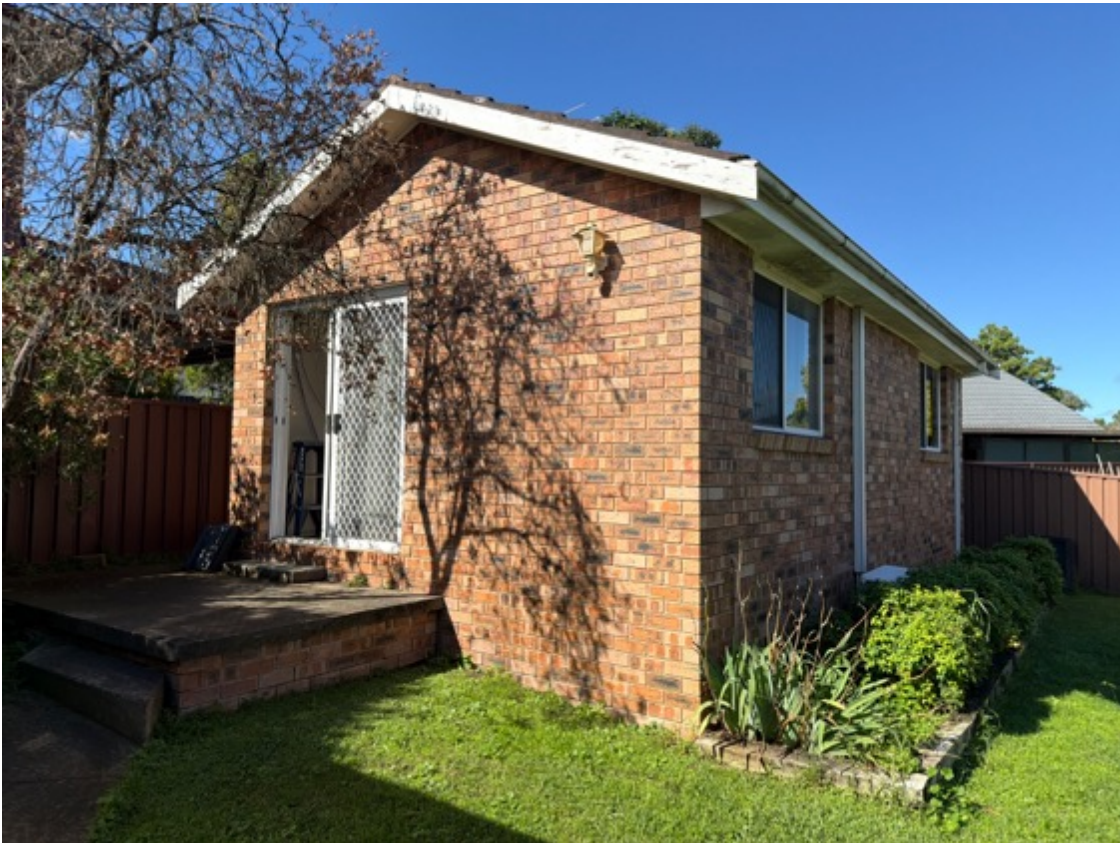
The rear granny flat is in serviceable condition, renovations are required due to the age.

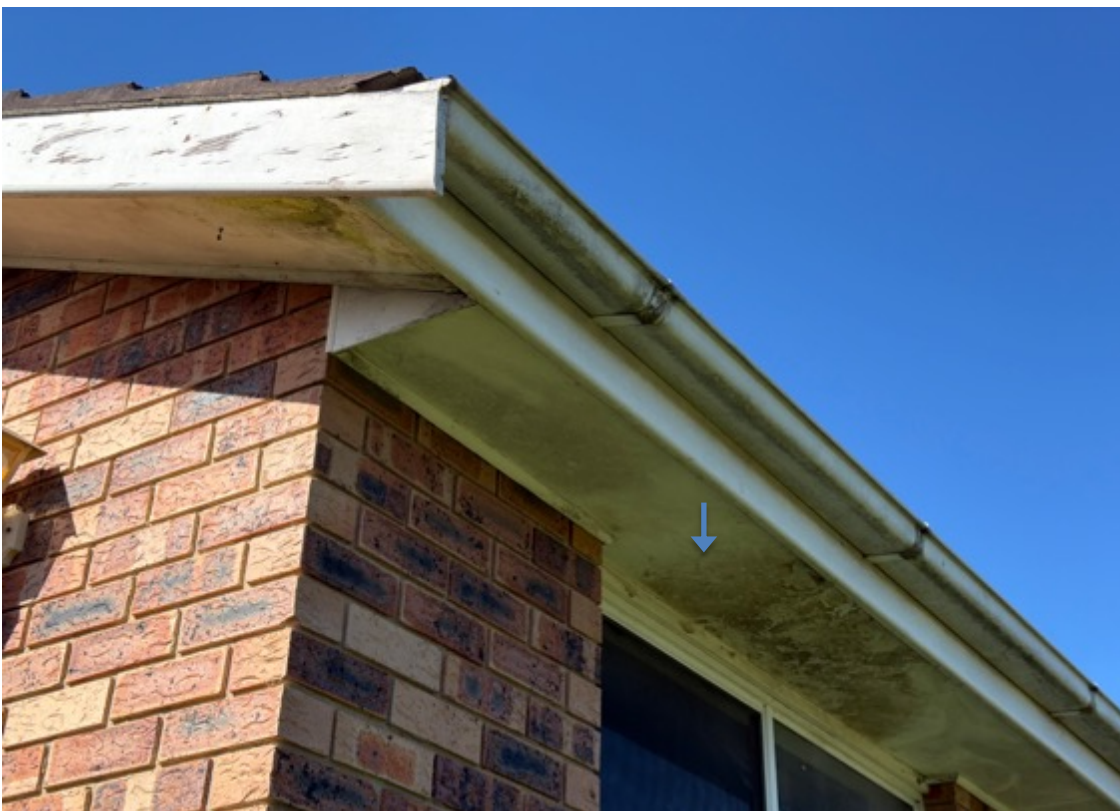
Exterior timber displays heavy signs of weathering and surfaces will require a fresh coat of paint on each elevation.

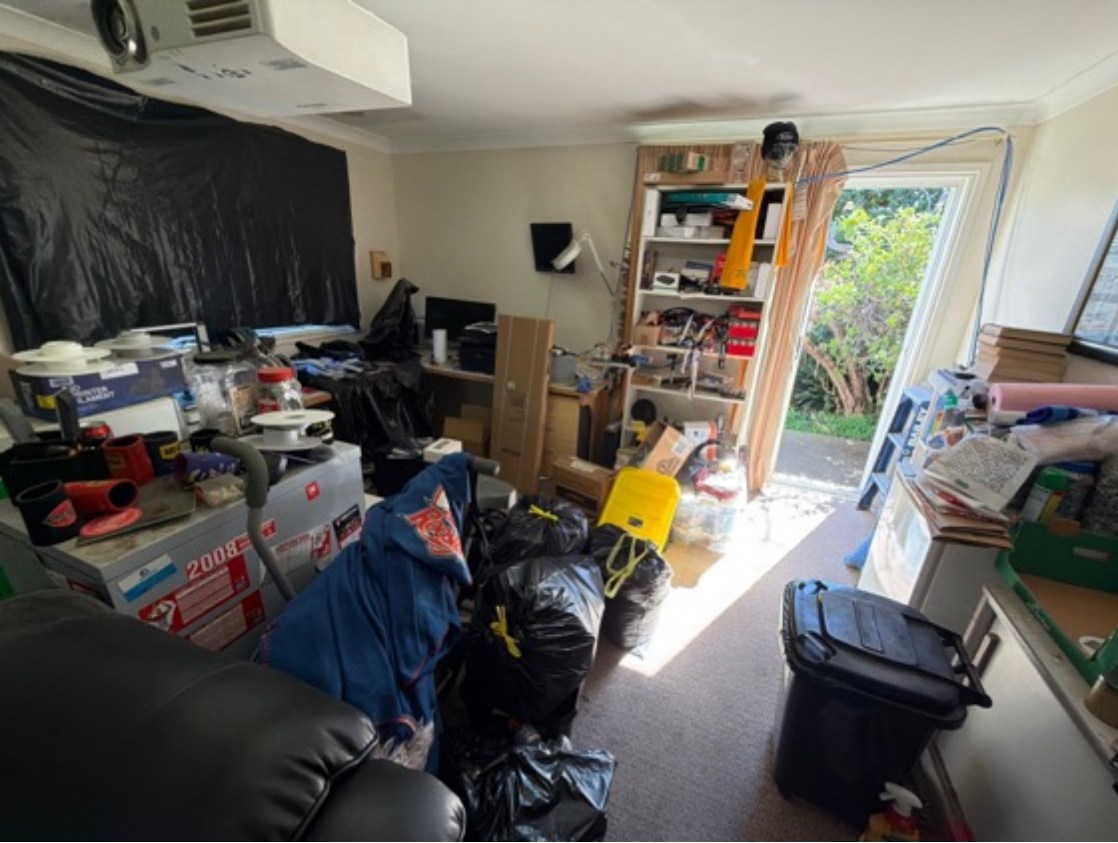
The granny flat interior is in serviceable condition, renovations are required due to the age.

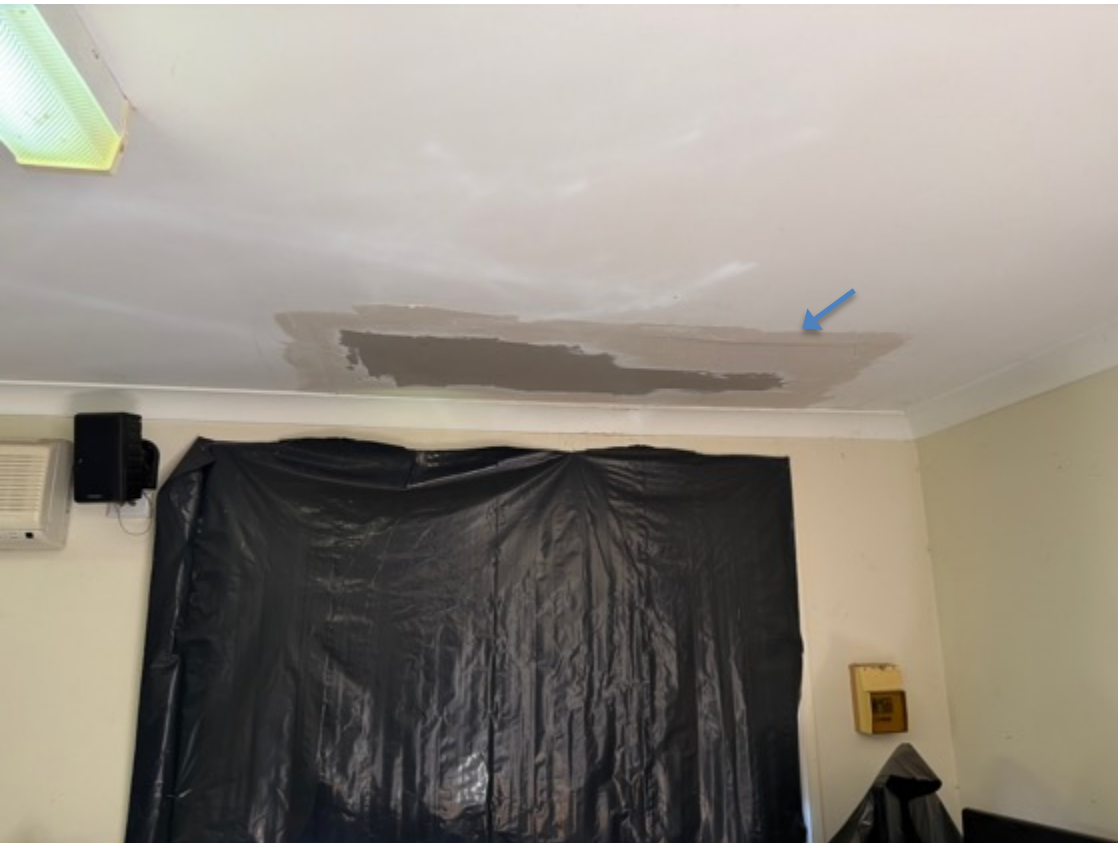
Painting works are incomplete and plasterboard has patches here.

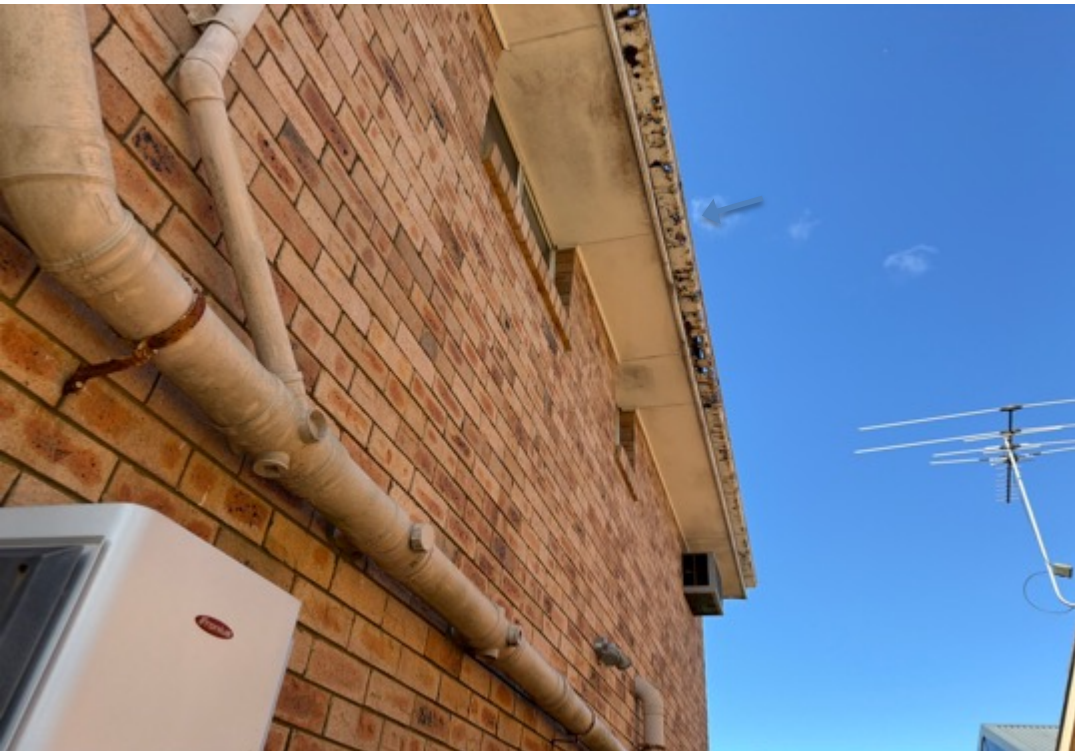
External gutters are rusted out, replacement is required.

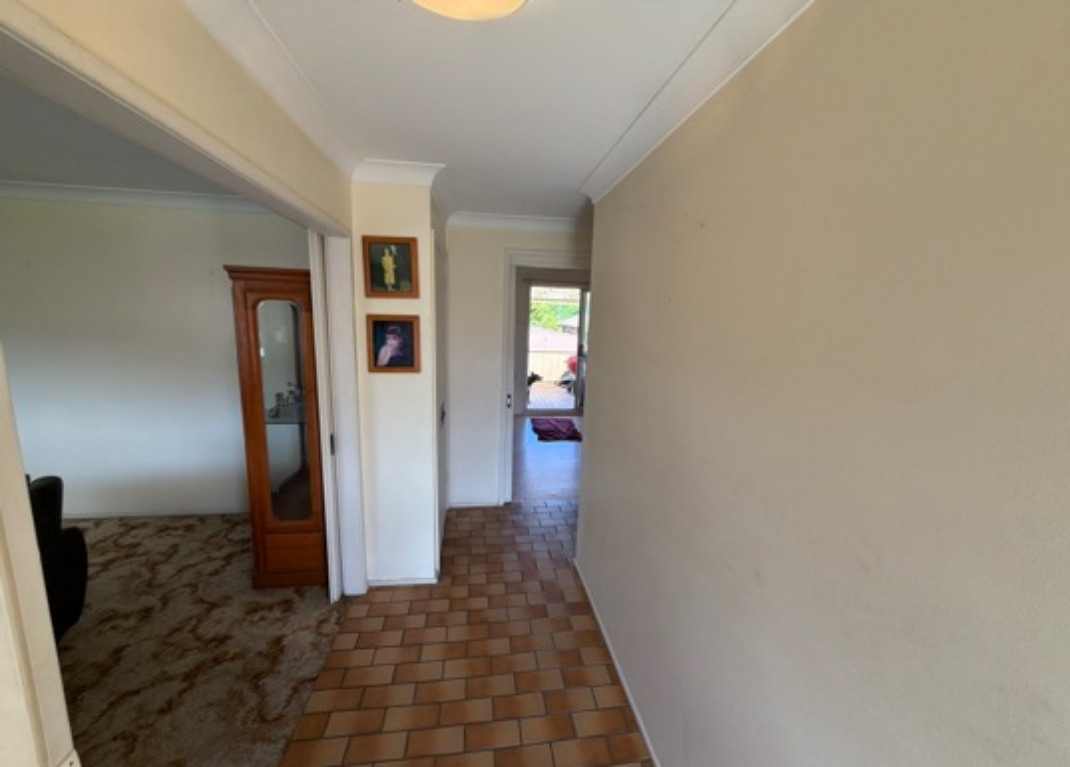
The interior of the house presents in serviceable condition for the age, renovation works are required throughout due to the age.

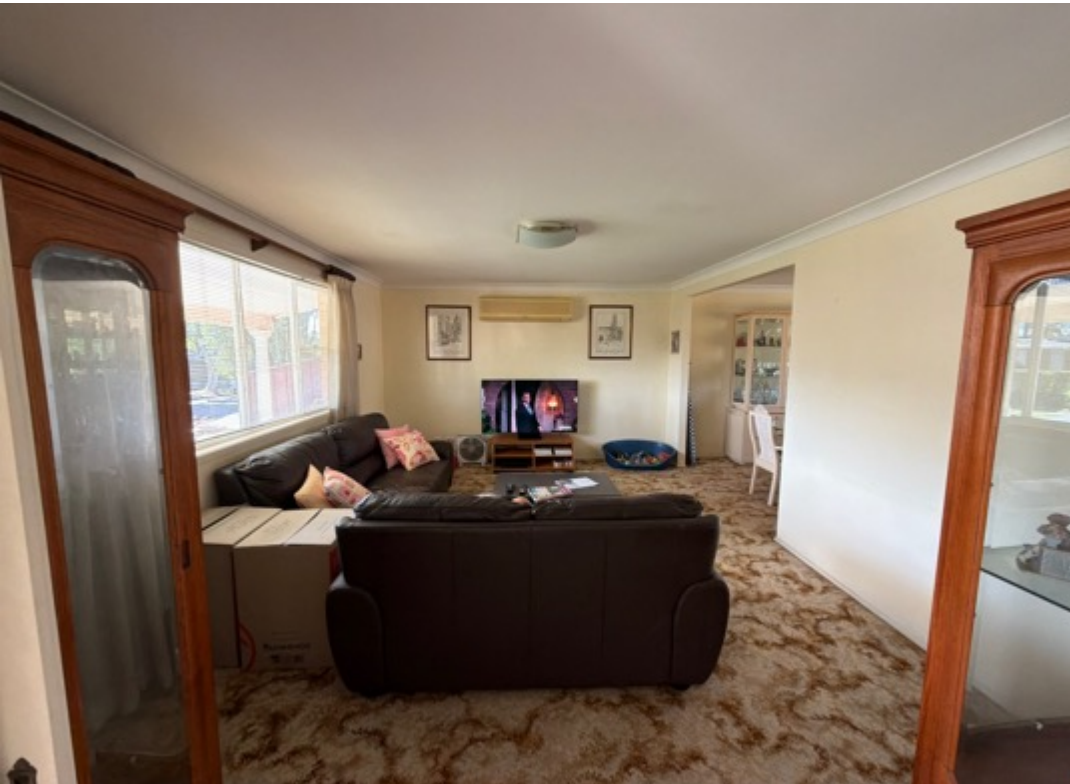
Interior living rooms present in serviceable condition for the age.

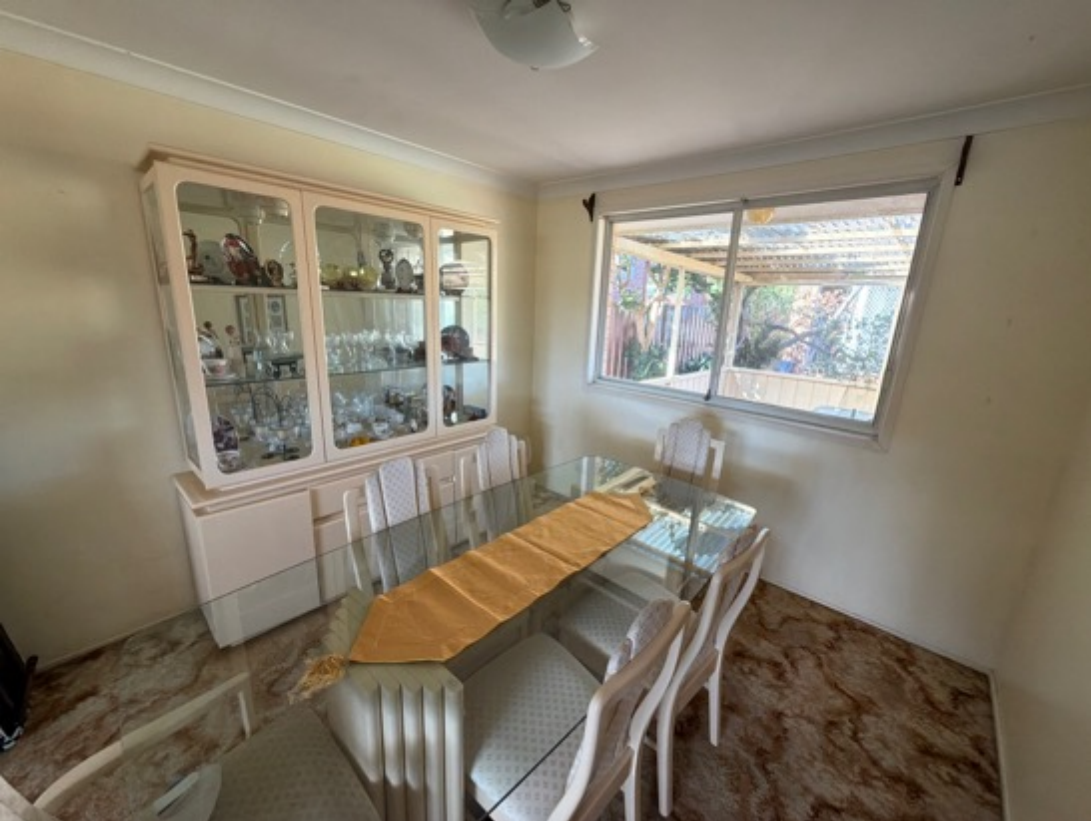
Example dining area above.

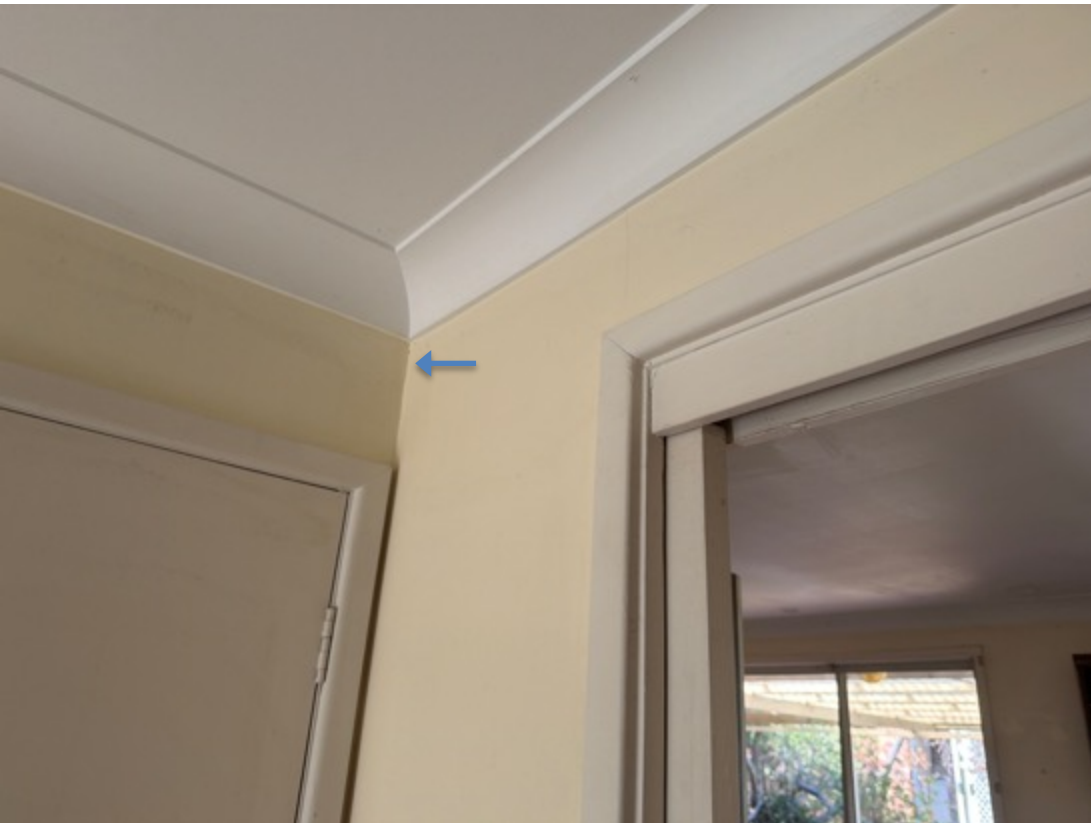
Sections of plasterboard and cornices are cracking (example above the kitchen entry cavity slider.)

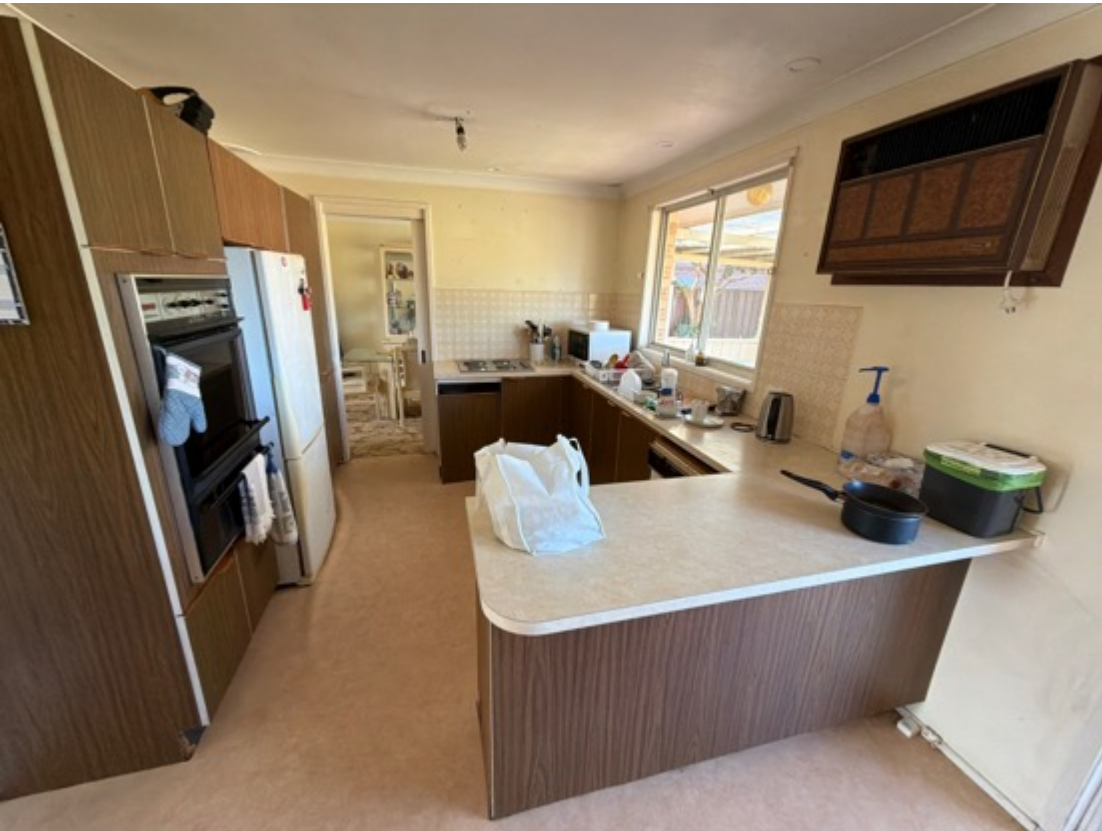
The kitchen area presents in serviceable condition for the age, renovation works are required (electrical works, painting etc.)

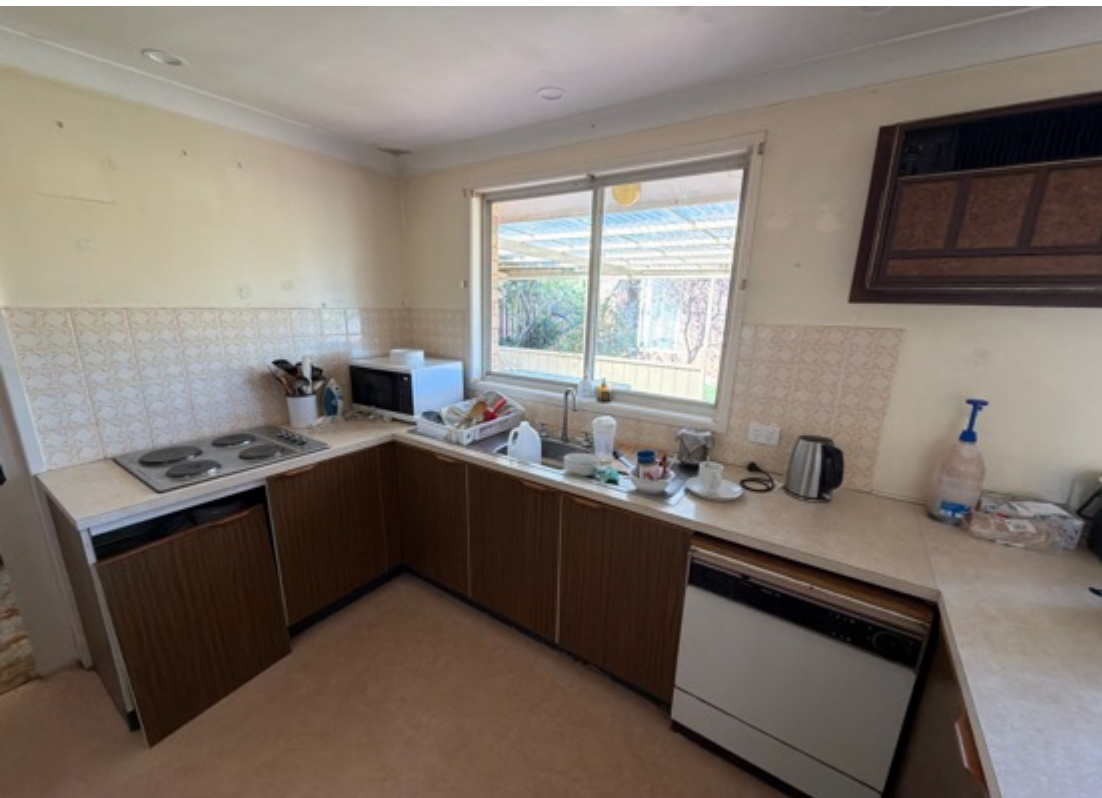
Water pressure tested, is sufficient.

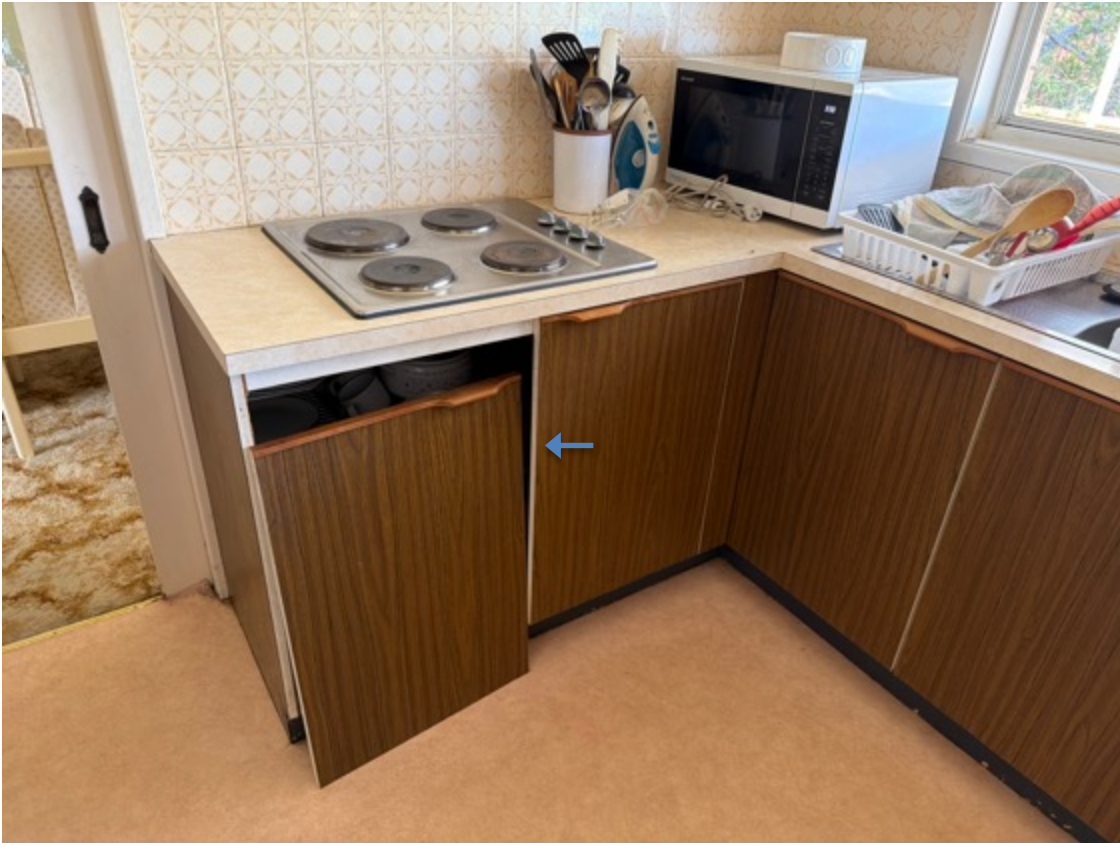
Cabinetry displays moderate level wear, sections of cabinets have come loose.
