# PRE-PURCHASE PROPERTY INSPECTION BUILDING REPORT

Inspector Paul Cavallo.

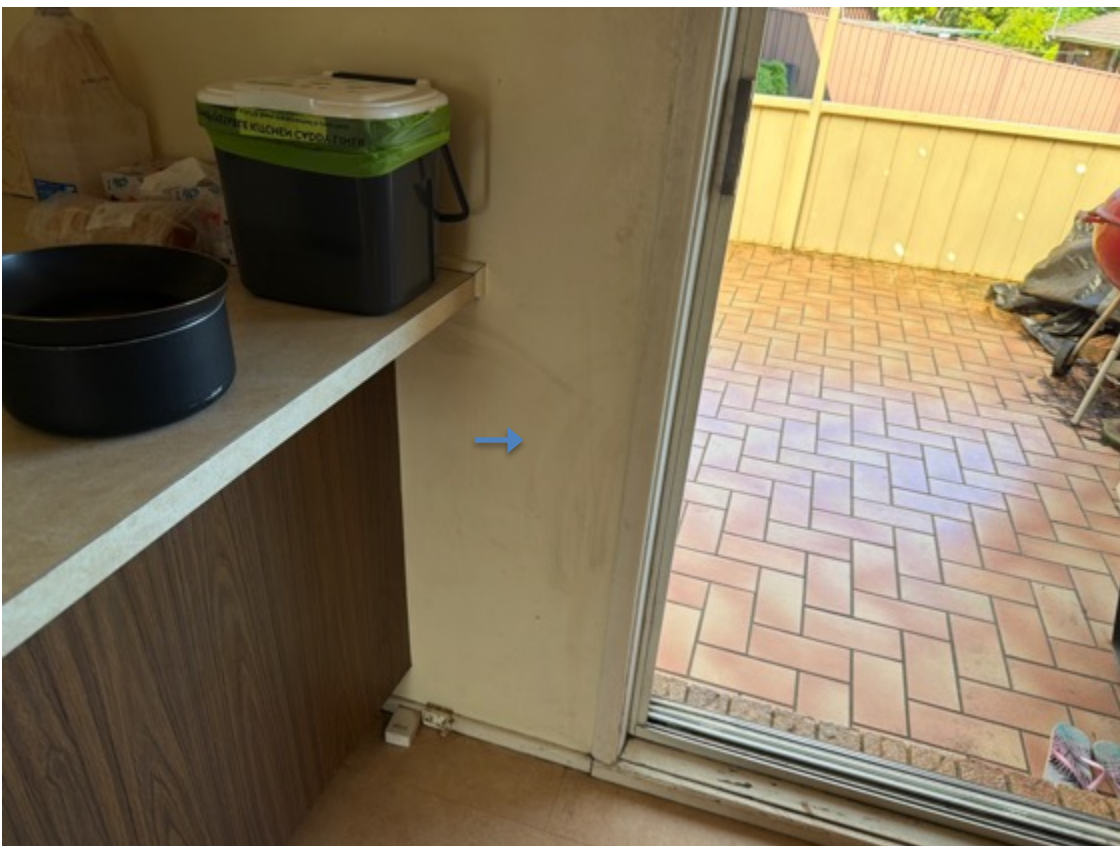
Internal surfaces will require a fresh coat of paint throughout the interior.

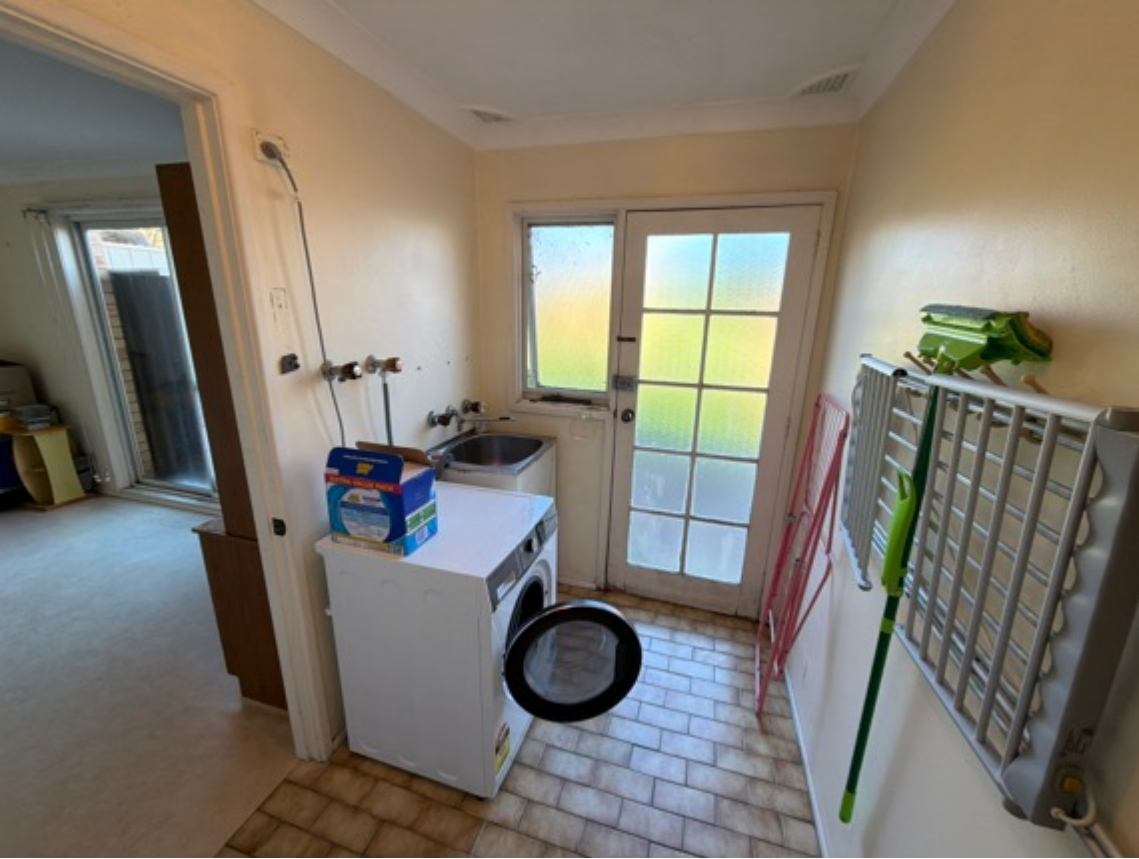
The laundry is in serviceable condition.

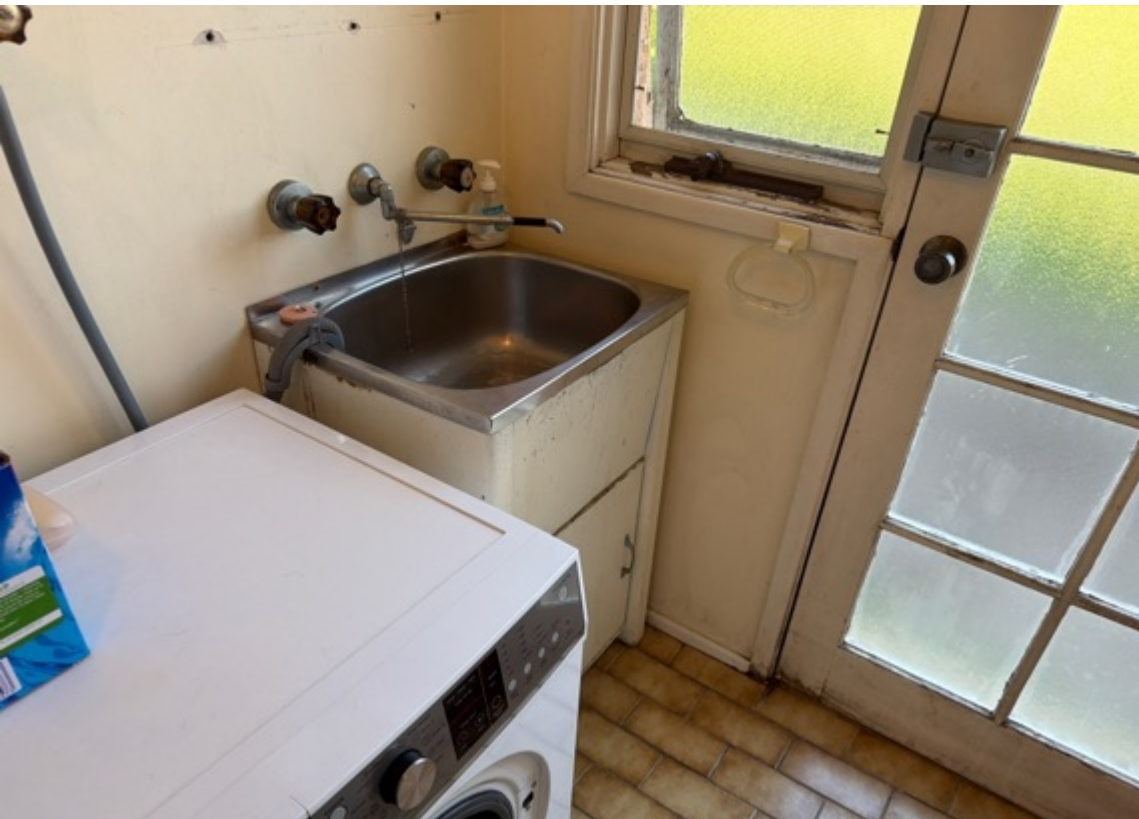
Water pressure tested, is sufficient.

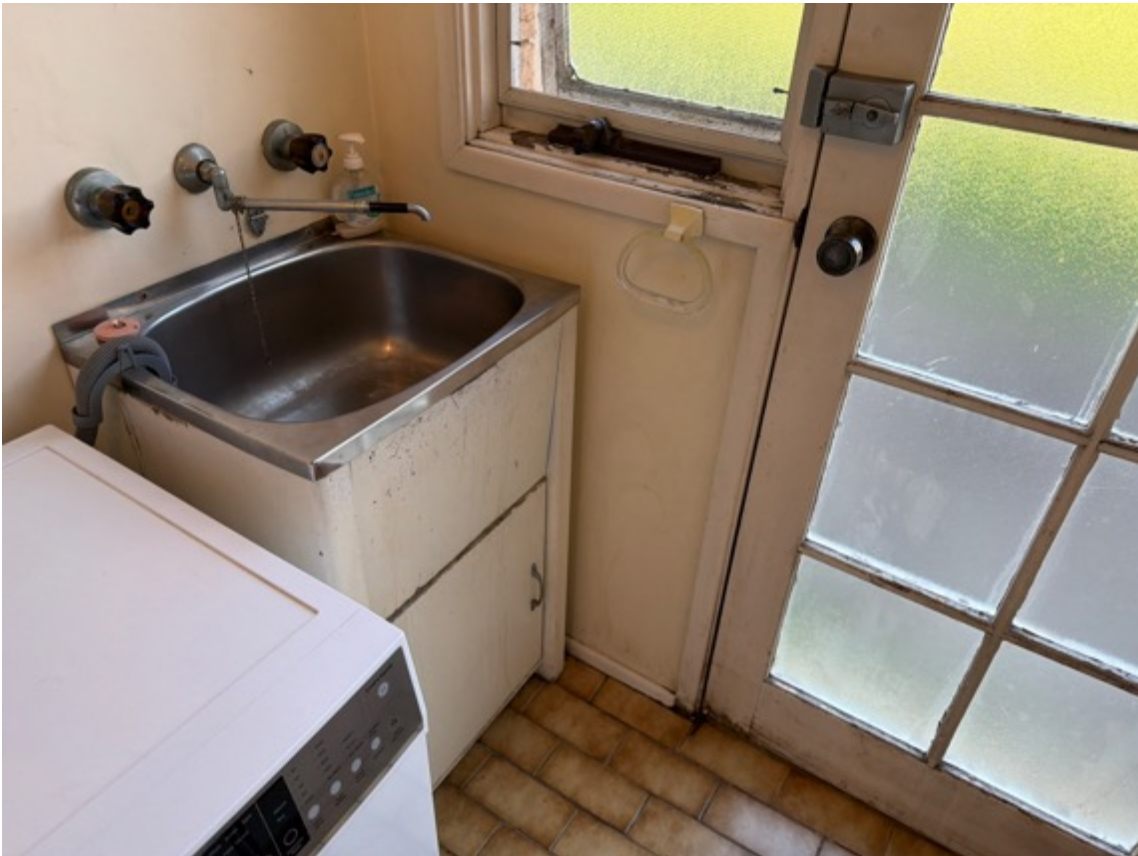
The laundry tub displays moderate level wear, cabinetry is heavily worn and architraves require remedial works.

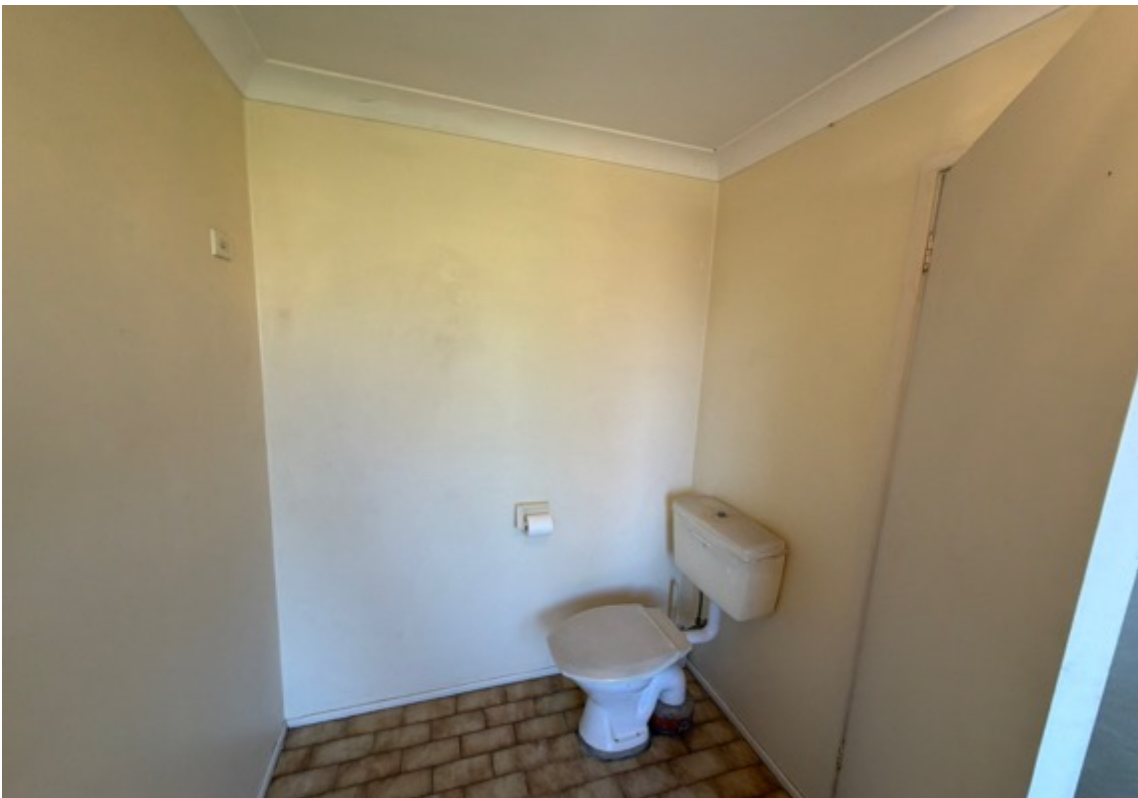
The toilet tested, functioned at the time of inspection - plasterboard and cornices are cracking.

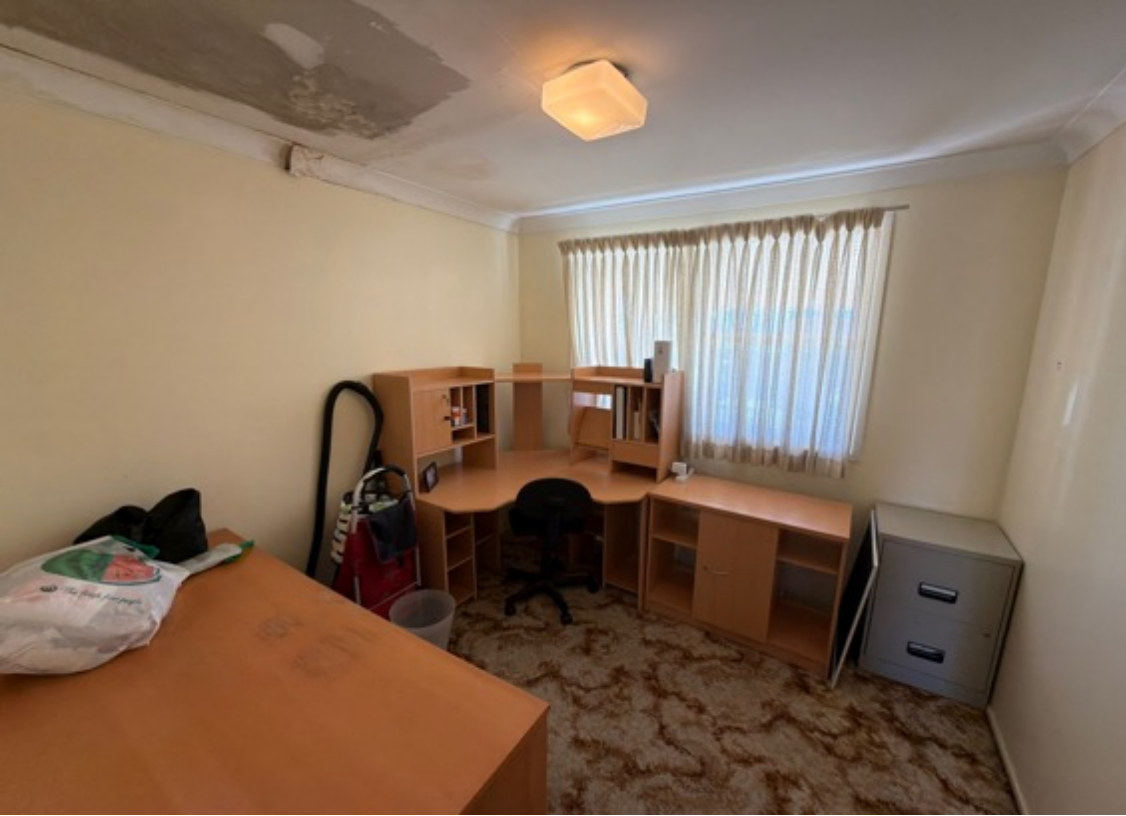
Interior bedroom areas present in serviceable condition for the age - renovations are required due to the age.

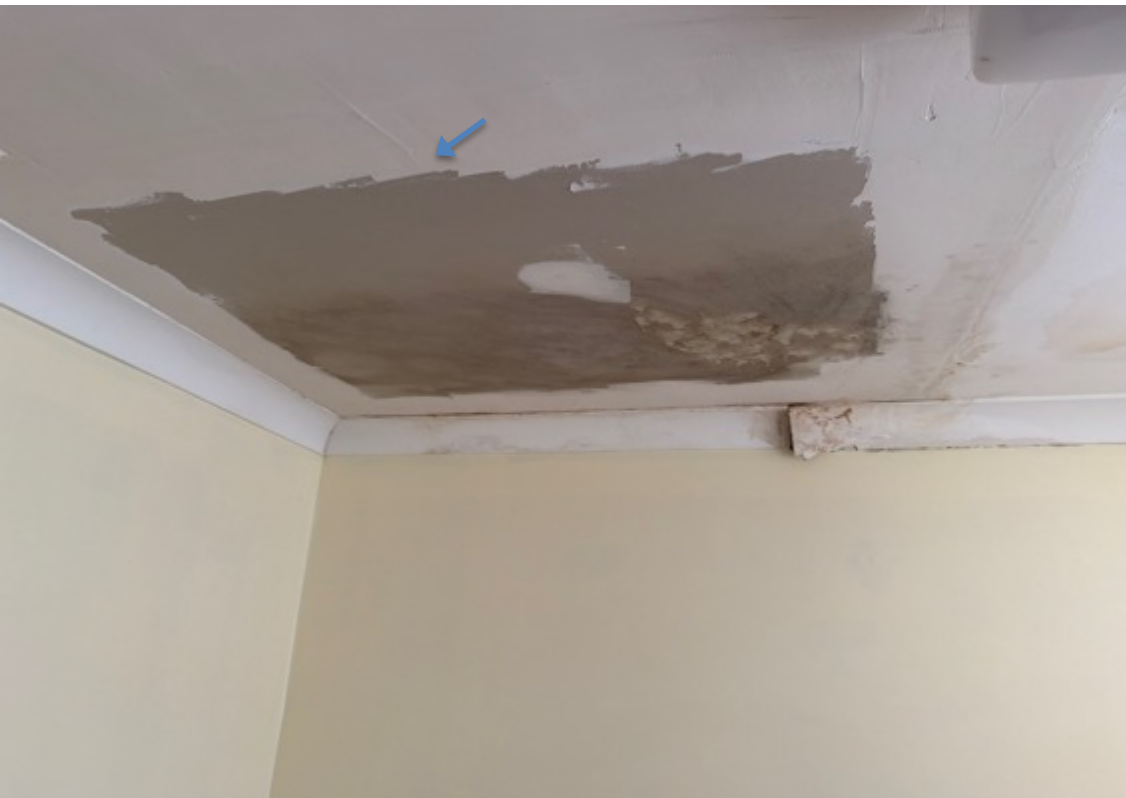
Past water staining is visible, plasterboard and cornices will require replacing in the front mid section bedroom area.

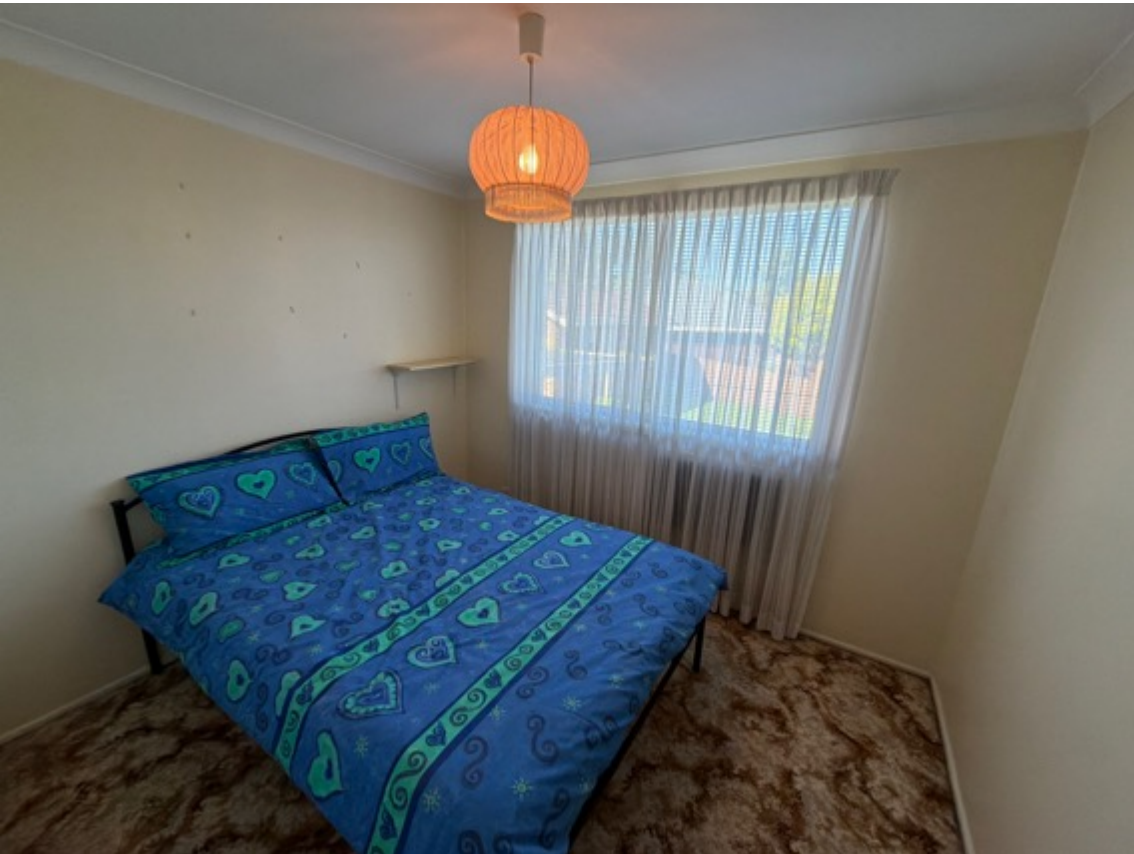
All interior lights tested, functioned as intended at the time of inspection.

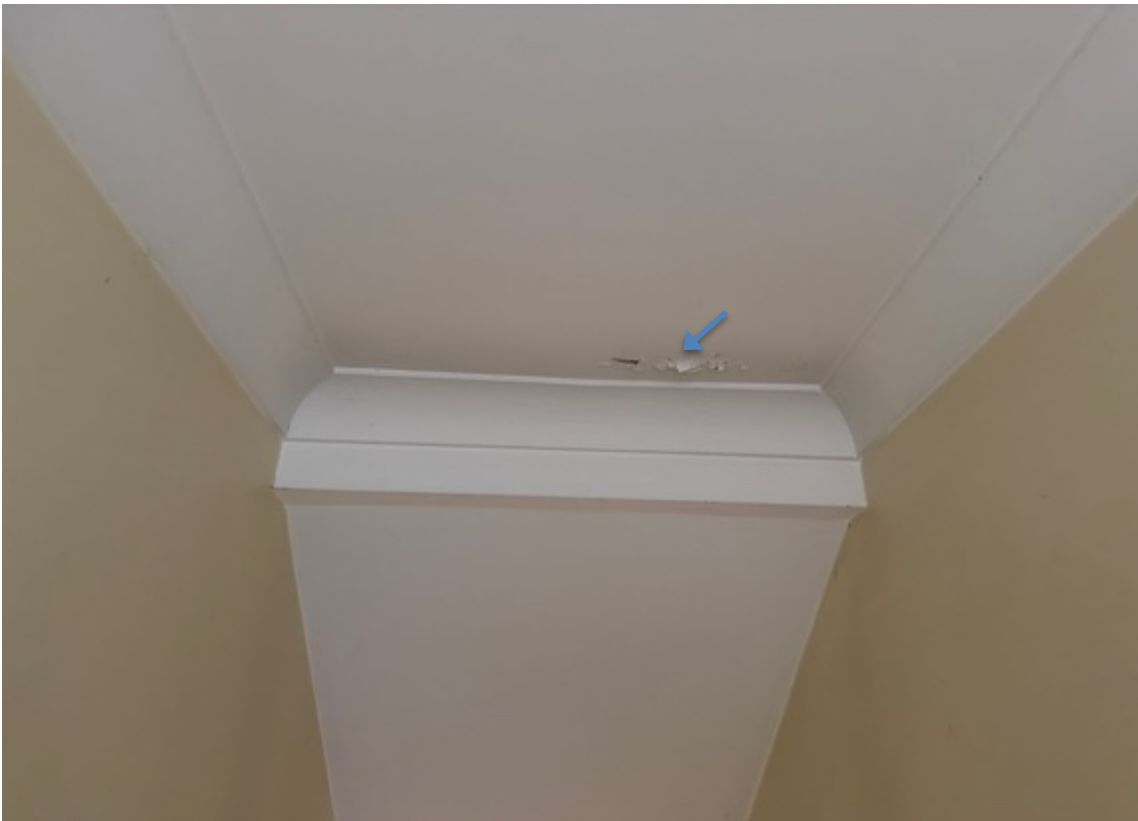
Top of bedroom hallway (above staircase) plasterboard has water damage here.

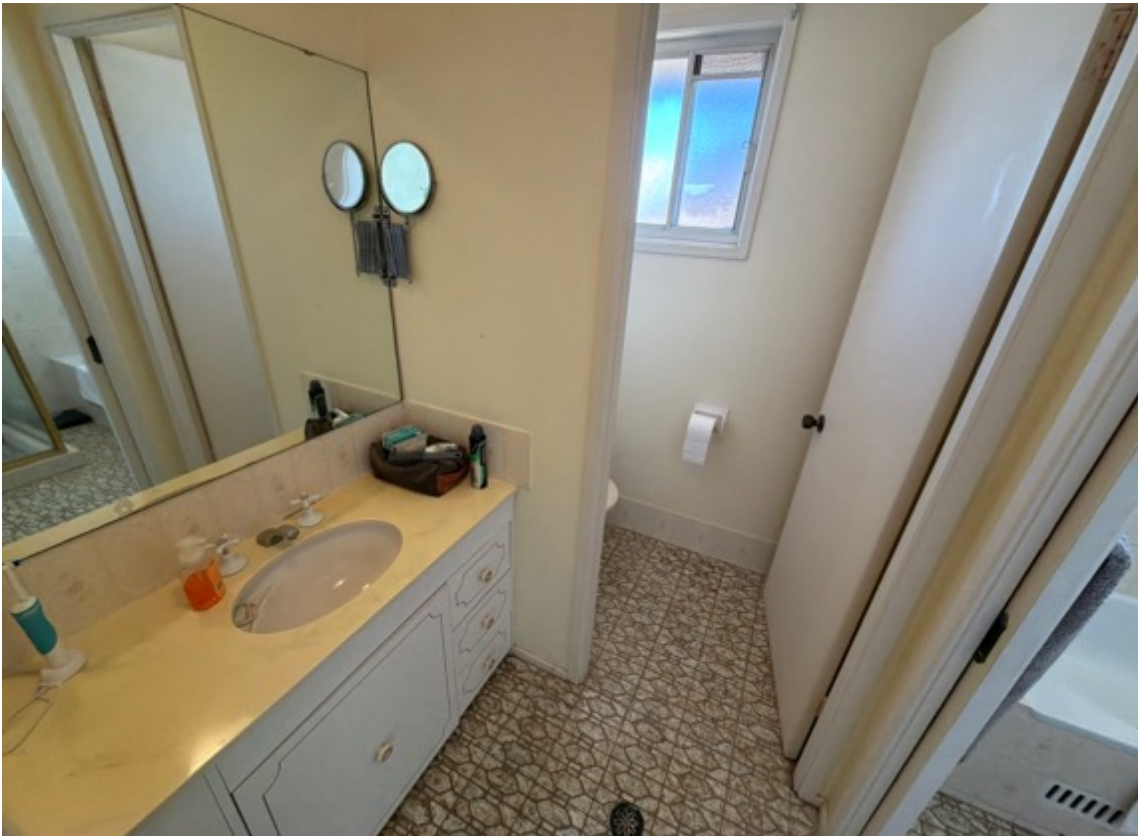
The first floor common bathroom area water services tested, functioned at the time of inspection - renovations are required due to the age.

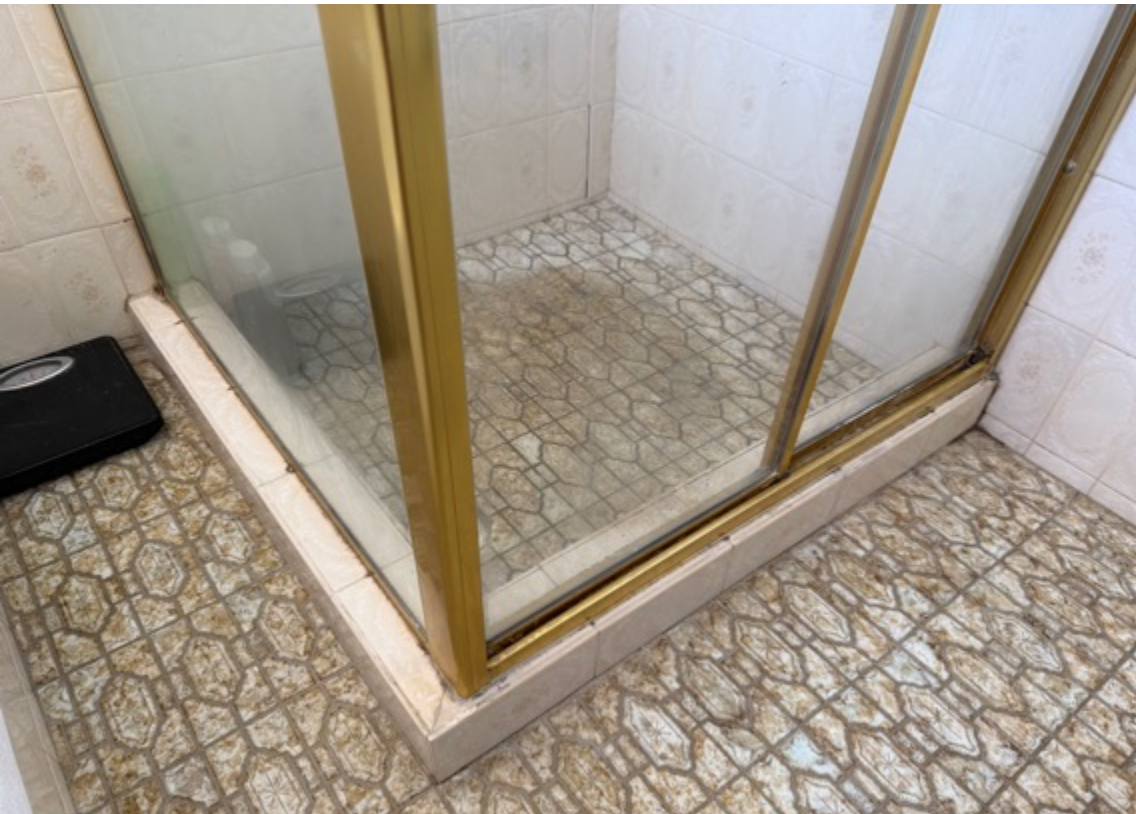
Sections of tiles are cracked, and grout - silicone requires reapplication.

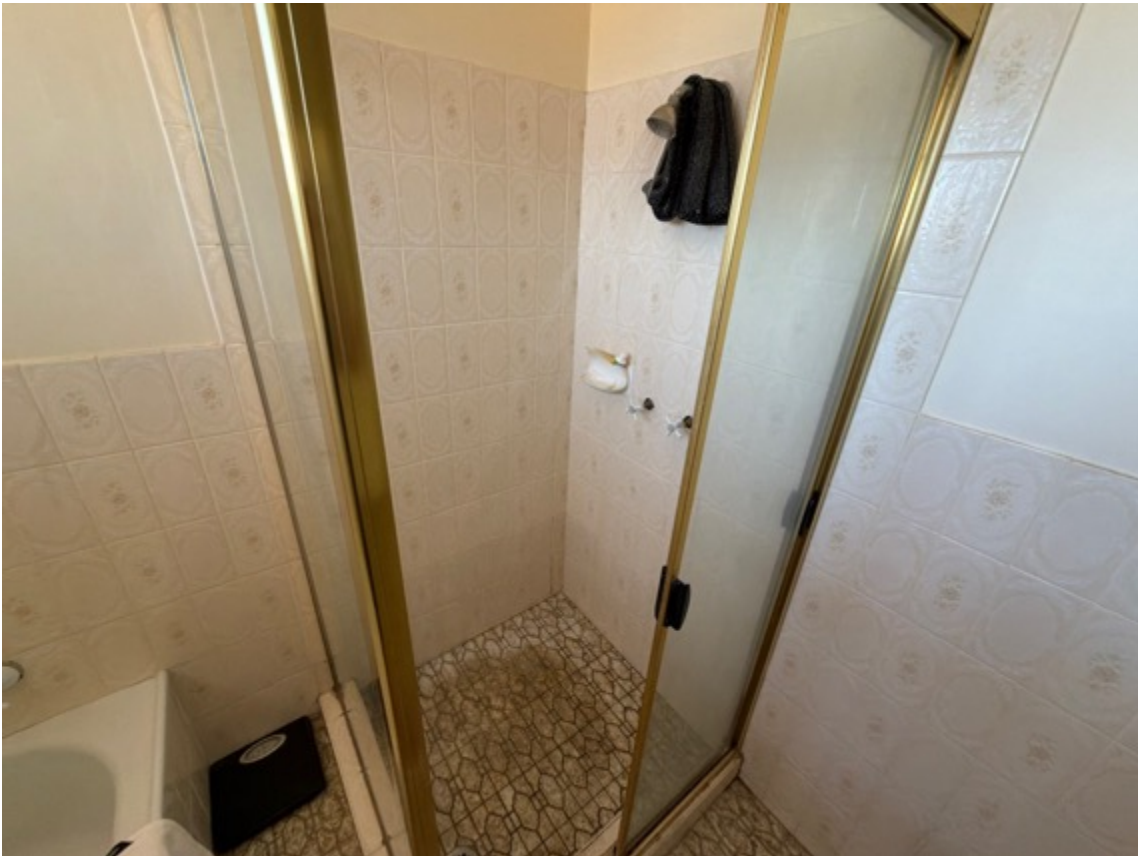
Water pressure tested, is sufficient.

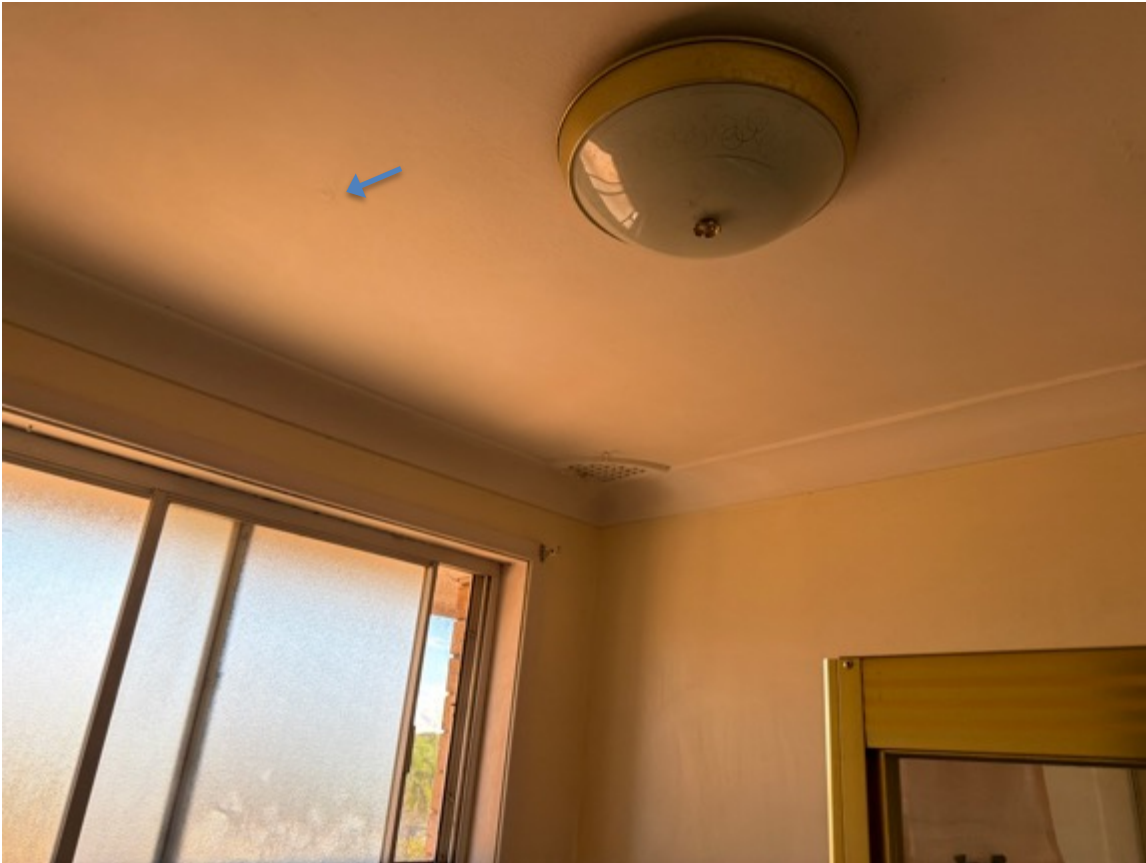
Ceiling paint is peeling, a fresh coat of paint is recommended.

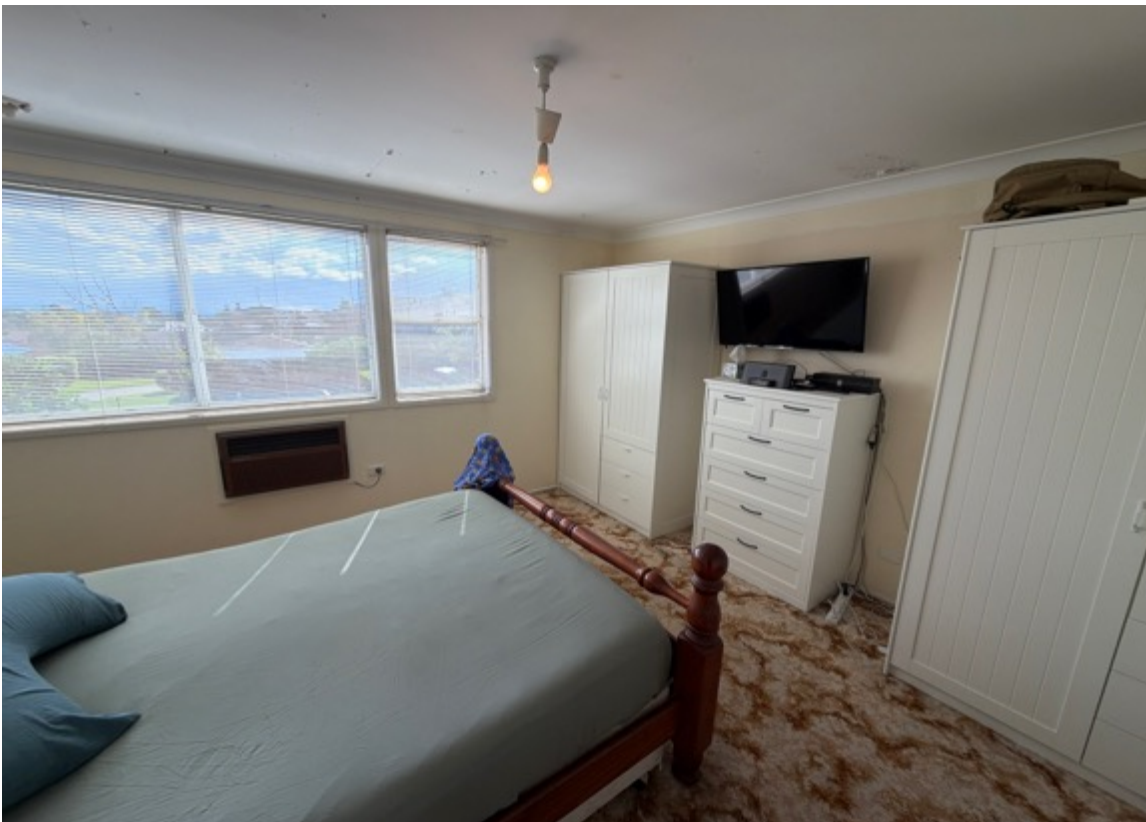
The main bedroom area presents in serviceable condition for the age.

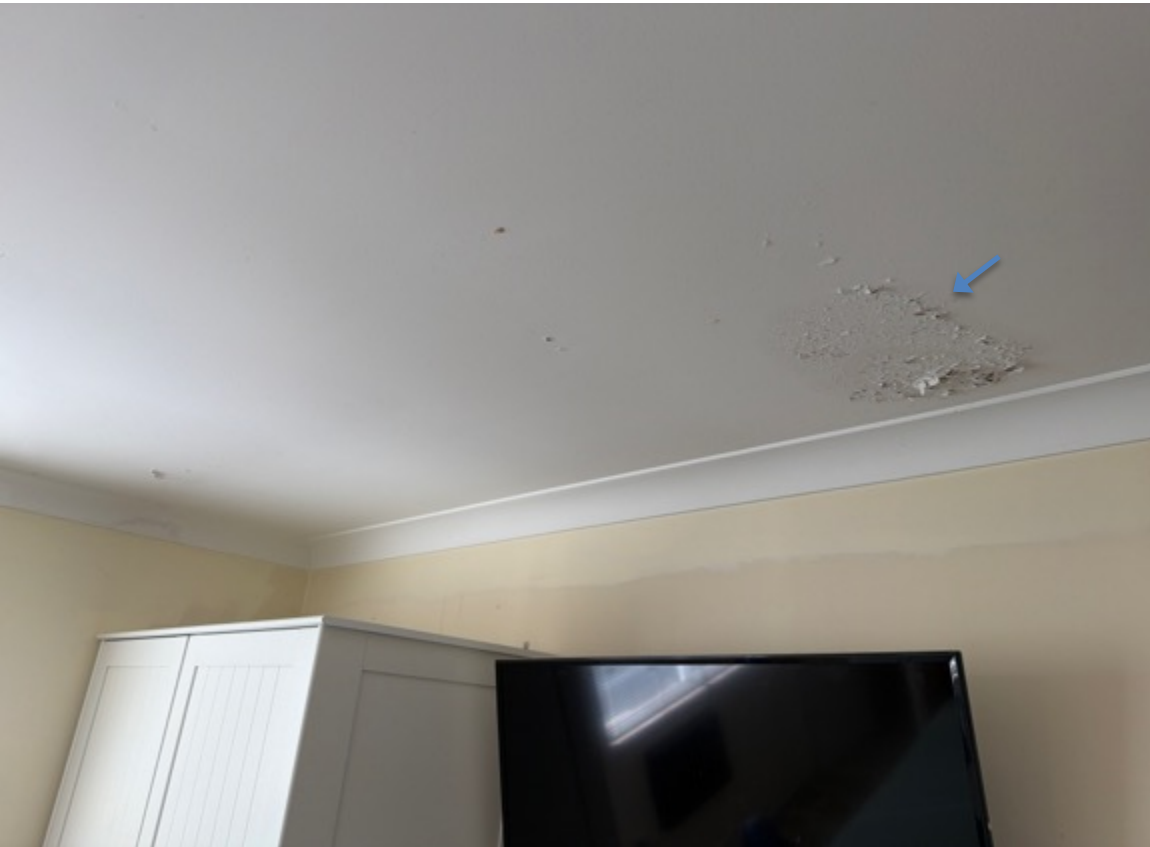
Ceiling paint is peeling, a fresh coat of paint is required.

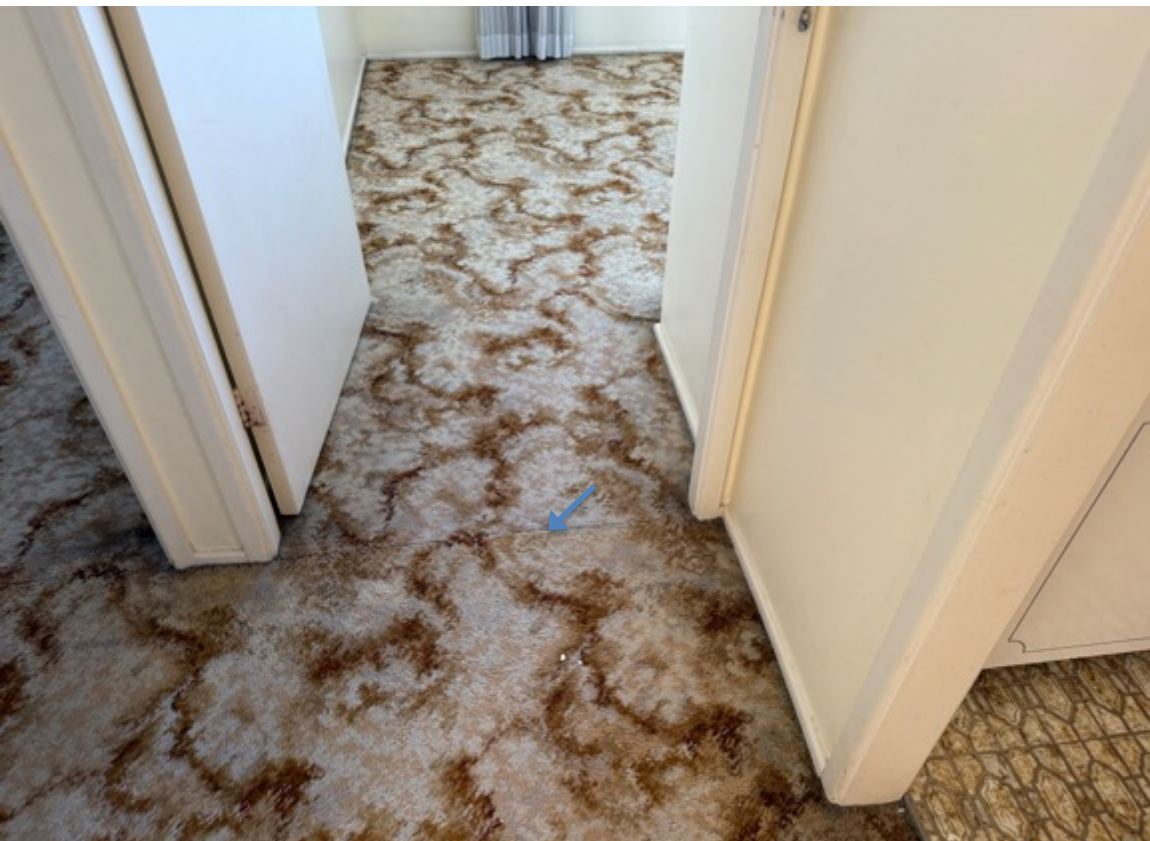
Internal carpet displays low level wear, consistent with age.

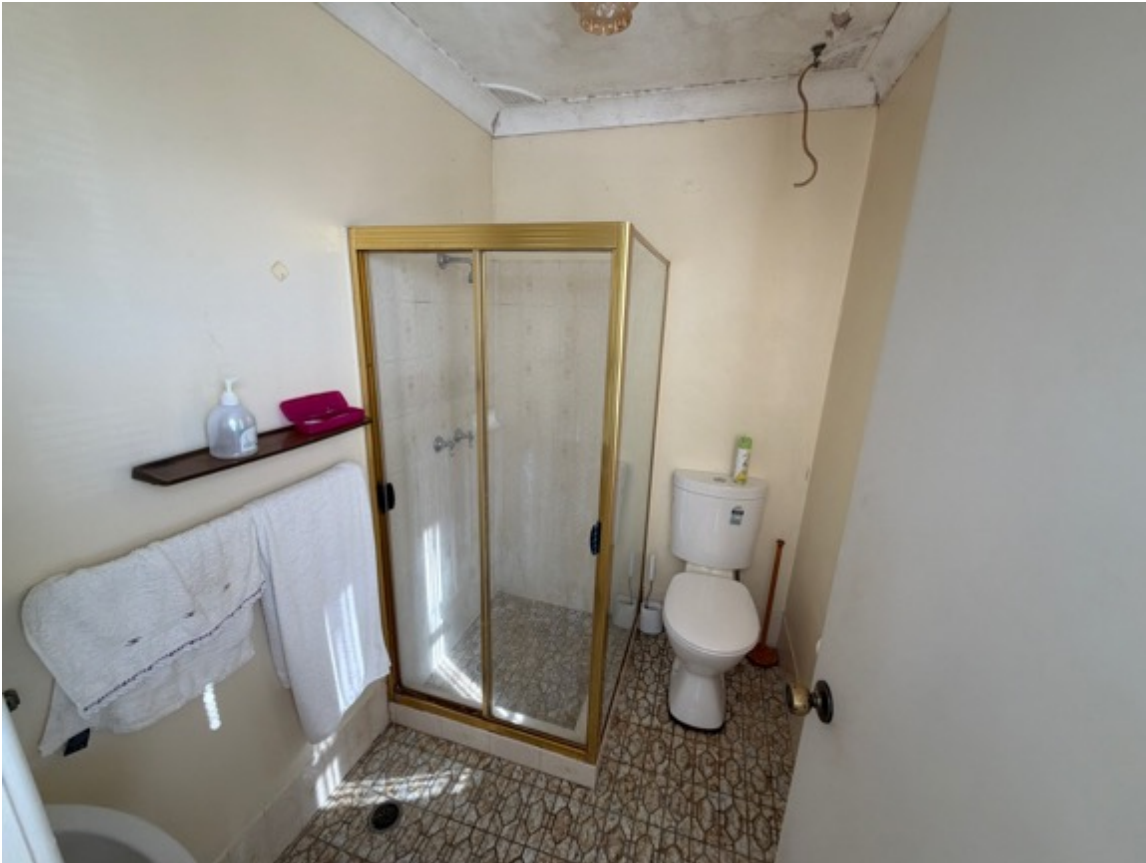
The ensuite bathroom will require renovating due to the age.

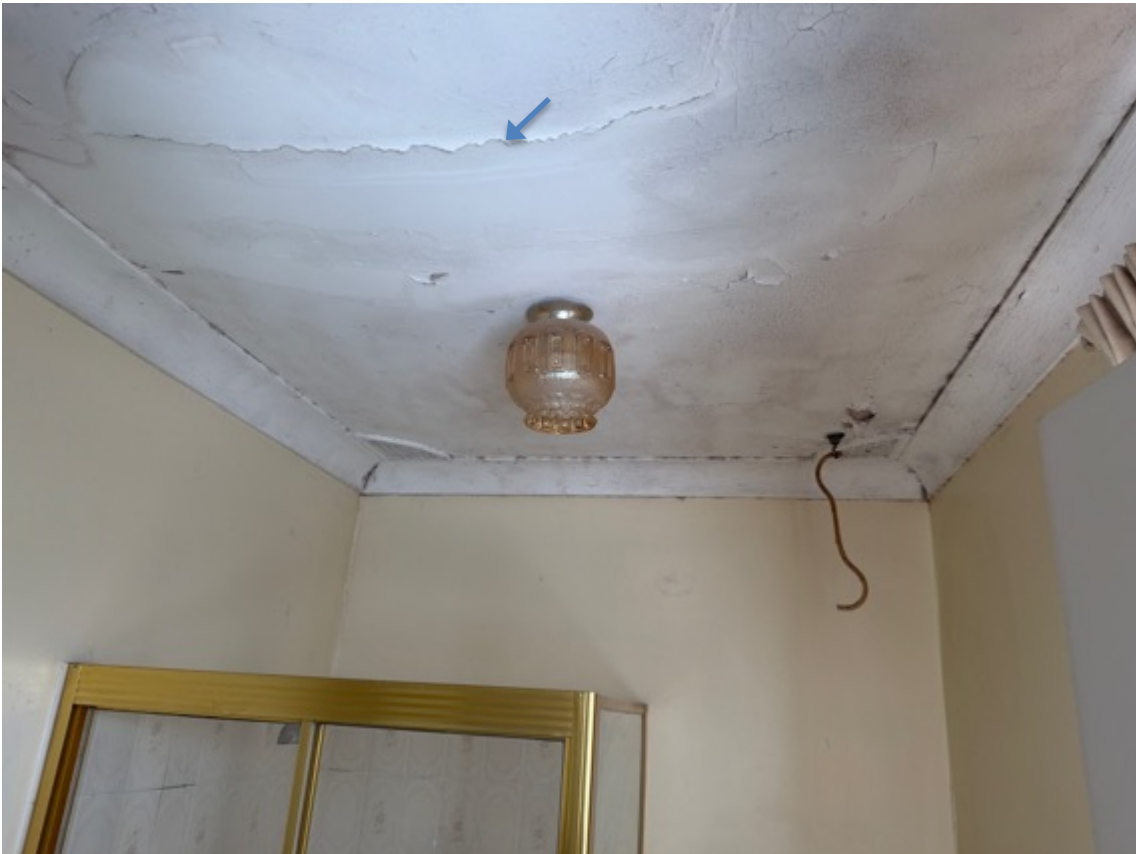
The ceiling will require remedial works - past water staining, peeling paint and sagging is visible.

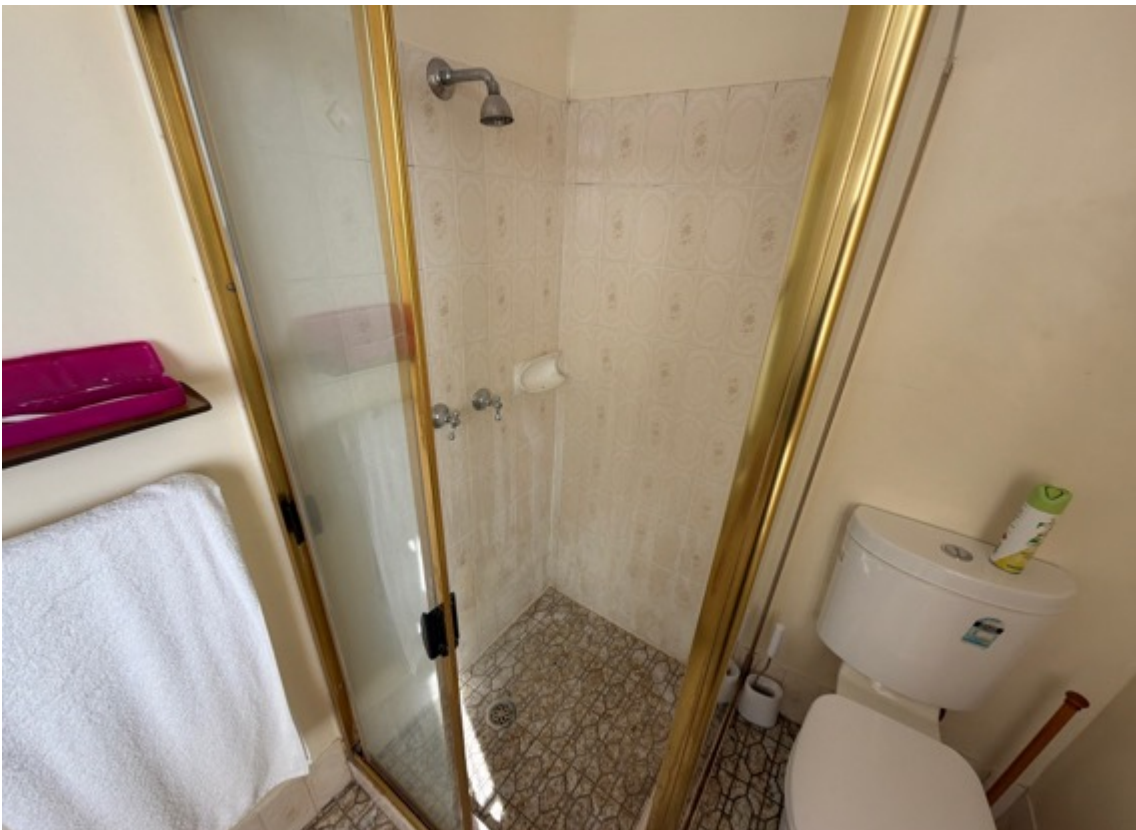
Water pressure tested, is sufficient - tile grout and silicone is darkened - reapplication is required.

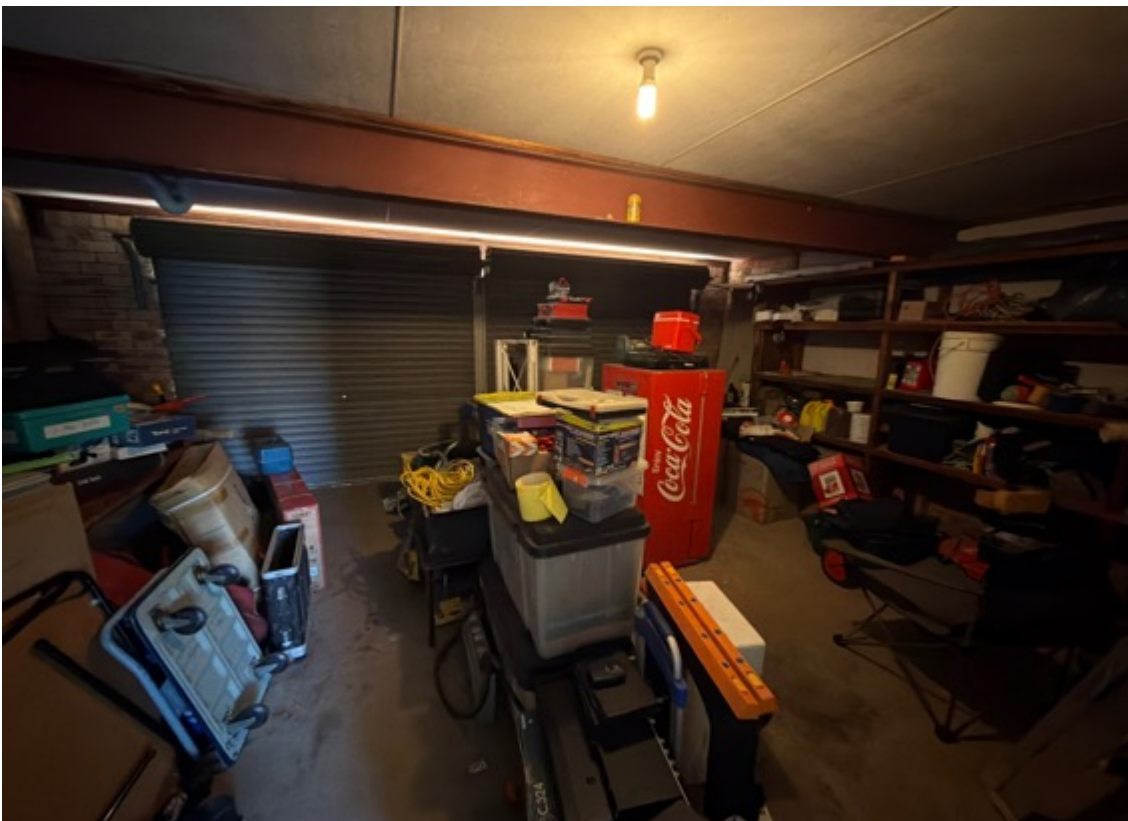
The garage area is in serviceable condition.

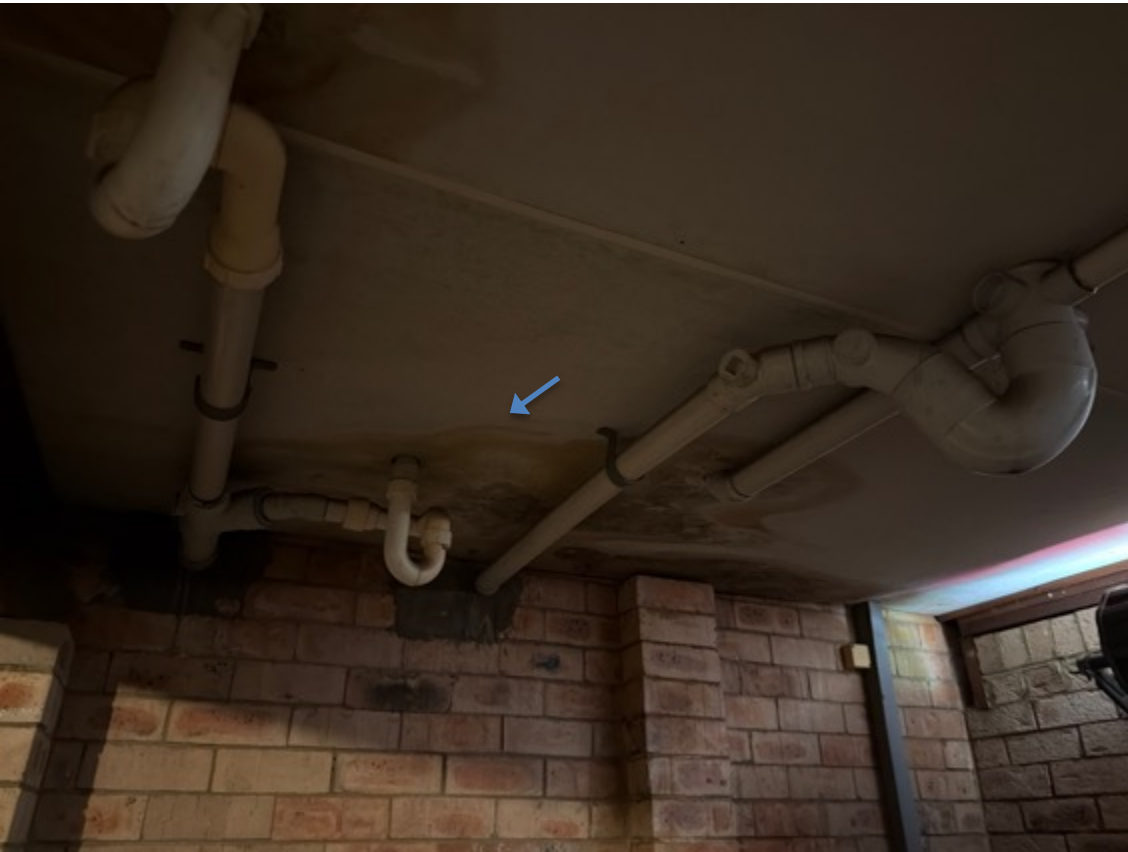
The garage ceiling has water staining visible - active leak.

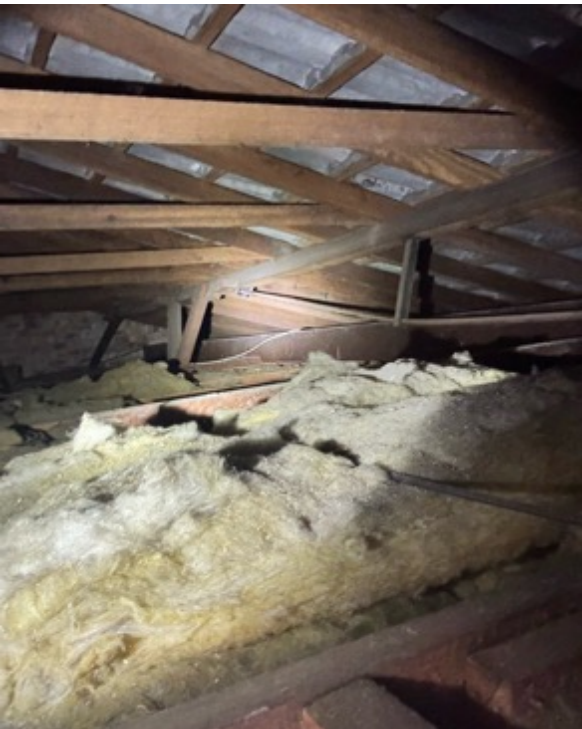
Maintain regular pest control by means of baits, sprays and monitoring to prevent pest attack within the roof space.
