Caboolture Building & Pest Inspections

PRE-SALE. STANDARD BUILDING REPORT

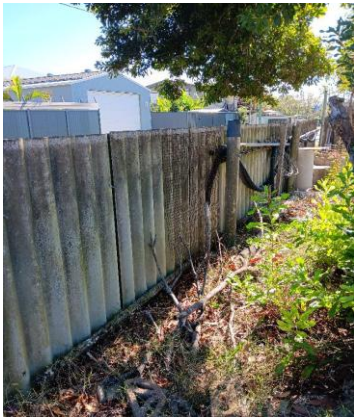
Super sixty six asbestos rear fence. Recommend an asbestos company to remove this.

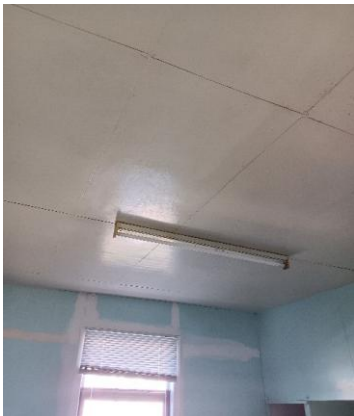
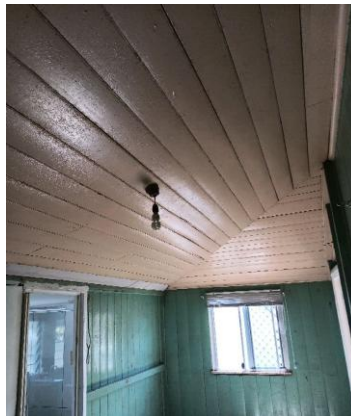
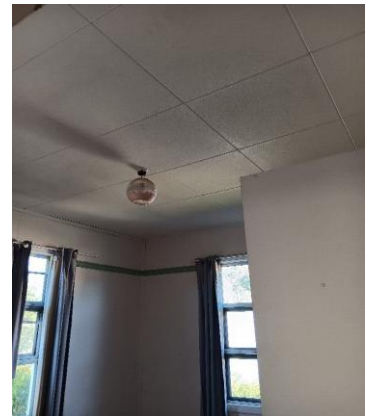
Some areas of the VJ ceiling are sagging. Recommend a builder to fix this.

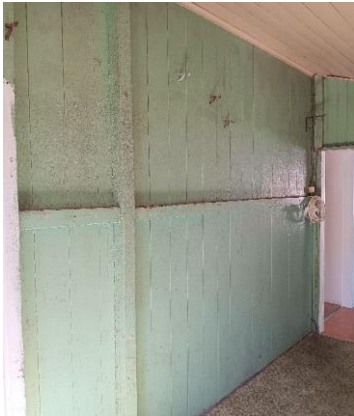
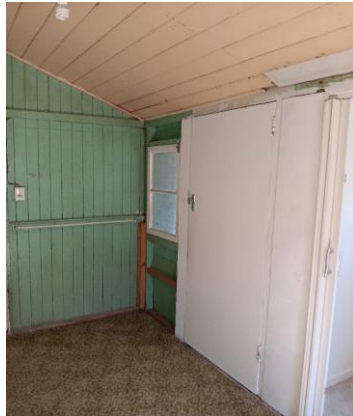
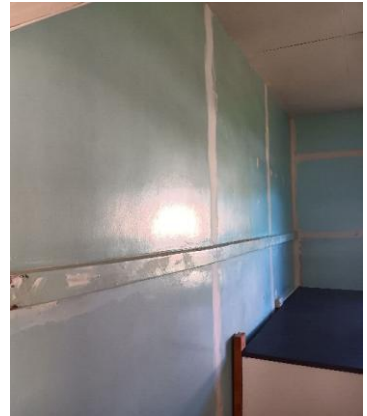
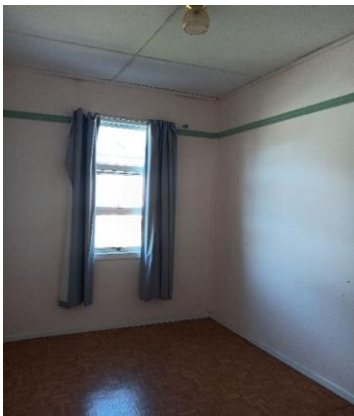
No evidence of Major Defects was found.

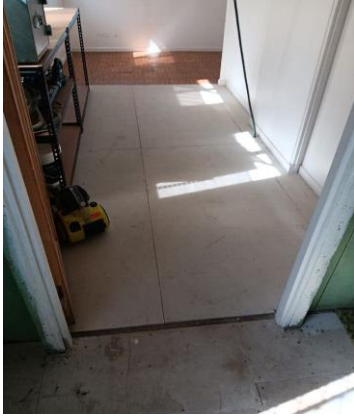
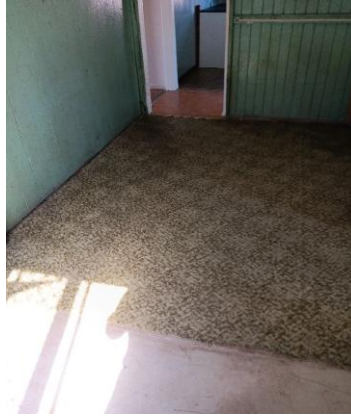
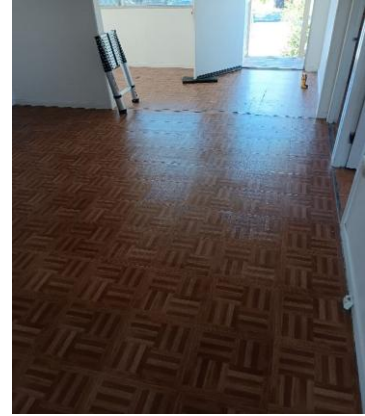
No evidence of Major Defects was found.

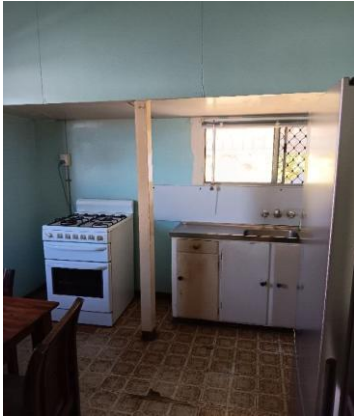
No evidence of Major Defects was found.

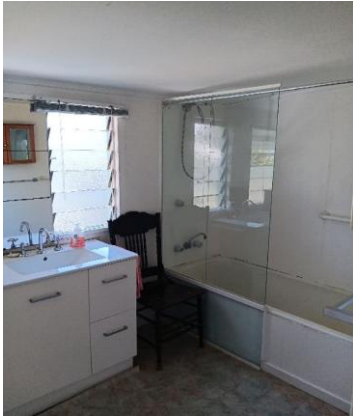
Evidence of Major Defects was found.

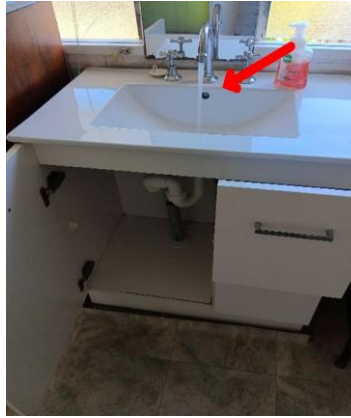
Bathroom Vanity.
No water leaks were found inside the cabinet on the day of inspection.
Please note, the red arrow shows the water running for water leak inspection.
(This was dry on the day of inspection.)

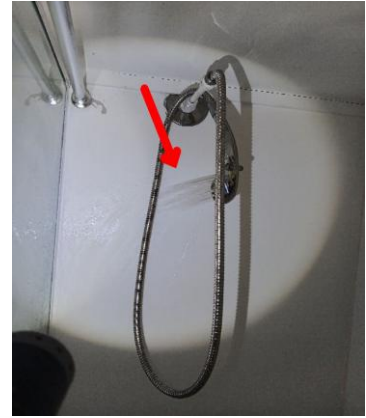
Shower Testing.
The red arrow shows the shower running. We are checking for water leaks / moisture readings inside the wall cavity and around the shower recess. Please note shower leaks can appear at any time. Owners should always monitor this.

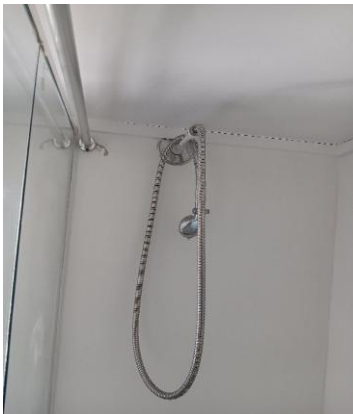
Minor.
The shower rose fitting requires replacing by a plumber.

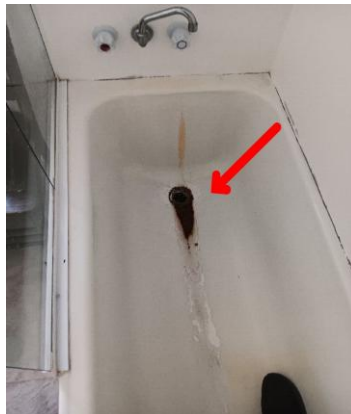
Major.
Rust to the bath. Recommend a builder to replace.

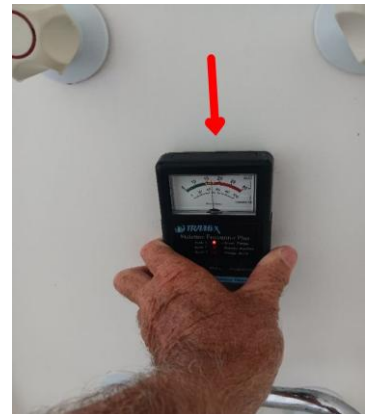
Moisture Readings Found- Major Defect.
Major moisture readings were found as per the photo supplied, after using a tramex plus moisture unit. There is a high possibility of structural internal wall framing damage. Recommend a plumber or a builder to do an invasive inspection and rectify the problem. Receipt of repairs is required for the buyer, stating they have fixed this problem.

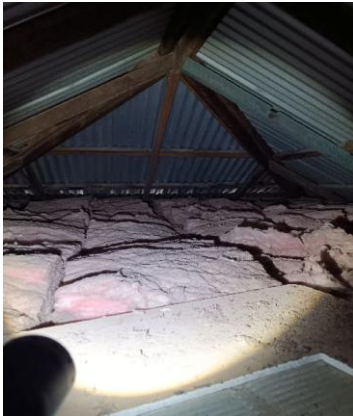
Roof Cavity Insulation.
There is roof cavity insulation installed. Please note the insulation is an obstruction, preventing us from visually inspecting all areas of the roof cavity, bottom of the trusses & the rear of the ceiling sheets.

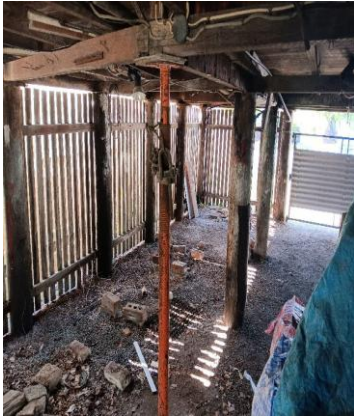
Major Structural.
All the timber stumps require replacing by a builder.

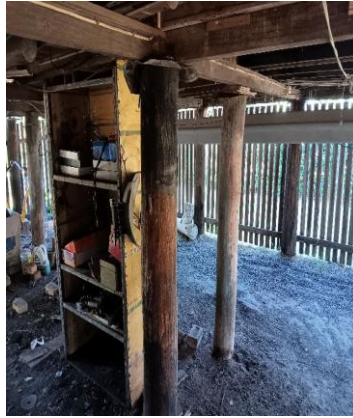
Please note subject to the deterioration to the house stumps the house will require re-levelling.

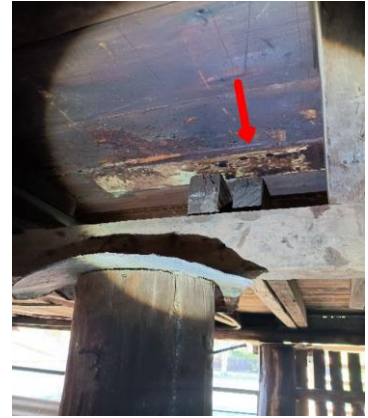
Minor.
Borers to the floor in several sections of the floor. Please read the report by the pest inspector.

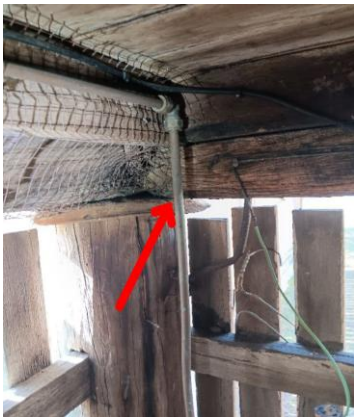
Major Structural Defect.
Major wood decay to structural floor frame, bearers and beams to the total house. Recommend a builder to replace all damaged timbers as required.

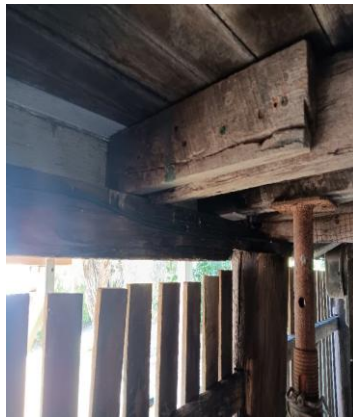
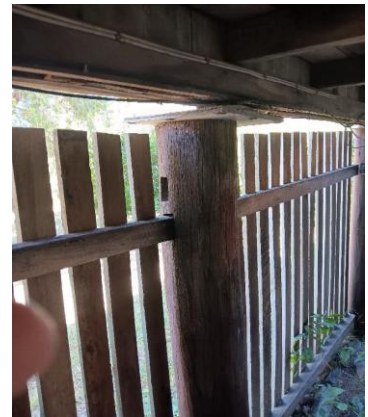
Please note several of the stumps have packers. These stumps have deteriorated underground and are sinking. Recommend that all the stumps be replaced by a builder.

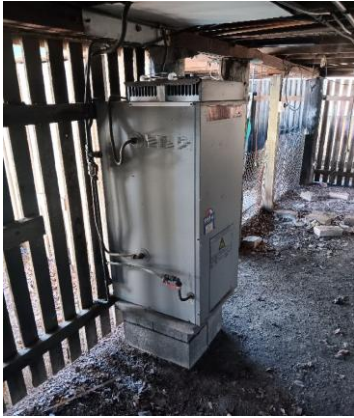
No water leaks were found on the day of inspection.

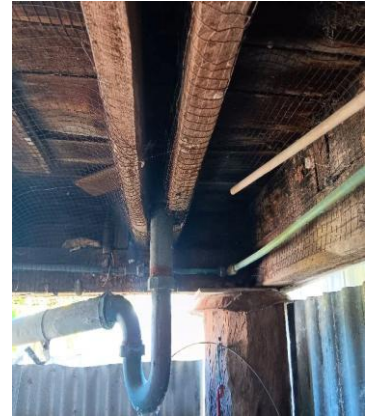
Laundry Area.
Please note that the laundry tub requires replacing by a plumber.

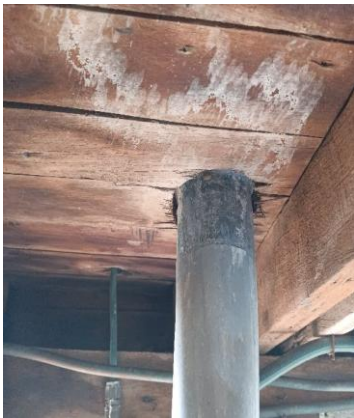
No water leaks found on the day of inspection.

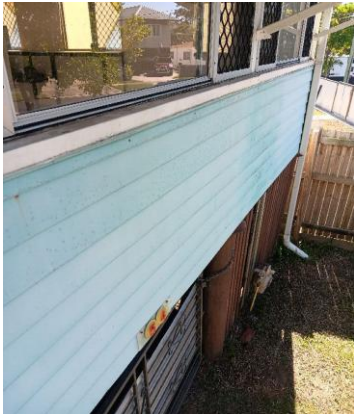
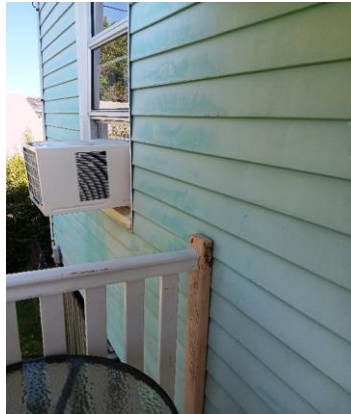
The external walls are sheeted over with a lightweight cladding system.

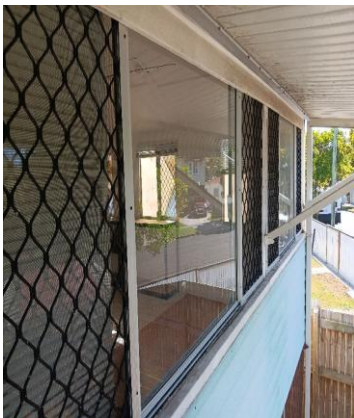
D13 External doors (including patio doors)

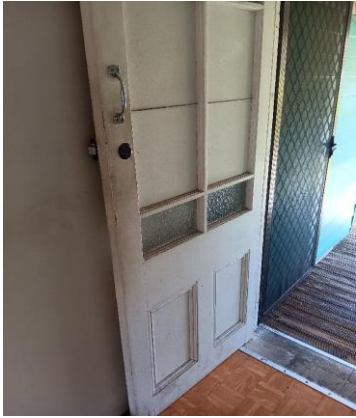
General deterioration to the rear door.

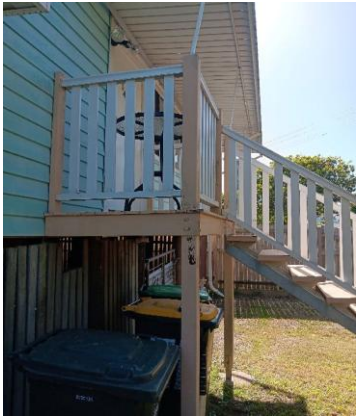
Minor.
The front southern balcony is out of level subject to the age of the property. Recommend a builder to replace or rectify as required.

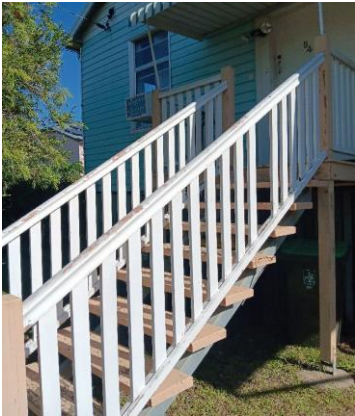
Minor.
The front verandah handrails require fixing by a builder.

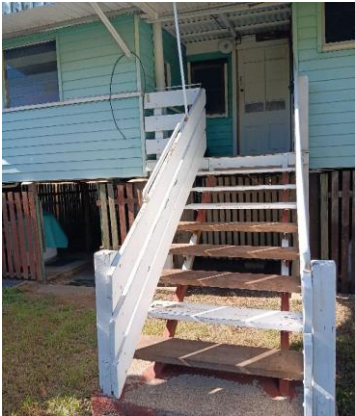
Rear Northern Steps.
General wood decay to the timbers. Recommend a builder to replace as required.

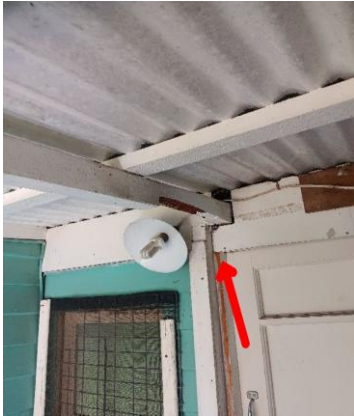
Minor.
Wood decay to the rear verandah roof rafters. Recommend a builder to replace as required.

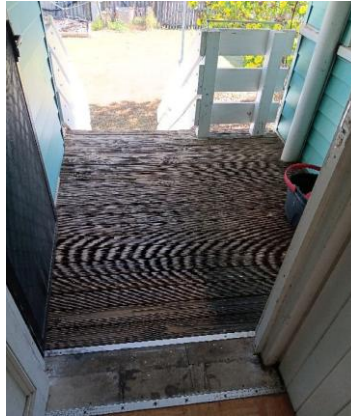
Major deterioration to the rear landing timbers. Recommend a builder to replace as required.

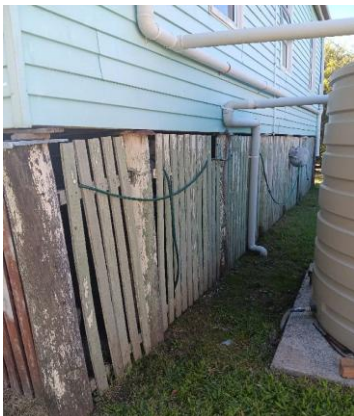
Major wood decay to the balustrade timbers around the dwelling. Recommend a builder to replace as required.

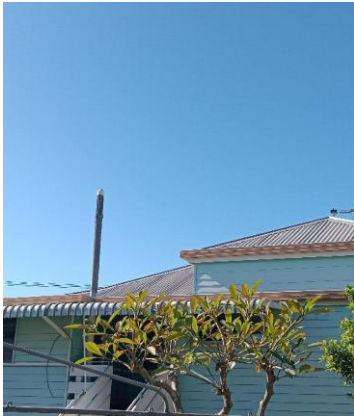
No evidence of Major Defects was found.

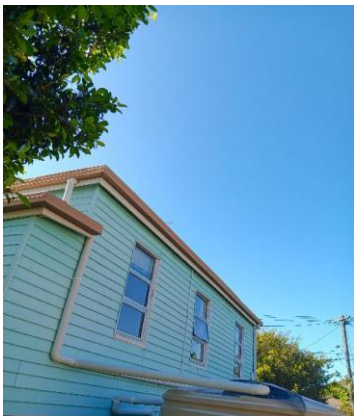
Minor rust and deterioration to the guttering. Recommend a plumber to replace as required.

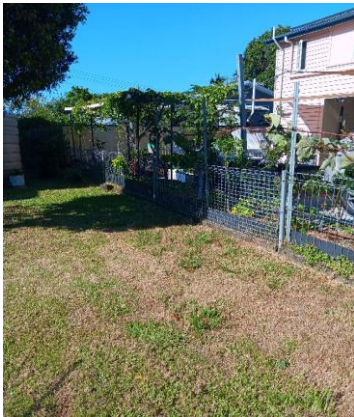
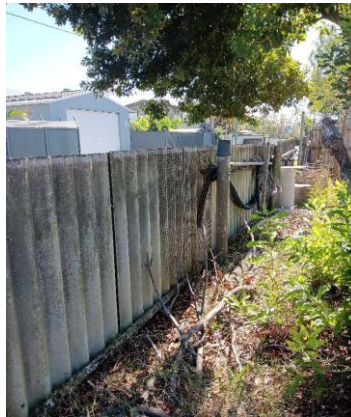
Evidence of Major Defects was found.

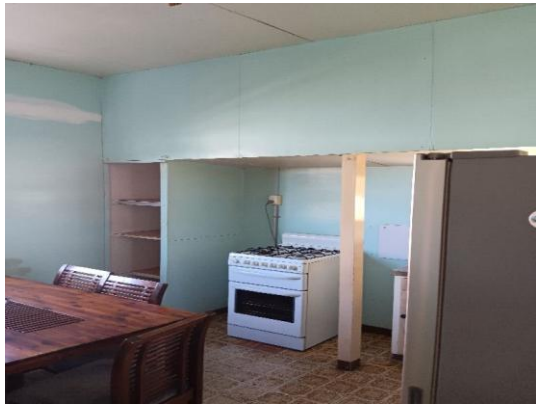
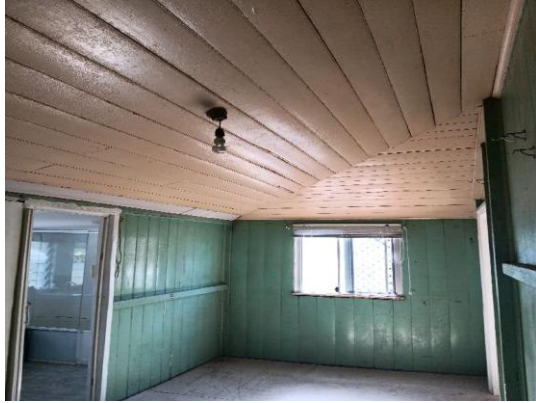
Section I Certification
