**NORTH BRISBANE  
BUILDING & PEST**  
**INSPECTIONS**

7 Picasso Crescent Carseldine 4034 Queensland Australia

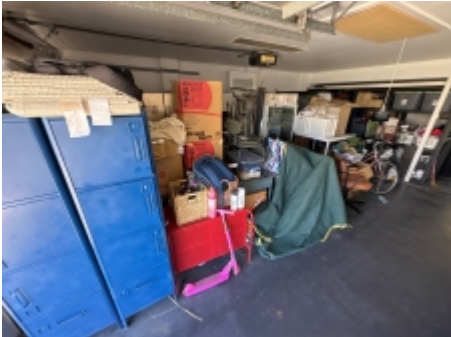
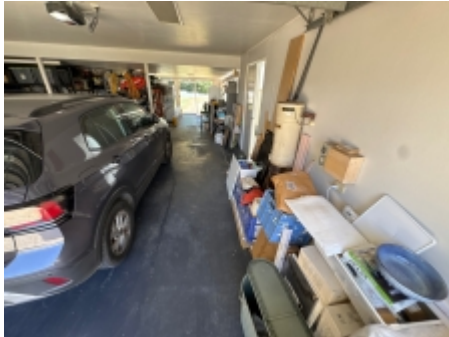
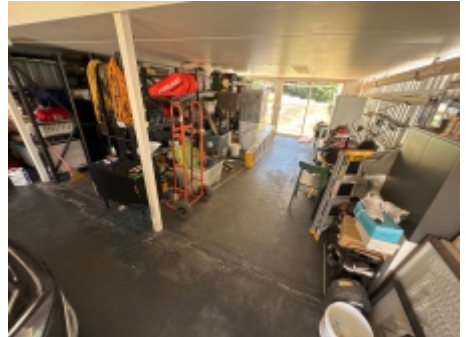
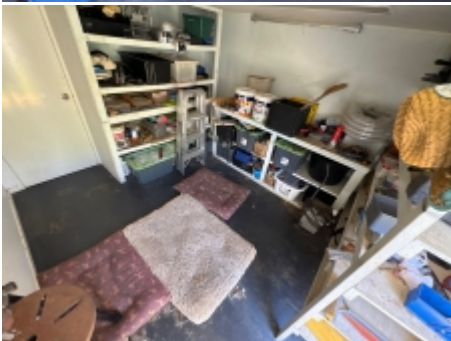
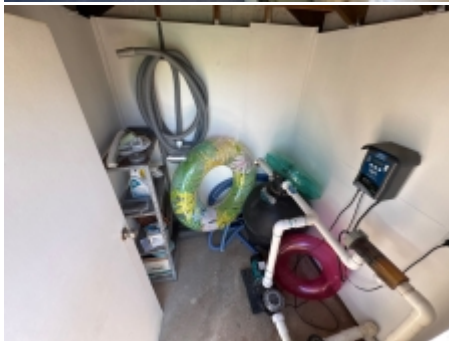
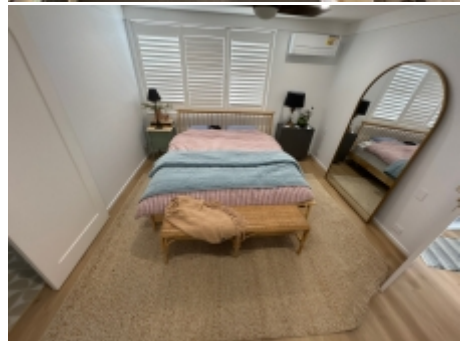
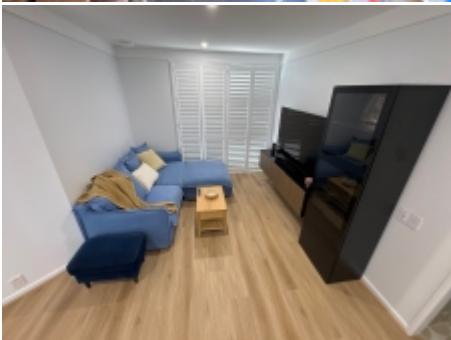
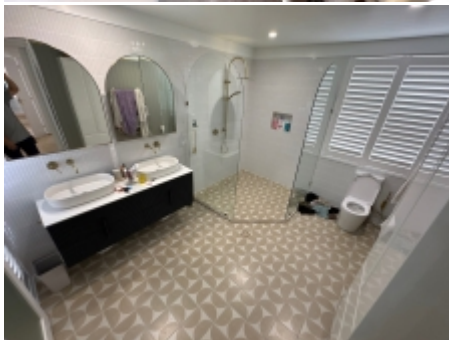
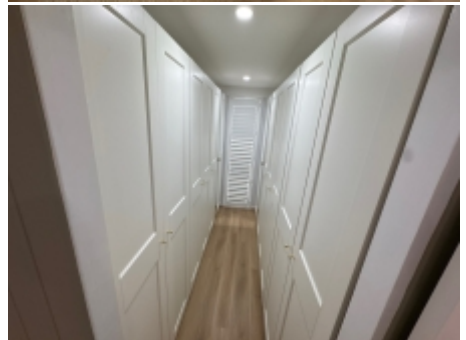
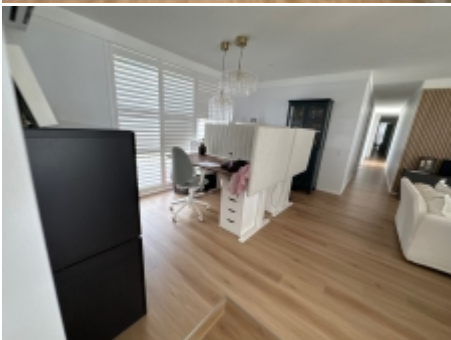
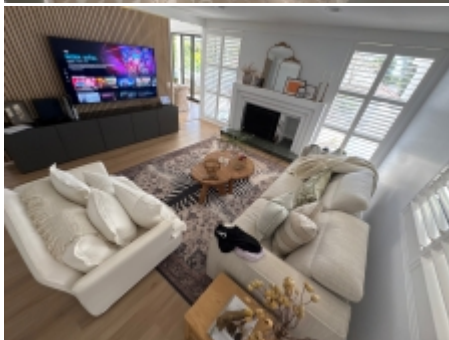
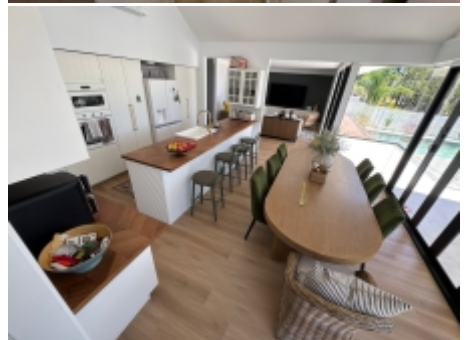
#### Obstruction Photos

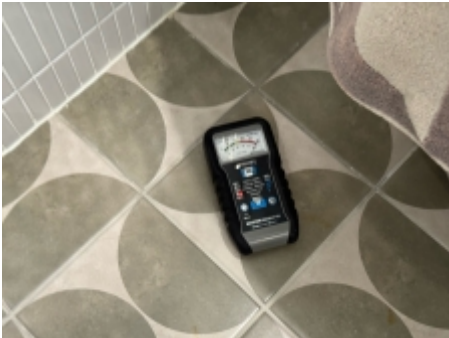
Elevated moisture levels outside the shower cubicles along with previous repairs was observed, and licensed shower repair repairer should be engaged for further assessment.

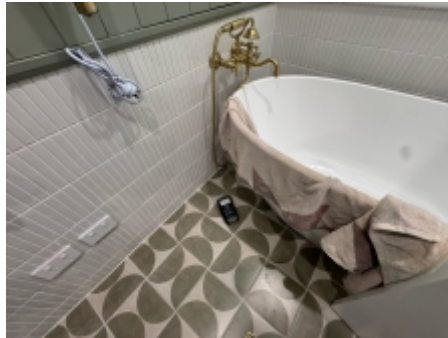
Elevated moisture levels outside the shower cubicles along with previous repairs was observed, and licensed shower repair repairer should be engaged for further assessment.

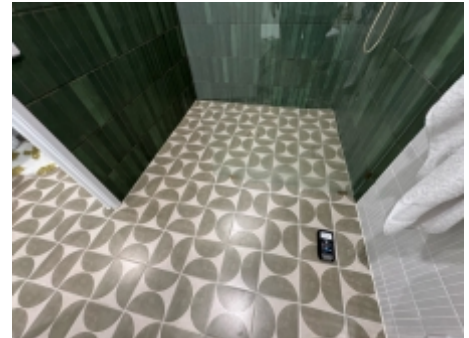
Elevated moisture levels outside the shower cubicles along with previous repairs was observed, and licensed shower repair repairer should be engaged for further assessment.

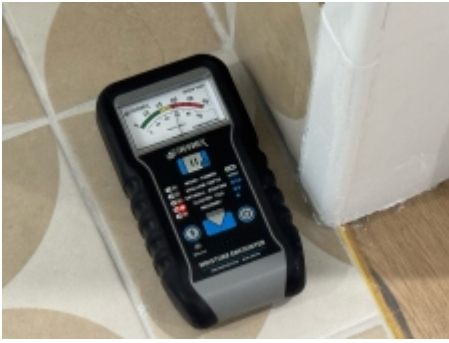
Elevated moisture levels outside the shower cubicles along with previous repairs was observed, and licensed shower repair repairer should be engaged for further assessment.

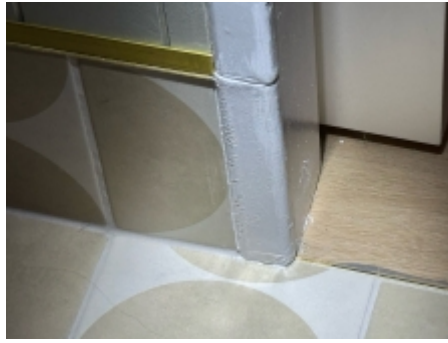
Elevated moisture levels outside the shower cubicles along with previous repairs was observed, and licensed shower repair repairer should be engaged for further assessment.

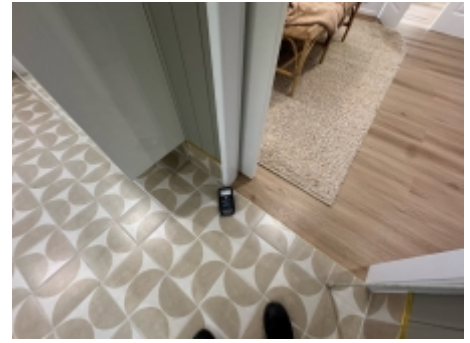
Elevated moisture levels outside the shower cubicles along with previous repairs was observed, and licensed shower repair repairer should be engaged for further assessment.

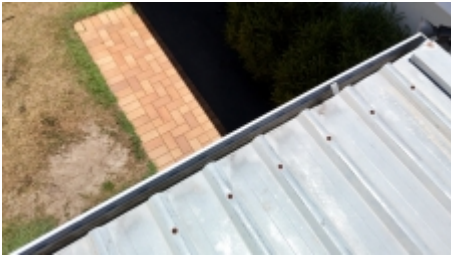
Corroded screws will eventually cause rust on the roofing iron, leading to water ingress. A licensed roofing contractor should be consulted for further assessment.

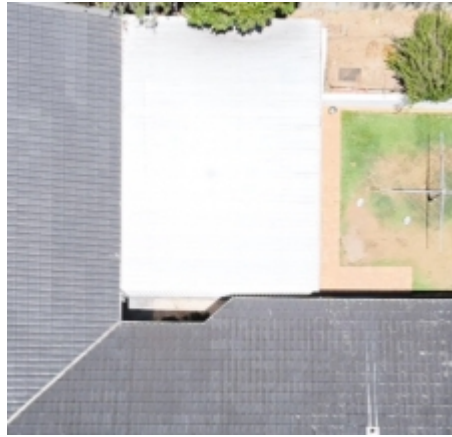
Corroded screws will eventually cause rust on the roofing iron, leading to water ingress. A licensed roofing contractor should be consulted for further assessment.

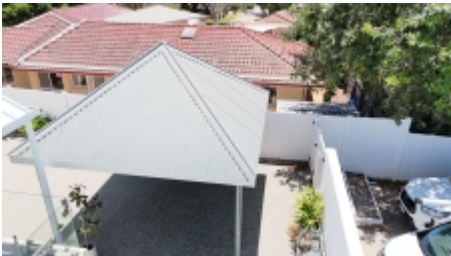
Rainwater goods have not been installed to the gazebo.

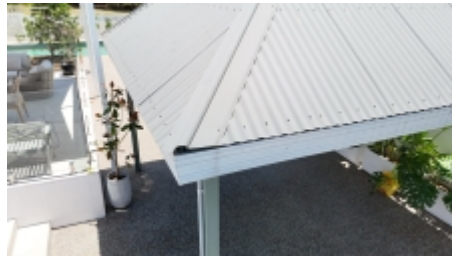
Rainwater goods have not been installed to the gazebo.

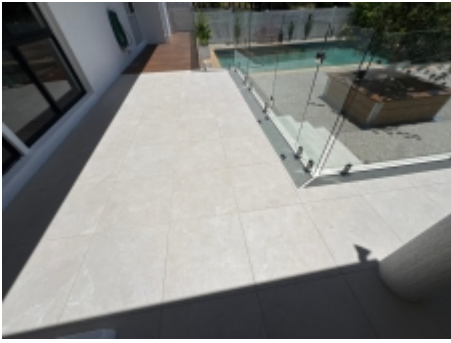
Drummy tiles were observed, resin injection may be a suitable repair.

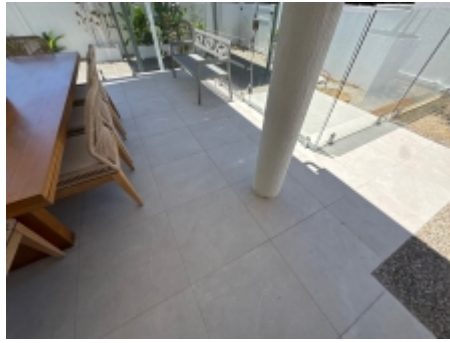
Drummy tiles were observed, resin injection may be a suitable repair.

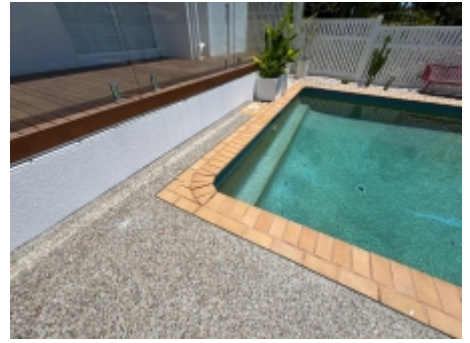
Pool coping pavers require re-grouting.

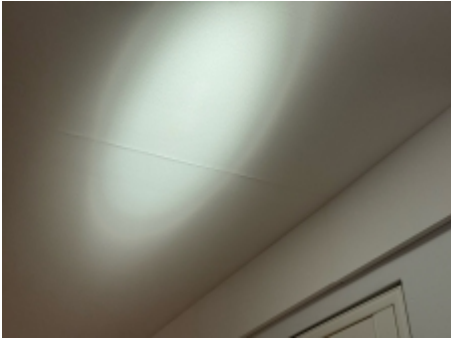
Ceiling cracking was observed, the installation of an expansion joint will reduce the likelihood of this recurring once repaired.

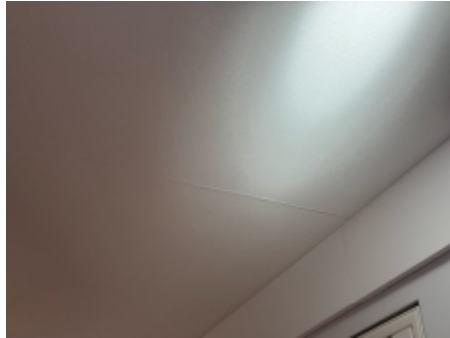
Ceiling cracking was observed, the installation of an expansion joint will reduce the likelihood of this recurring once repaired.

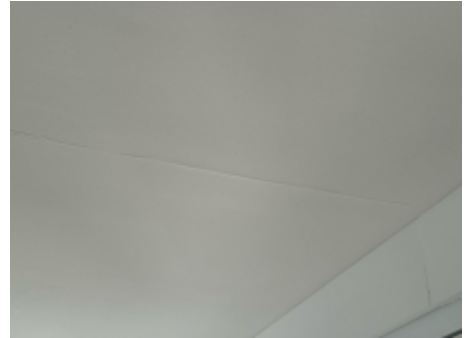
Ceiling cracking was observed, the installation of an expansion joint will reduce the likelihood of this recurring once repaired.

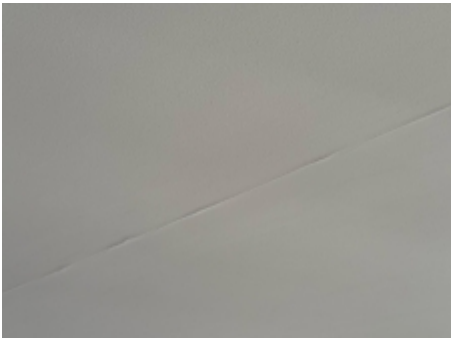
Ceiling cracking was observed, the installation of an expansion joint will reduce the likelihood of this recurring once repaired.

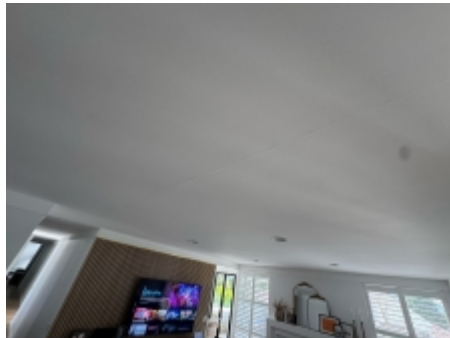
Ceiling cracking was observed, the installation of an expansion joint will reduce the likelihood of this recurring once repaired.

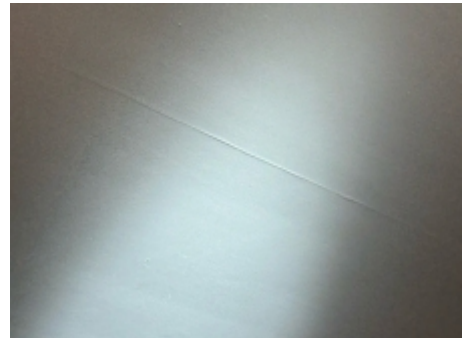
Ceiling cracking was observed, the installation of an expansion joint will reduce the likelihood of this recurring once repaired.

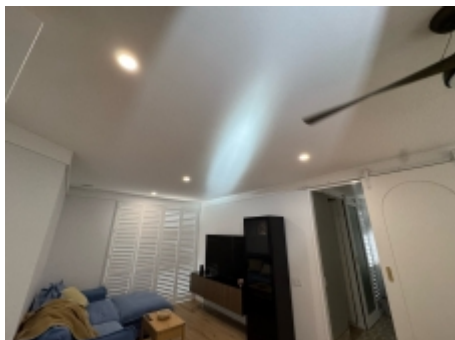
Ceiling cracking was observed, the installation of an expansion joint will reduce the likelihood of this recurring once repaired.

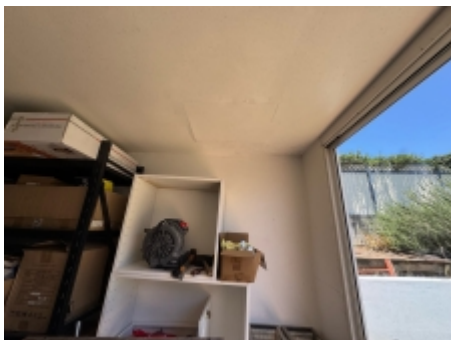
Evidence of previous water ingress at the rear of the garage was observed, moisture testing was performed and no elevated levels were detected.

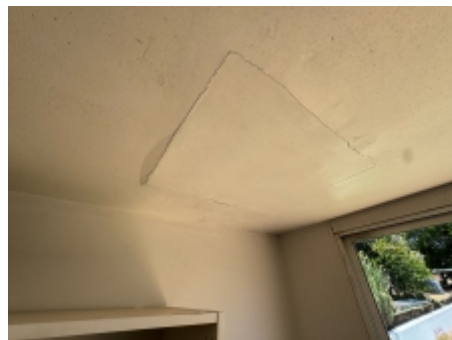
Evidence of previous water ingress at the rear of the garage was observed, moisture testing was performed and no elevated levels were detected.

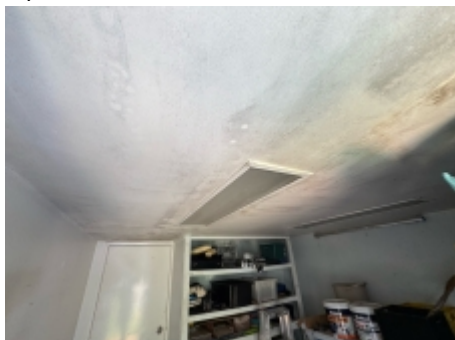
Evidence of previous water ingress at the rear of the garage was observed, moisture testing was performed and no elevated levels were detected.

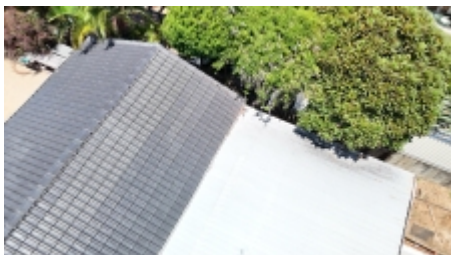
Foliage needs to be cleared away from all structures and debris needs to be cleared out of gutters.

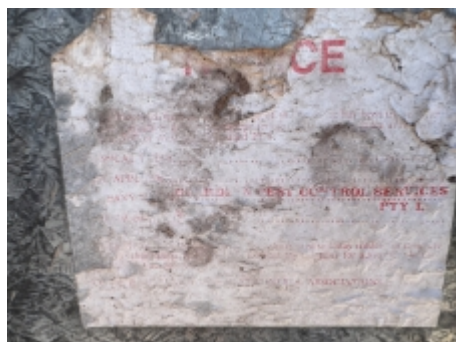
E5 Frequency of future inspections: The next inspection to help detect termite attack is recommended in:	6 months
E6 Chemical delignification	No evidence was found.
E7 Fungal decay	The following evidence was found:

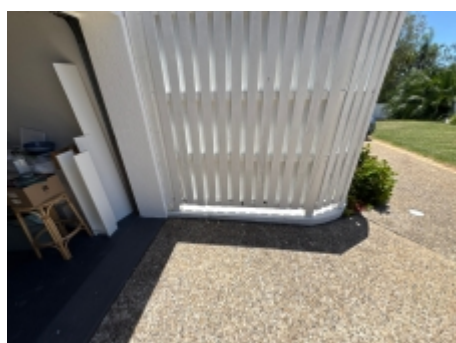
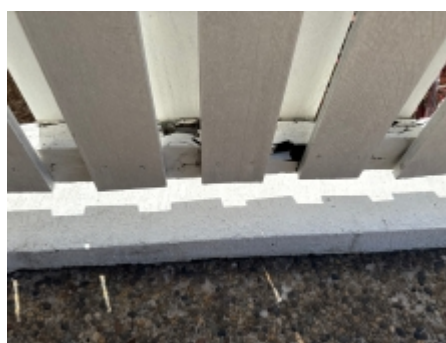
All timbers affected by fungal decay should be repaired to prevent possible timber pest attack. A licensed builder should be engaged for further advise.

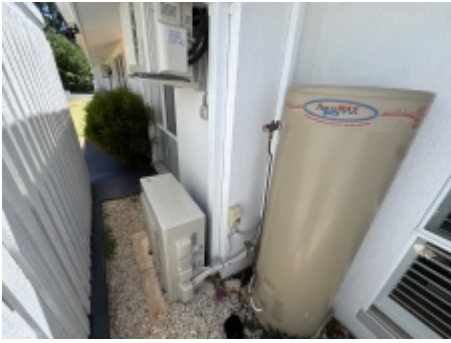
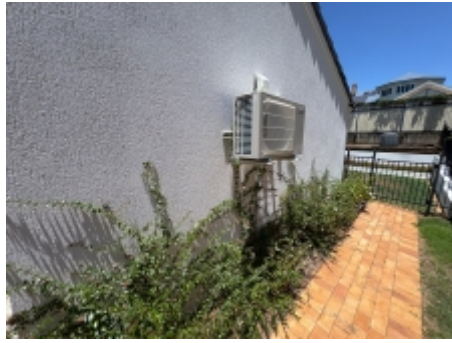
E11 Bridging or breaching of termite barriers and inspection zones	The following evidence was found
--	----------------------------------

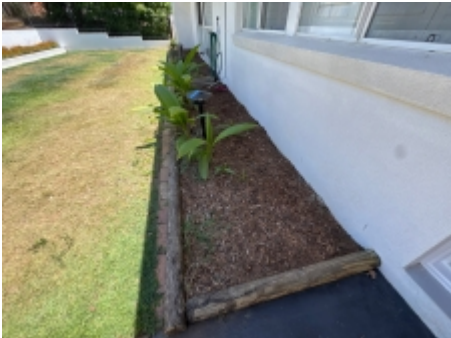
Gardens up against the house hinder the visual inspection zone's, hard surfaces abutting the building are always recommended. A pest controller should be engaged for further assessment.

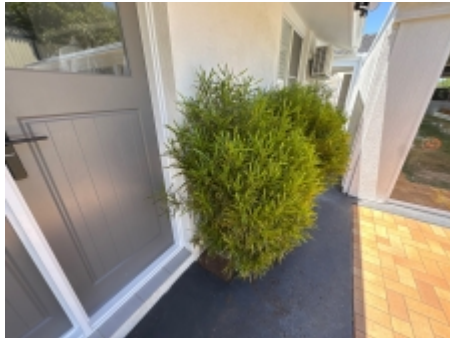
Gardens up against the house hinder the visual inspection zone's, hard surfaces abutting the building are always recommended. A pest controller should be engaged for further assessment.

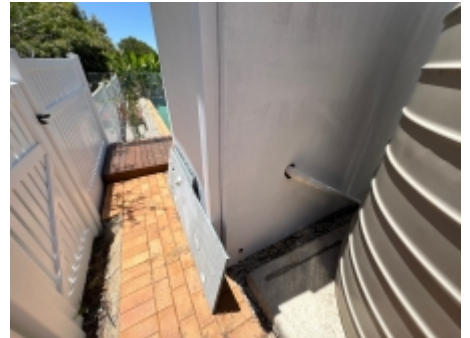
A 75 mm exposed slab edge should be maintained under all external cladding. a pest controller should be engaged for further advice.

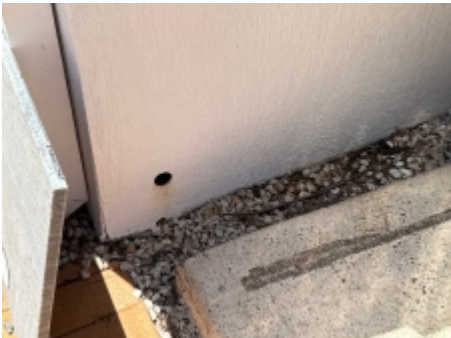
A 75 mm exposed slab edge should be maintained under all external cladding. a pest controller should be engaged for further advice.

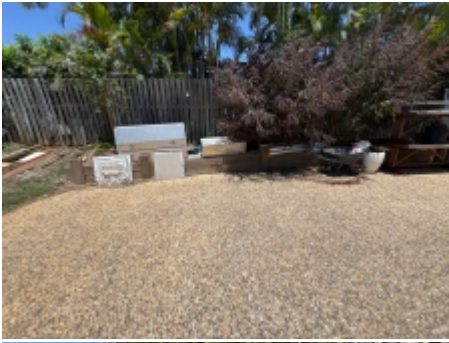
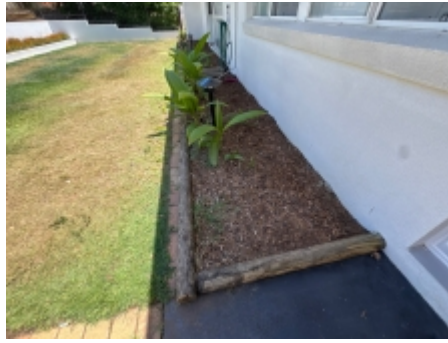
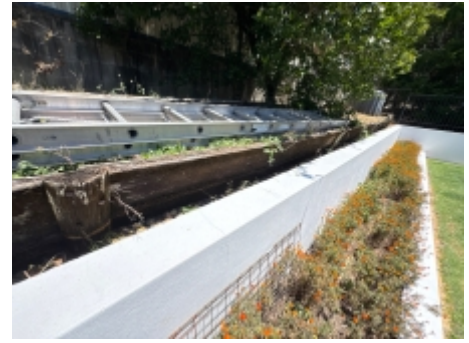
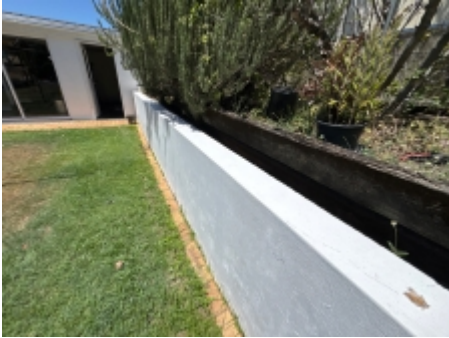
## MAJOR SAFETY HAZARDS

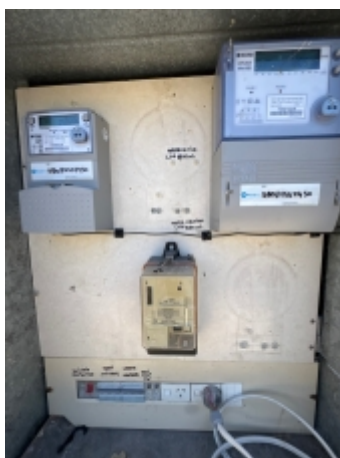
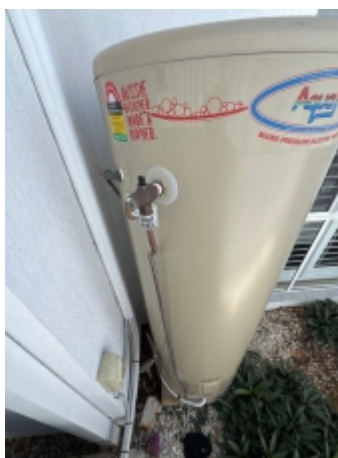
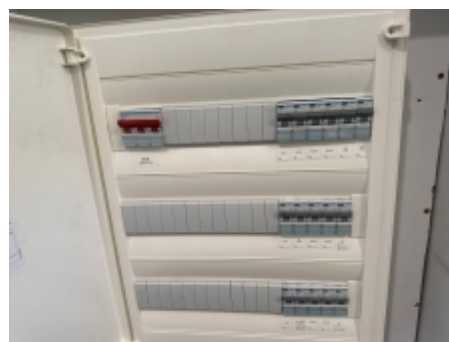
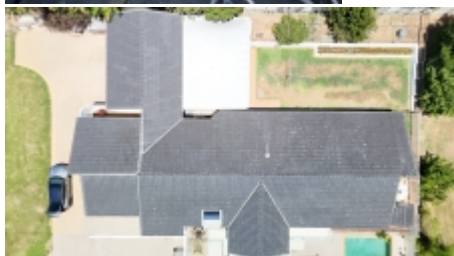
## SECTION J CERTIFICATION
