Seller disclosure statement

Property address 15 Sport Street, Kedron Qld 4031
(referred to as the
“property” in this
statement)

Inspection Report

15 Sport St, Kedron, QLD

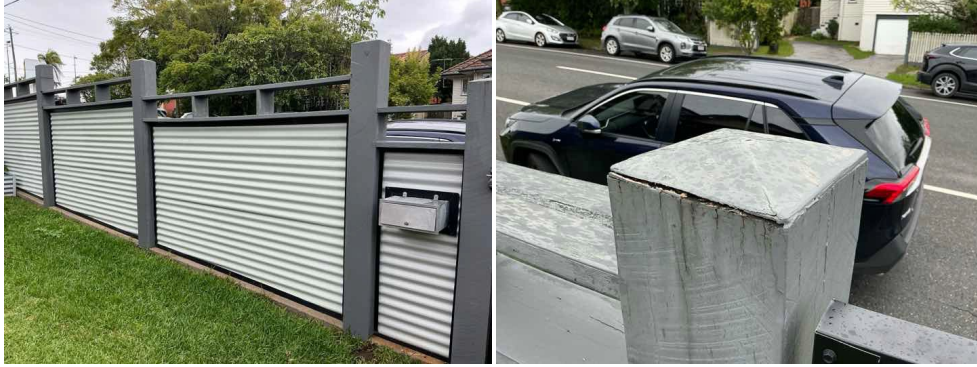
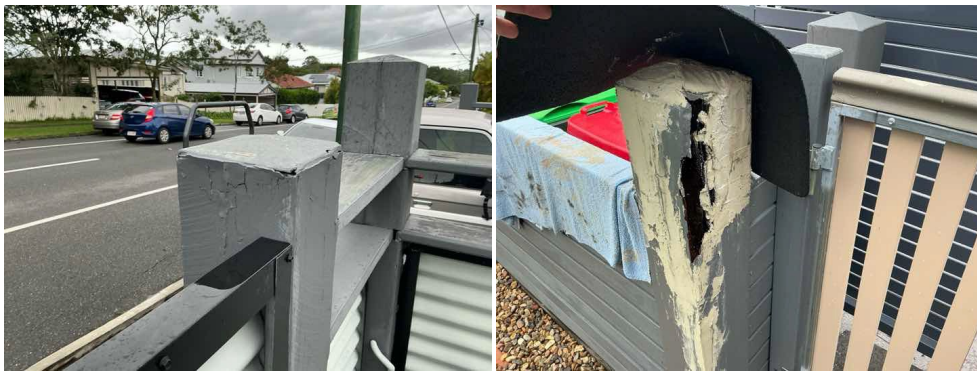
#1. General age to fence components - Recommendations: General upkeep and maintenance. A qualified fencing contractor should be engaged for repairs

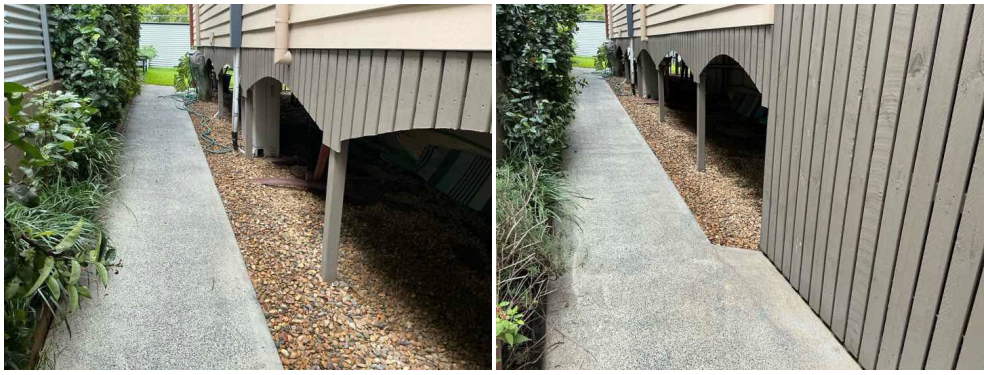
Surface Drainage

#2. The ground levels along the perimeter walls at the side of the home did not appear to fall away from the property walls sufficiently due to the natural landscape and contour. Recommendations: This will need to be assessed during a period of rainfall and if surface water appears to be entering the sub floor if applicable or ponding against the perimeter walls, engage a plumber or landscaper to assess and rectify as required. All drains should be regularly checked by a plumber and kept clean of debris to allow surface water to be carried away from the dwelling.

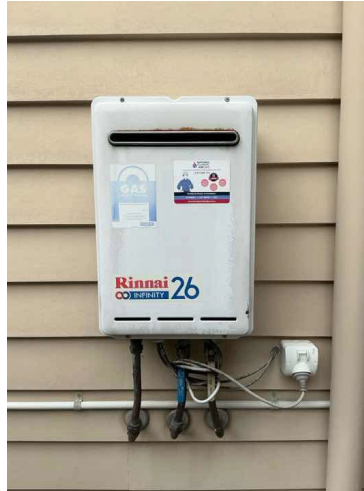
Hot Water Unit Findings

The hot water system appears to be in a serviceable condition. No specific tests other than running the hot water from a tap was carried out. No determination has been made as to the suitability or adequacy of the hot water system in relation to capacity or otherwise.

The hot water unit is located outside.

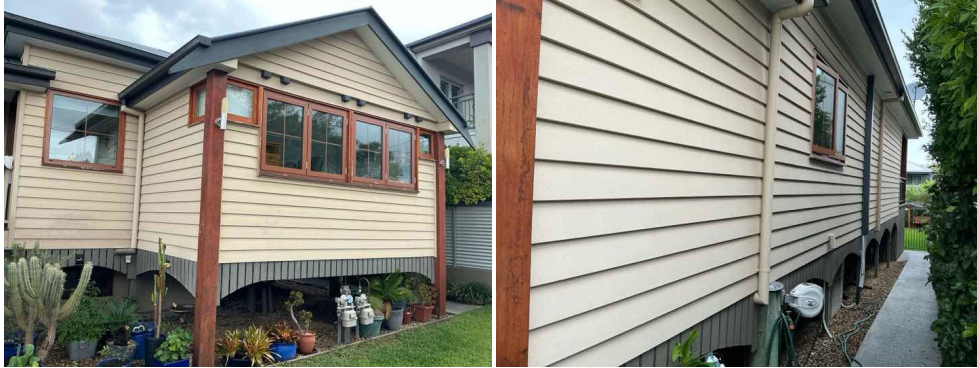
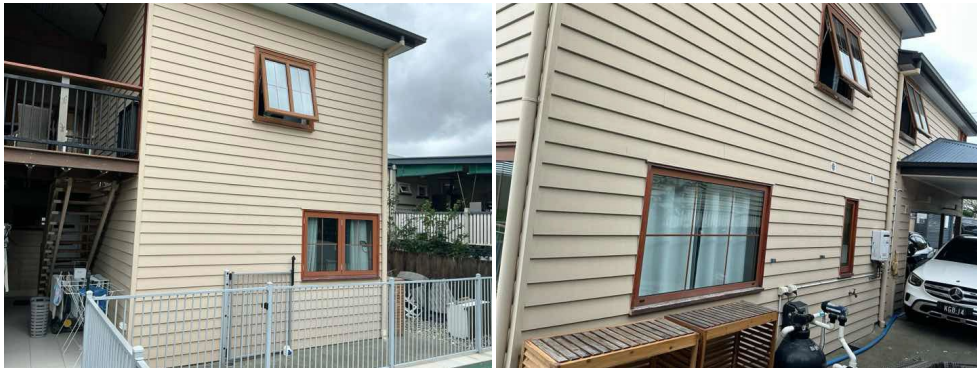
Hardie Plank

Weatherboard

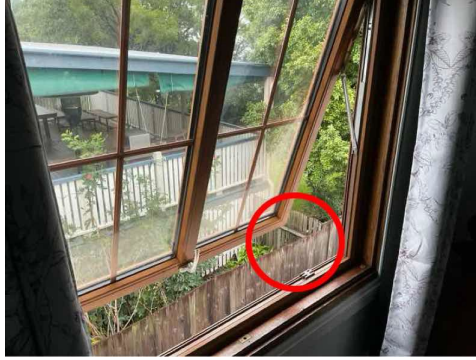
Exterior Windows

#3. Age observed to window components and clear protective coating. Maintenance required. Assess each window and improve sealants and lubricants to mechanical components.

#4. Selected upstairs windows are able to be fully opened. This was compliant at the time of construction and technically no requirement to rectify. Current building code has identified a fall risk and requires a limited opening of 125 mm or secure screening to be in place.

Contact a lic Builder, Glazier to assess and rectify.

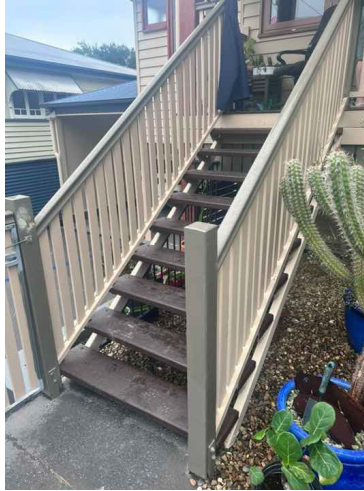
Balustrade and Rails

#5. Timber fungal decay in areas of balustrade and/or rails. Recommendations: A qualified carpenter should be engaged for advice and recommendations. This is a safety issue and requires immediate assessment.

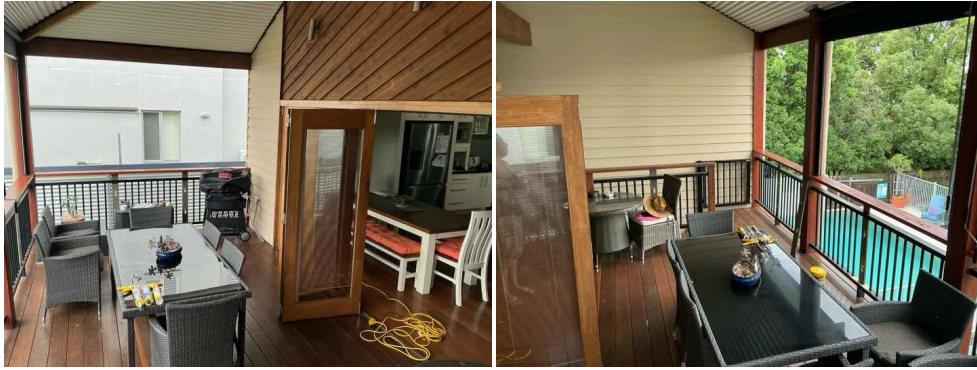
Balustrade and Rails

#6. Timber fungal decay in areas of balustrade and/or rails. Recommendations: A qualified carpenter should be engaged for advice and recommendations. This is a safety issue and requires immediate assessment.

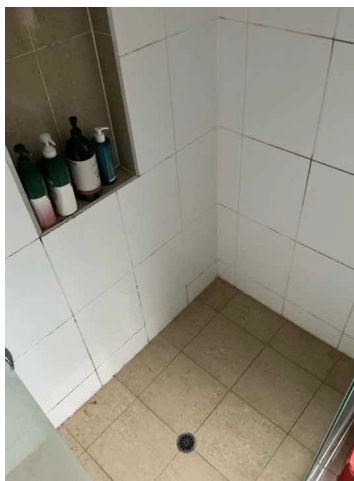
Bathroom 2**Location**

#7. General age visible to the cabinet, fittings and sealants of the bathroom.

General maintenance required.

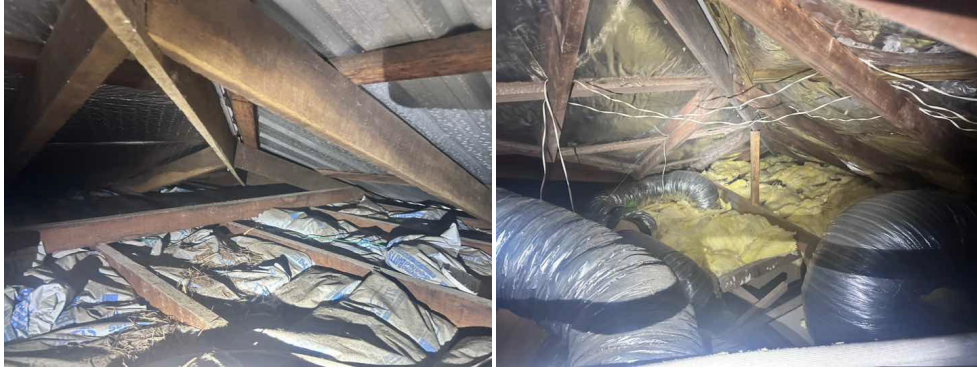
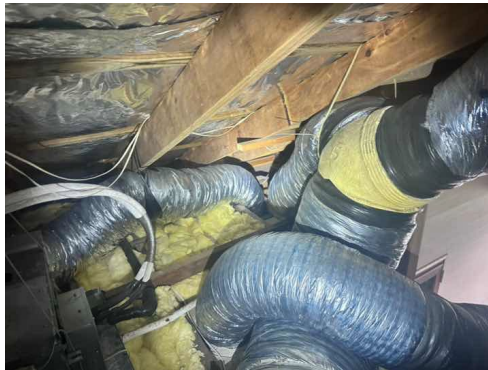
Roof Frame Type

The roof frame is a conventional timber frame.

#8. The ceiling void was too confined to physically access. This was inspected from the manhole access point only. From this point the area appeared serviceable. Certain areas were unable or difficult to inspect, and as such are not included in this inspection. Invasive inspection, (areas of roof lifted) would be required to inspect these areas.

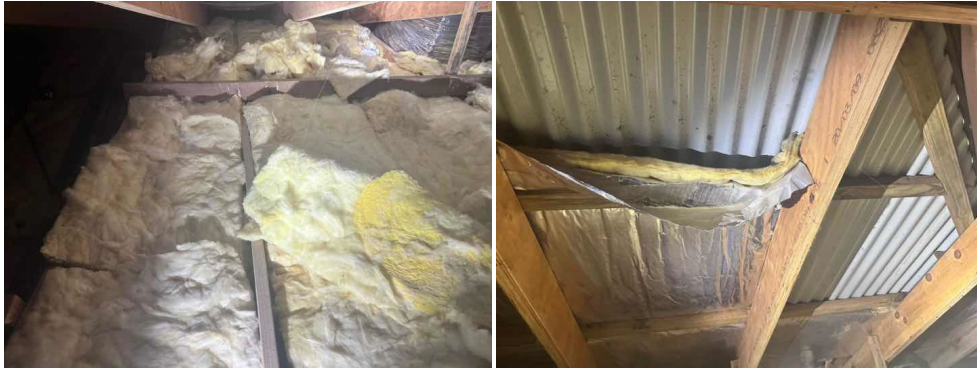
The roof space is insulated with reflective fibreglass batts under the roof cladding. Sections are missing.

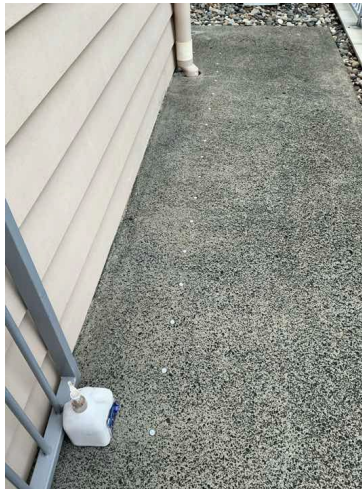
Yes, Drill Holes (Chemical Treatment) was seen at the property,

Recent chemical soil treatment. Termidor. 5-7 year active lifespan.
