BUILDING INSPECTION

Complies with Australian Standard AS 4349.1-2007
Inspection of Buildings Part 1: Pre-Purchase
Inspections of Residential Buildings - Appendix C

80 Commodore Crescent
Port Macquarie, NSW
2444, Australia

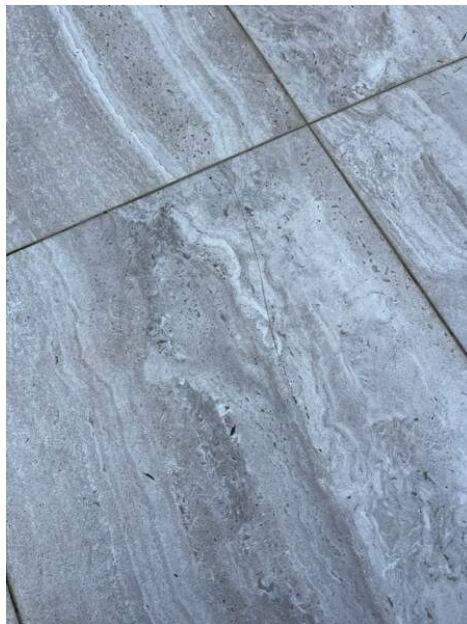
Comments : Cracked tile
Defect Significance: minor
Defect Type: Damaged

Photo Ref #7: There is a cracked tile on the front entrance floor

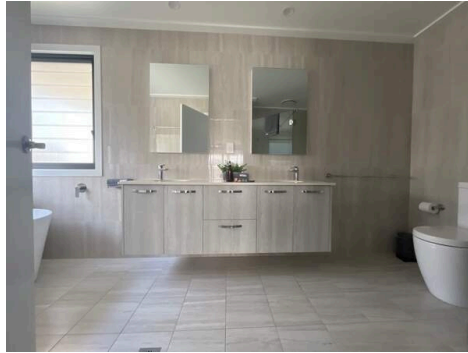
Photo Ref #10

Comments :	Ponding water on shower floor Cracked shower floor tile
Defect Significance:	Minor
Defect Type:	D (Material Deterioration: rusting, rotting, corrosion, decay)

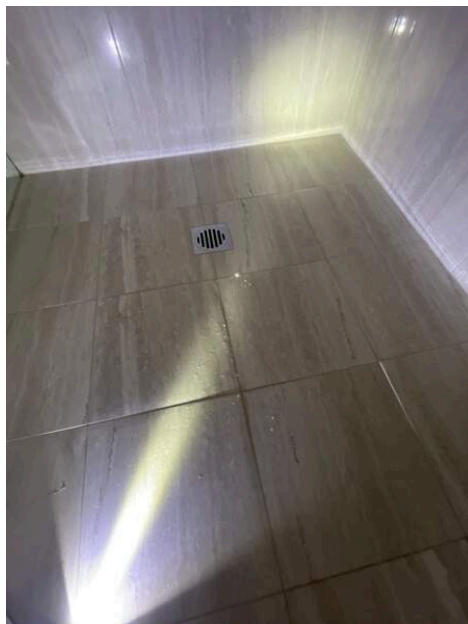
Photo Ref #11: There is minimal fall to the shower floor waste subsequently allowing ponding water

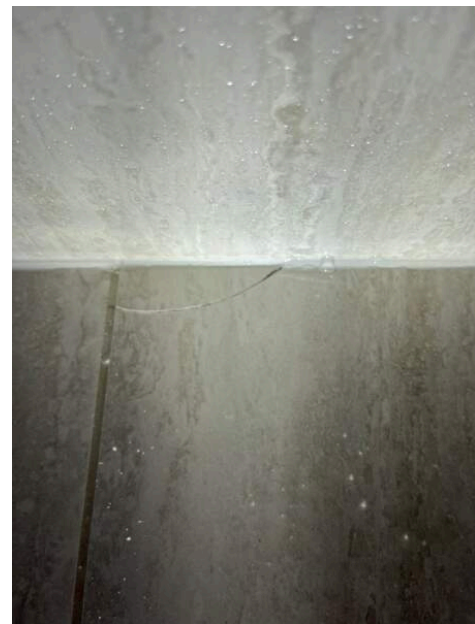
Photo Ref #12: There is a cracked tile on the shower floor. This should be repaired/renewed to prevent possible moisture ingress into the substrate.

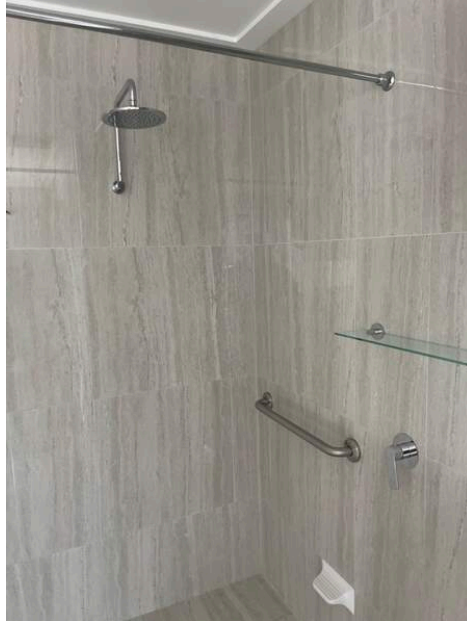
Comments : Moderate water hammer to shower tap
Extensive water hammer to bath tap

Photo Ref #13: There is moderate water hammering to the ensuite taps. This will require a licensed plumber to inspect and assess.

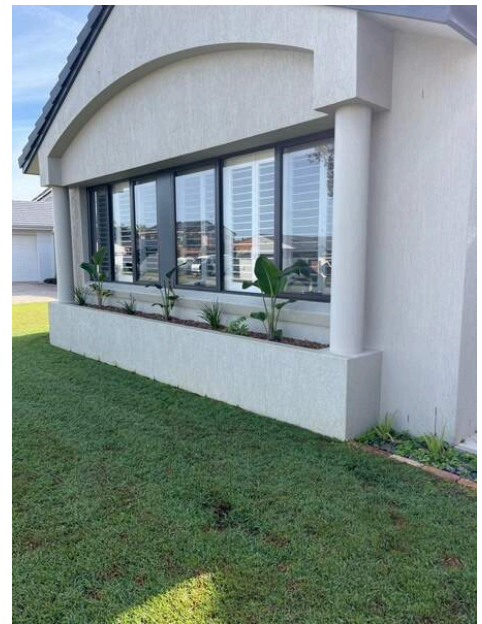
Photo Ref #19: The external garden bed level is higher than the bedroom four internal floor level suggesting possible lateral dampness

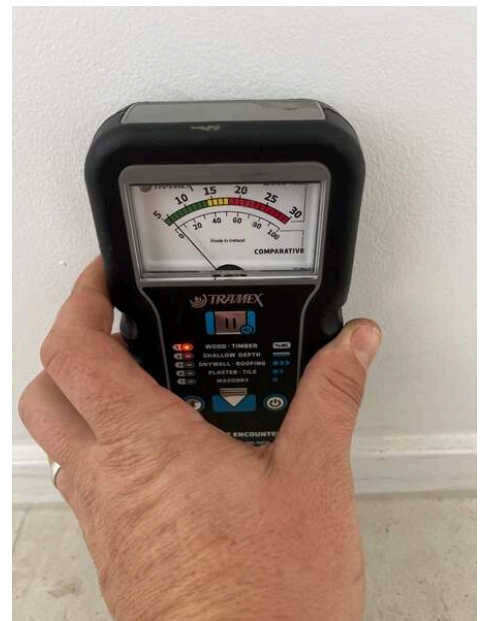
Photo Ref #22: Moisture levels taken on the day of inspection to the wall common to the shower were normal to this region

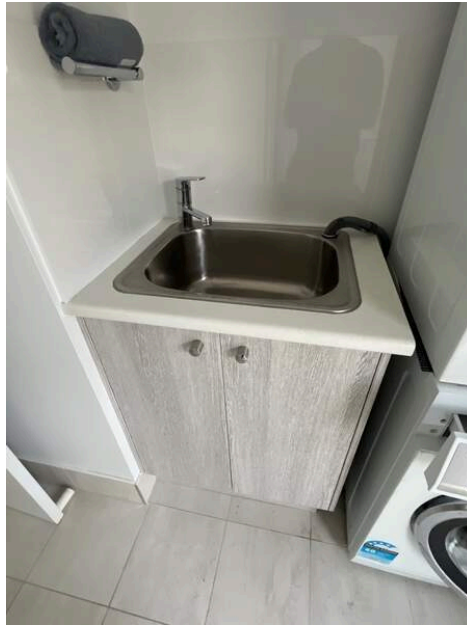
Comments : Moderate water hammer
Defect Significance: Minor
Defect Type: D (Material Deterioration: rusting, rotting, corrosion, decay)

Photo Ref #25: There is moderate water hammering to the laundry tap. This will require a licensed plumber to inspect and assess

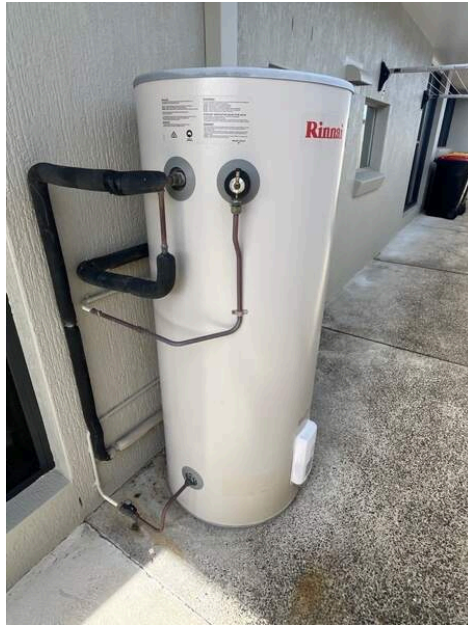
Photo Ref #26: The hot water system is an electric hot water unit. There were no visible defects to the hot water system on the day of inspection

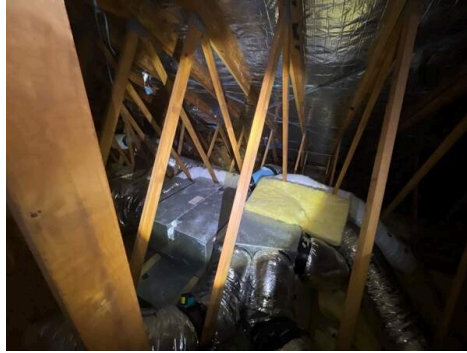
Photo Ref #29

Comments : Trusses loaded with clutter
Defect Significance: Minor
Defect Type: Deterioration

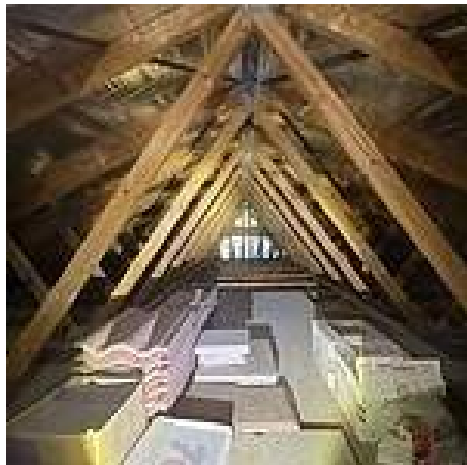
Photo Ref #30: The roof trusses have been incorrectly loaded for storage. Trusses should not be loaded on the webbing and bottom cords.

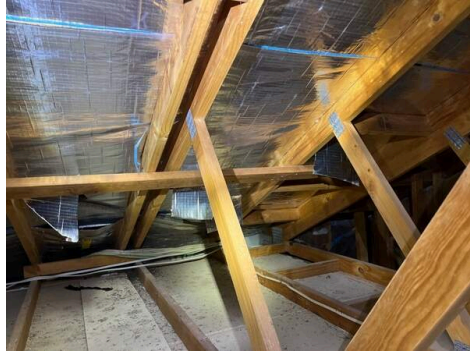
Comments : Deterioration to areas of the roof sarking
Defect Significance: Minor
Defect Type: D (Material Deterioration: rusting, rotting, corrosion, decay)

Photo Ref #31: The sarking is torn in several areas. The affected areas should be repaired to prevent possible moisture ingress.

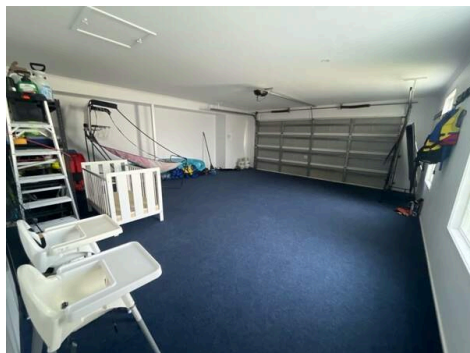
Photo Ref #34

Comments : Cracking and sagging to ceiling lining at sets
Defect Significance: Minor
Defect Type: D (Material Deterioration: rusting, rotting, corrosion, decay)

Photo Ref #35: There is moderate cracking and ceiling separation in the garage ceiling. This should be monitored for further deterioration and repaired as necessary

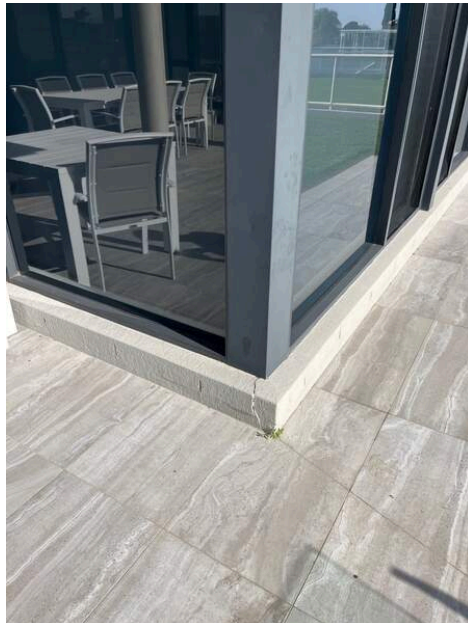
Comments : Cracking through sill at back of lounge room
Defect Significance: Minor
Defect Type: D (Material Deterioration: rusting, rotting, corrosion, decay)

Photo Ref #37: There is moderate cracking on the lounge room rear windowsill. This should be repaired to prevent moisture ingress into the surrounding areas

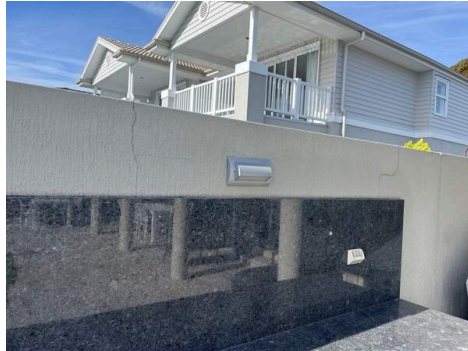
Comments : Cracking to eastern block fence at the rear of the property
Defect Significance: Minor
Defect Type: D (Material Deterioration: rusting, rotting, corrosion, decay)

Photo Ref #39: There is moderate cracking to the rear rendered block fence. This should be monitored for further deterioration and repaired as necessary

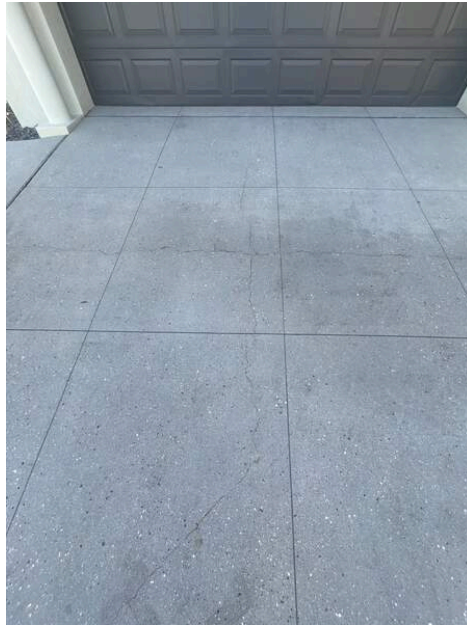
Comments : Cracking to driveway
Defect Significance: Minor
Defect Type: D (Material Deterioration: rusting, rotting, corrosion, decay)

Photo Ref #41: There is moderate cracking to the concrete driveway. This should be monitored for further cracking

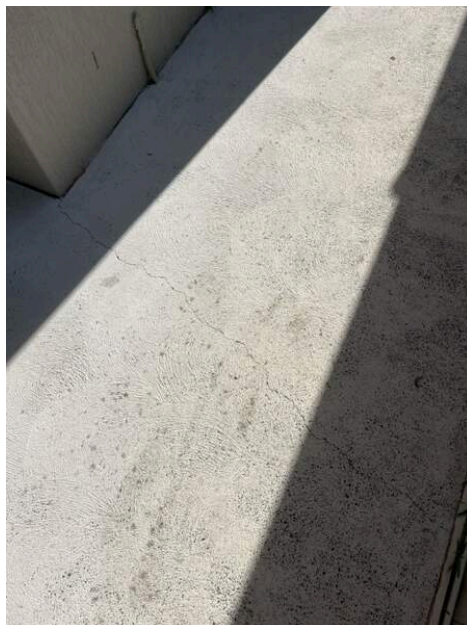
Comments : Cracking to concrete on the eastern side of the home
Defect Significance: Minor
Defect Type: D (Material Deterioration: rusting, rotting, corrosion, decay)

Photo Ref #42: There is moderate cracking to the eastern concrete path.

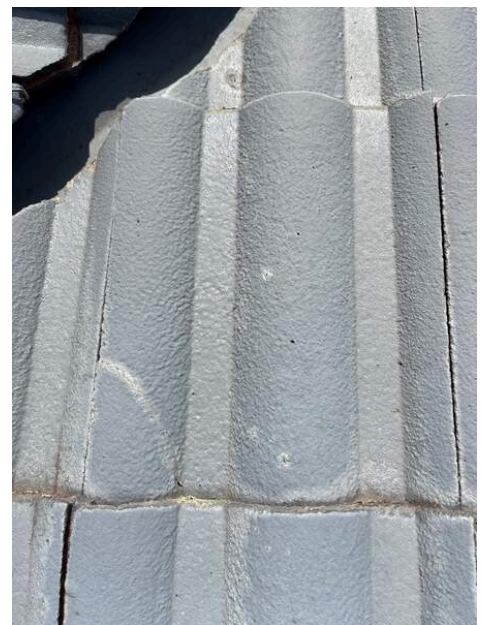
Photo Ref #47: There are several repaired cracked tiles to the roof exterior. This should be monitored as silicon will deteriorate

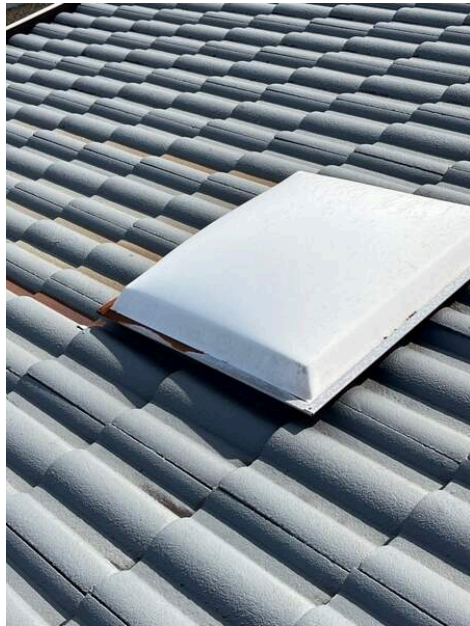
Photo Ref #52: There is moderate corrosion to the skylight structure

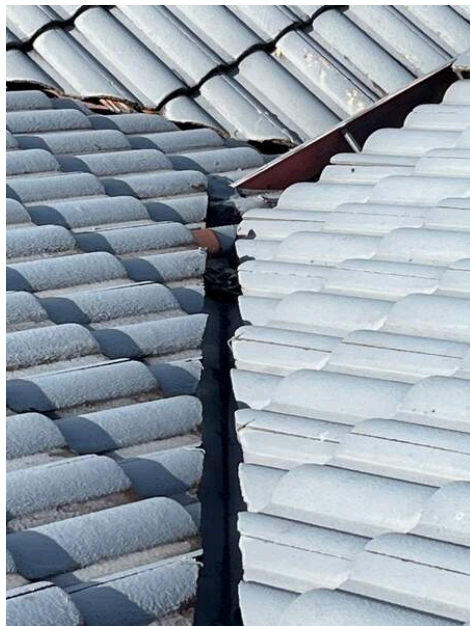
Comments : Valley tiles out of alignment
Defect Significance: Minor
Defect Type: D (Material Deterioration: rusting, rotting, corrosion, decay)

Photo Ref #54: There are several valley tiles that have moved out of alignment. This should be re-aligned to prevent possible blockage and/or

moisture ingress.
