Pre-Purchase Inspection - Residential Building Report

Complies with Australian Standard AS 4349.1- 2007 Inspection of Buildings Part 1: Pre-Purchase inspections - Residential buildings

42 Hassall Street

42 Hassall Street
Port Macquarie NSW

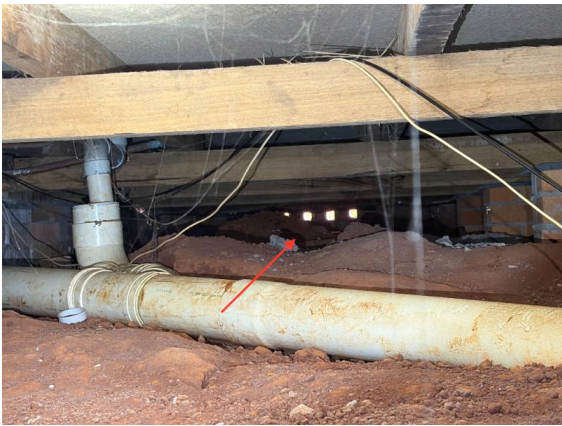
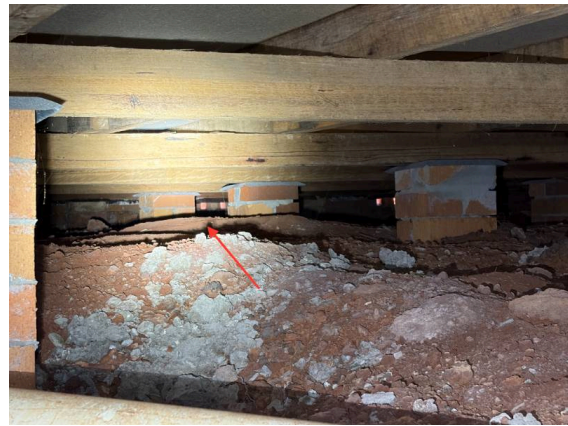
Access Issue 1. - Subfloor

Due to limited crawl space in the western side access was restricted.

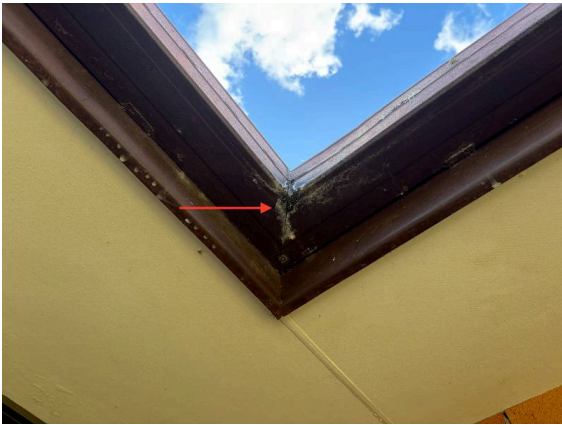
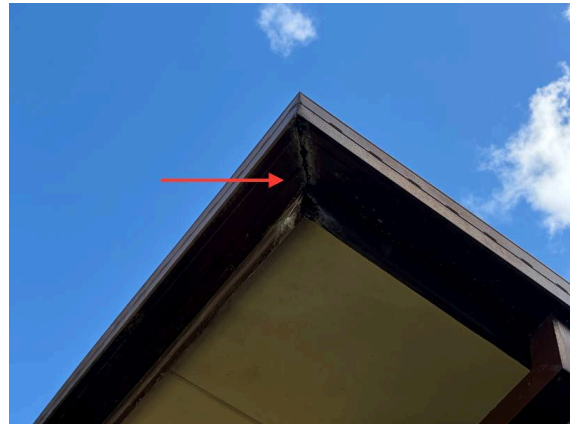
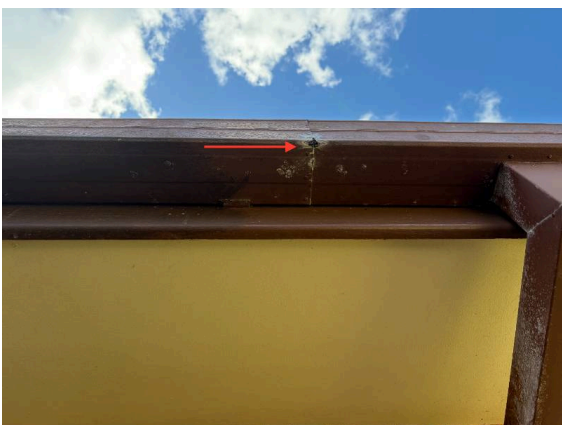
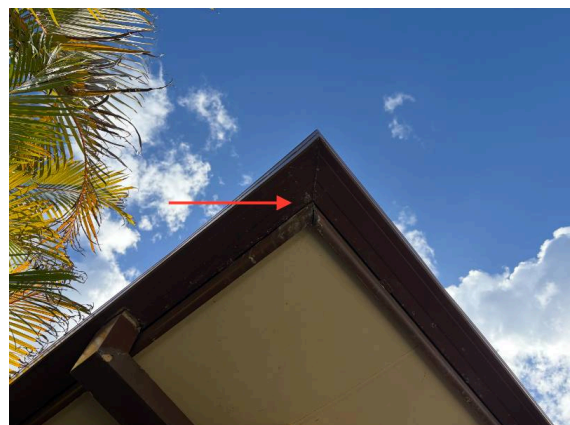
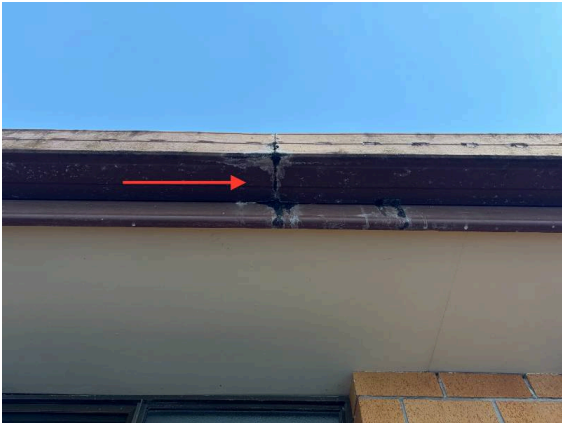
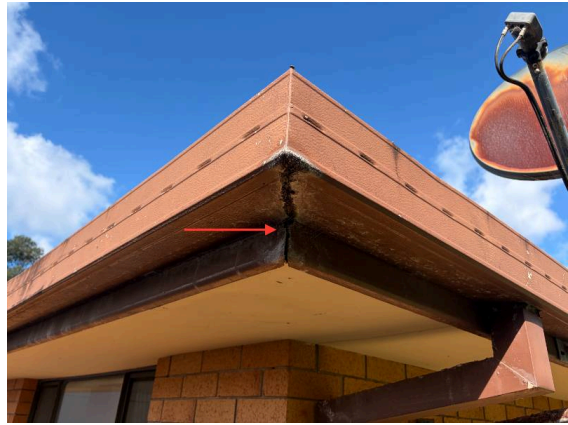
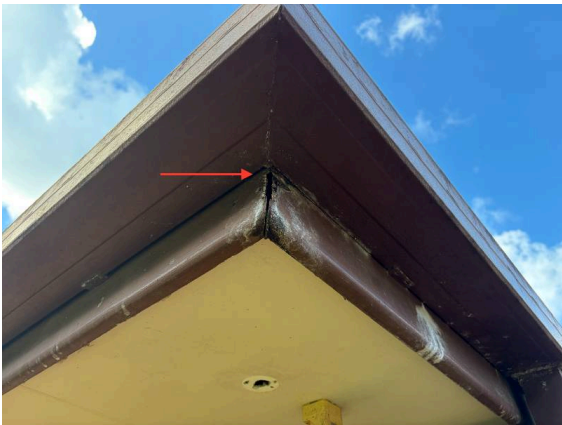
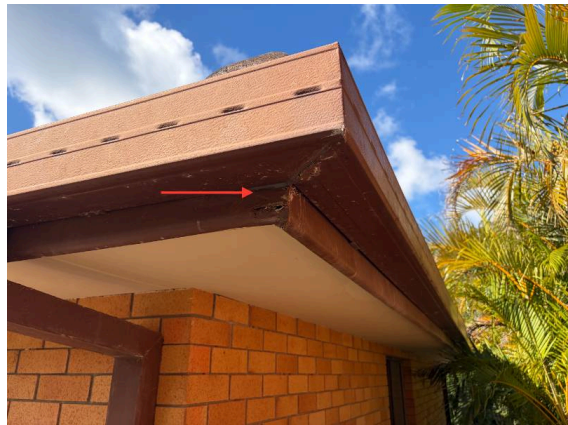
Defect 1. - Roof Exterior

Joins in gutter are leaking and causing timber fascia below to decay

Continue to leak causing further water damage to fascia

Areas where gutters leak damaging fascia

Building Professional Required: Carpenter

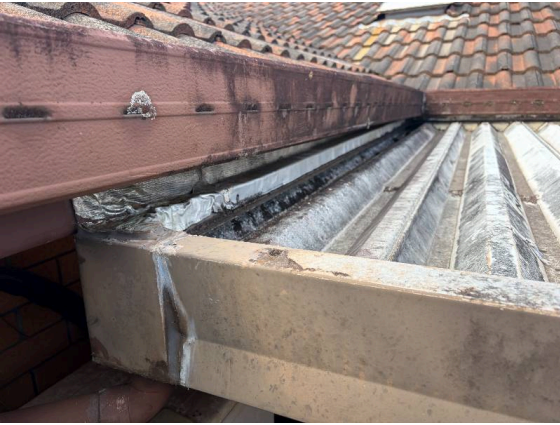
Skillion patio roof has been installed under the house gutter and is susceptible of leaking. Parts of the patio roof are rusting.

Patio skillion roof has been installed under house gutter.

Building Professional Required: Builder, Roof Plumber

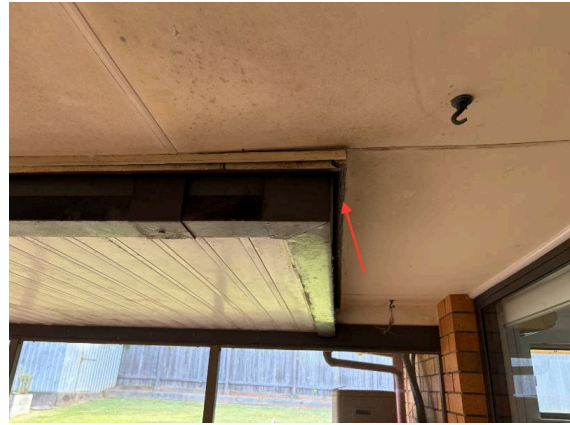
Areas where patio is susceptible of leaking.

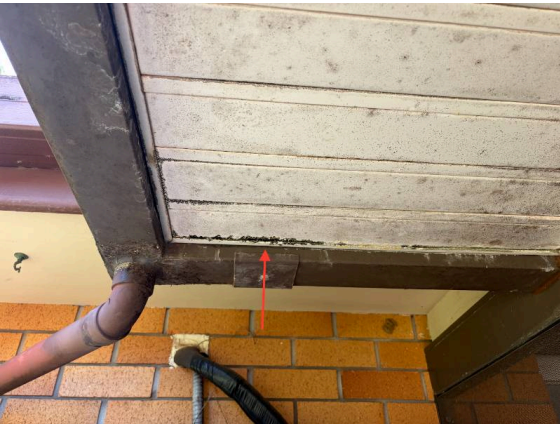
Area of leaks.

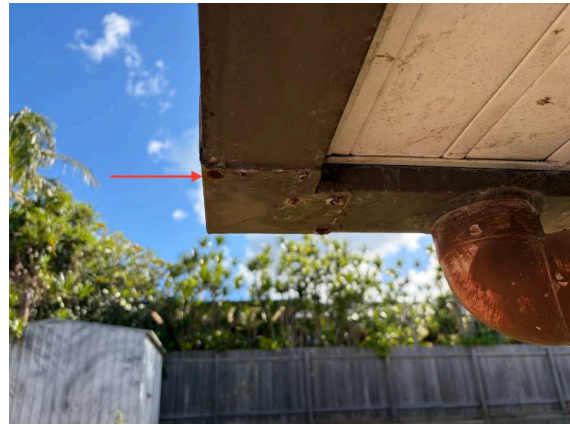
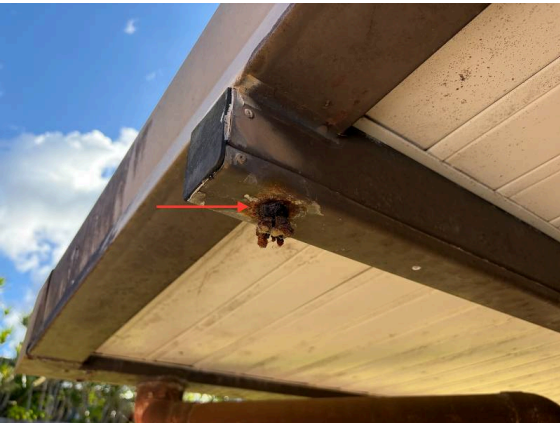
Areas of rust

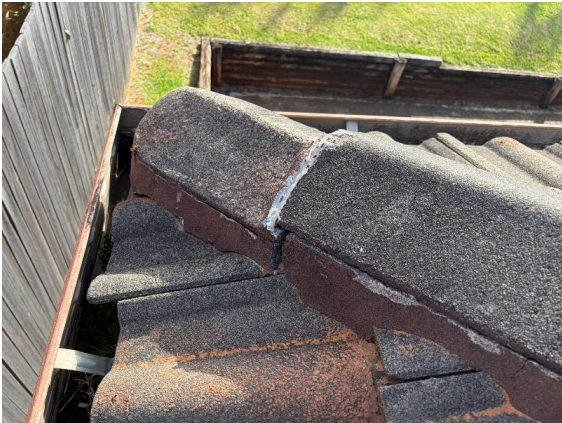
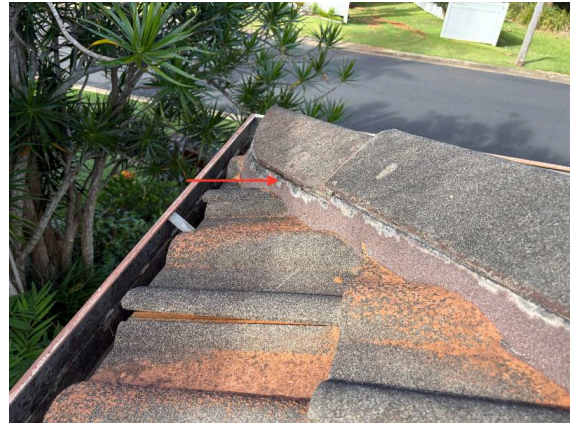
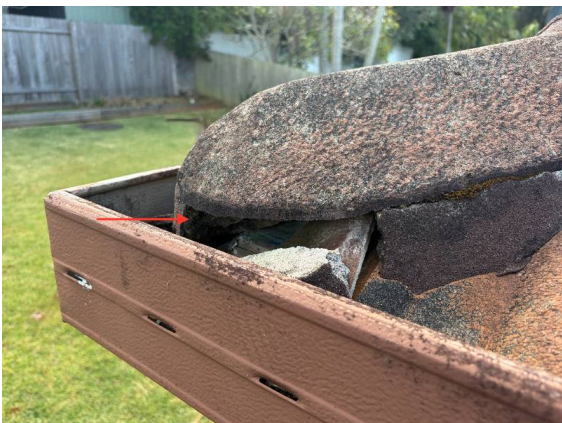
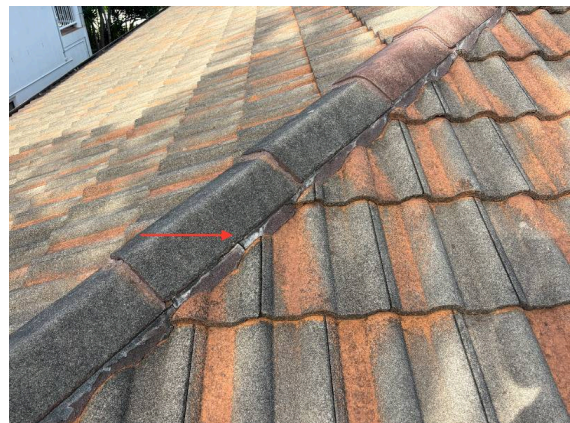
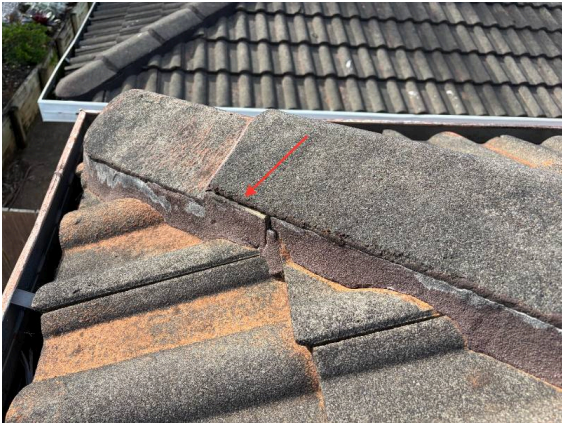
Defect 3. - Roof Exterior

Sand and cement bedding on hip and ridge tiles has cracked and parts have fallen out of position.

Tiles will loosen and slip out of position.

Sand and cement bedding has cracked and parts have fallen out of position.

Building Professional Required: Roof Tiler

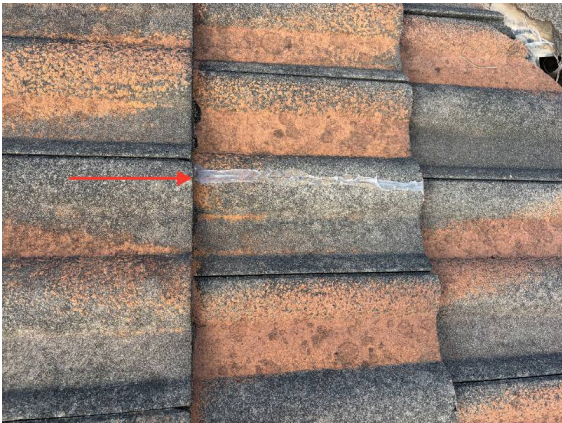
Defect 4. - Roof Exterior

There is one cracked/broken roof tile.

Cracked/broken roof tile.

Building Professional Required: Roof Tiler

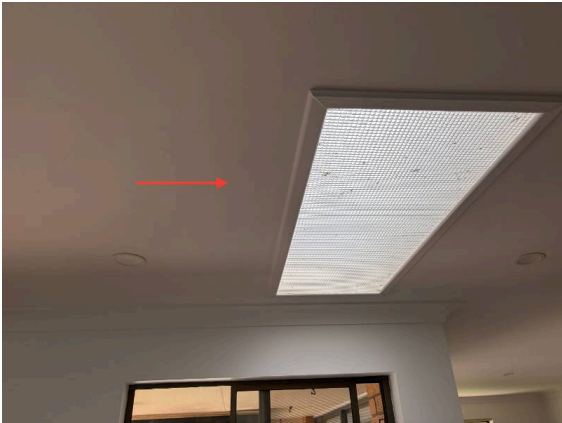
Skylight above kitchen leaks and skylight above bathroom is rusting.

Area where skylight leaks onto the ceiling

Building Professional Required: Carpenter, Roof Tiler

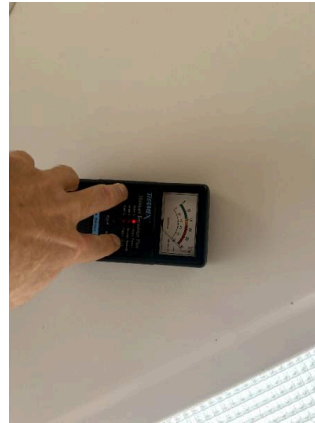
Tramex moisture meter recording high moisture readings to the plaster board ceiling.

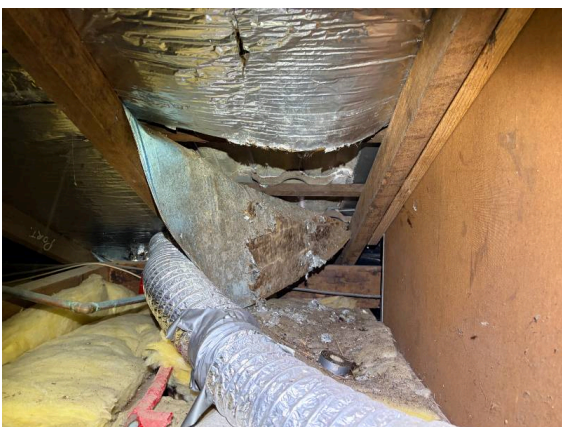
As seen from the roof void, area where water leaks from sarking out of place.

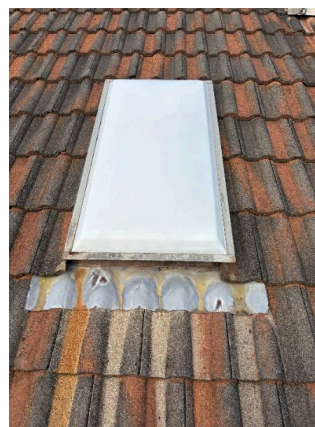
Skylight that leaks

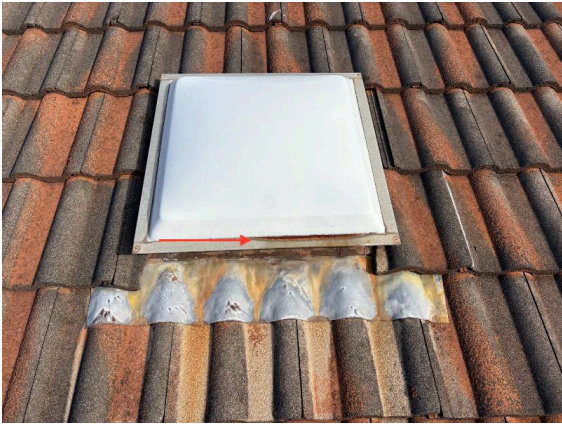
Rusting skylight.

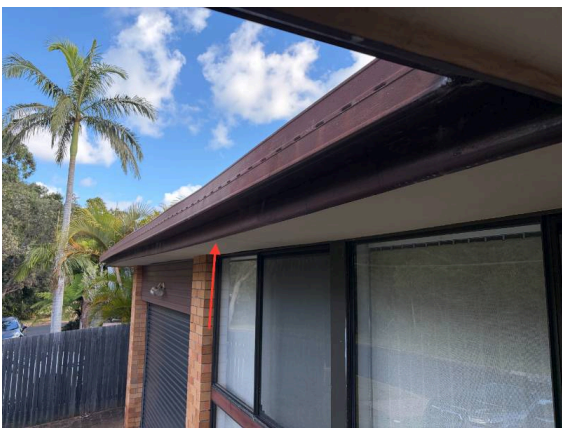
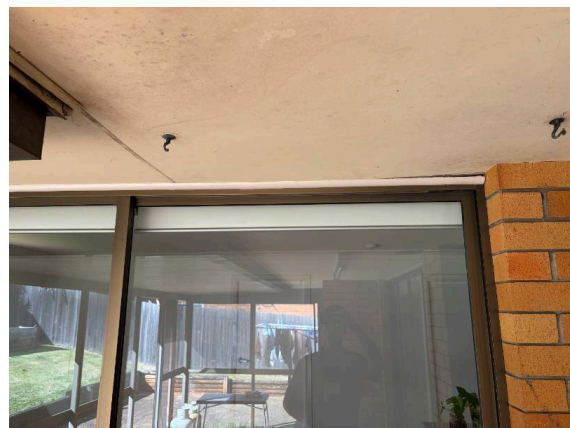
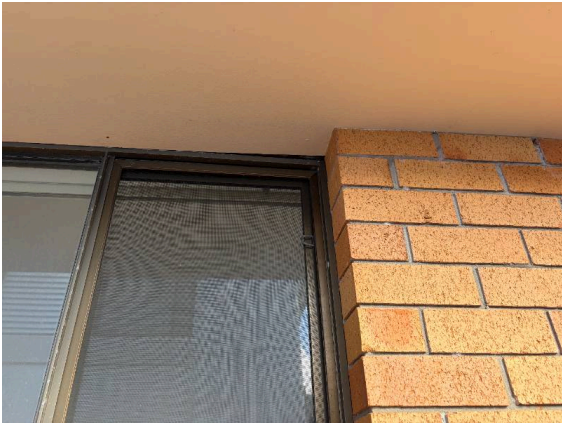
Defect 6. - Roof Exterior

Roof frame bows over window openings.

Cause fascia and gutter to move out of position and eaves to bow over windows.

Areas where roof has bowed over window openings.

Building Professional Required: Builder

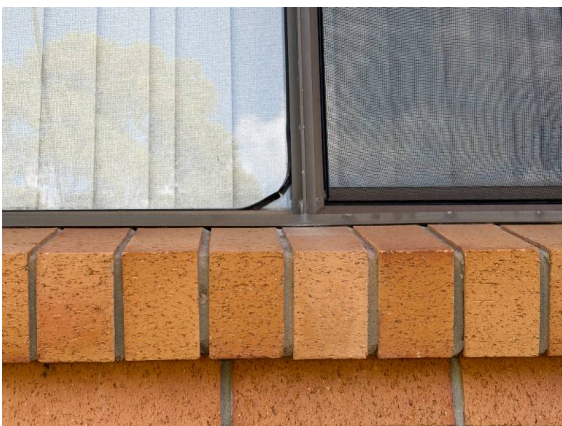
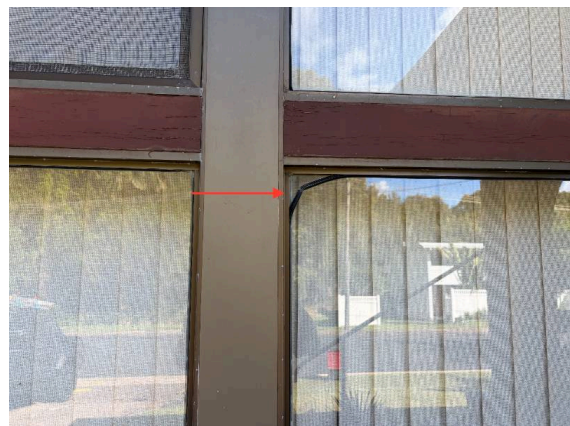
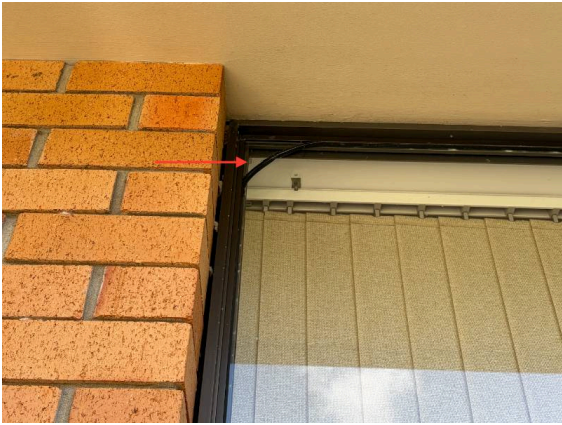
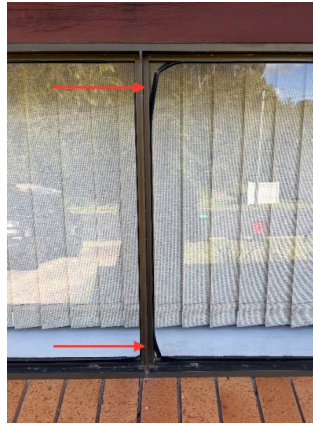
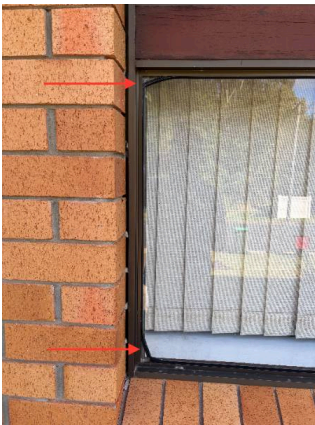
Defect 7. - Exterior

Rubber glazing seals have deteriorated.

Further deterioration of rubber seals could allow water ingress and cause glass pane to loosen.

Rubber glazing seals are deteriorating.

Building Professional Required: Glazier

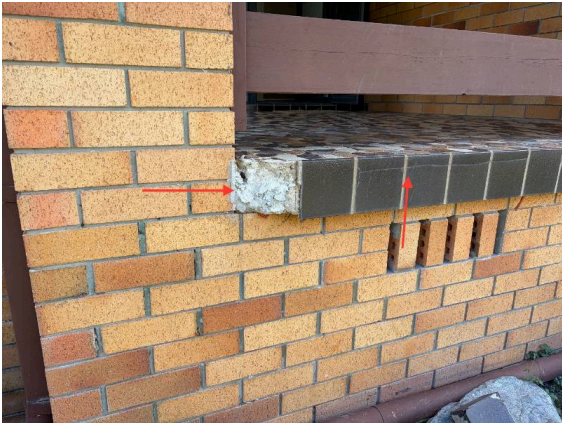
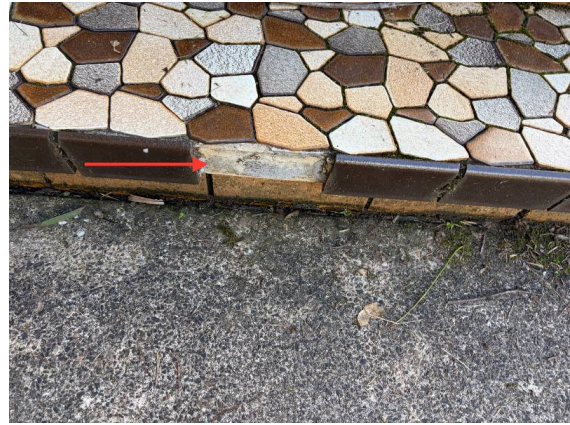
Defect 8. - Exterior

| Description: | Some of the tiles on the front porch have fallen out of position and some have cracked. |
| Ongoing Consequence: | Cracked tiles may loosen overtime and also fall out of position. |

| | Building Professional Required: Tiler |

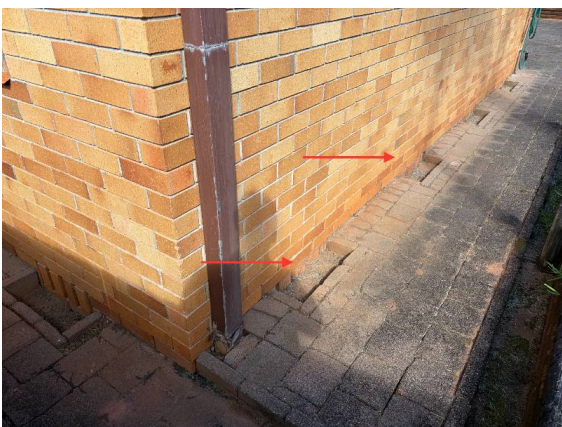
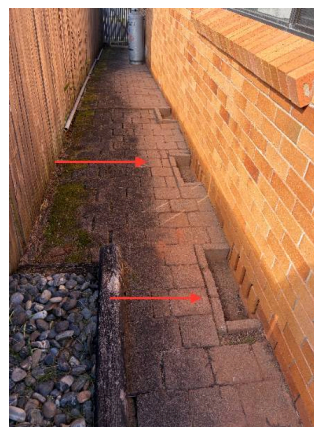
Pavers next to the house could allow surface water to fall into the subfloor brick ventilation holes. Pavers on the north western side have moved and are uneven.

Excessive water in the subfloor could cause damage to piers and footings. Uneven pavers could be a tripping hazard.

Area where surface water could fall into subfloor brick vent holes.

Building Professional Required: Plumber
Landscaper.

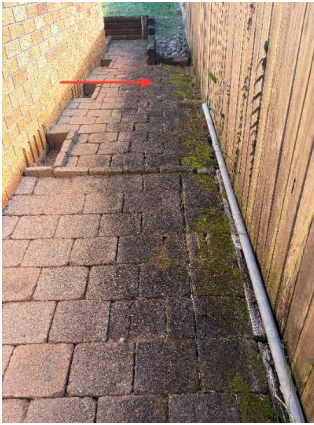
Area where pavers have moved.

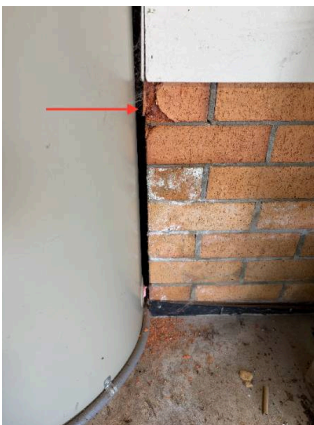
Defect 10. - Interior

| Description: | Brick next to hotwater system has spalling. |

| | Building Professional Required: Bricklayer |

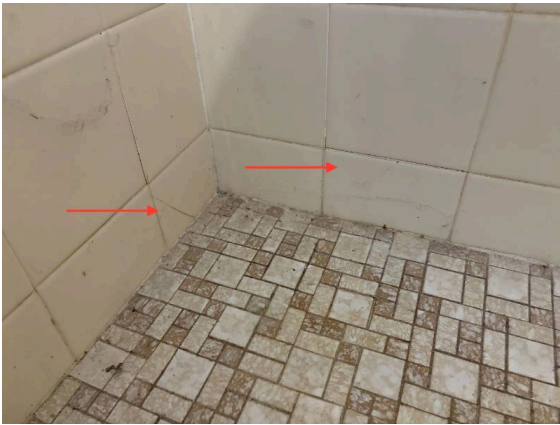
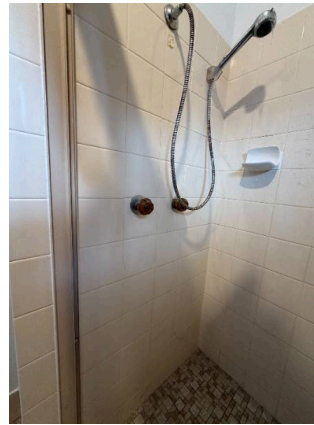
Defect 11. - Interior

Wall tiles in laundry shower are loose and some have cracked.

Tiles may continue to loosen and allow water into substrate

Cracked and loose wall tiles.

Building Professional Required: Tiler
Waterproofing specialist.

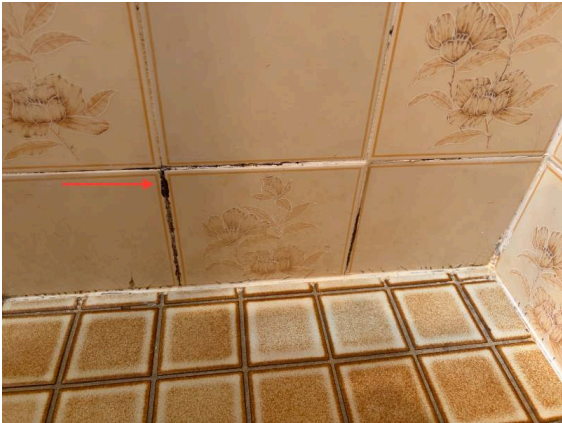
Some wall tiles in the shower are loose and shower leaks into linen cupboard wall and flooring below shower.

Loose wall tiles

Building Professional Required: Builder

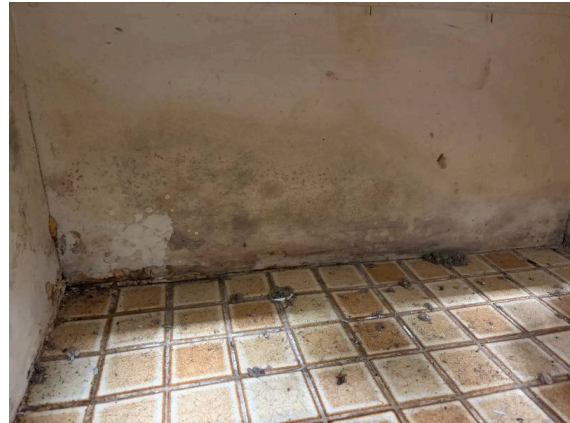
Water ingress into linen cupboard wall.

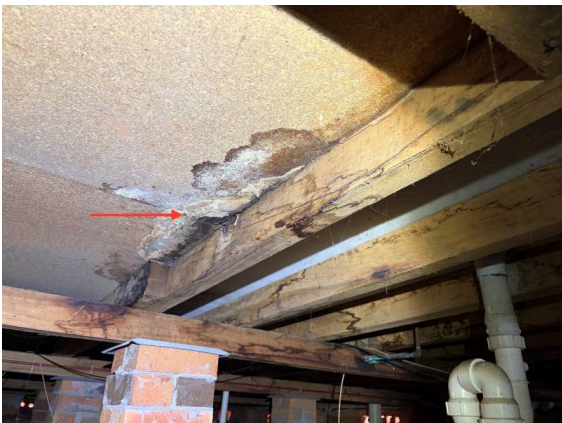
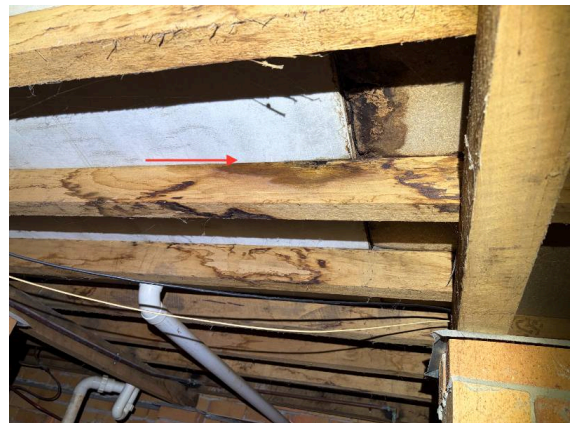
Leaking showers will cause major water damage to flooring, walls and surrounding elements.

Water leaking onto flooring below shower.

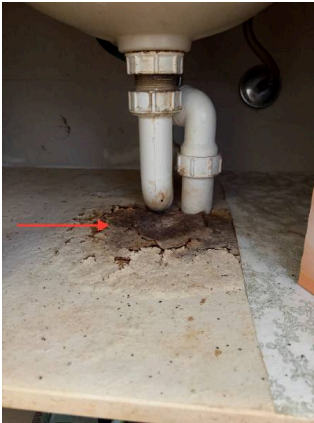
| Description: | Previous leak has caused water damage to shelving below the vanity sink. |

Water damaged shelving

| | Building Professional Required: Joiner |

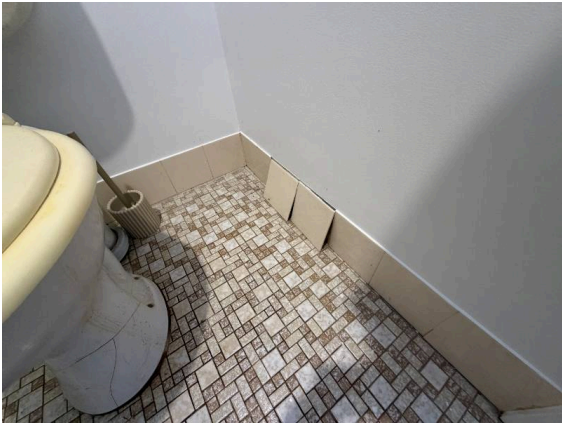
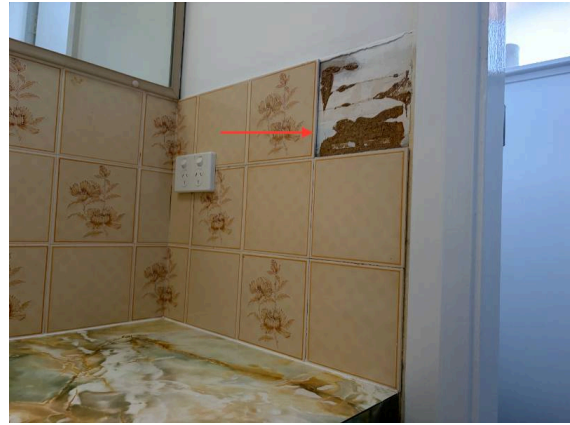
Defect 14. - Interior

| Description: | Some tiles are loose and falling out of position. |
| Ongoing Consequence: | Tiles may continue to loosen and fall out of position |

| | Building Professional Required: Tiler |

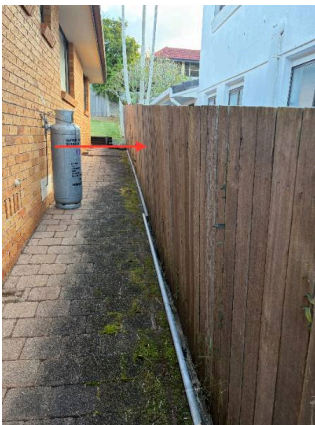
Timber fence is loose

Timber fence is loose.

Building Professional Required: Fencer

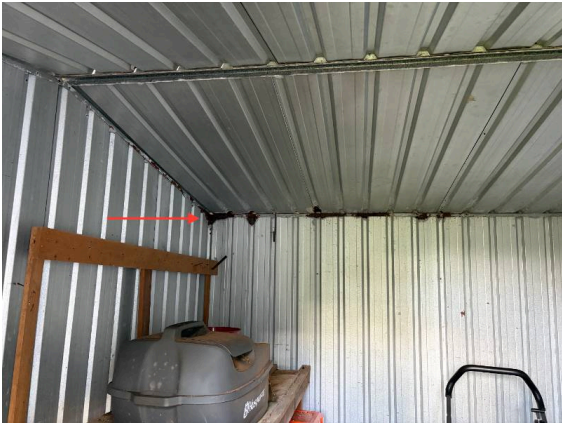
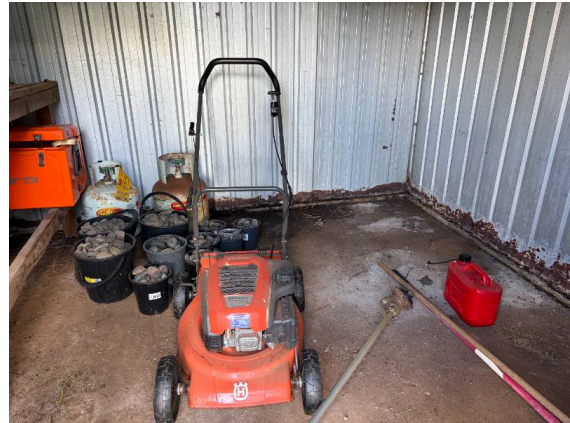
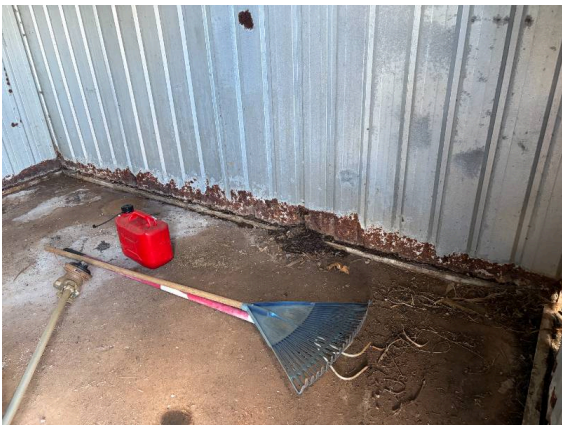
Site Defect 2. - Sheds

Garden shed walls and roof are rusting

Continue to rust and deteriorate

Building Professional Required: Builder
