## BUILDING REPORT

442 Orange Grove Rd  
Blackwall, NSW 2256

Peter McFadyen  
12/03/2026

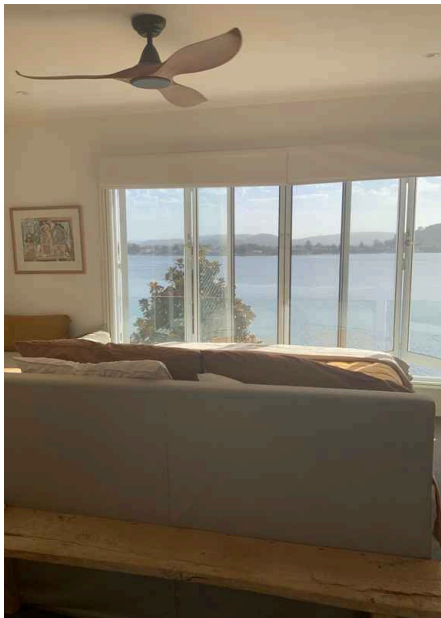
#### Bedroom 1 image

**Door(s) Condition: In serviceable condition at the time of inspection**

**Window(s) Condition: In serviceable condition at the time of inspection**

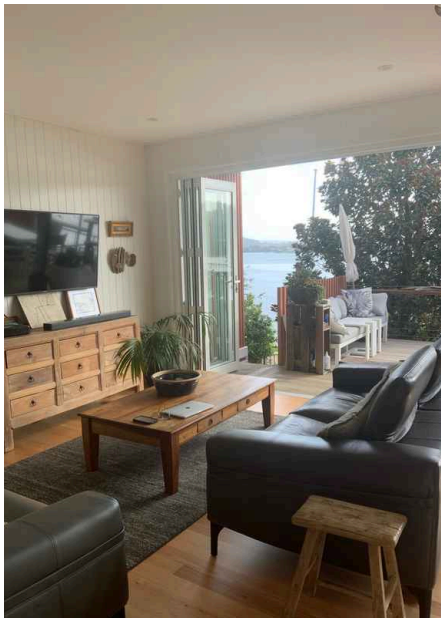
#### Lounge room image(s)

**Door(s) Condition: In serviceable condition at the time of inspection**

**Wall Condition: In serviceable condition at time of inspection**

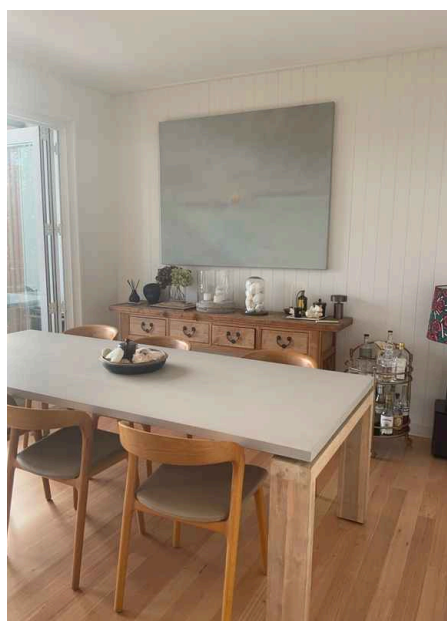
### Dining room image(s)

**Door(s) Condition:** In serviceable condition at the time of inspection

**Window(s) Condition:** In serviceable condition at time of inspection

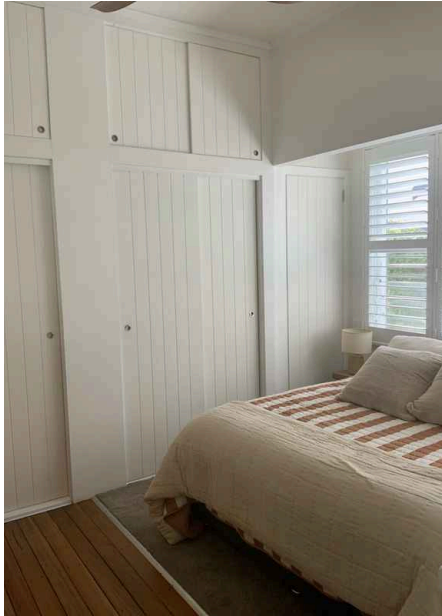
### Bedroom 2 image

**Door(s) Condition:** In serviceable condition at the time of inspection

**Window(s) Condition:** In serviceable condition at the time of inspection

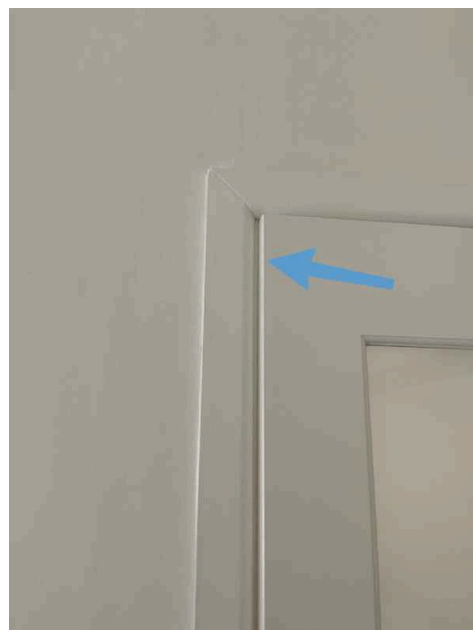
### 8.1.1 Door(s) Condition

The door requires trimming or adjustment to function properly.

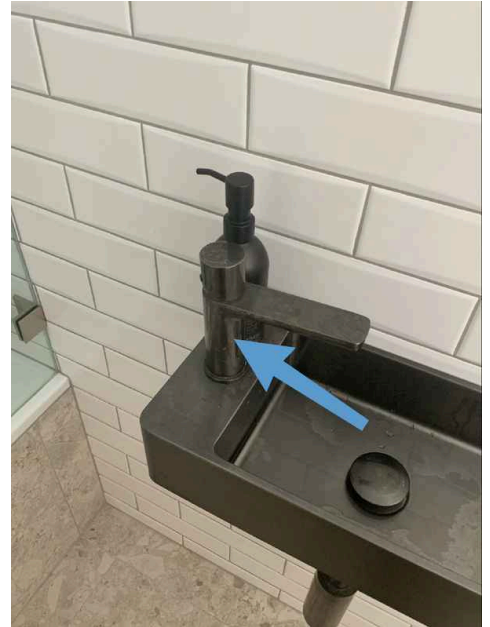
**TAP IS LOOSE**

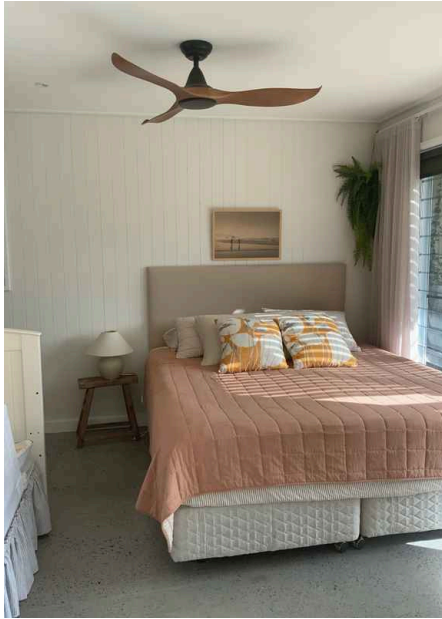
**Bedroom 3 image**

**Window(s) Condition: In serviceable condition at the time of inspection**

**Window(s) Condition: Window(s) Type**  
Aluminium Window Frame/s,  
Flyscren fitted

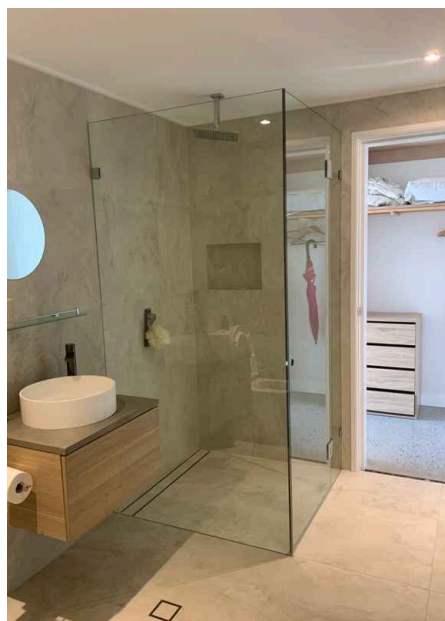
### Ensuite General View

**Door(s) : In serviceable condition at the time of inspection**

**Walls : In serviceable condition at the time of inspection**

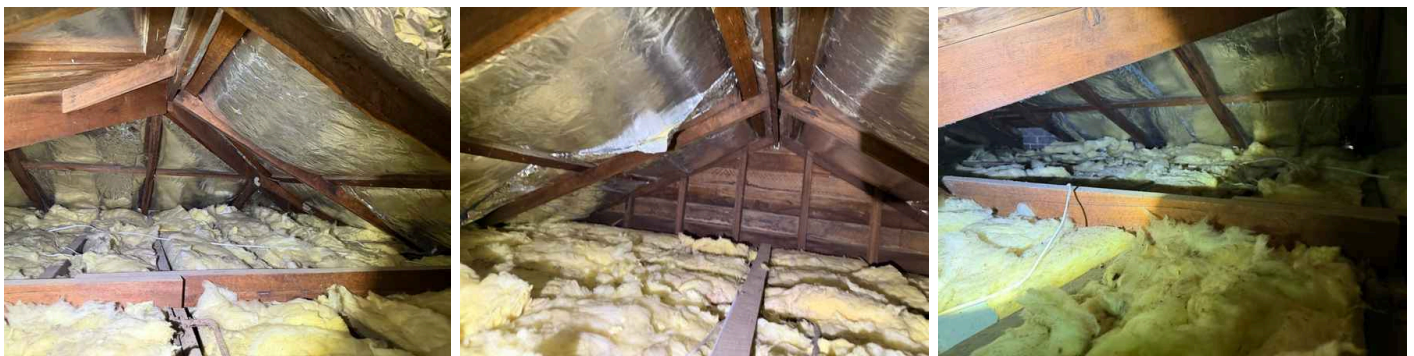
### Roof Void Images

### Framing : Framing condition to accessible frame appeared to be serviceable

The visibly accessible framing components were found to be in good condition at the time of inspection, consistent with the age and type of construction. This assessment does not guarantee that all sizing and fixings comply with current building codes. It is essential to note that roof voids often contain hidden or inaccessible areas where defects may be present. Due to factors such as varying heights, mechanical services, insulation, and other obstructions, not all components could be inspected. These excluded areas and components are not covered in this report.

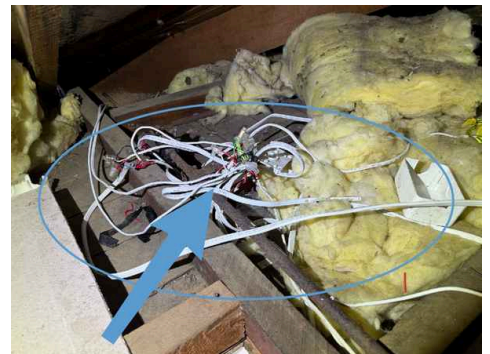
Exposed wiring connection observed. This is a safety concern. Recommend review all electrical connections and installing proper junction boxes as needed by a licensed electrician.

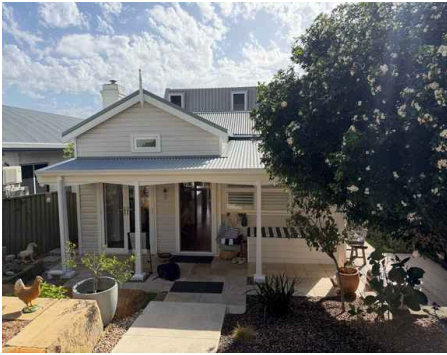
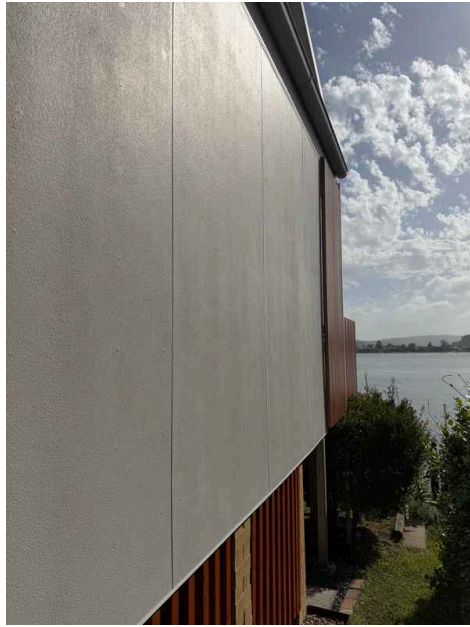
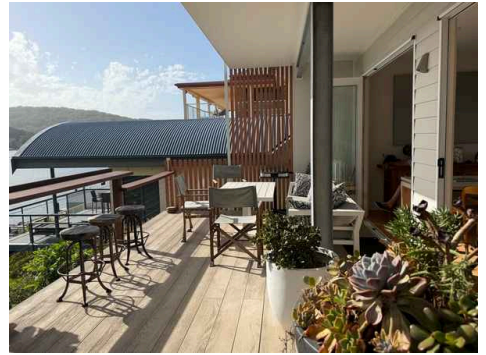
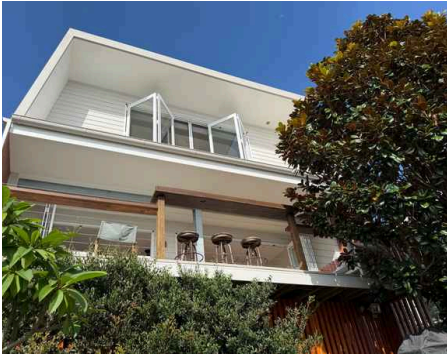
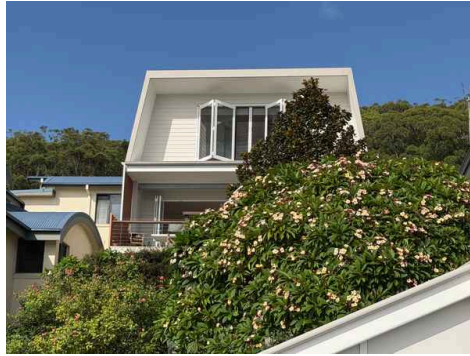
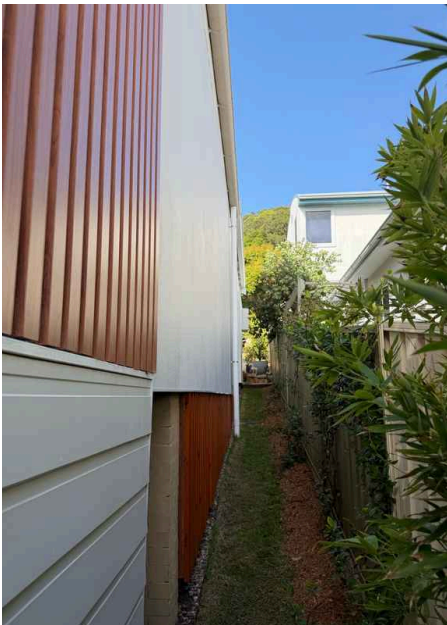
### Exterior Images

**Walls: The inspected external walls was determined to be in a serviceable condition relative to age**

The external walls are consistent with the age and type of construction. A thorough annual inspection is highly recommended to ensure ongoing maintenance and address any potential issues.
