Pre-Purchase Inspection - Residential Building Report

Complies with Australian Standard AS 4349.1- 2007 Inspection of Buildings Part 1: Pre-Purchase inspections - Residential buildings

55 Kooronga Ave Orange

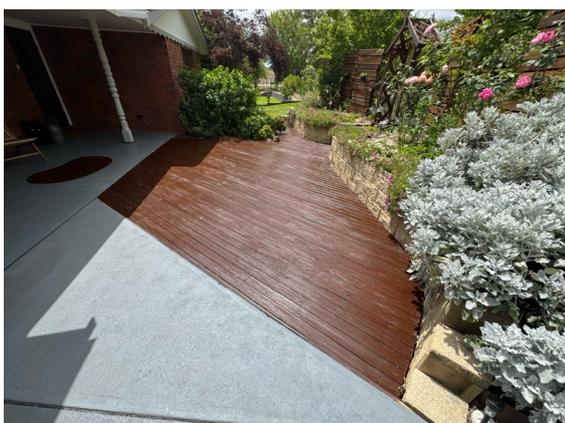
Access Issue 1. - Subfloor

Enclosed Foundation Area, Height

The subfloor of the deck could not be inspected.

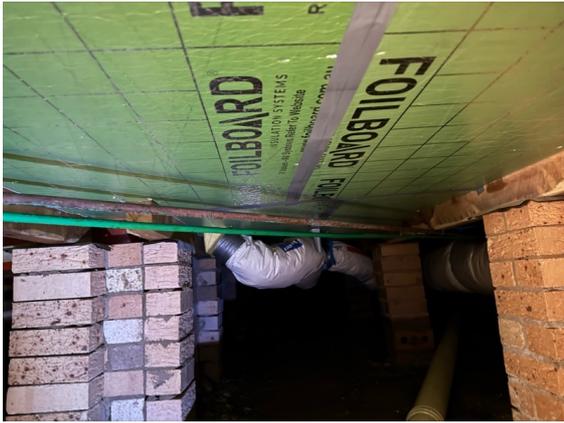
Access Issue 2. - Subfloor

Insulation to Underside of Flooring

Areas of the floor framing and flooring could not be inspected

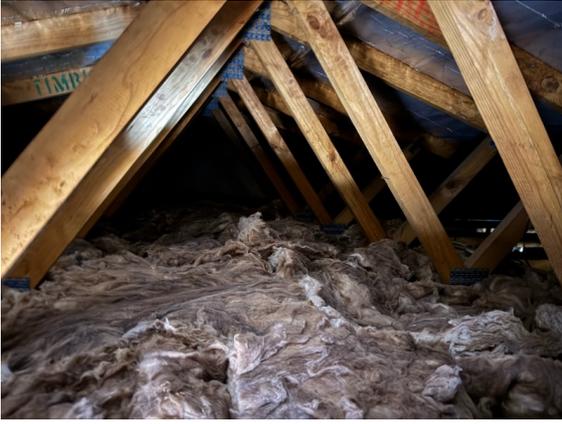
Access Issue 4. - Roof Void

Insulation

The bottom chords of the trusses could not be inspected as they were covered with insulation.

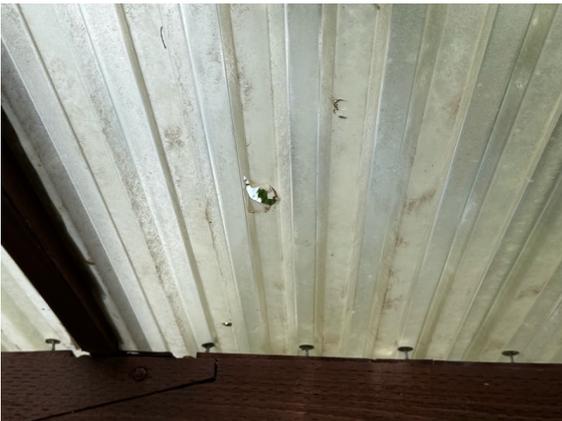
Defect 1. - Roof Exterior

The roof sheeting is damaged

Water ingress to Roof Void

The damaged roof sheeting.

Building Professional Required: Roof Plumber

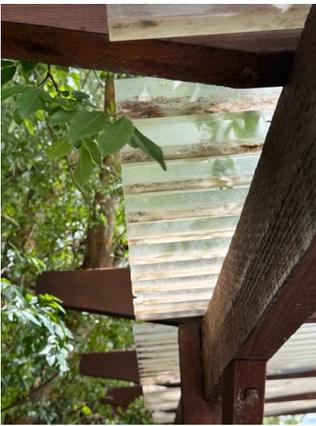
Defect 2. - Roof Exterior

Defect Location:	South Side
Defect Summary:	Guttering
Type of Defect:	Installation
Description:	There is no gutter installed.
Ongoing Consequence:	Excessive ground moisture in the area.
Opinion of Cracking:	Not Applicable
Building Professional:	Note: This defect should be referred to a qualified building professional for the repairs/scope of work required.
	Building Professional Required: Plumber

Missing gutter.

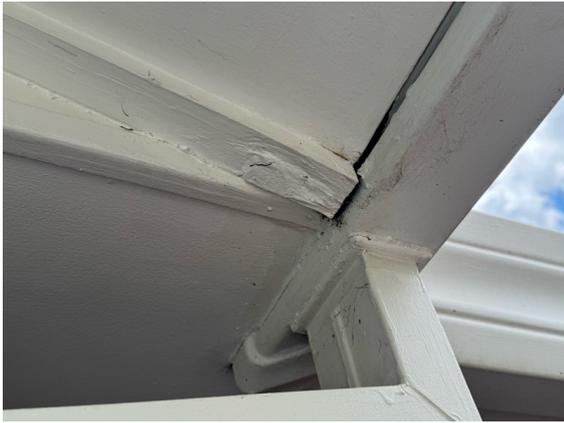
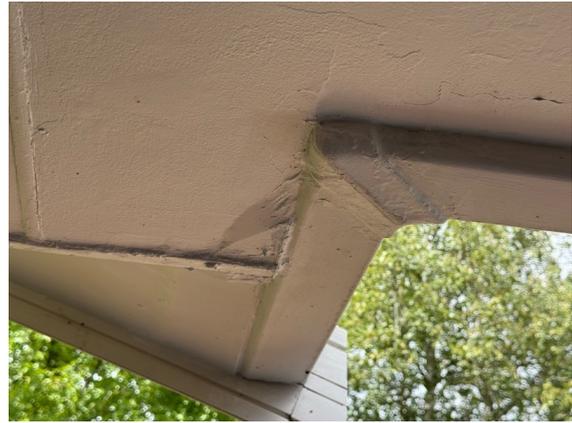
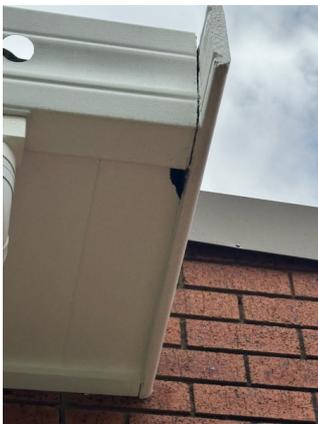
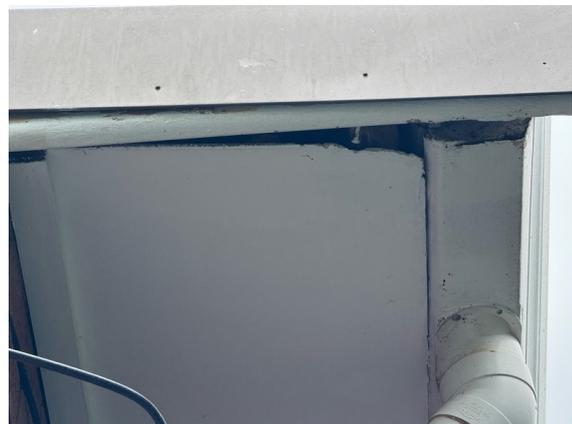
Defect 3. - Roof Exterior

Defect Location:	Various Areas
Defect Summary:	Eaves Fascia and Barges
Type of Defect:	Material deterioration
Description:	The eave sheeting and eave trim is damaged and deteriorating
Ongoing Consequence:	Damage to surrounding elements
Opinion of Cracking:	Not Applicable
Building Professional:	Note: This defect should be referred to a qualified building professional for the repairs/scope of work required.
	Building Professional Required: Carpenter, Painter

Water damaged eave trim

Patched and damaged eave sheeting

Damaged eave sheeting.

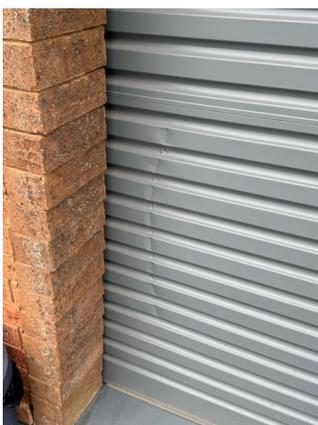
Defect 5. - Exterior

The face of the door is dented

The dented door

Building Professional Required: Garage door technician

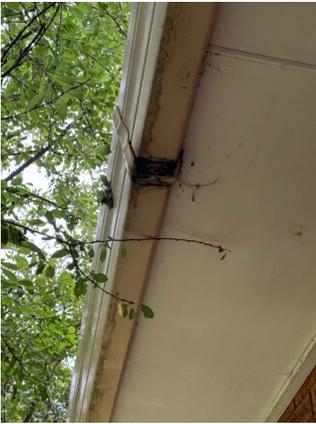
Defect 6. - Roof Exterior

Defect Location:	North Side
Defect Summary:	Guttering
Type of Defect:	Material deterioration
Description:	The gutter is leaking
Ongoing Consequence:	Damage to surrounding elements
Opinion of Cracking:	Not Applicable
Building Professional:	Note: This defect should be referred to a qualified building professional for the repairs/scope of work required.
	Building Professional Required: Plumber

The gutter is leaking and needs a re-seal.

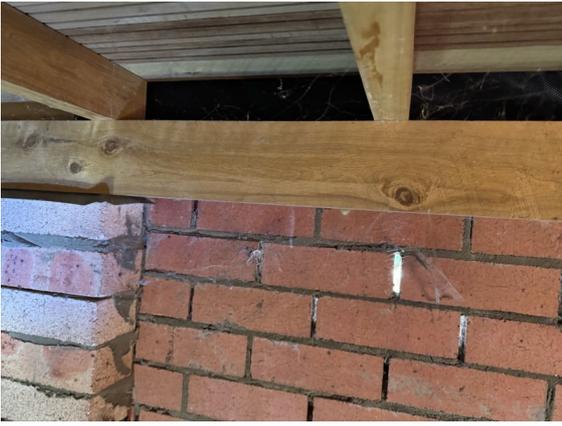
Defect 7. - Subfloor

Defect Location:	Various areas.
Defect Summary:	Ant Shielding
Type of Defect:	Installation
Description:	Inadequate
Ongoing Consequence:	Increase risk of undetected termite entry
Opinion of Cracking:	Not Applicable
Building Professional:	Note: This defect should be referred to a qualified building professional for the repairs/scope of work required.
	Building Professional Required: Timber Pest Inspector

Missing termite shields in the subfloor. This is typical to the era of the construction, They were not required.

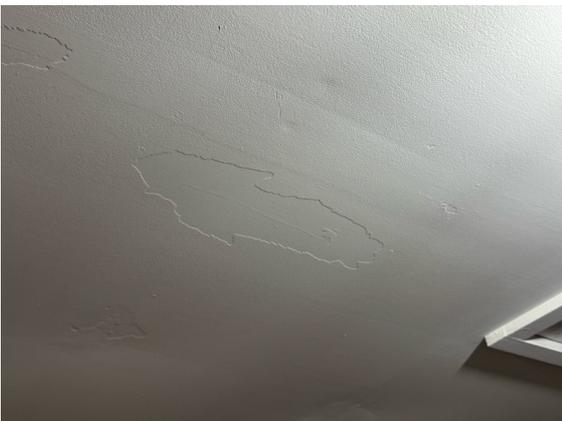
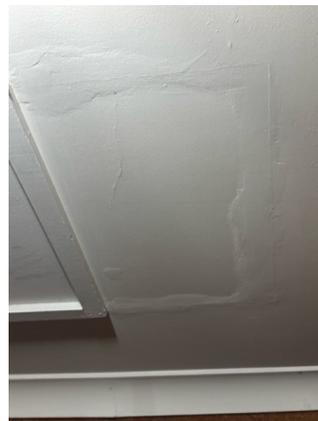
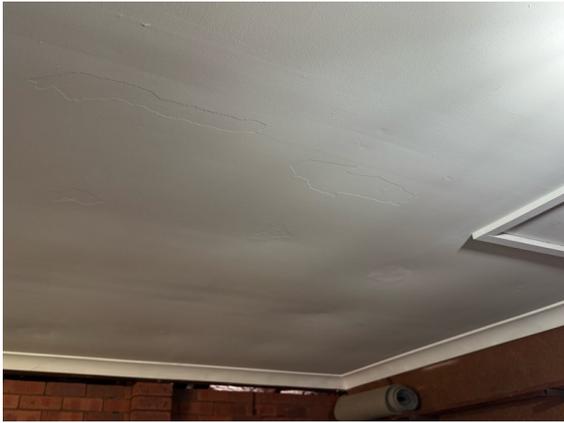
Defect 8. - Interior

Defect Location:	Attached Garage
Defect Summary:	Ceiling Nails Popping
Type of Defect:	Damage
Description:	Popping ceiling nails, patched areas and sagging in areas.
Ongoing Consequence:	Further deterioration of the area.
Opinion of Cracking:	Not Applicable
Building Professional:	Note: This defect should be referred to a qualified building professional for the repairs/scope of work required.
	Building Professional Required: Plasterer, Painter

Patched ceiling

Popping nails and sagging.

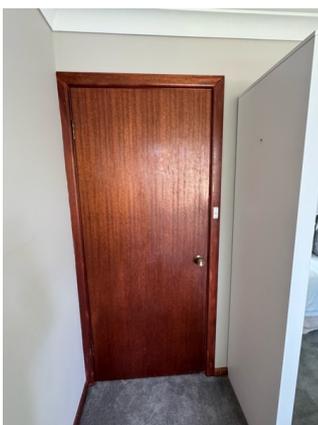
Defect 9. - Interior

The door is binding.

Difficult to operate, Damage to surrounding elements

The door is binding and needs easing.

Building Professional Required: Carpenter

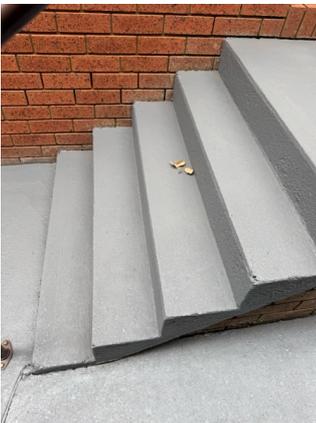
Defect 10. - Exterior

Defect Location:	South Side
Defect Summary:	Verandah
Type of Defect:	Installation, Safety hazard
Description:	The stair treads are too small.
Ongoing Consequence:	Personal injury, Personal injury
Opinion of Cracking:	Not Applicable
Building Professional:	Note: This defect should be referred to a qualified building professional for the repairs/scope of work required.
	Building Professional Required: Concreter

The stair treads are too small.

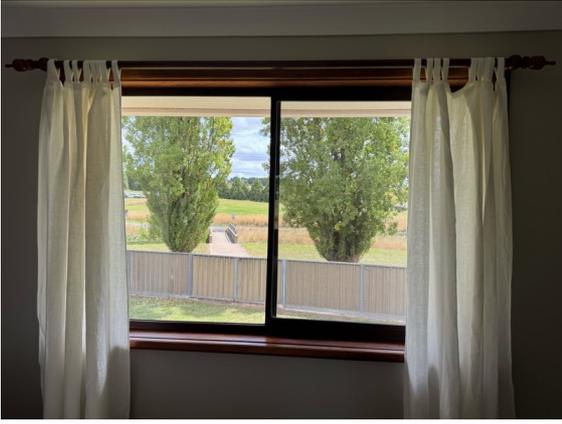
Defect 11. - Interior

Defect Location:	Various Areas
Defect Summary:	Metal Windows and Doors - Sash/Door Operation
Type of Defect:	Material deterioration
Description:	The rollers are damaged
Ongoing Consequence:	damage to the sash/door
Opinion of Cracking:	Not Applicable
Building Professional:	Note: This defect should be referred to a qualified building professional for the repairs/scope of work required.
	Building Professional Required: Glazier

The window sash running wheels need maintenance in various areas.

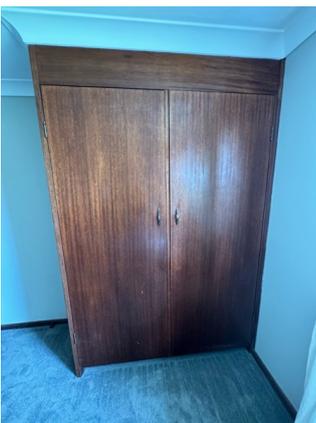
Defect 12. - Interior

The face of the door is damaged.

Building Professional Required: Carpenter, Painter

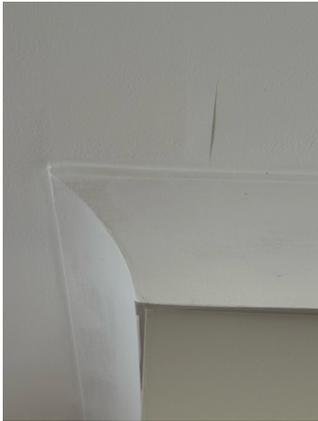
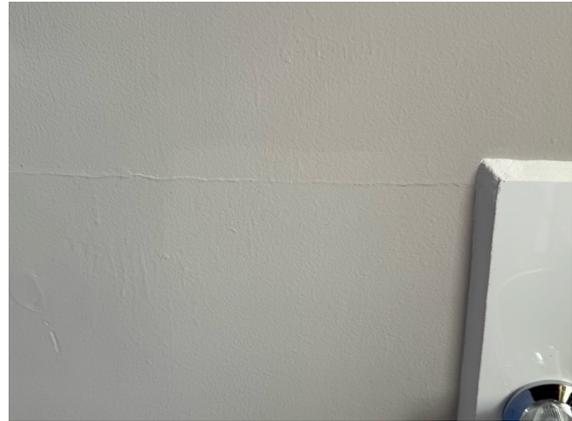
Defect 13. - Interior

Defect Location:	Hallway
Defect Summary:	Ceiling Cracking and/or evidence of damage repaired
Type of Defect:	Damage
Description:	Cracking
Ongoing Consequence:	Further cracking
Opinion of Cracking:	Not Applicable
Building Professional:	Note: This defect should be referred to a qualified building professional for the repairs/scope of work required.
	Building Professional Required: Plasterer, Painter

Ceiling cracking.

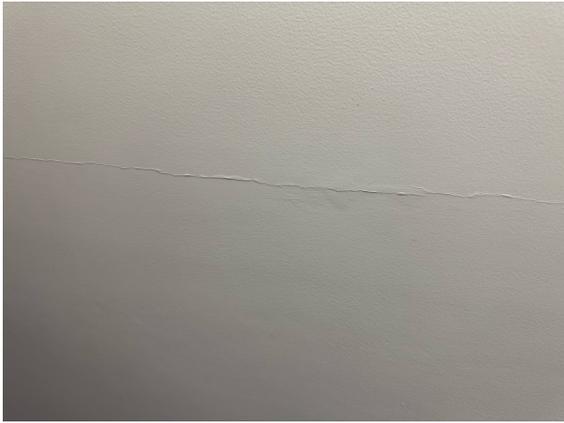
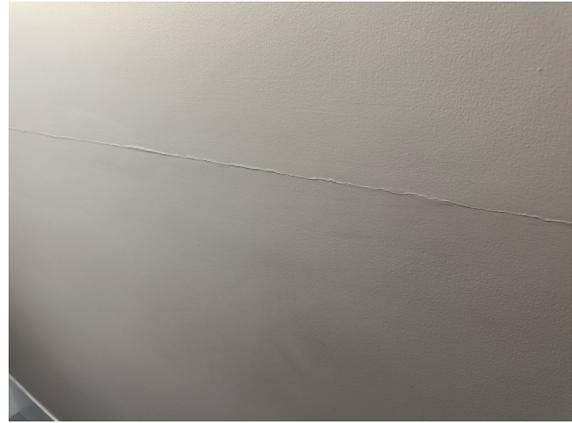
Defect 14. - Interior

Defect Location:	Toilet 1
Defect Summary:	Plaster wall cracking.
Type of Defect:	Damage
Description:	Cracking.
Ongoing Consequence:	Further cracking.
Opinion of Cracking:	Not Applicable
Building Professional:	Note: This defect should be referred to a qualified building professional for the repairs/scope of work required.
	Building Professional Required: Plasterer, Painter

Wall cracking.

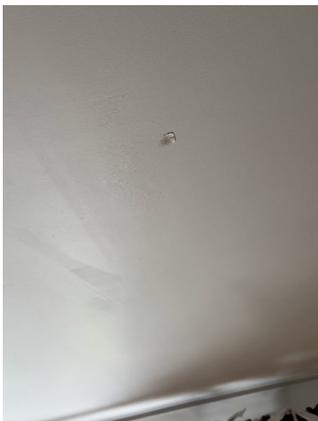
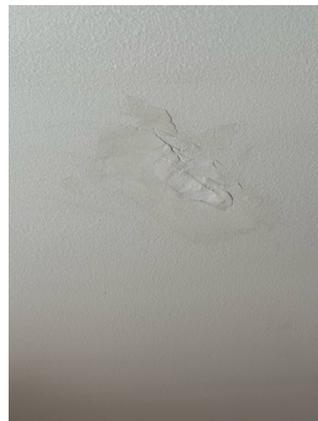
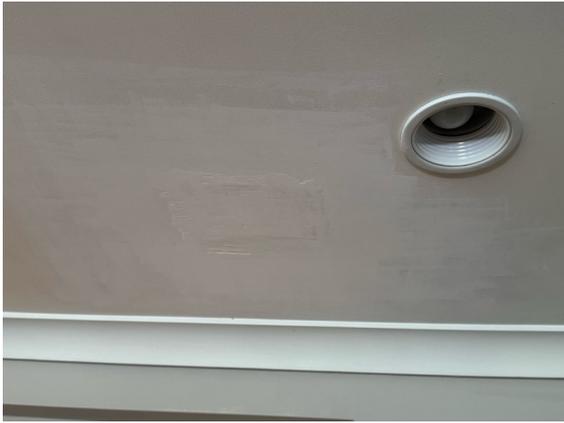
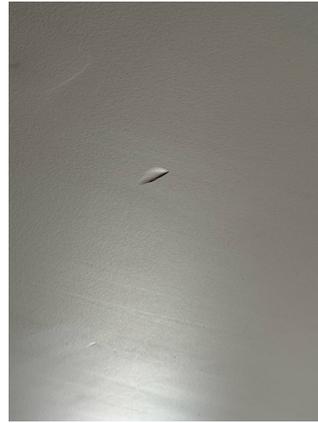
Defect 15. - Interior

Evidence of repairs to cracking Damaged ceiling sheeting

The damaged ceiling.

Patched ceiling.

Building Professional Required: Plasterer, Painter

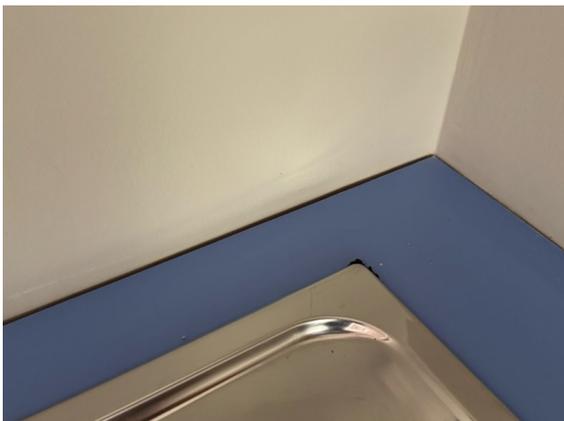
Defect 16. - Interior

There are no splash back tiles installed

Deterioration of surrounding elements

The sink has no splash back tiles installed.

Building Professional Required: Tiler

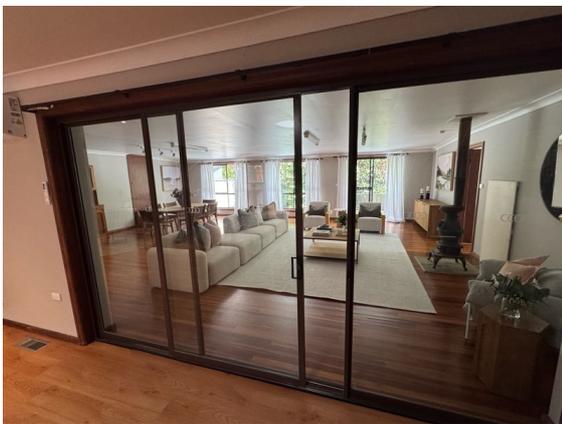
Defect 17. - Interior

Defect Location:	Family Room
Defect Summary:	Metal Windows and Doors - Sash/Door Operation
Type of Defect:	Operational
Description:	The rollers are damaged
Ongoing Consequence:	damage to the sash/door
Opinion of Cracking:	Not Applicable
Building Professional:	Note: This defect should be referred to a qualified building professional for the repairs/scope of work required.
	Building Professional Required: Glazier

The sash wheels need maintenance

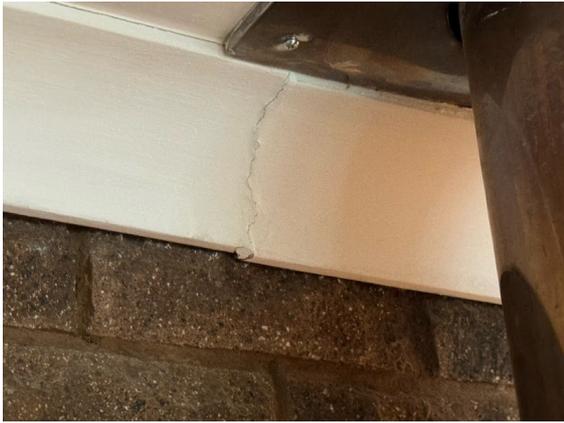
Defect 18. - Interior

Defect Location:	Lounge Room
Defect Summary:	Ceiling Cracking and/or evidence of damage repaired
Type of Defect:	Damage
Description:	Cracking
Ongoing Consequence:	Further cracking
Opinion of Cracking:	Not Applicable
Building Professional:	Note: This defect should be referred to a qualified building professional for the repairs/scope of work required.
	Building Professional Required: Plasterer, Painter

The cracking cornice.

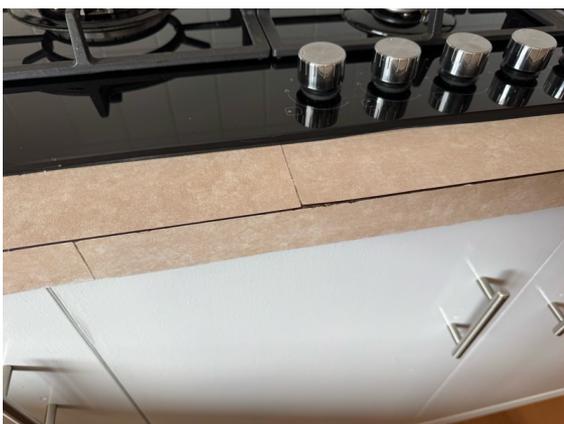
Defect 19. - Interior

Lifting of laminate

The damaged laminate.

Building Professional Required: Carpenter

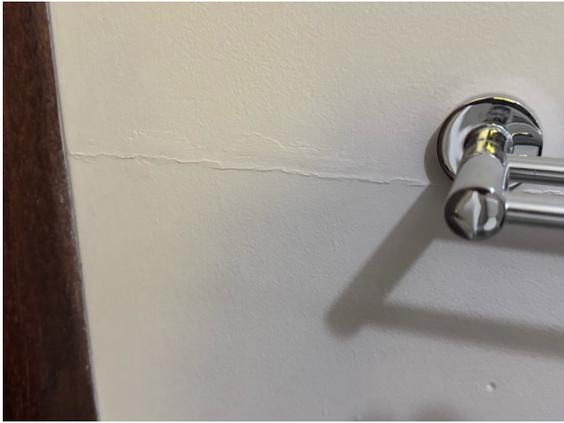
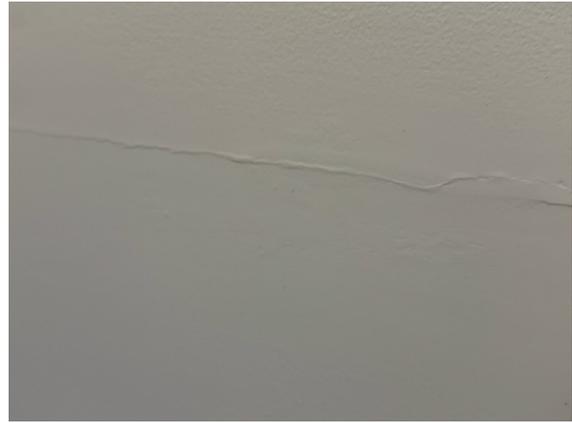
Defect 21. - Interior

Defect Location:	Ensuite 1
Defect Summary:	Plaster wall cracking.
Type of Defect:	Damage
Description:	Cracking.
Ongoing Consequence:	Further cracking.
Opinion of Cracking:	Not Applicable
Building Professional:	Note: This defect should be referred to a qualified building professional for the repairs/scope of work required.
	Building Professional Required: Plasterer, Painter

Wall cracking.

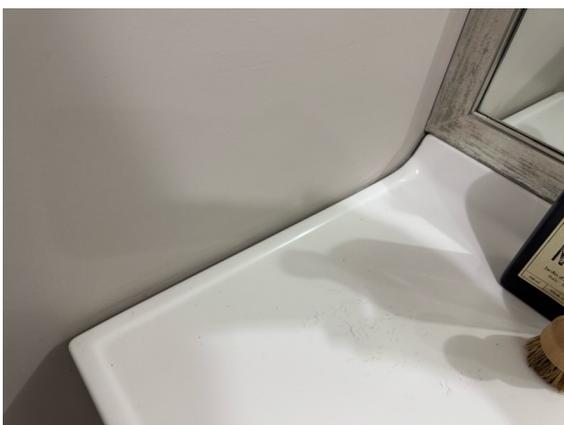
Defect 22. - Interior

There is no sealant at the junction of the splashback and vanity top

Allow water to enter the wall or vanity top

The vanity needs a silicone seal applied

Building Professional Required: Tiler

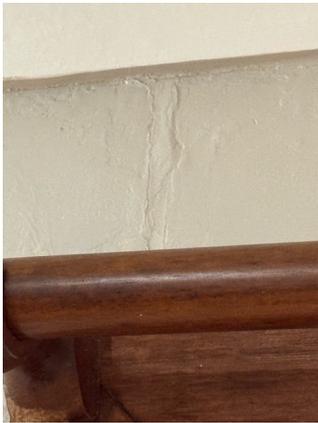
Defect 23. - Interior

Defect Location:	Dining Room
Defect Summary:	Wall cracking.
Type of Defect:	Damage
Description:	Cracking.
Ongoing Consequence:	Further cracking.
Opinion of Cracking:	Not Applicable
Building Professional:	Note: This defect should be referred to a qualified building professional for the repairs/scope of work required.
	Building Professional Required: Plasterer, Painter

Wall cracking.

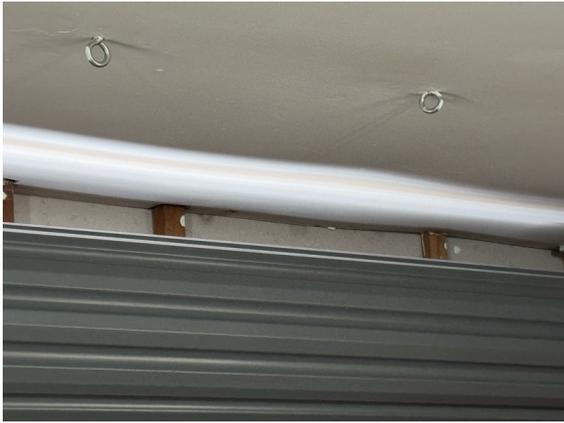
Defect 24. - Interior

Defect Location:	Attached Garage
Defect Summary:	Wall trim
Type of Defect:	Installation
Description:	The wall trim above the garage doors is not installed
Ongoing Consequence:	Incomplete installation
Opinion of Cracking:	Not Applicable
Building Professional:	Note: This defect should be referred to a qualified building professional for the repairs/scope of work required.
	Building Professional Required: Carpenter, Painter

Missing wall trim

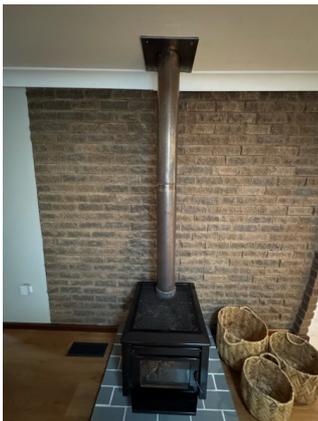
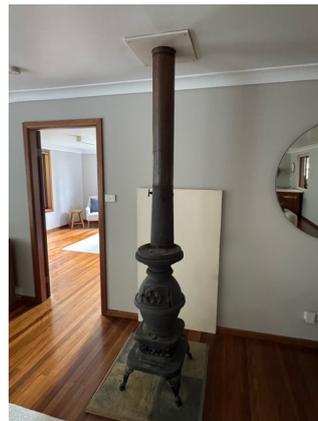
Observation 1

The fire flue needs to be checked that it is installed to the current Australian Standards and is safe before use.

The fire flue needs to be checked before use.

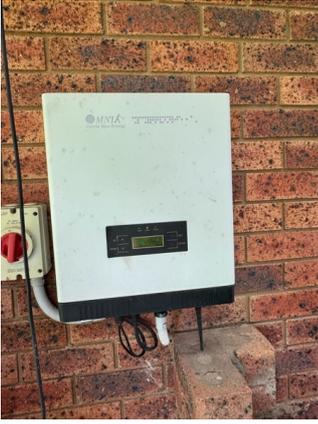
The solar system needs to be checked for operation by a licensed solar technician.

Electrical, Plumbing Timber pest inspector ,
Licensed Solar Technician.

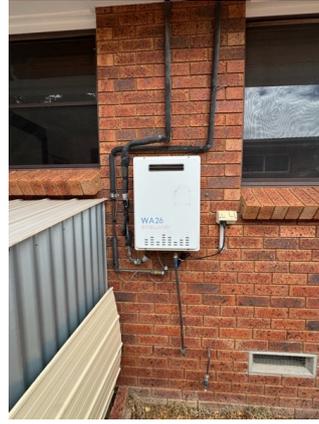
The hot water system was operating.

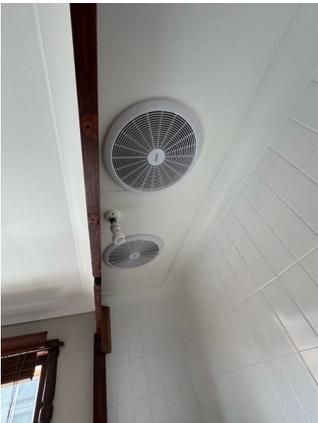
The range hood/ exhaust fans were operating.

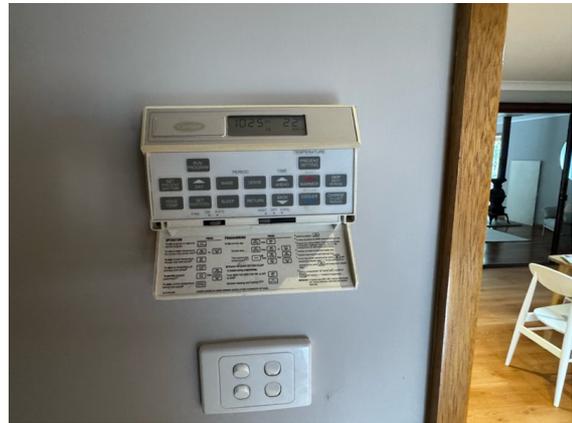
The central heating was operating.

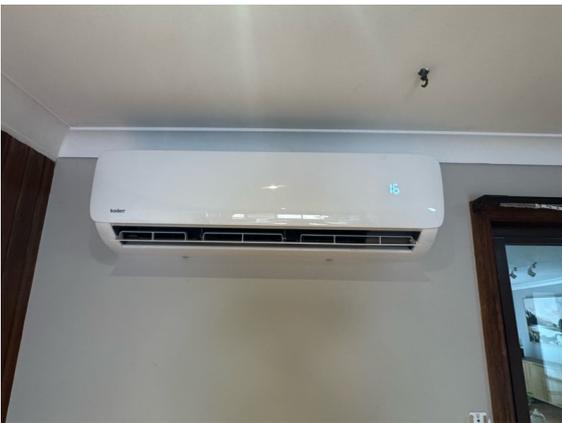
The split system was operating

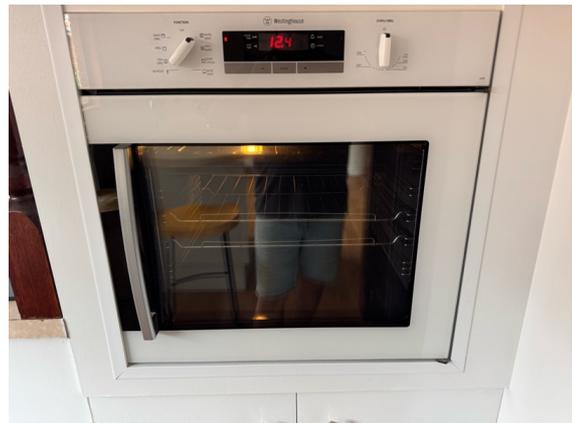
The oven was operating

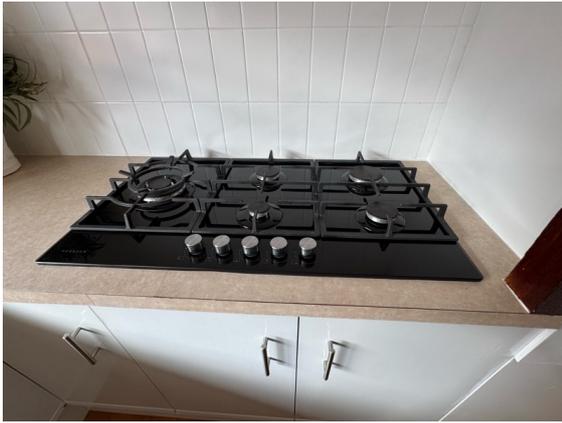
The cook top was operating
