Residential Pre-Purchase Building Inspection Report

Complies with Australian Standard AS 4349.1-2007

Property Address: 774 Friday Hut Rd Binna Burra

Date of inspection: 01/07/2024

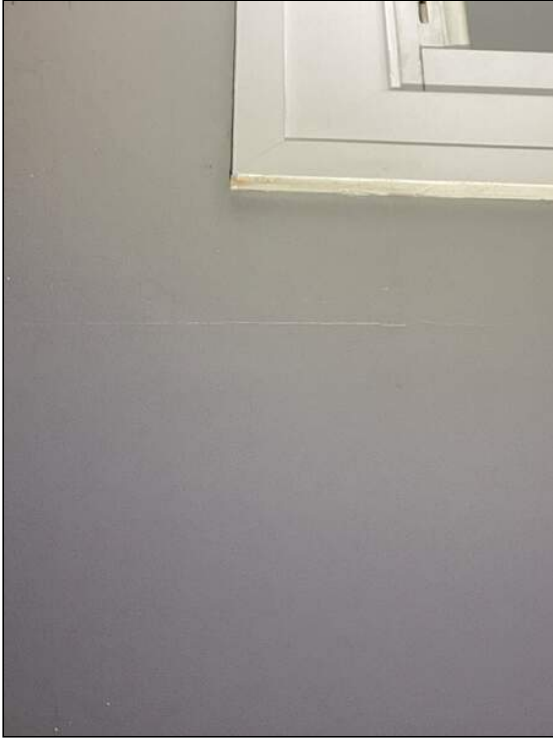
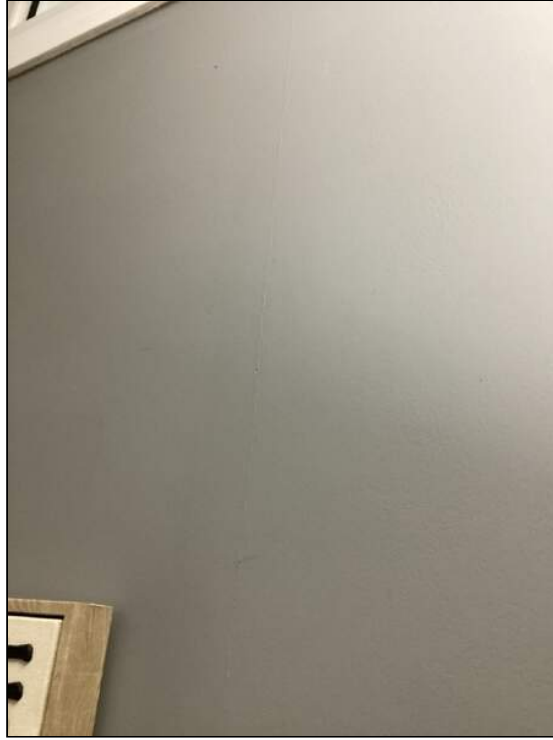
Location (Optional): Internal
Defect Rating: Minor Defect

Walls; Are the wall linings free of bulging, nail popping, cracking, dampness/staining, vertical distortion and other damage?

Imperfections in flush jointing - The imperfections could easily be rectified prior to the next painting.

Imperfections in flush jointing - The imperfections could easily be rectified prior to the next painting.
Location (Optional): Internal
Details (Optional):
Defect Rating: Minor Defect

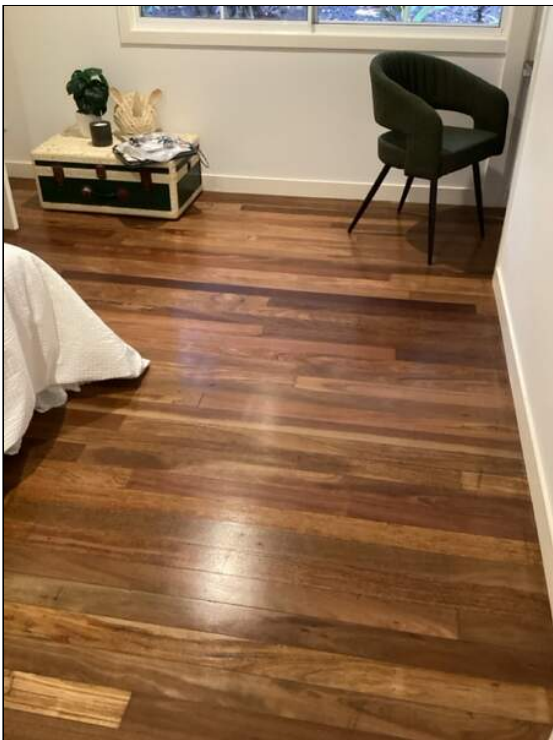
Floors (Timber); Are floors free of movement such as spring and bounce, and cracking, and are they free of dampness/staining and other damage?

The flooring has minor spring and bounce, which is typical of a building of this age.
Location (Optional): Internal
Defect Rating: Minor Defect

The flooring has minor spring and bounce, which is typical of a building of this age.
Location (Optional): Internal
Details (Optional):
Defect Rating: Minor Defect

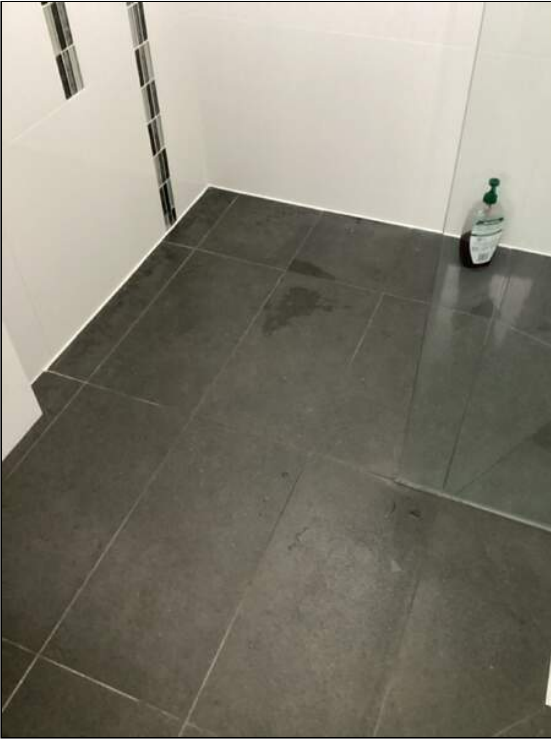
Bathrooms/WC; Is the bath free of damage, and is it properly recessed at the junction with the wall?	Yes
Bathrooms/WC; Is the shower screen free of cracks, and is it adequately sealed at the floor/wall junctions?	No Location (Optional): Bathroom Details (Optional): As there is no shower screen door fitted to the screen excess shower spray may occur outside the shower cubicle Defect Rating: Safety Defect

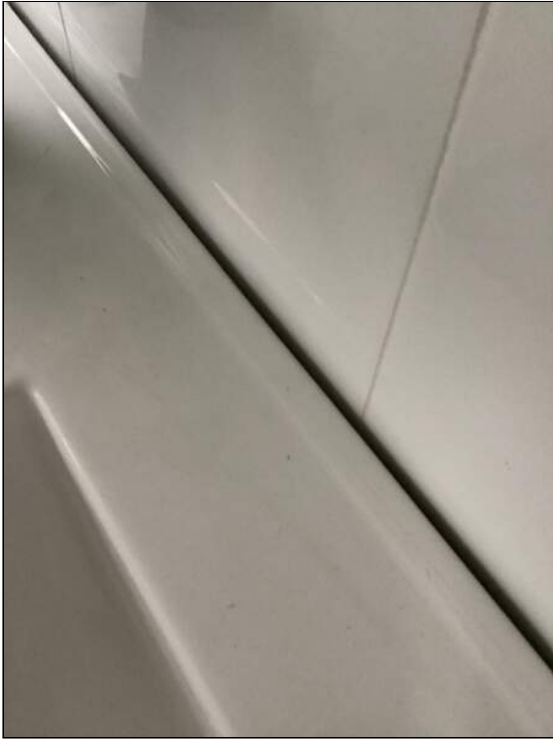
Bathrooms/WC; Is the vanity basin, cabinet and mirrors free of damage, and do the doors/drawers operate correctly?

No

**Location (Optional): Bathroom vanity
Details (Optional): Consideration should be given to seal vanity bench top with an approved flexible sealant to prevent moisture content entering behind cupboard
Defect Rating: Minor Defect**

No
Location (Optional): Bathroom vanity
Details (Optional): Consideration should be given to seal vanity bench top with an approved flexible sealant to prevent moisture content entering behind cupboard
Defect Rating: Minor Defect

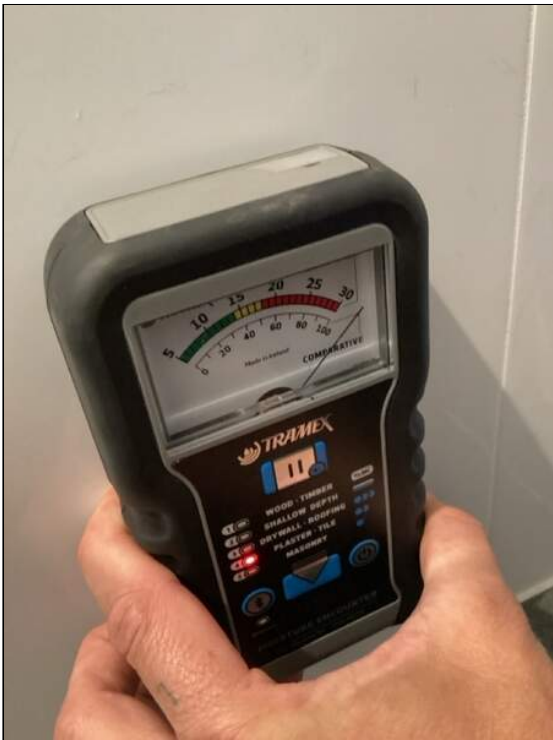
Bathrooms/WC; Is the room free of condensation damage, and is it adequately ventilated?	Yes
Laundry; Are taps free of leaks, and does the water supply operate correctly?	Yes
Laundry; Is the tub/cabinet free of water damage, corrosion or other defect?	Yes
Laundry; Are the tiles free of cracks, drumminess, or loose/missing grout/sealant?	Yes
Laundry; Is the room free of condensation damage, and is it adequately ventilated?	Yes
Electrical; Do battery or hardwired smoke alarms exist?	Yes. Smoke alarms have been installed. Smoke alarms should be checked and tested by a licensed electrician prior to occupancy of this dwelling.
All rooms: Are all rooms free of damp problems, including rising/falling damp, condensation, horizontal penetrating dampness?	No Location (Optional): Shower walls Details (Optional): High moisture readings to the shower walls evident. Recommend to engage a licensed plumber to further investigate possible pipe leak Defect Rating: Further Investigation

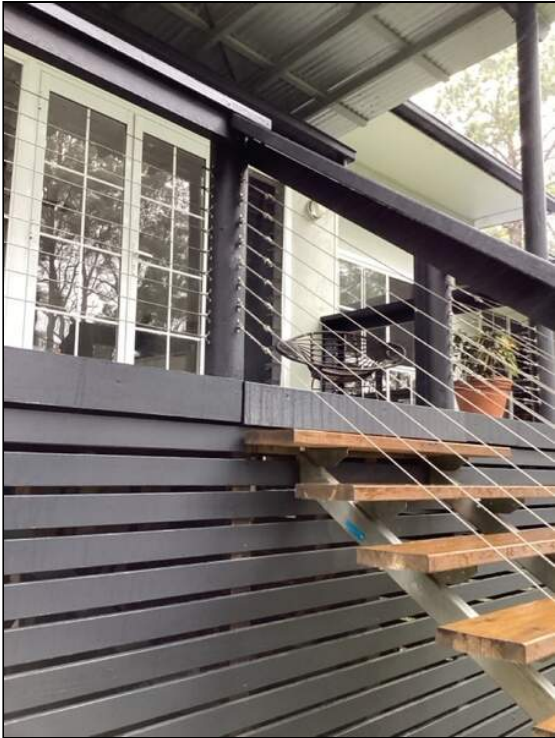
Balconies/verandahs/patios/decks/suspended floors/balustrades; Are handrails at correct height to comply with Building Code?

No

Defect Rating: Safety Hazard

Details (Optional): Consideration should be given to keep wires fully tensioned at all times

No
Location (Optional): External
Details (Optional): Consideration should be given to keep wires fully tensioned at all times
Defect Rating: Safety Hazard

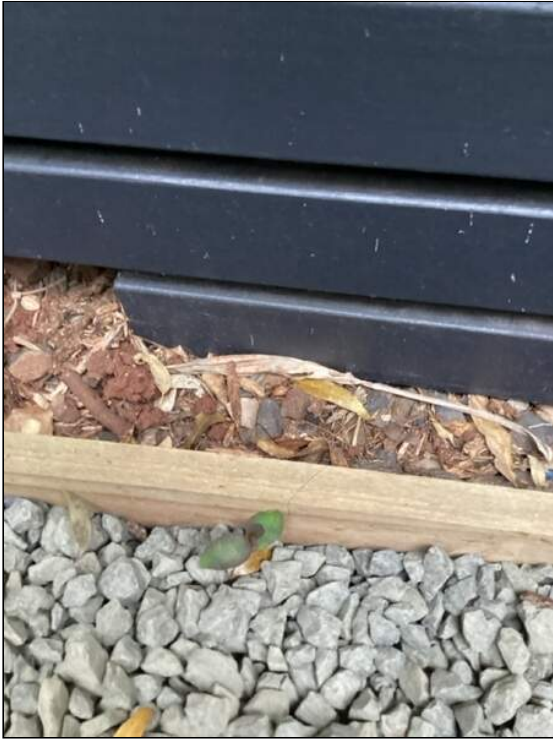
General; Is the exterior free of any other damage or defects?

No

Defect Rating: Minor Defect

Details (Optional): Timbers are in contact with the ground - Maintain 75mm ground clearance to prevent decay and possible termite activity

No
Location (Optional): External
Details (Optional): Timbers are in contact with the ground - Maintain 75mm ground clearance to prevent decay and possible termite activity
Defect Rating: Minor Defect

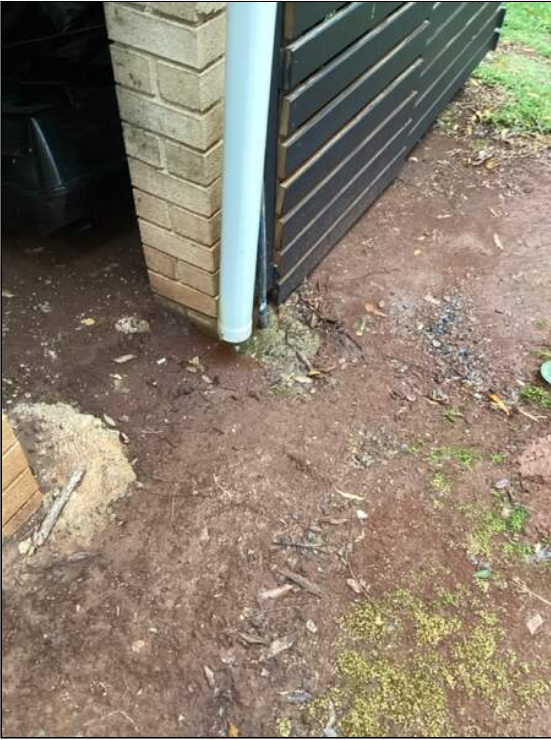
Location (Optional): External

Valleys/gutters/downpipes; Are they free of rust, and do they appear to drain effectively?

Down pipes in areas are not connected to storm water. See a plumber to have connected. This has potential to cause differential settlement to the footings, cause rising damp and is also conducive to termite infestation. Defect because of potential problems relating to excess water in sub floor.

Defect Rating: Further investigation

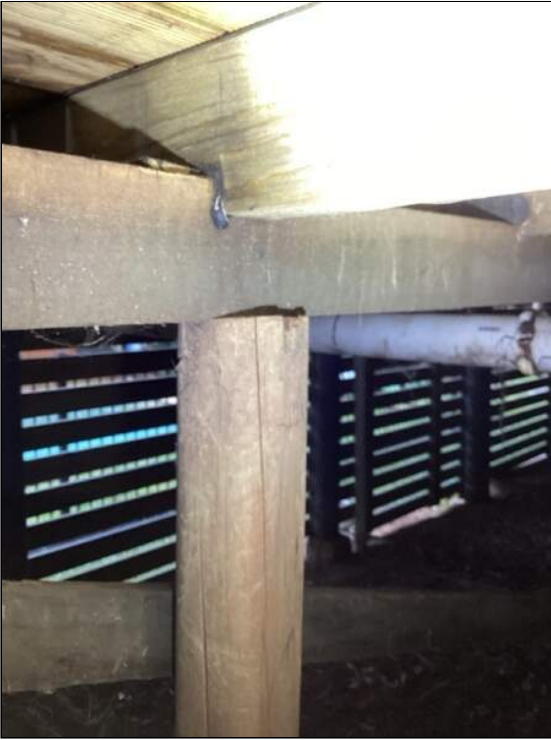
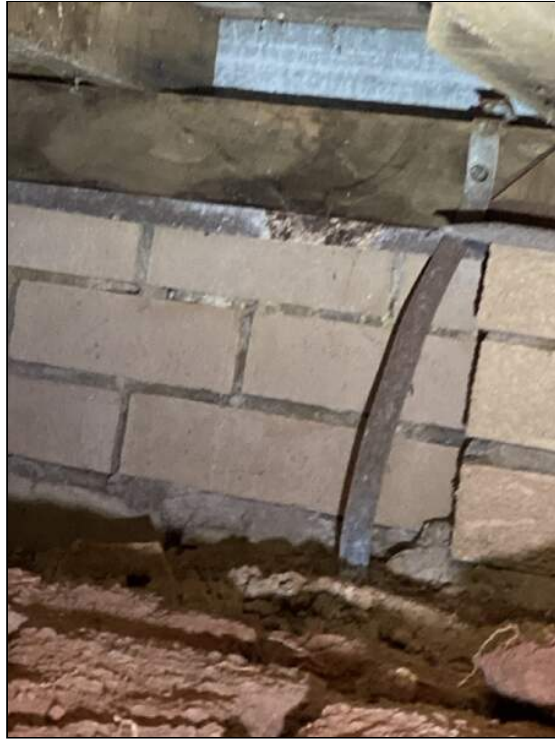
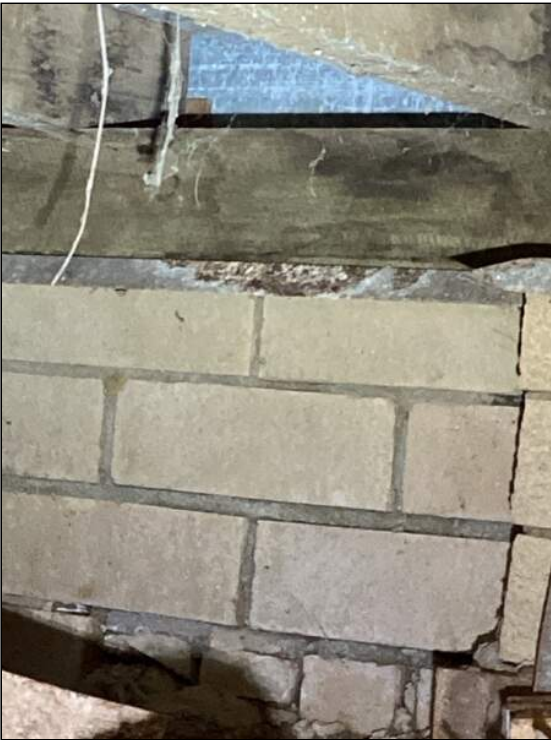
Timber floor; Do columns/posts appear to be structurally sound, with undamaged antcaps, and free of cracks, corrosion, decay?

This can allow concealed termite entry to occur and should be rectified immediately.
Location (Optional): Sub Floor
Details (Optional): Refer Pest Report for best recommended management
Corroded ant sheilding evident.
Defect Rating: Minor Defect

This can allow concealed termite entry to occur and should be rectified immediately.
Location (Optional): Sub Floor
Details (Optional): Refer Pest Report for best recommended management
Corroded ant sheilding evident.
Defect Rating: Minor Defect

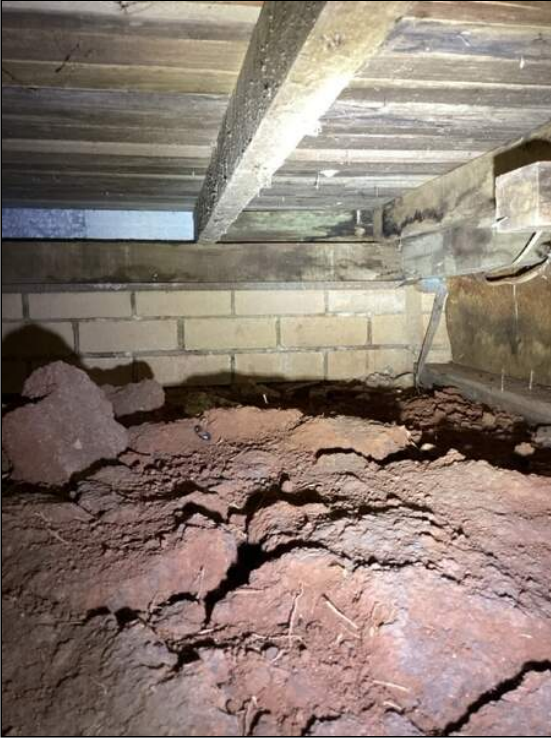
Timber floor; Does the sub floor area appear to be adequately ventilated, and free of dampness?

Inadequate. As with older dwellings, sub floor ventilation is inadequate when compared with today's requirements. You could improve the sub floor ventilation to meet today's requirements if desired as it is advisable in older brick dwellings.

Defect Rating: Minor Defect

Details (Optional): Improved ventilation may need consideration to the front foundation wall

Inadequate. As with older dwellings, sub floor ventilation is inadequate when compared with today's requirements. You could improve the sub floor ventilation to meet today's requirements if desired as it is advisable in older brick dwellings.

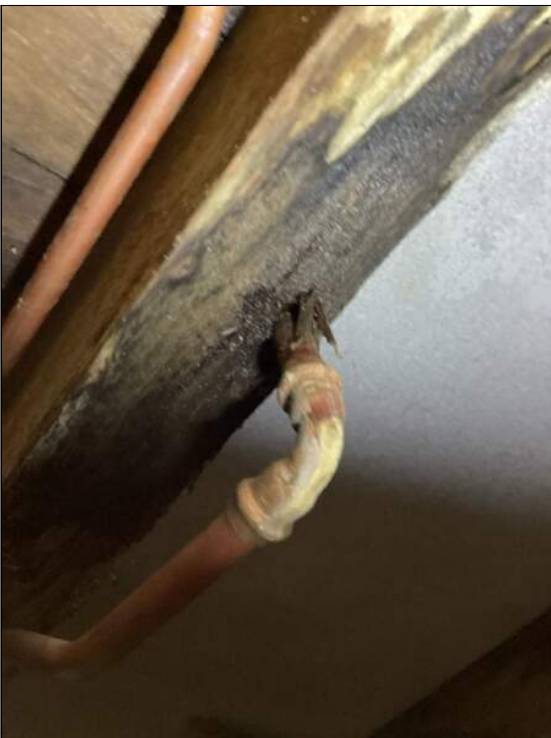
Timber floor; Are the floor boards free of dampness and decay?

Condensation evident to underside of floorboards

Defect Rating: Minor Defect

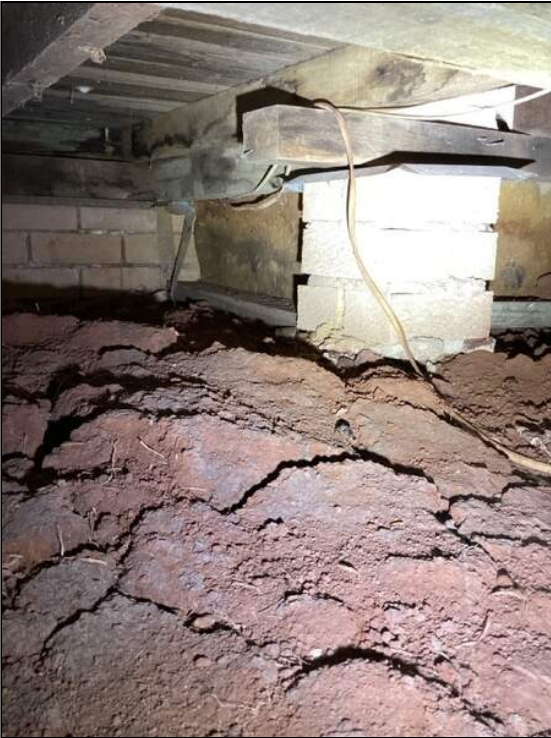
General; Is the sub floor space free of any other damage or defects?

No
Location (Optional): Sub Floor
Details (Optional): Timbers are in contact with the ground . This is susceptible to termite entry . Refer Pest report for best

recommended management .Possible
removal should be considered
Defect Rating: Further investigation

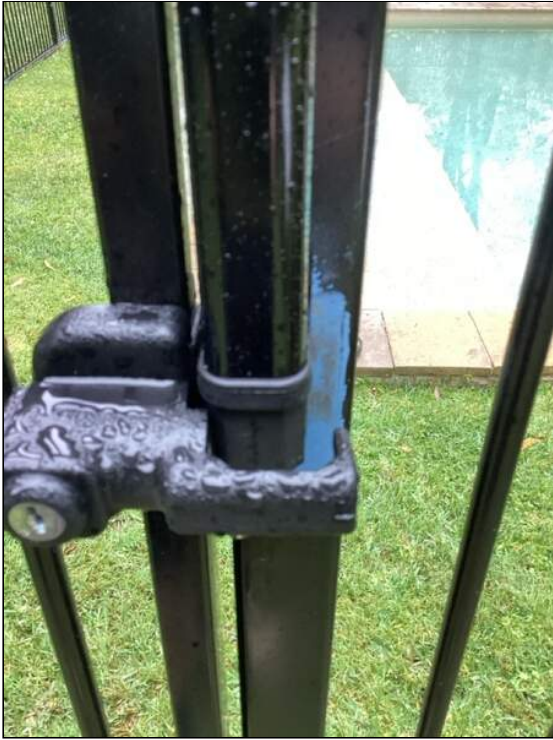
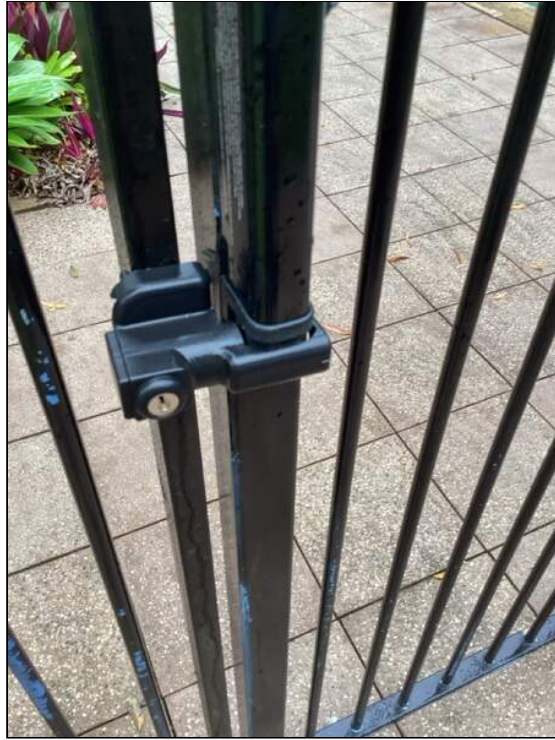
Swimming Pool; Do fences completely surround the pool, and does the pool appear to be in good cosmetic condition?

No
Location (Optional): Pool gates
Details (Optional): Ease and adjust pool gate latches to enable self closing at all times
Defect Rating: Safety Hazard

No
Location (Optional): Pool gates
Details (Optional): Ease and adjust pool gate latches to enable self closing at all times
Defect Rating: Safety Hazard

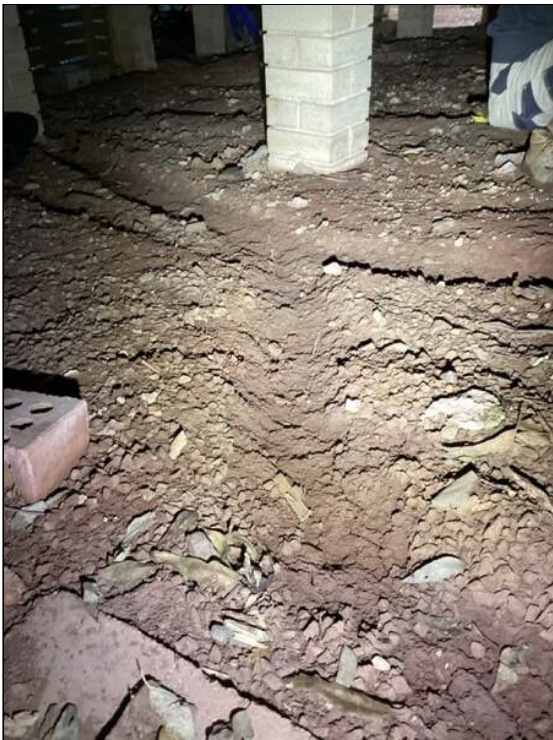
Surface water; Does rainwater drain effectively and not pond against structures?

No
Location (Optional): Sub Floor
Details (Optional): Typical tracking of sub floor surface water flow evident. this is nbot uncommon taking into consideration site characteristics
Defect Rating: Minor Defect

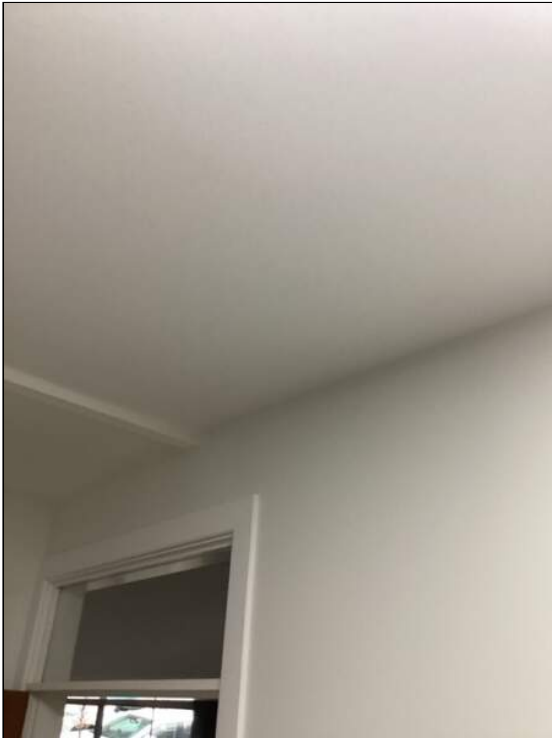
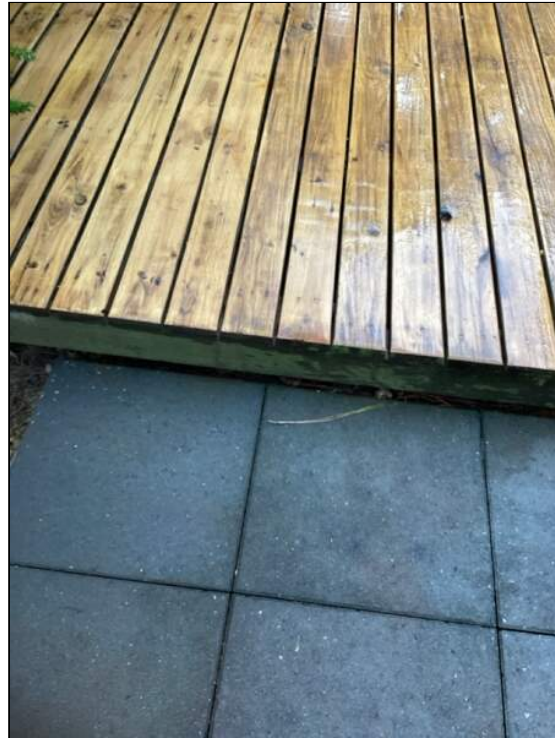
Were there Areas not inspected and, if so, the reasons were:

Yes
Reasons: Roof void due to raked ceiling.
Underside of external decking due to onground construction
