Inspection Report

28 Weston St, Zillmere, QLD

Pest And Building Inspection

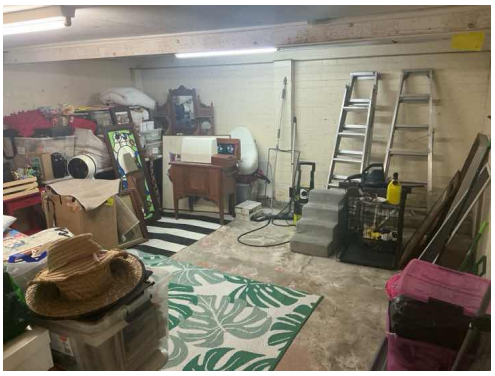
Removal of support posts has occurred during the history of the building. The deflection appears minimal. No ability to fully inspect beam loading, supports or foundations is possible within this inspection.

Contact a lic Engineer to assess if required.

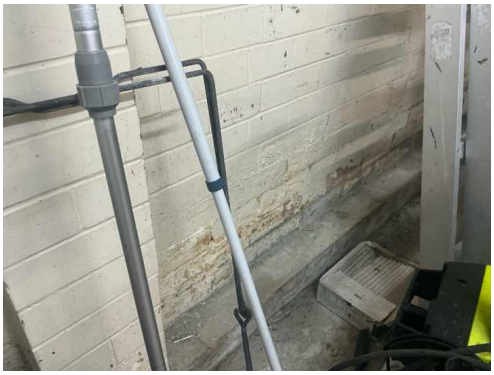
#5. Walls are below ground level. Potential damp issues. Call a drainage plumber for advice

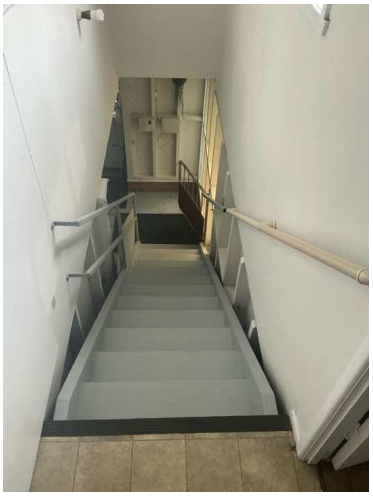
Internal Stair Case

The interior stairs are in a serviceable condition with no notable defects sighted.

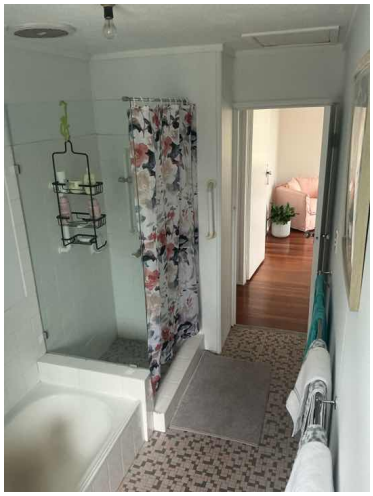
Hall

Of the visible areas, the general condition of this bathroom is serviceable or in reasonable condition for age of dwelling.
