Inspection Report

BPP Inspections

6 Craigslea St, Chermside West, QLD

Pest And Building InsP-ection

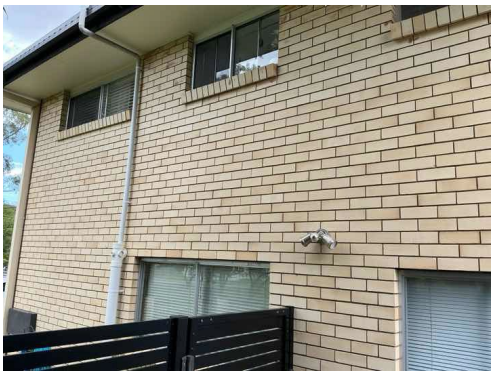
#1. There appears to have been some settlement in the building which has caused some cracking to the walls. This can also cause some doors to bind or be out of square. In the inspectors opinion these cracks are due to settlement, usually due to ground movement and subsequent movement to building materials can be expected. Any cracks should be monitored and if cracks increase in size, further investigation should be carried out by a structural engineer.

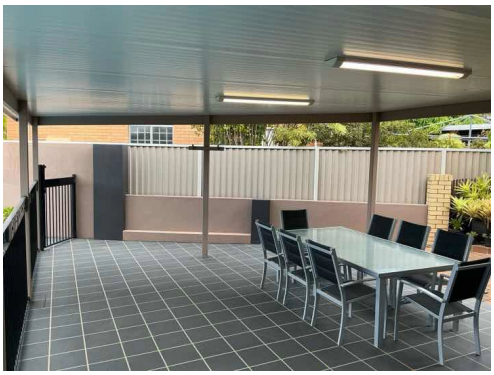
Visible sections of the Alfresco area are serviceable or in reasonable or condition for the age of this dwelling.

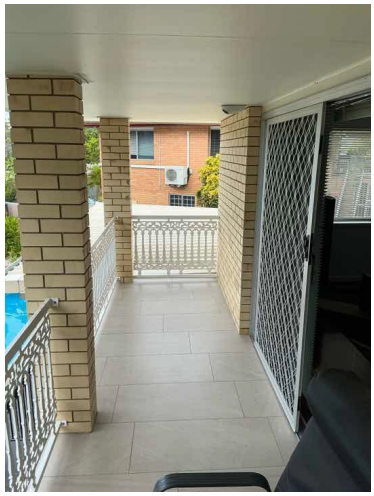
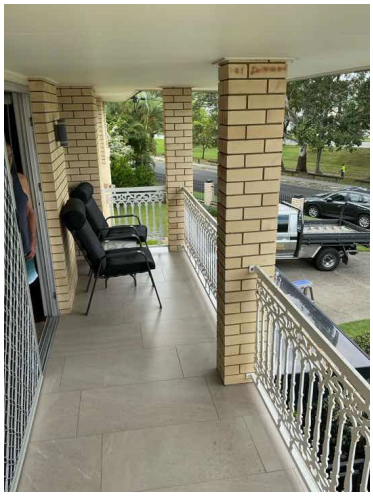
Though we are not structural engineers the balcony/s appear to be in a serviceable condition.

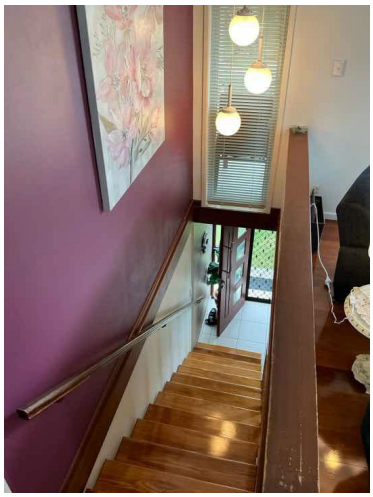
The interior stairs are in a serviceable condition with no notable defects sighted.

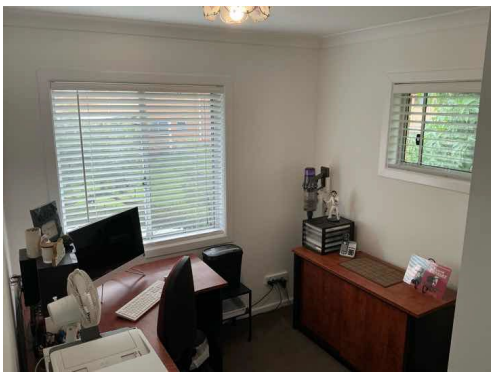
This bedroom is in serviceable condition with no notable structural defects sighted.
