PRE-PURCHASE PROPERTY INSPECTION BUILDING REPORT

To comply with Australian Standard AS4349.1-2007

15 ATTLEE PLACE WINSTON HILLS

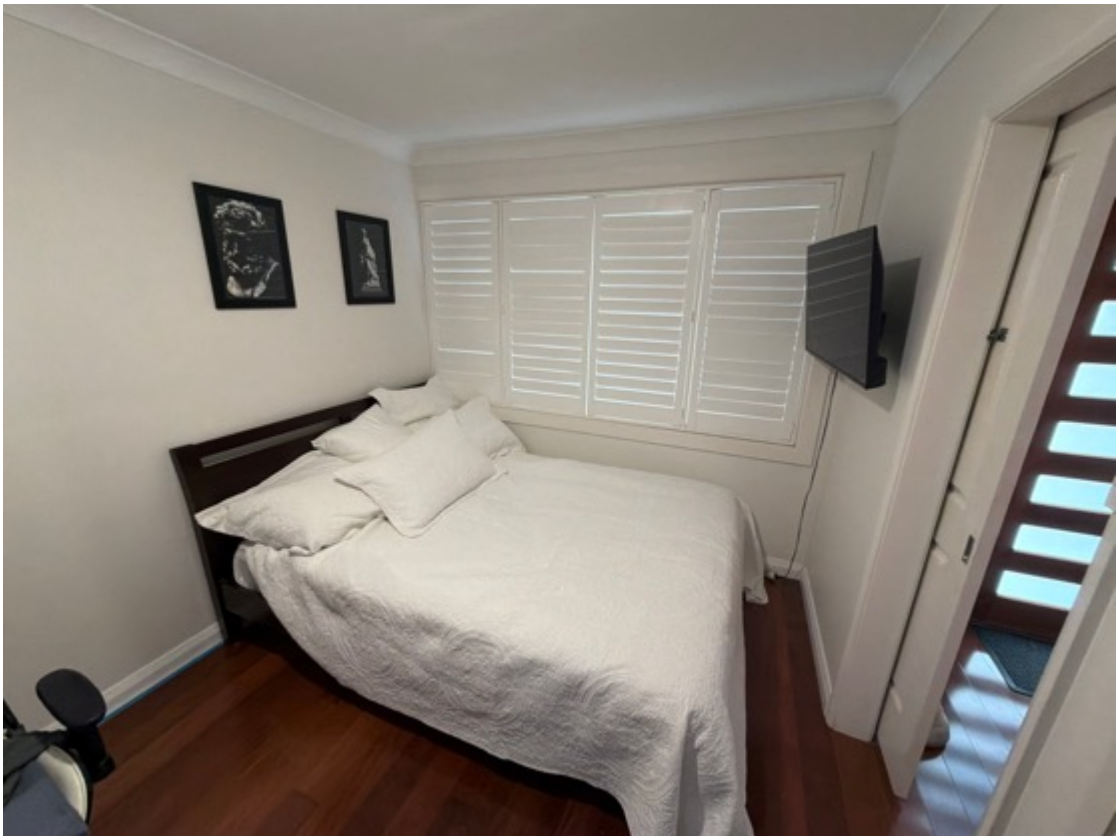
Example bedroom area above.

Plasterboard and cornices display minor imperfections.

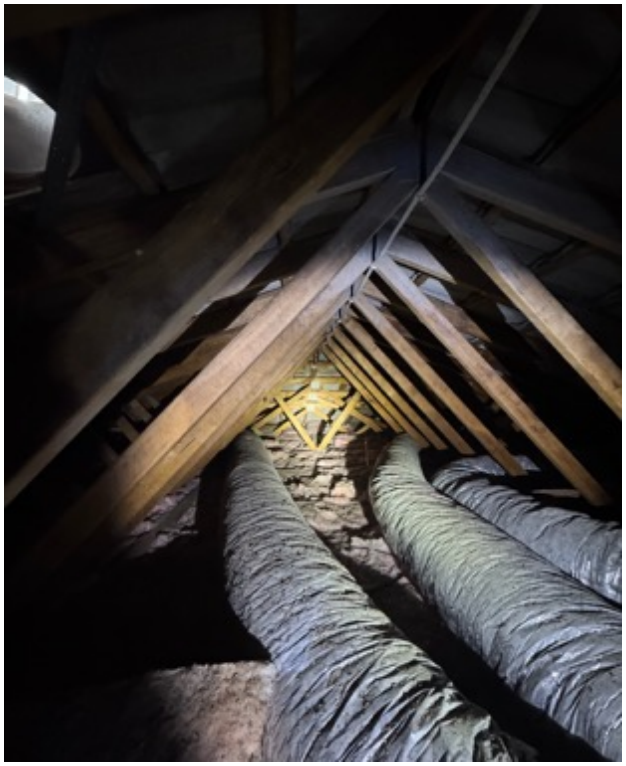
All areas within the roof space were dry at the time of inspection.

Maintain regular pest control by means of baits, sprays and monitoring to prevent pest attack within the roof space.
