Building and Pest Report

13 Ocean Breeze Dr, Lennox Head

Inspection Report

13 Ocean Breeze Drive, Lennox Head, Nsw, 2478

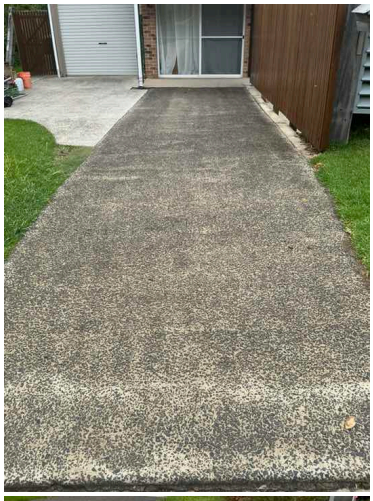
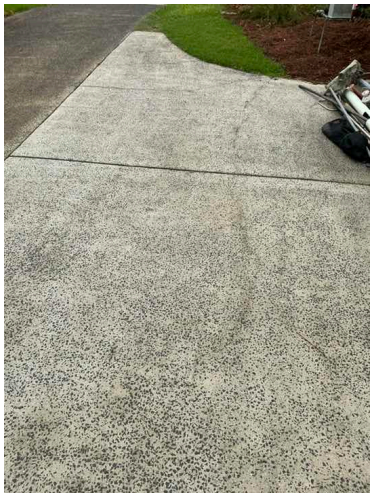
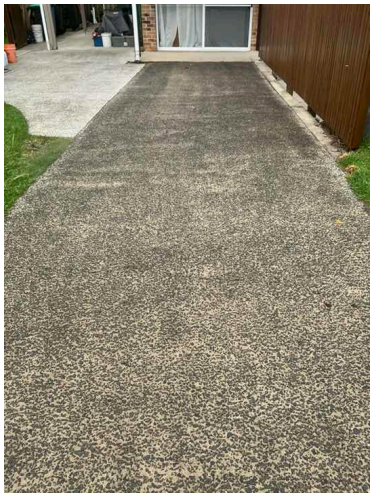
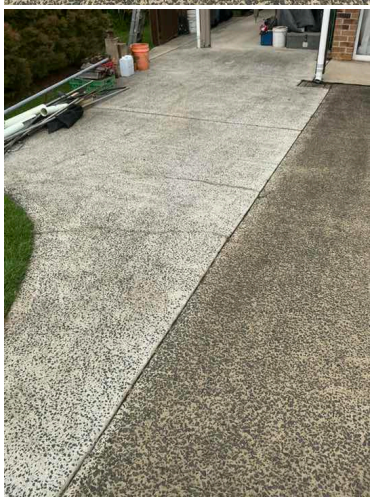
Driveway Condition

On visual inspection, the general condition of the driveway is serviceable.
Common cracks were observed on the driveway. Whilst these cracks appeared to be typical at the time of inspection, we strongly recommend you monitor these cracks and if worsening occurs contact a concreter for further advice.

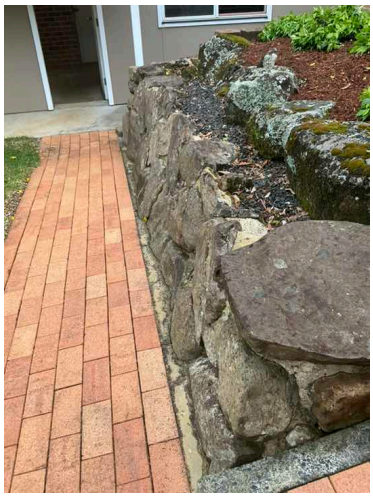
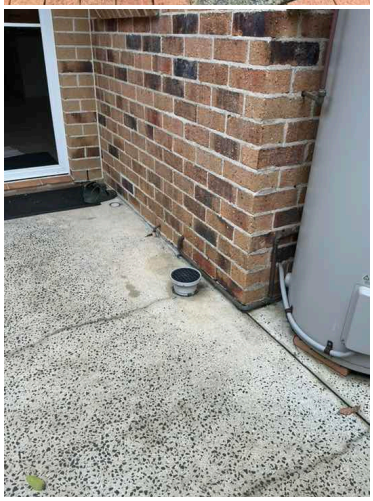
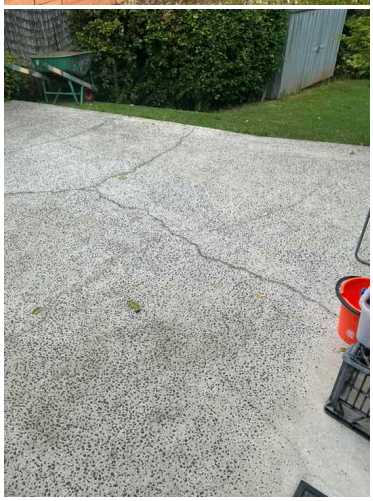
Pathways Condition

The paths around the home are in a serviceable condition for the age of this dwelling with no major defects visible.
Common cracks and settlement were observed on paths. Whilst these cracks appeared to be typical at the time of inspection, we strongly recommend you monitor these cracks and if worsening occurs contact a concreter for further advice.

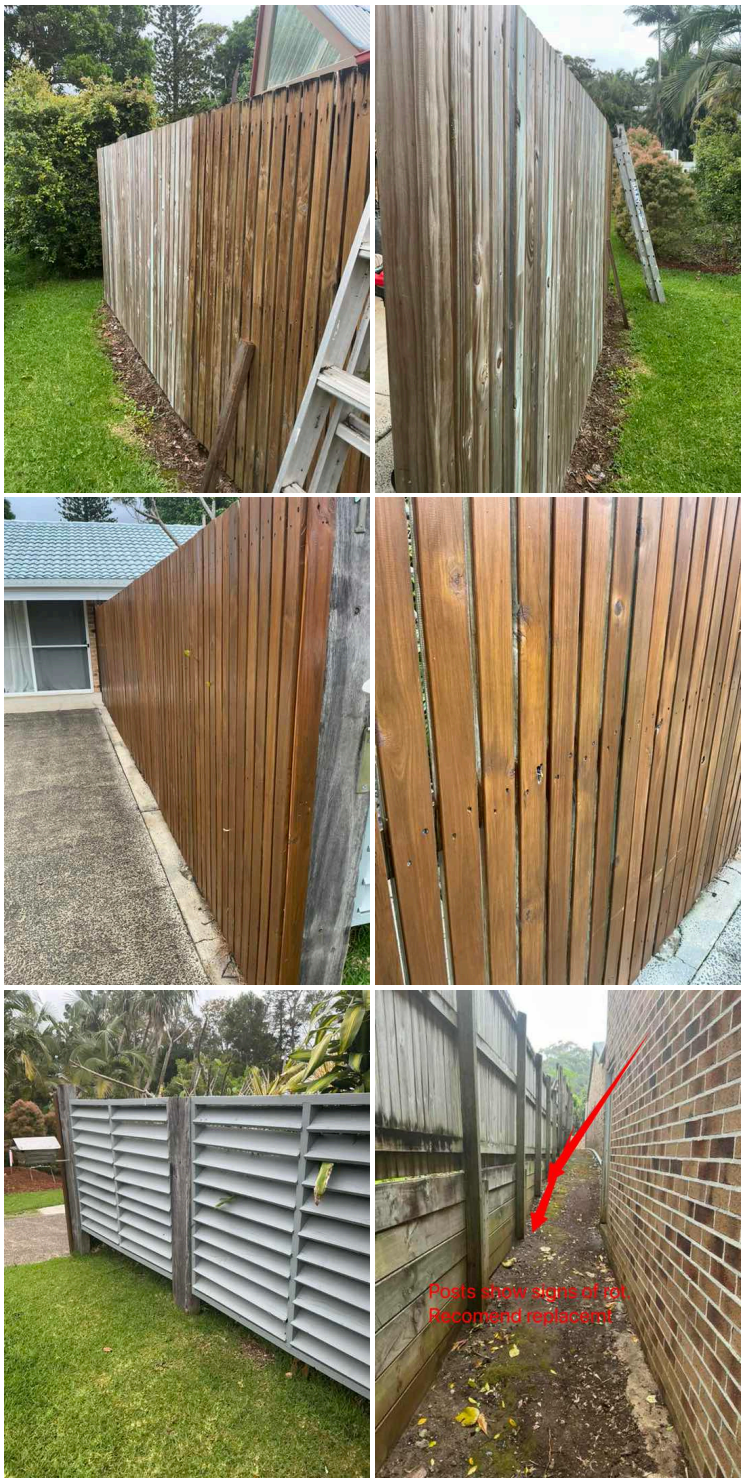
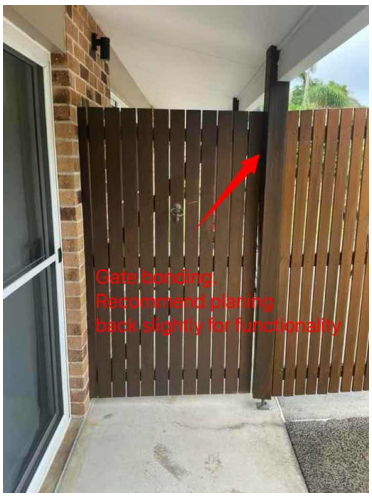
Fences & Gates

On inspection, defects were present that will require further accessing and recommendations by licensed and qualified trades persons.
General age to fence components. General upkeep and maintenance required. A qualified fencing contractor should be engaged for repairs.
General age/damage/binding of gate/s components - Recommendations: A qualified fencing contractor should be engaged for advice and recommendations.
Damage was noted to the timber fence. Contact a fencing contractor for repairs.

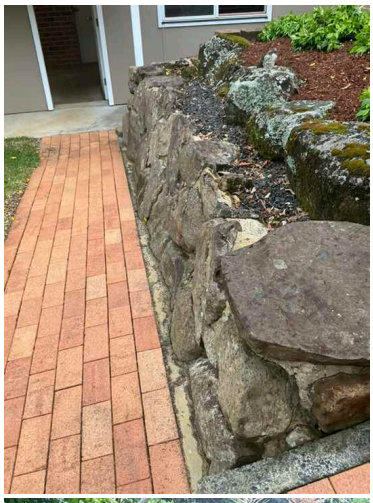
Keystone blocks
The retaining wall material is stone.

Of the visible areas, the general condition is serviceable or in reasonable condition for age of dwelling.

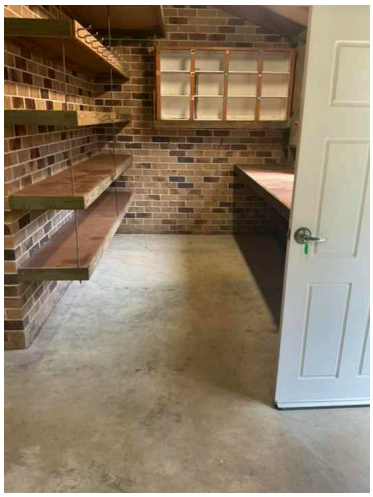
Shed Condition

The shed is in fair usable condition.

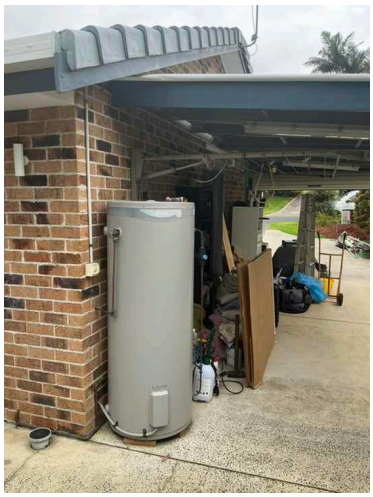
System Make

The make of the hot water unit is rheem.

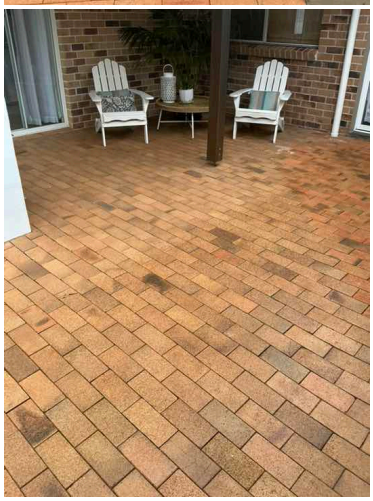
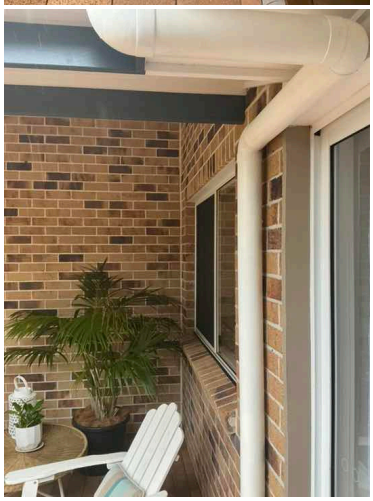
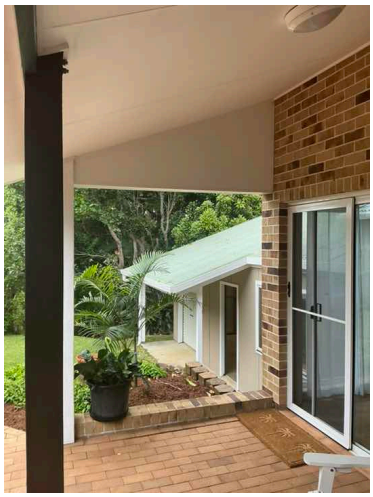
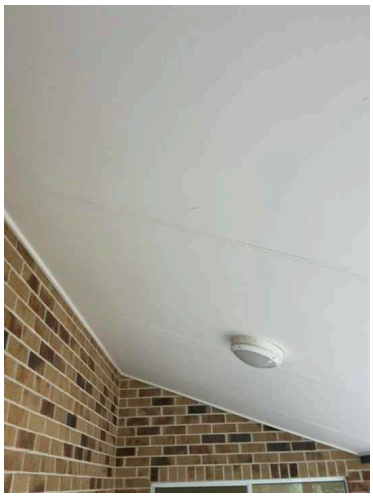
Visible sections of the Alfresco area are serviceable or in reasonable or condition for the age of this dwelling.

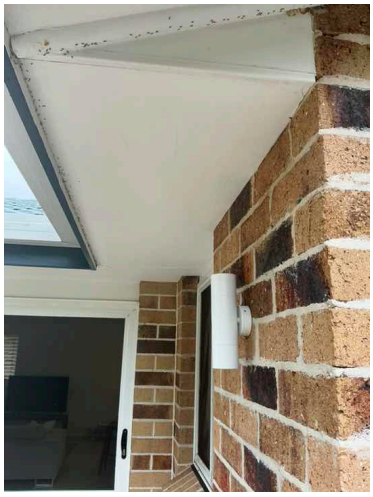
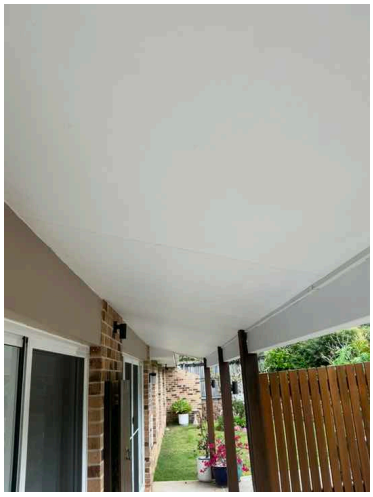
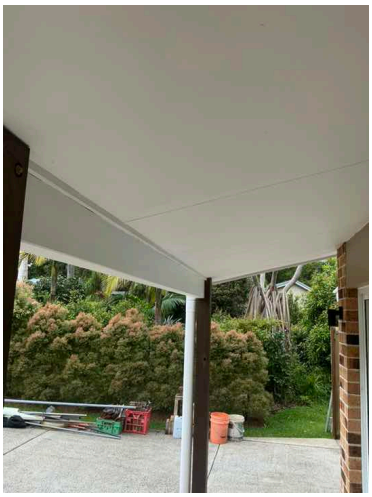
Eave Condition

The soffit lining (eaves) are in a serviceable condition with no notable defects.

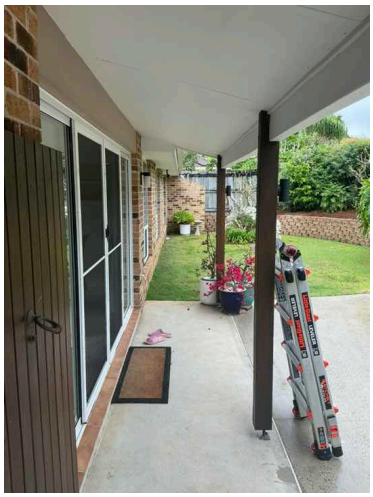
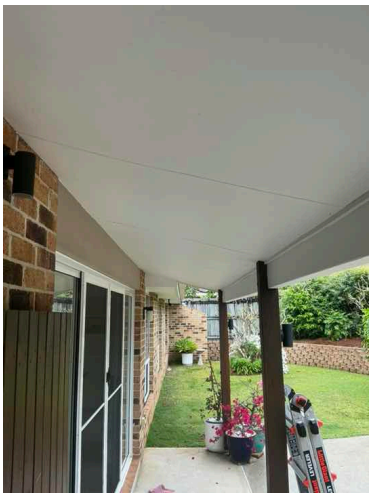
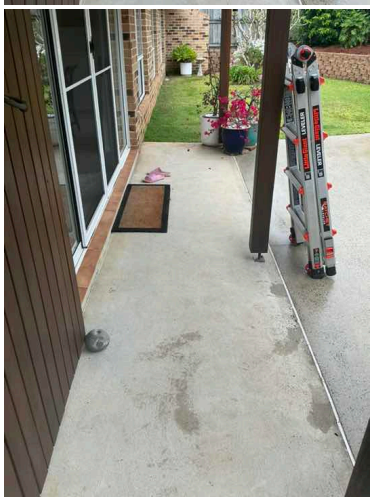
Entry Porch Area

The entry porch serviceable or in reasonable or condition for the age of this dwelling.

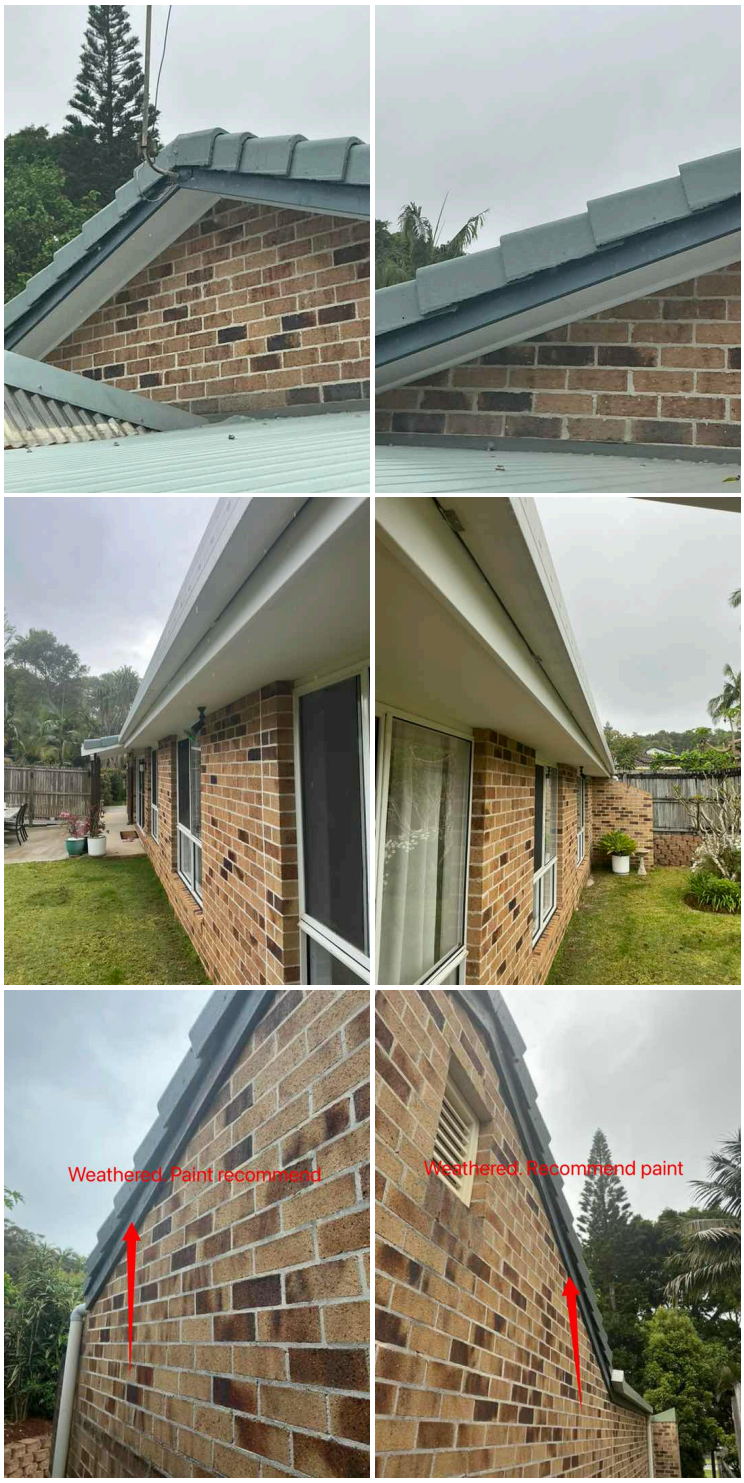
#1. Minor deterioration & ageing evident. Recommendations: Maintenance works, general upkeep should be carried out.
#2. Paint / finish was deteriorated in areas and is in need of maintenance - Sanding back affected areas and painting required.

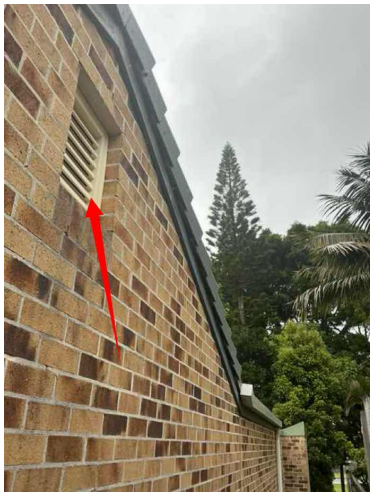
The weep holes are unobstructed .
The vents are unobstructed.

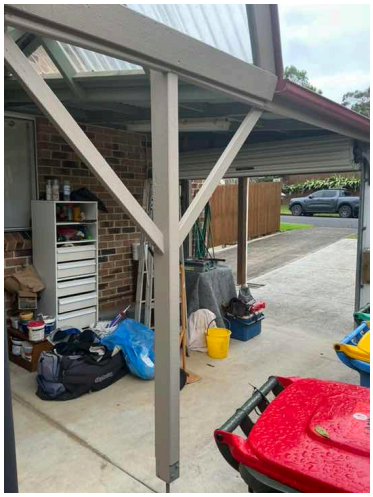
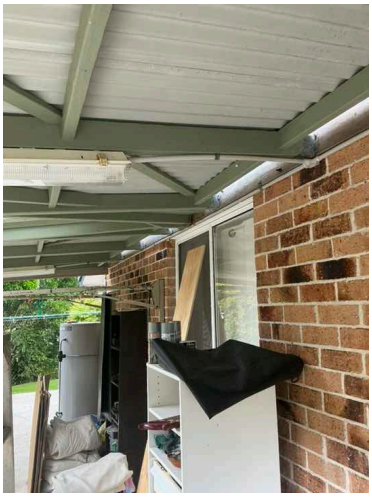
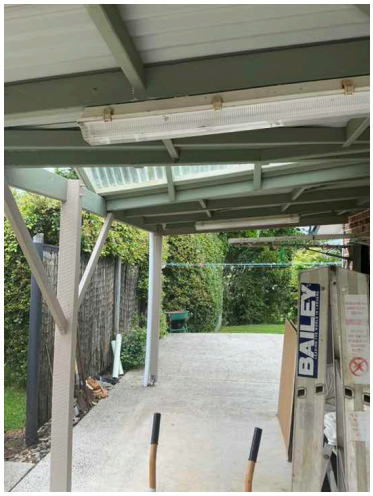
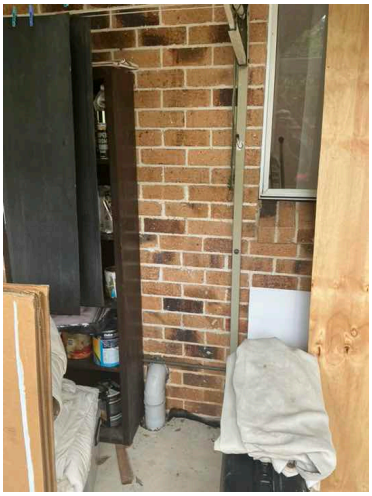
Carport

The overall condition of the carport is serviceable for the age.

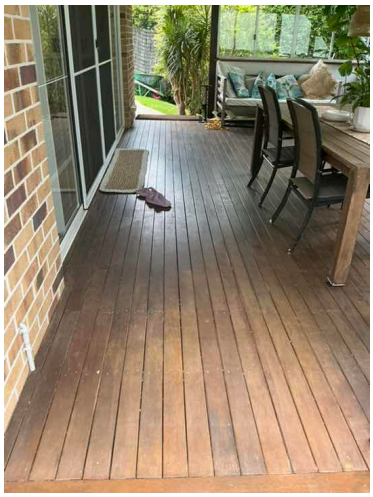
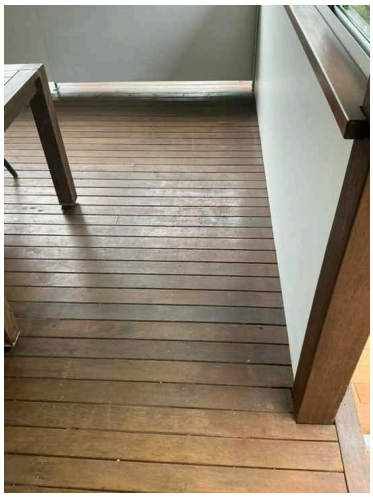
Though we are not structural engineers the balcony/s appear to be in a serviceable condition.

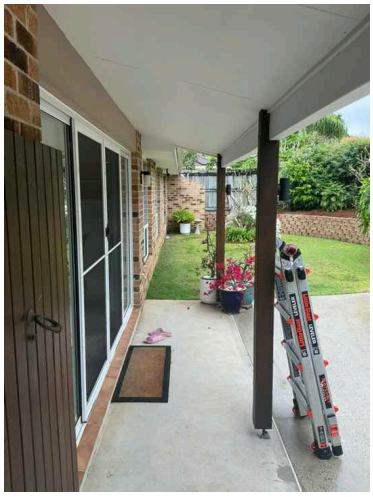
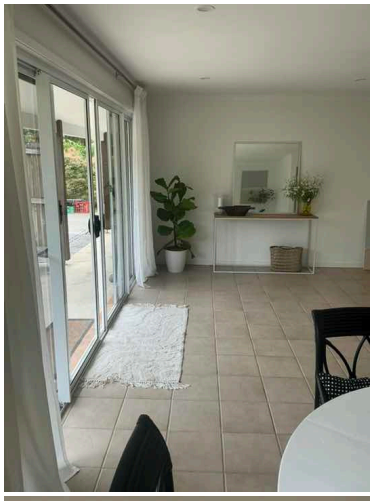
Front Entry Doors

The doors are in serviceable condition with no notable defects observed.

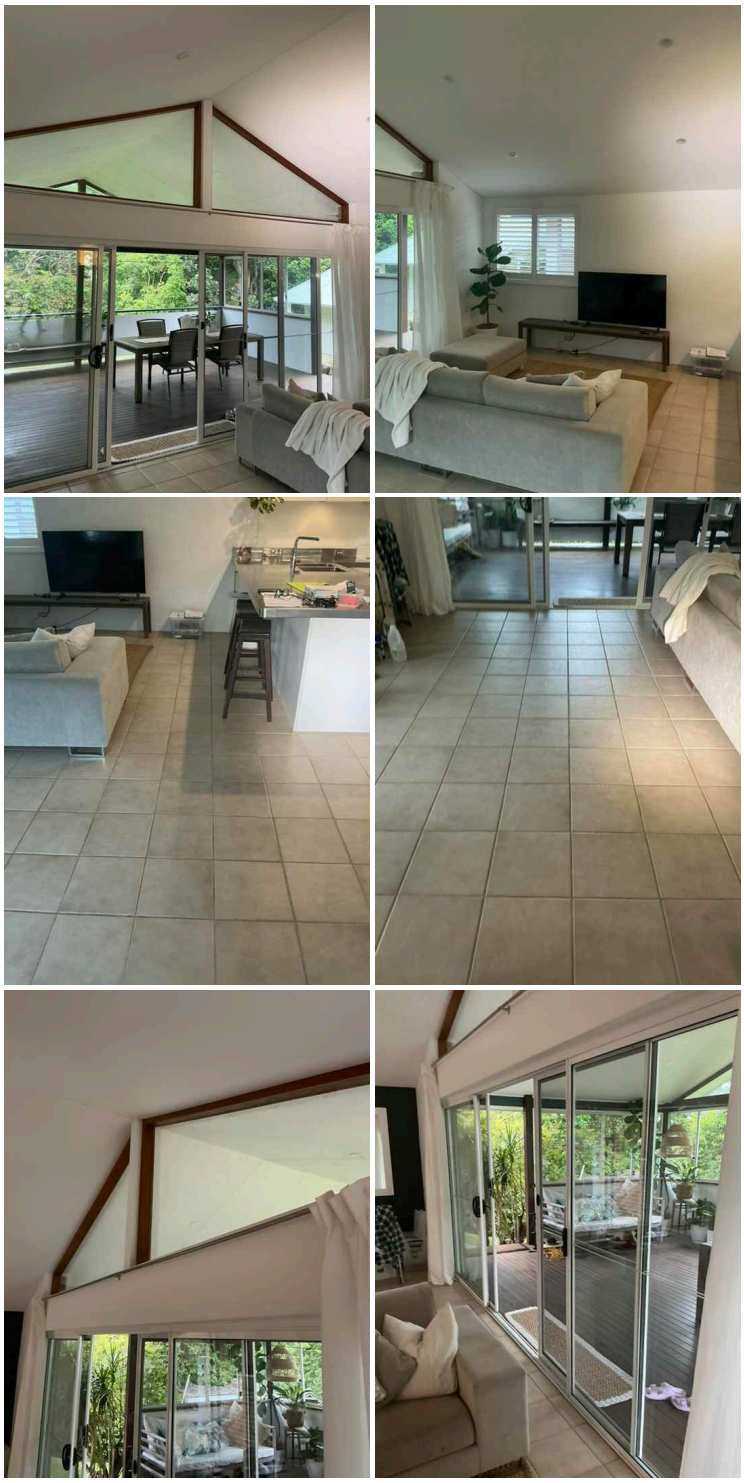
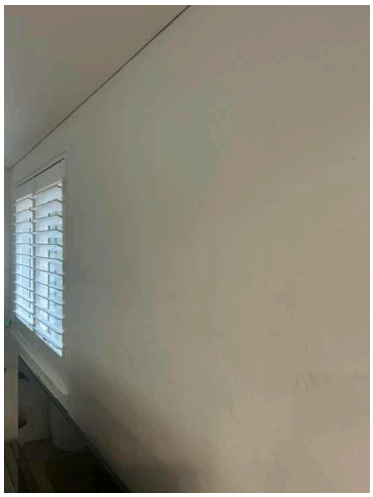
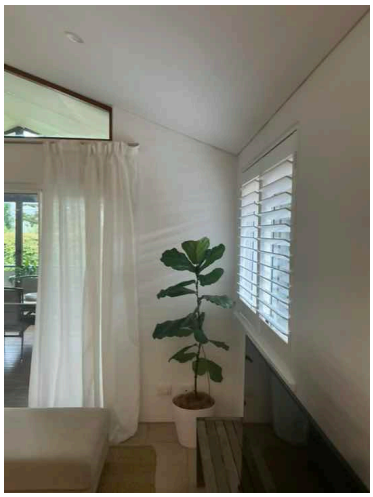
Combined Living & Dining

From the visible and accessible areas, this room appears to be in a serviceable condition for the age of the property with no notable structural defects sighted.

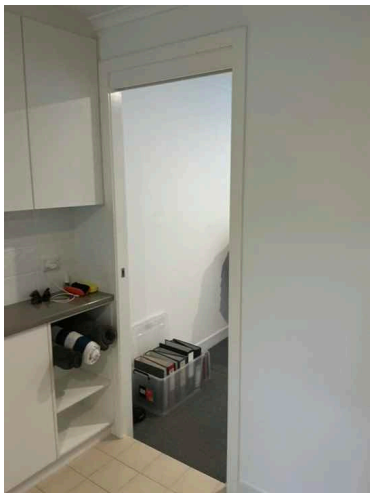
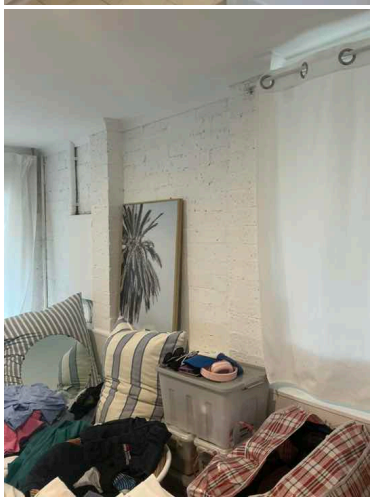
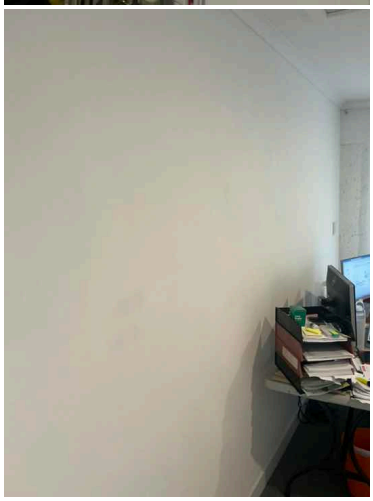
Study

From the visible and accessible areas, this room appears to be in a serviceable condition for the age of the property with no notable structural defects sighted.

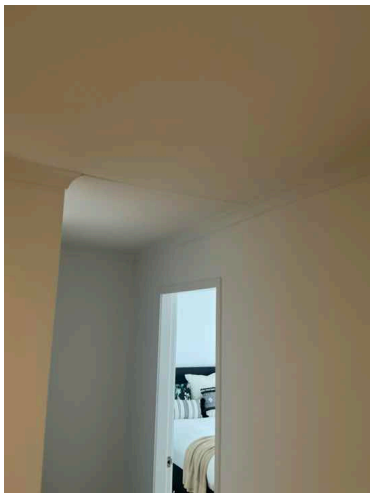
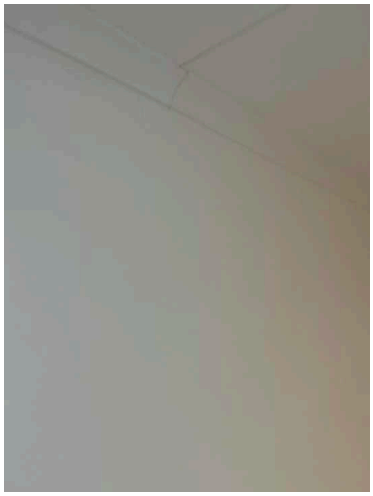
Hallway/s

On inspection, defects were present that will require further assessing and recommendations by a qualified trades persons, please read below for details.

Upon visual inspection, a vertical crack is visible on the wall. It is recommended to have a licensed plasterer assess and repair the crack to prevent further damage. Ensure the area is properly sealed and repainted to maintain structural integrity and aesthetics.

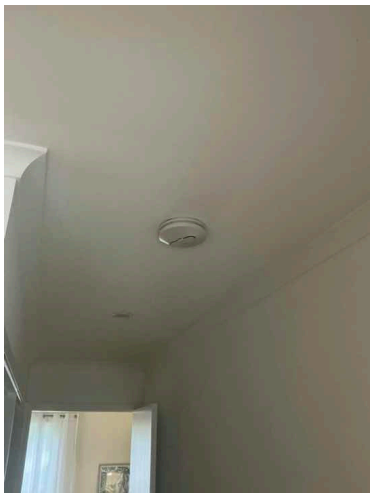
Ceiling

#3. Settlement Cracks Noted. These are typical and generally patch and paint will suffice, however monitoring these cracks is advised for 12 months and if they become worse, further investigation by a suitably qualified professional is advised.

#4. Settlement Cracks Noted. These are typical and generally patch and paint will suffice, however we recommend you monitor these cracks and if they become wider or longer, you will need to contact a structural engineers to assess.

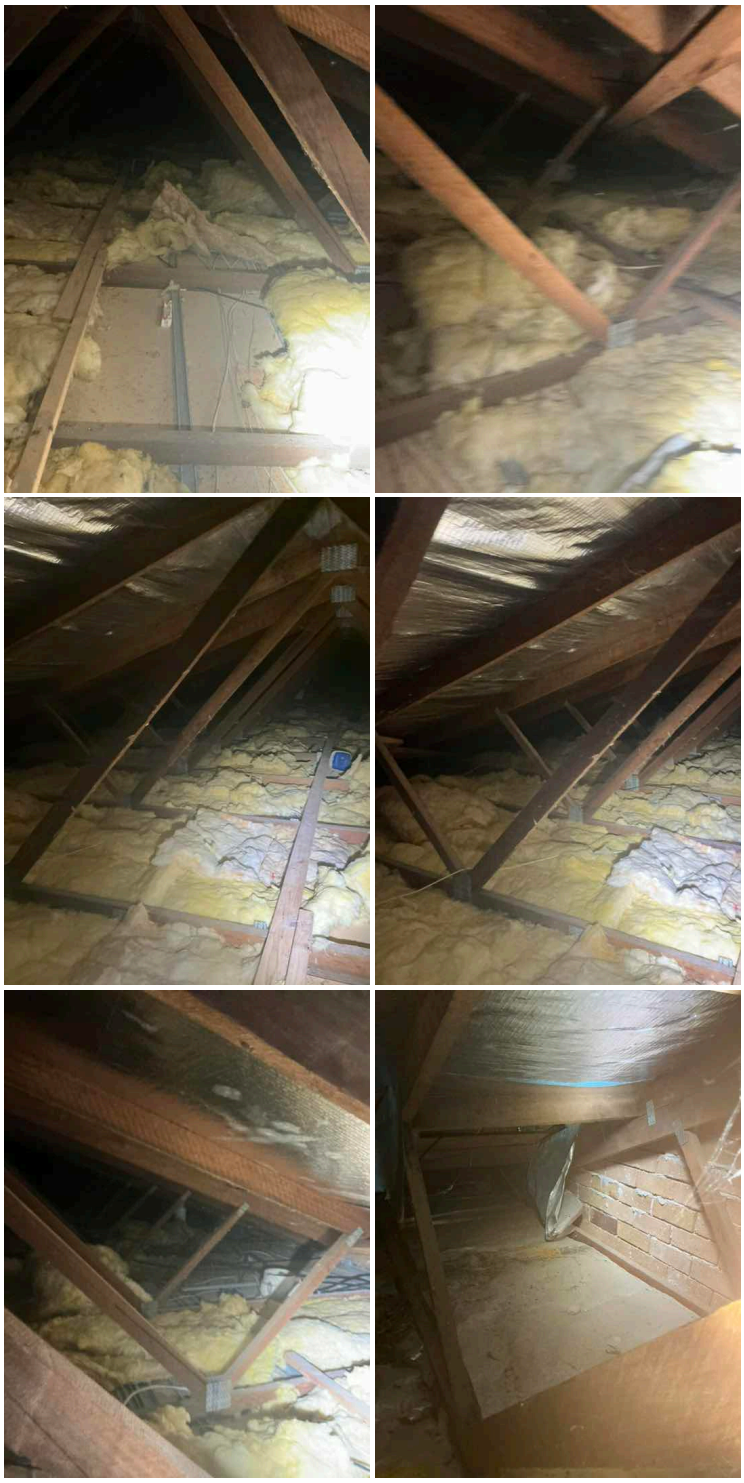
Sarking is installed.
#5. Sarking deteriorated/ damaged / aged in some sections. A qualified roofing contractor should be engaged for advice and recommendations.

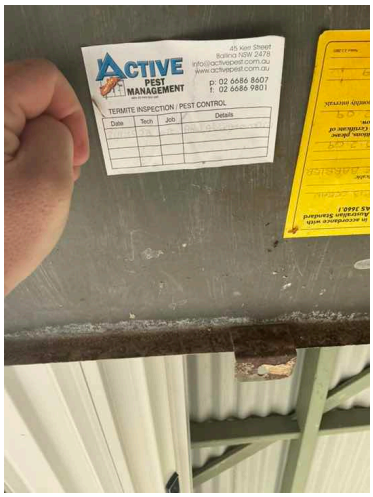
Was a Treatment Notice Found

Yes, a durable notice was found in the meter-box
during the inspection.
