Building and Pest Report

33 Karalauren Crt, Lennox Head

Inspection Report

Pest And Building Inspection

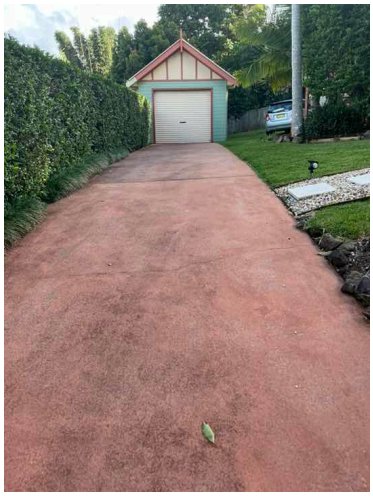
Driveway

On visual inspection, the general condition of the driveway is serviceable.
Common cracks were observed on the driveway. Whilst these cracks appeared to be typical at the time of inspection, we strongly recommend you monitor these cracks and if worsening occurs contact a concreter for further advice.

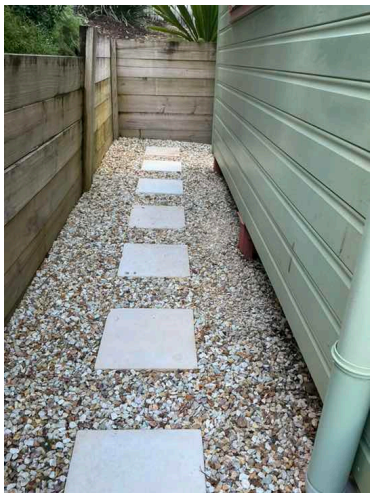
The paths around the home are in a serviceable condition for the age of this dwelling with no major defects visible.

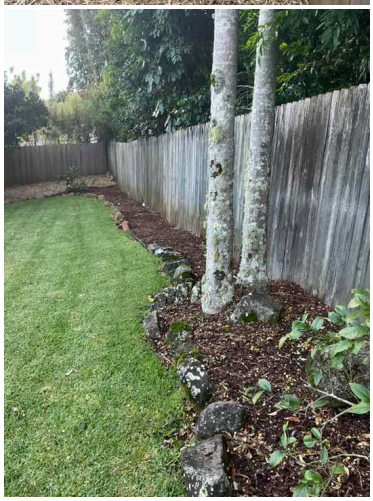
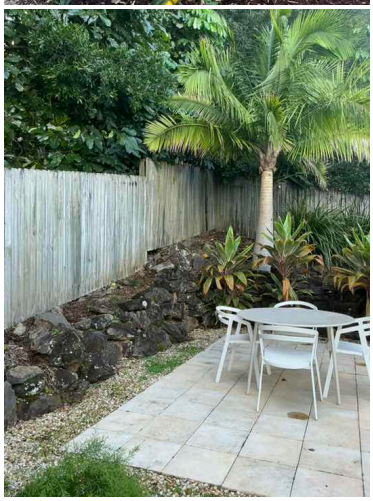
Of the visible areas, the general condition of the fences and gates is serviceable for the age of dwelling.

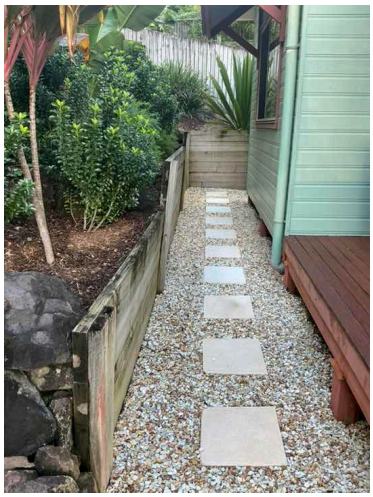
Retaining Walls

#1. Retaining wall leaning due to deterioration and age. A qualified brick layer should be engaged for advice and recommendations.

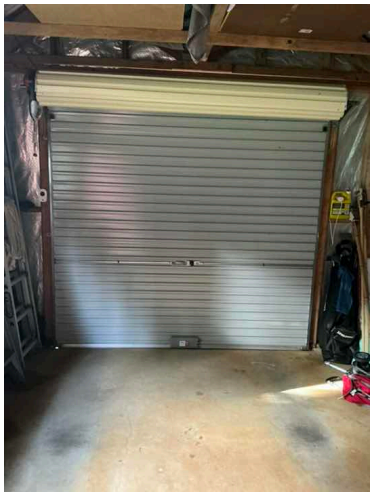
The shed is in fair usable condition.

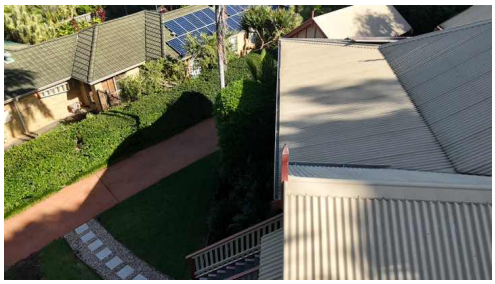
Of the visible areas, the general condition of the roof is in serviceable condition for the age.
Note: In the absence of rainfall there is no guarantee that the roof won't leak.

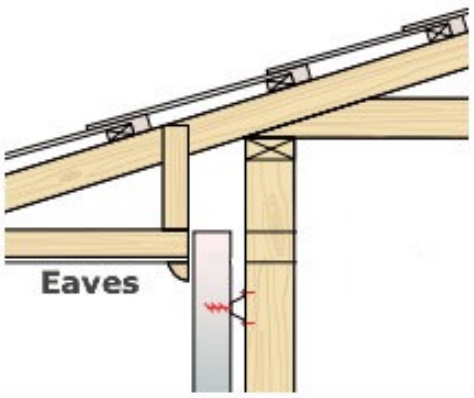
The soffit lining (eaves) are in a serviceable condition with no notable defects.

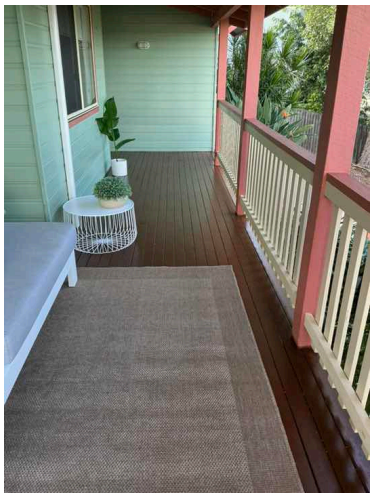
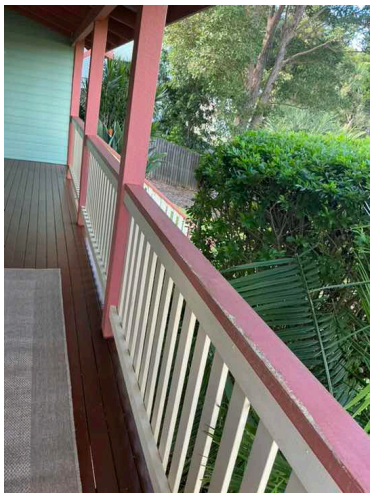
The entry porch serviceable or in reasonable or condition for the age of this dwelling.

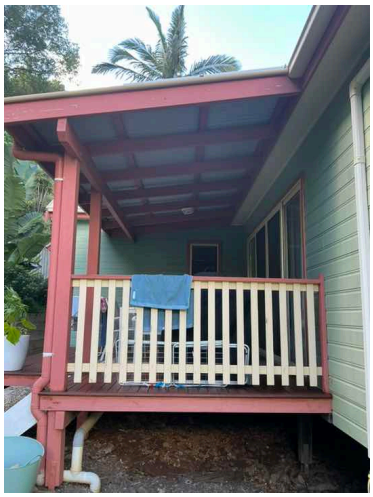
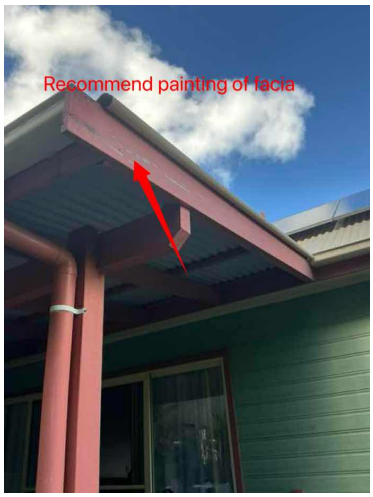
#2. Paint / finish was deteriorated in areas and is in need of maintenance - Sanding back affected areas and painting required.
Upon visual inspection, the fascia board shows signs of peeling paint, indicating potential weather exposure. Recommend sanding and repainting to protect the wood.

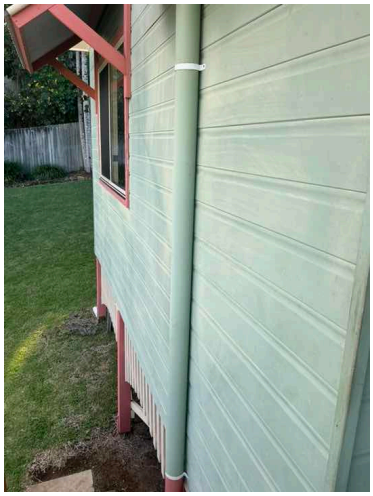
#3. Paneling/cladding damaged. Have a suitably qualified tradesman assess and repair.

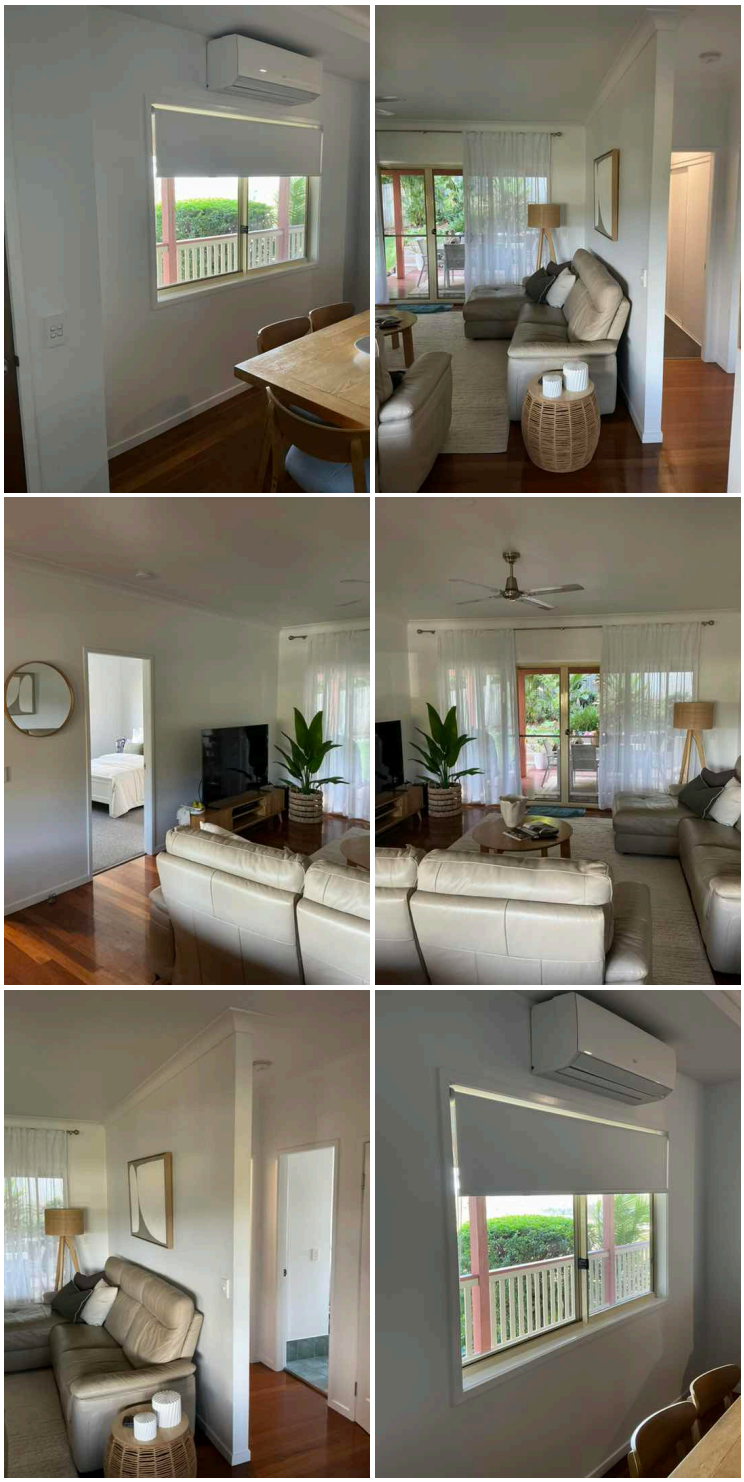
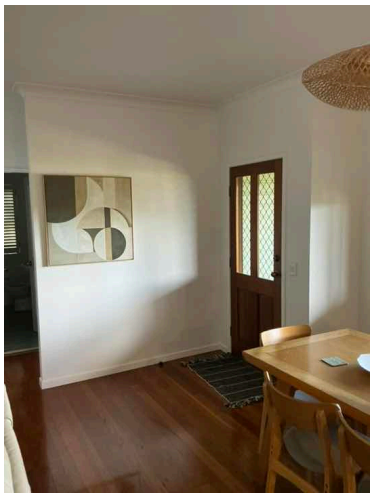
From the visible and accessible areas, this room appears to be in a serviceable condition for the age of the property with no notable structural defects sighted.

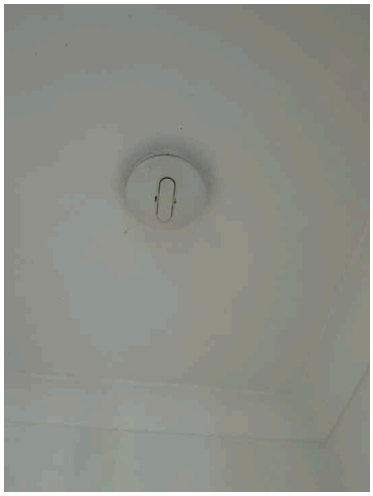
From the visible and accessible areas, the hallways/ appears to be in a serviceable condition for the age of the property with no notable structural defects sighted.

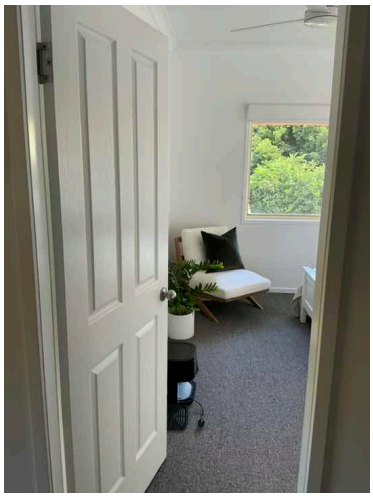
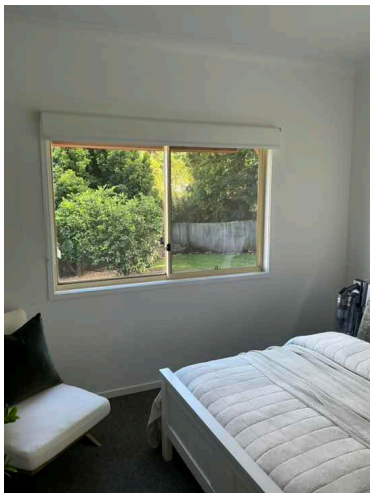
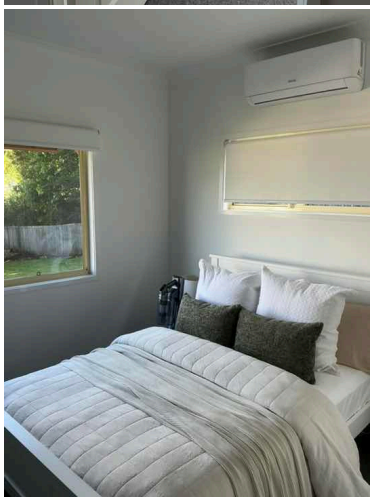
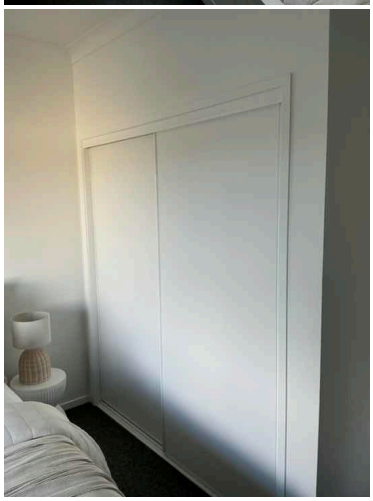
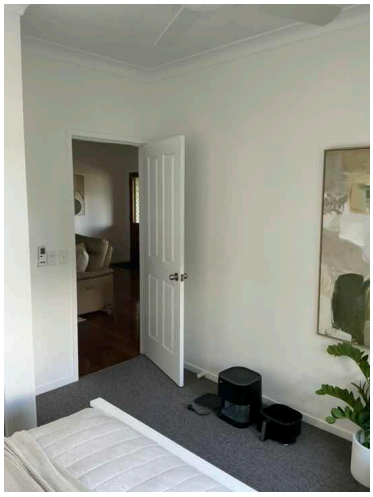
From the visible and accessible areas, this bedroom appears to be in a serviceable condition for the age of the property with no notable structural defects sighted.

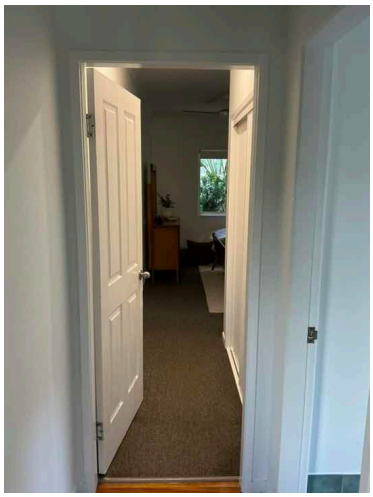
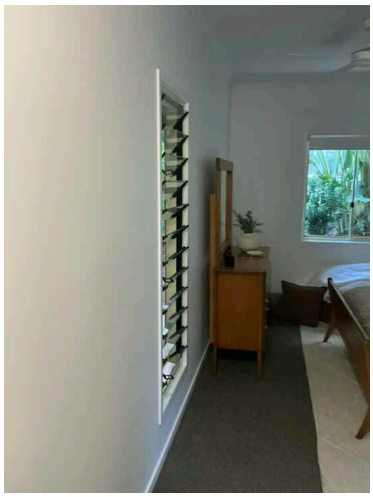
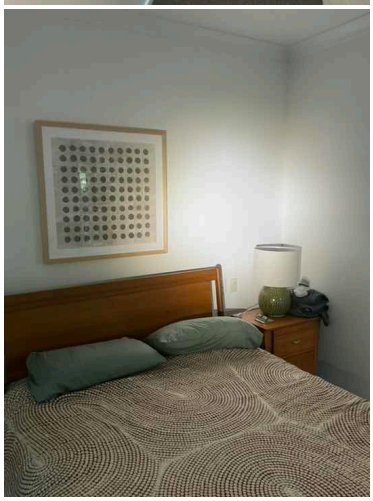
From the visible and accessible areas, this bedroom appears to be in a serviceable condition for the age of the property with no notable structural defects sighted.

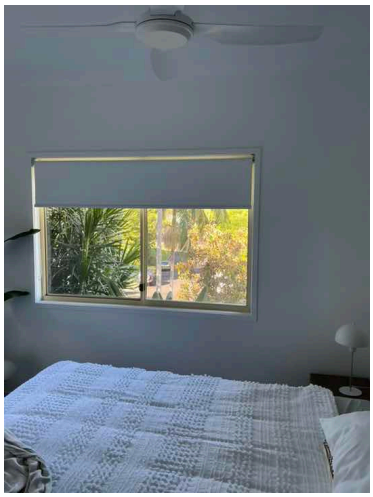
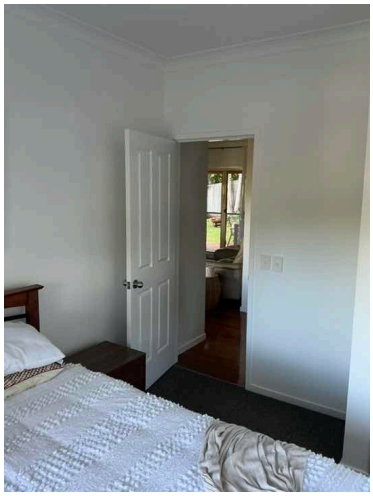
From the visible and accessible areas, this bedroom appears to be in a serviceable condition for the age of the property with no notable structural defects sighted.

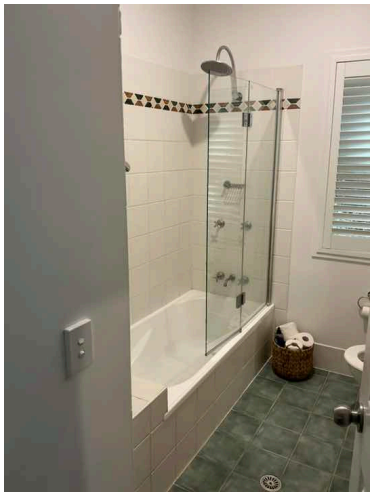
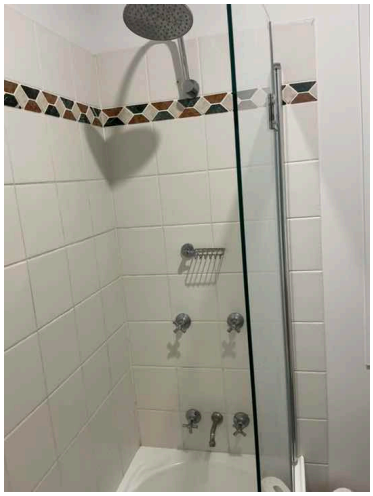
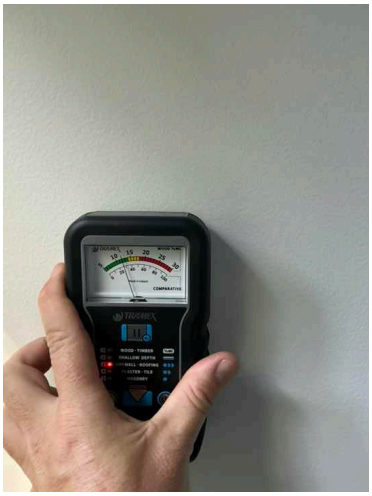
Of the visible areas, the general condition of this bathroom is serviceable or in reasonable condition for age of dwelling.

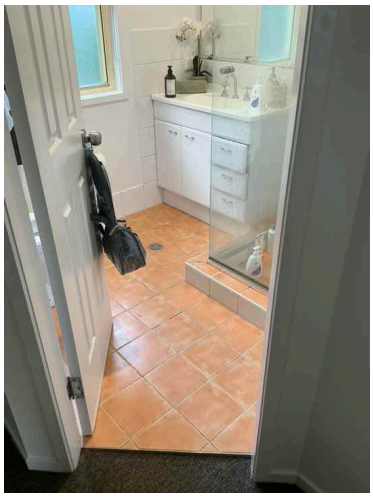
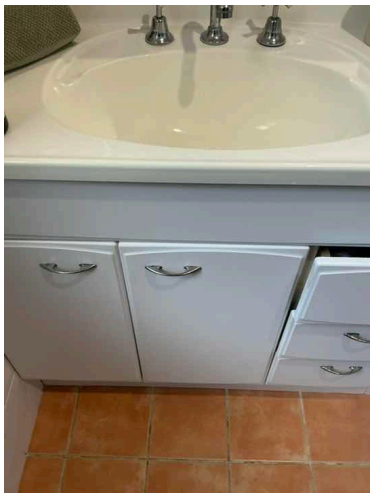
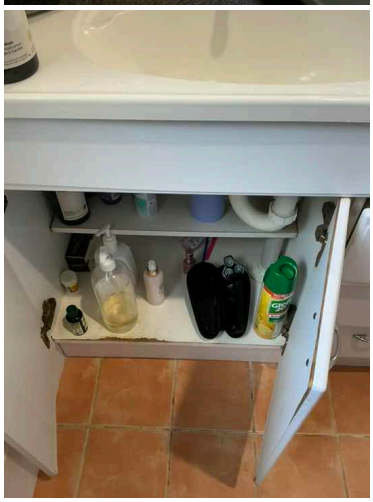
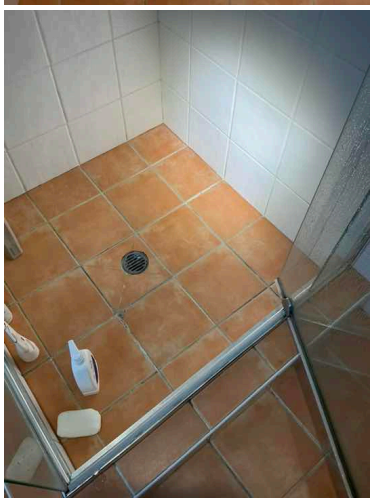
Upon visual inspection, there is water staining on the subfloor indicating a possible leak. It is recommended to have a licensed plumber inspect and repair the plumbing to prevent further water damage. Additionally, assess the surrounding materials forany signs of mold or rot and replace if necessary.

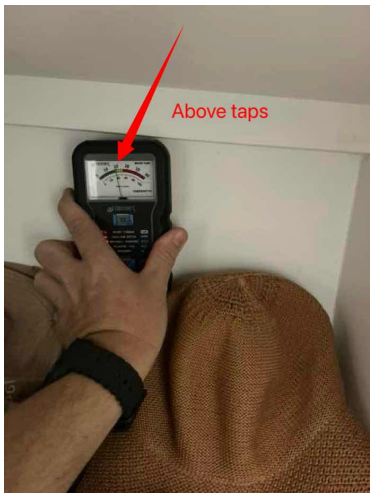
Below taps very high
Moisture

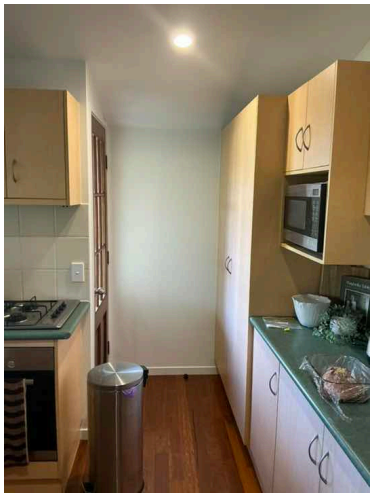
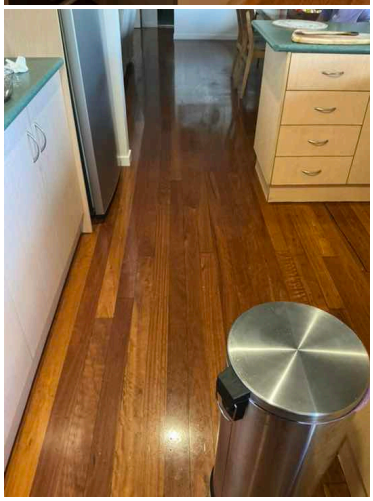
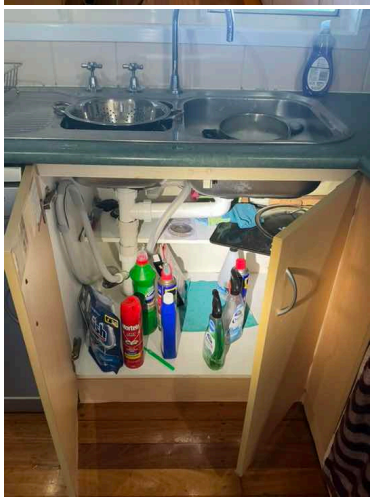
Of the visible areas, the general condition of the kitchen and pantry is serviceable or in reasonable condition for age of dwelling.

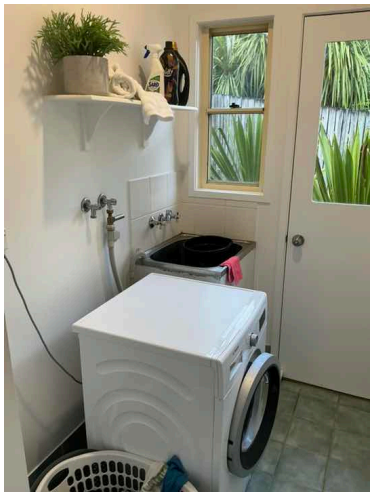
Appliances and the like restricted a full visual inspection.

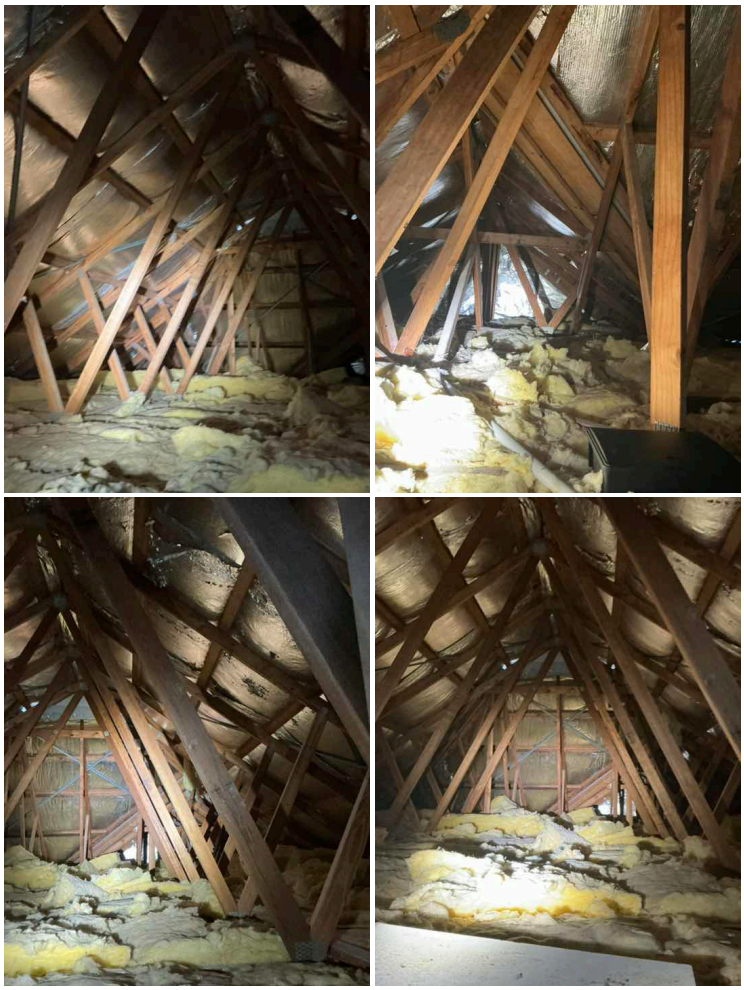
There is insulation present in the roof space/void. This is preventing a full inspection of ceiling joists from being undertaken. It is strongly recommended that full access be gained as it could be harbouring timber pest activity, damage or defects.

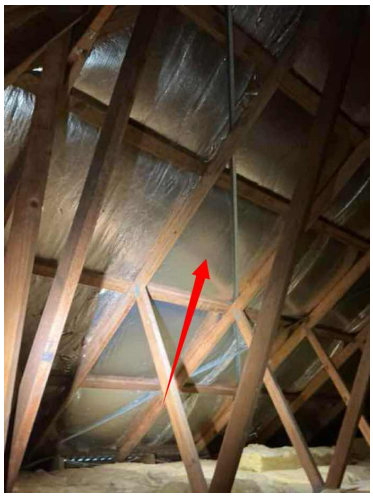
The roof space is insulated with fibreglass batts.

Where visible and accessible, the insulation appears to be in a serviceable condition.

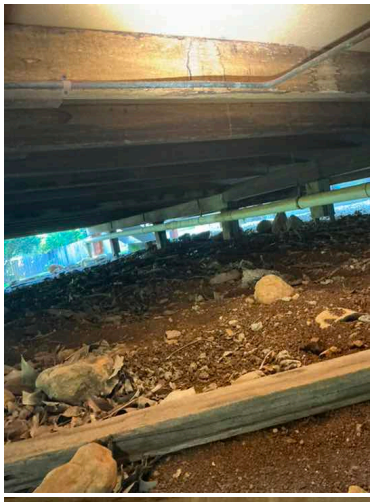
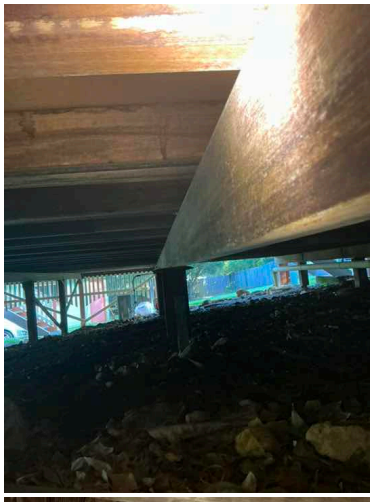
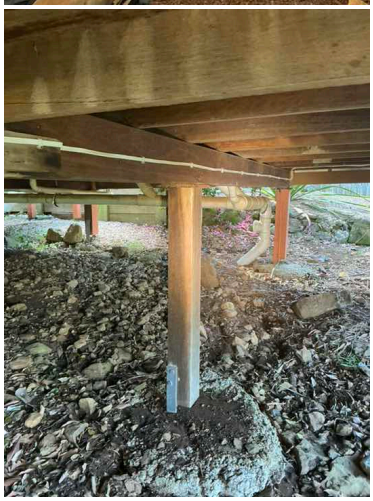
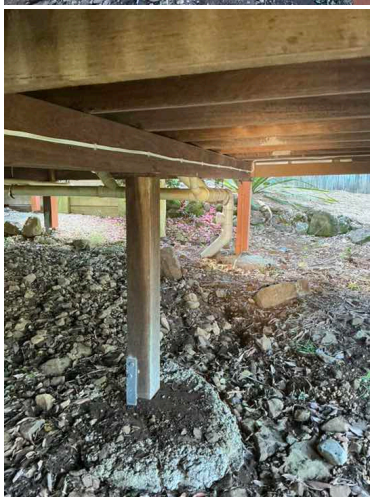
Of areas accessible and visible, the subfloor and components appeared to be in a serviceable condition.

#4. Damp/Moisture damage noted. Possible failed water proof membrane to shower area. Reconstruction of this area may be the best option long term. Contact a licensed builder for further evaluation.
