# Inspection Report

## Profile building and pest inspections

**4 Woodstock Ct Parkwood , Gold Coast , QLD**

### Pest And Building Inspection

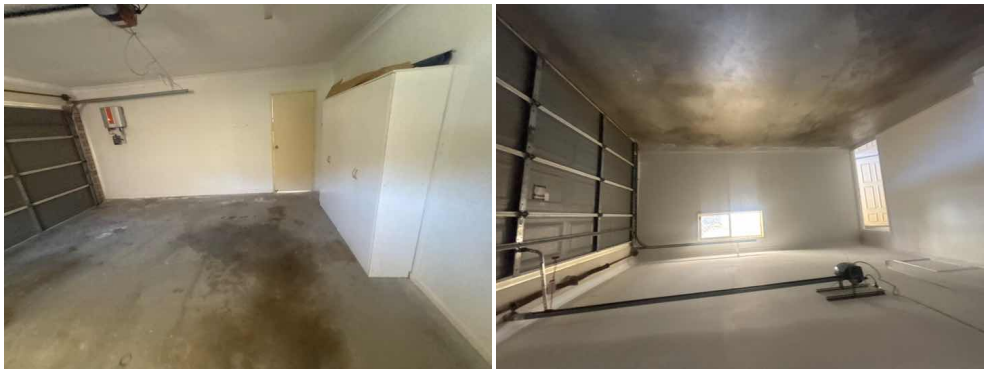
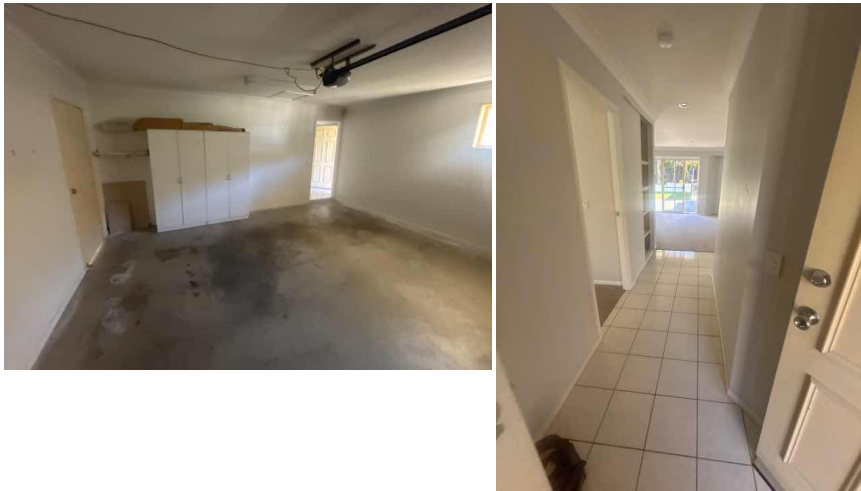
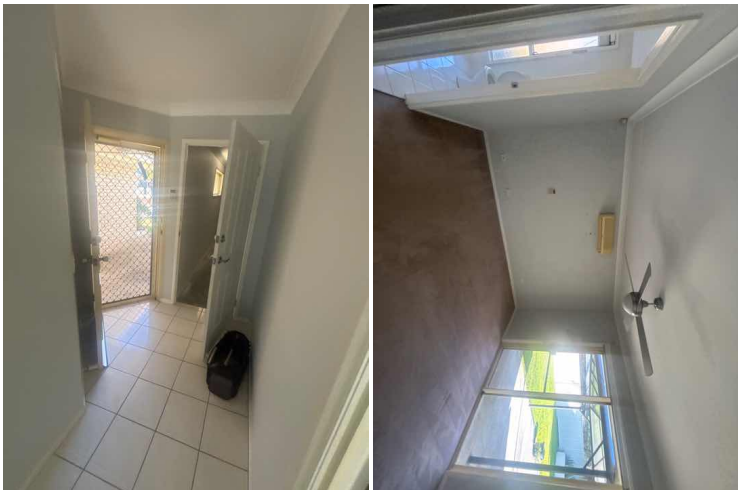
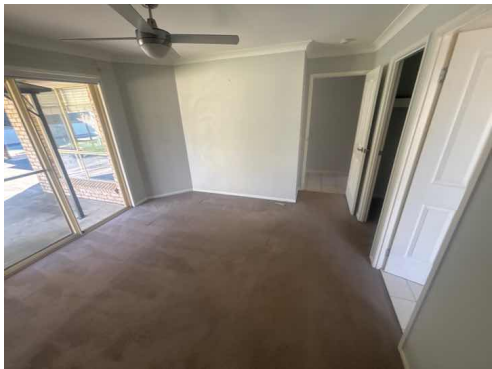
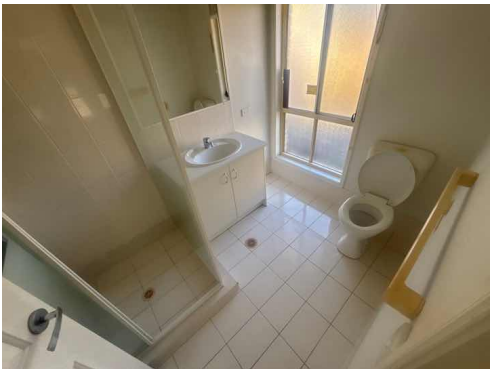
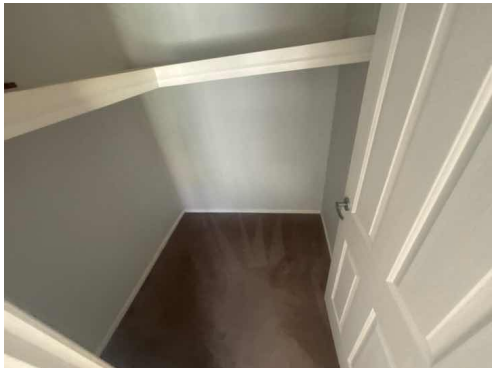
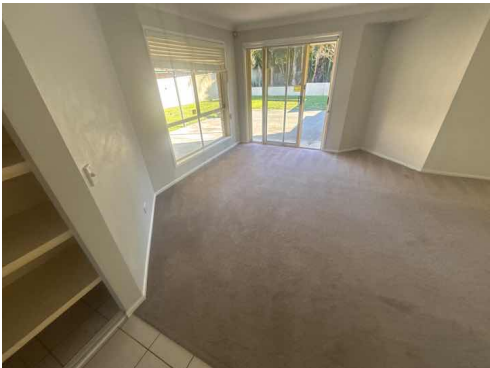
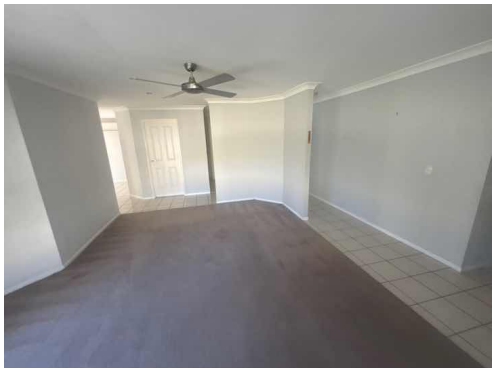
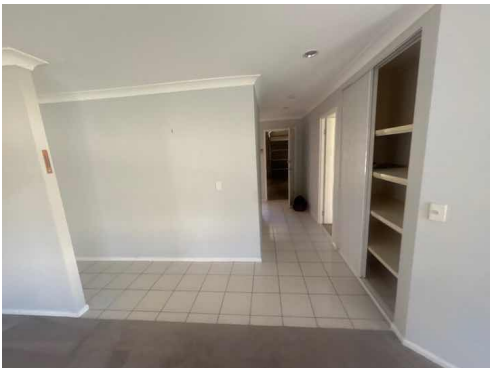
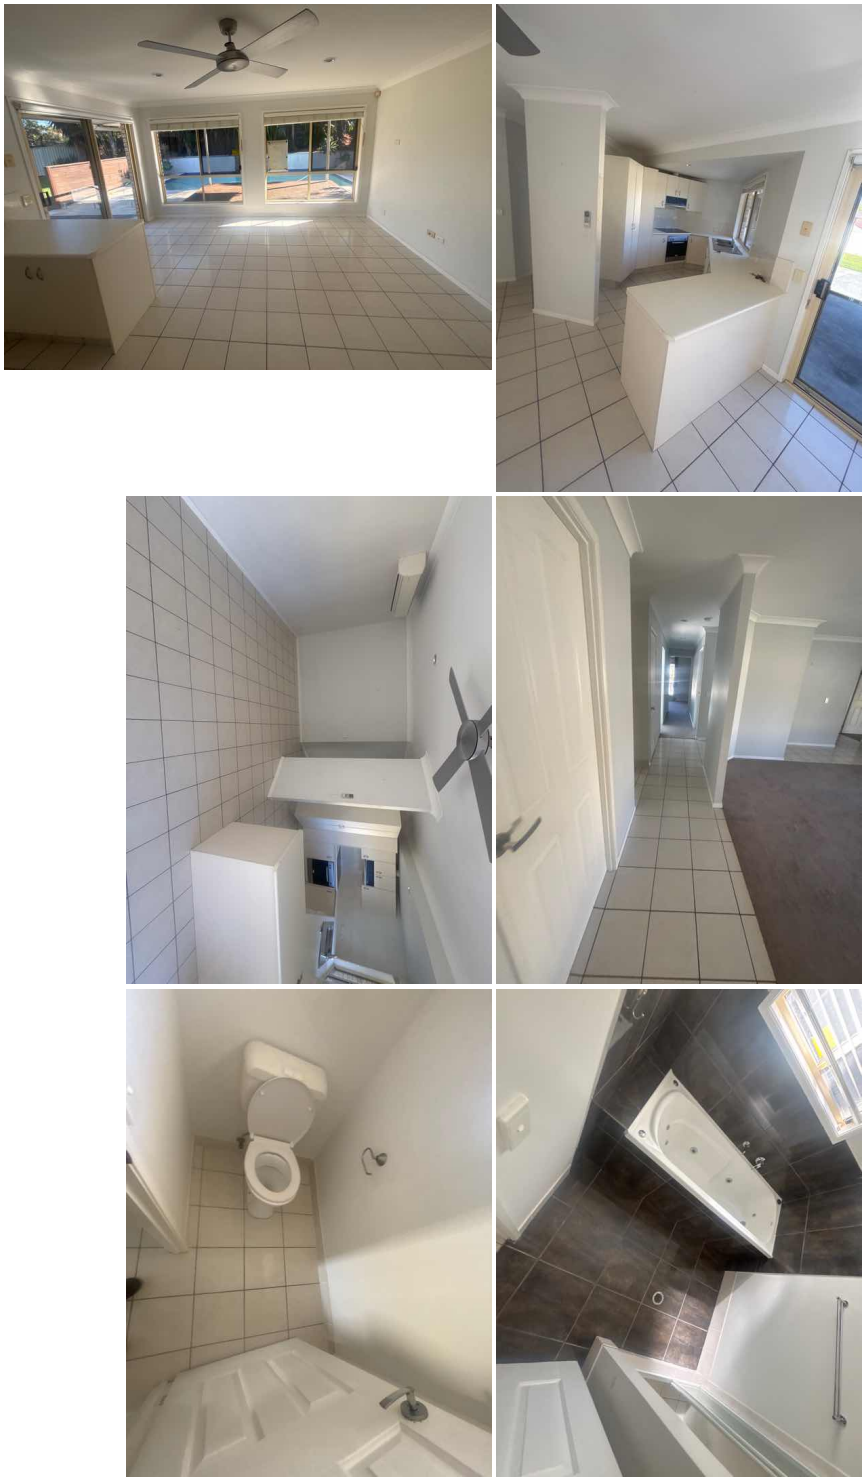
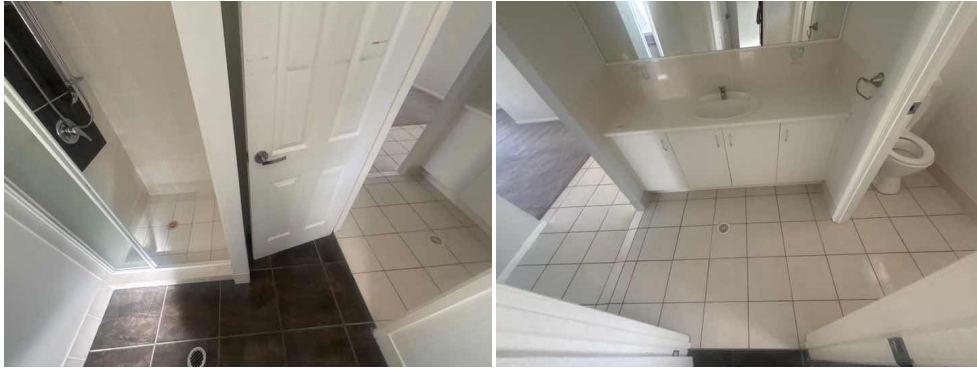
Inspection restricted due to, but not limited to floor coverings, built in sections, wall and ceiling linings, voids in built in cupboards, cavity walls, Flooring systems, bathtubs and ducts etc.

Inspection restricted due to window furnishings

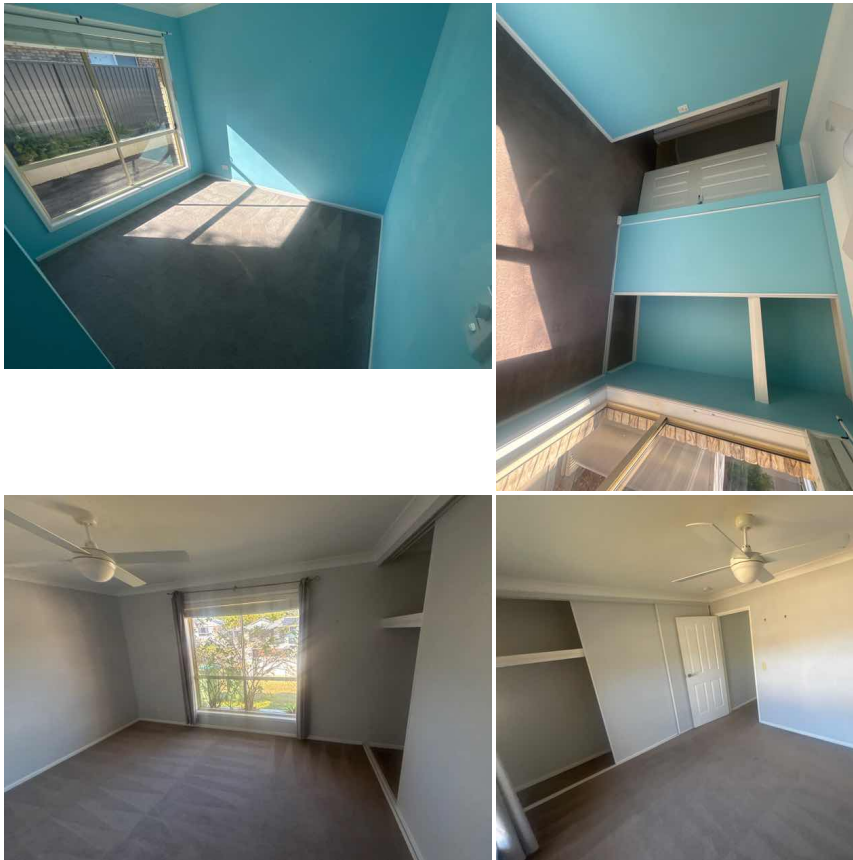
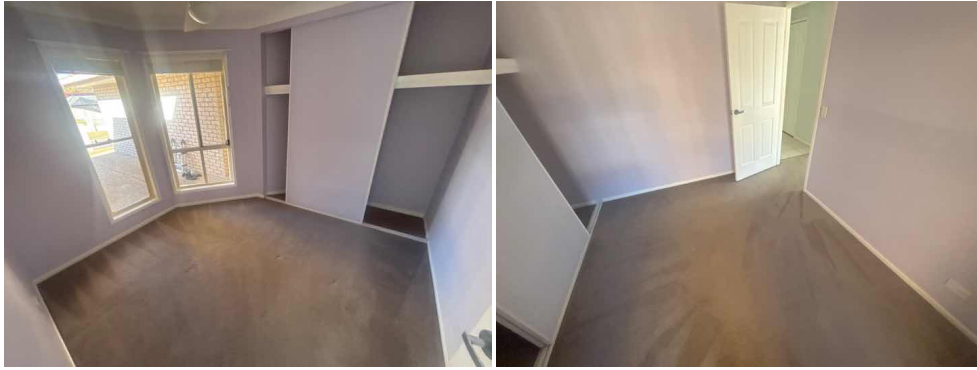
Inspection restricted due to floor coverings, built in sections, wall and ceiling linings, voids in built in cupboards, bathtubs and ducts.

Inspection restricted due to window furnishings

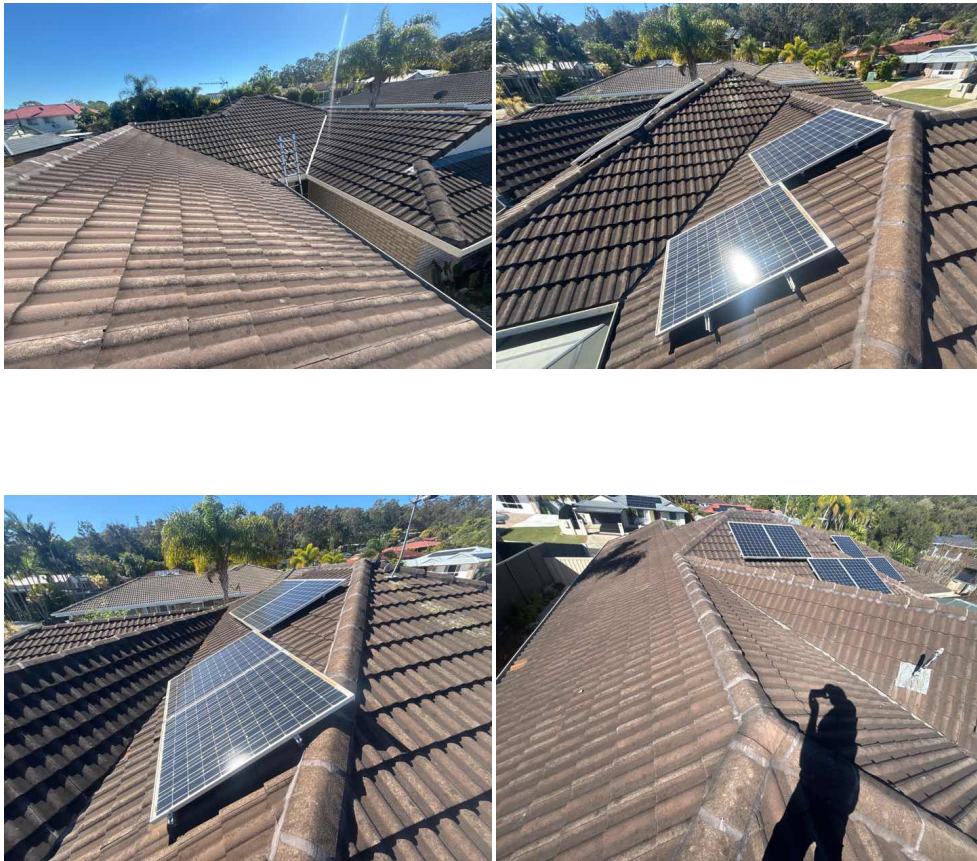
## Roof surface

Solar panels restricted visual inspection

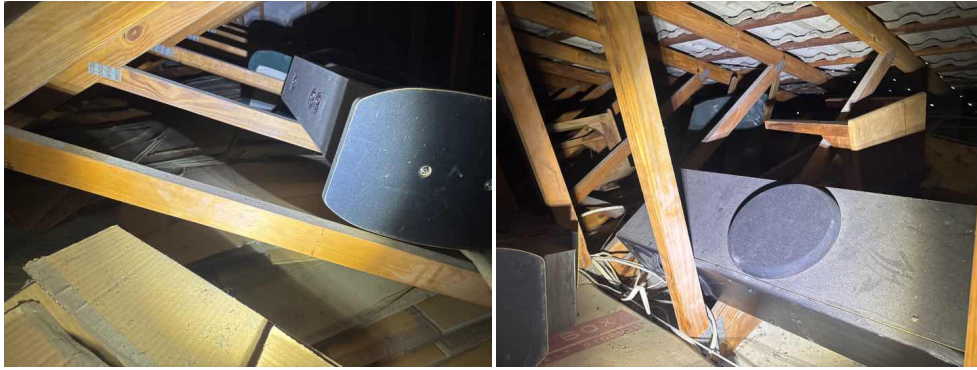
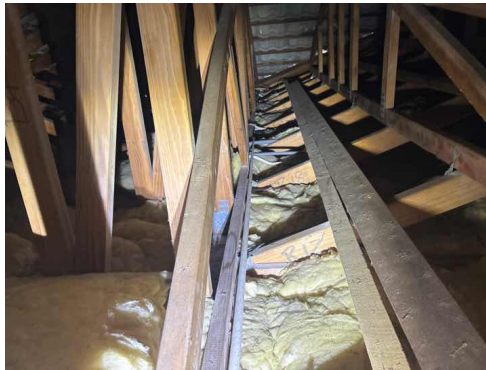
## Roof void

Visual inspection restricted to eaves due to design

Visible inspection restricted due to ceiling batts

Inspection restricted due to storage

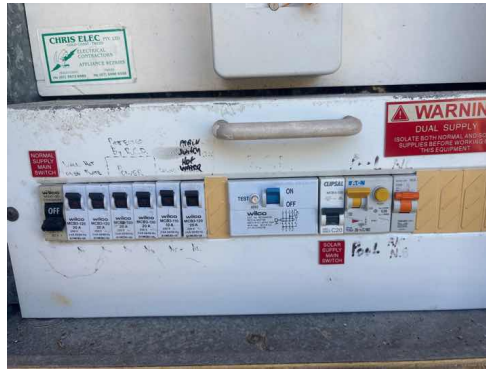
## Safety Switch

A safety switch was cited but is not checked or tested.

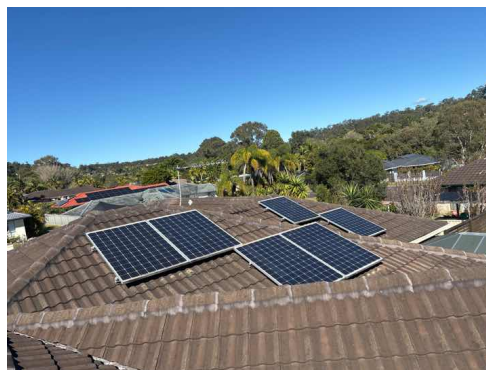
## Solar panels

Solar panels sighted. The solar system was NOT tested during the inspection. it is strongly recommended that a licenced contractor specialising in Solar installations check the system for any defects or deficiencies.
