# Inspection Report

## Profile building and pest inspections

**1/16 Cassia Dr Coomera , Gold Coast , QLD**

### Pest And Building Inspection

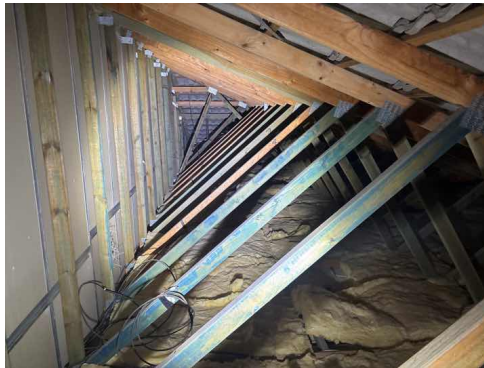
Visible inspection restricted due to ceiling batts

Inspection was limited to some areas due to the design of the roof structure restricting access

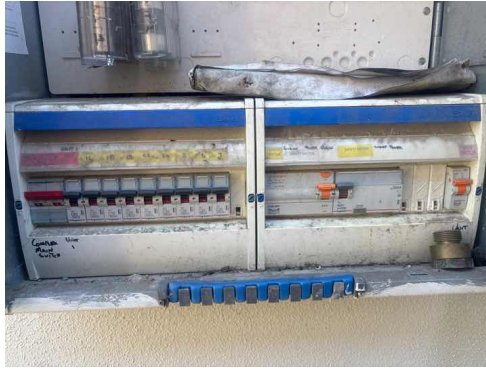
## Safety Switch

A safety switch was cited but is not checked or tested.
