# Inspection Report

## BPP Inspections

**21 Ellerdale St, Aspley, QLD**

### Pest And Building InsP-ection

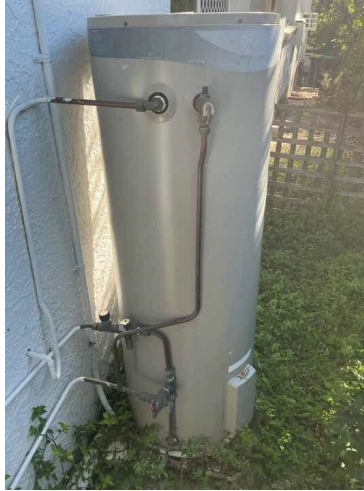
The hot water system appears to be in a serviceable condition. No specific tests other than running the hot water from a tap was carried out. No determination has been made as to the suitability or adequacy of the hot water system in relation to capacity or otherwise.

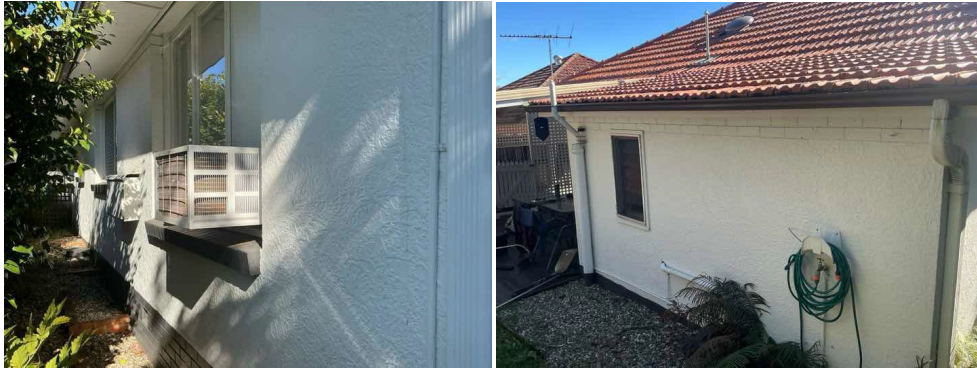
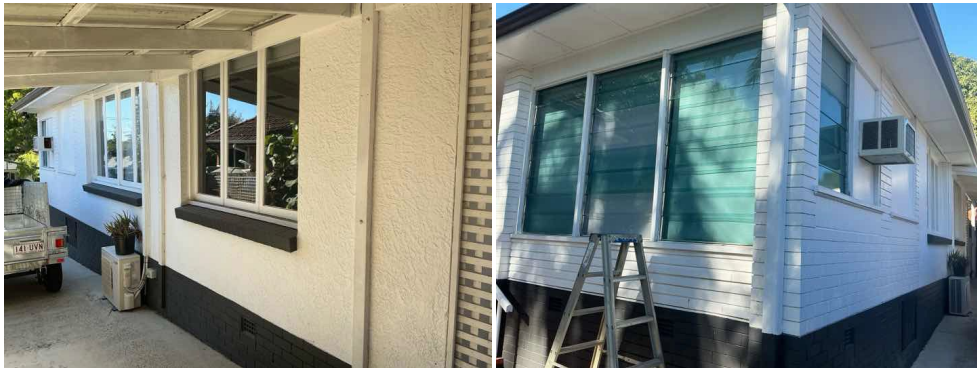
On visual inspection, the general condition of the exterior walls is serviceable for the age.

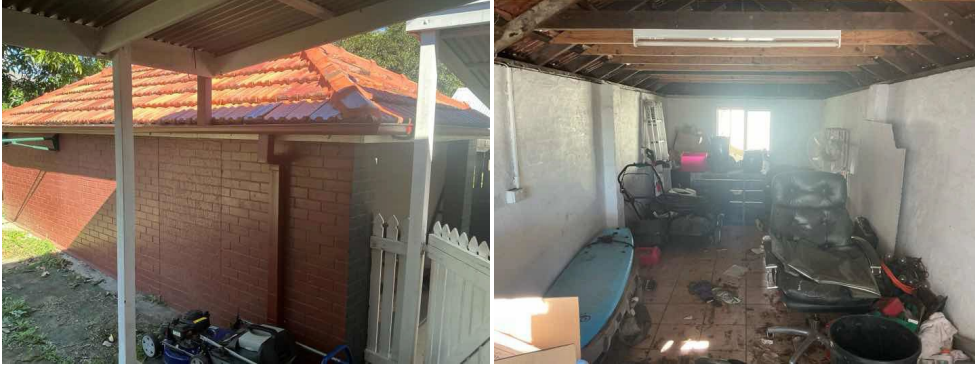
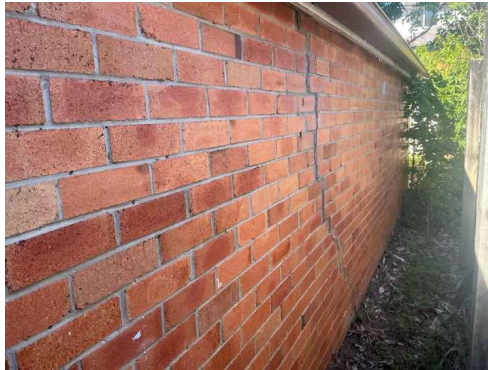
Of accessible and visible areas, the garaging is considered to be in a serviceable condition.

Crack visible to brick wall.

Termite damage to ceiling Timbers.

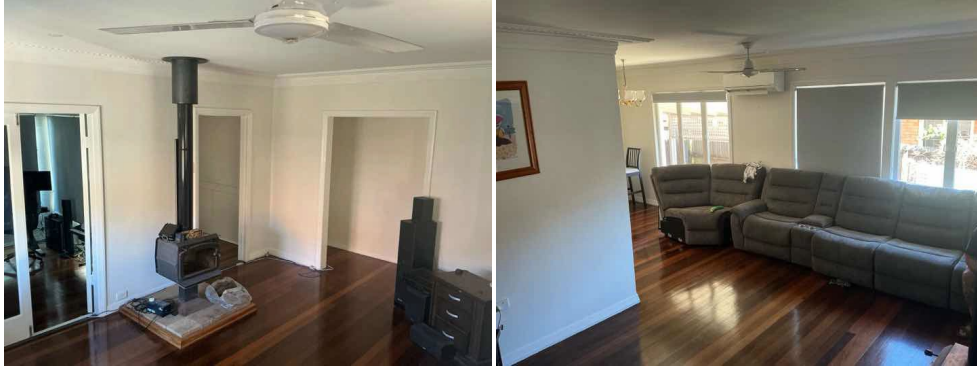
#4. Ceiling paint flake/deterioration is evident. Recommendations: General maintenance / painting as required.

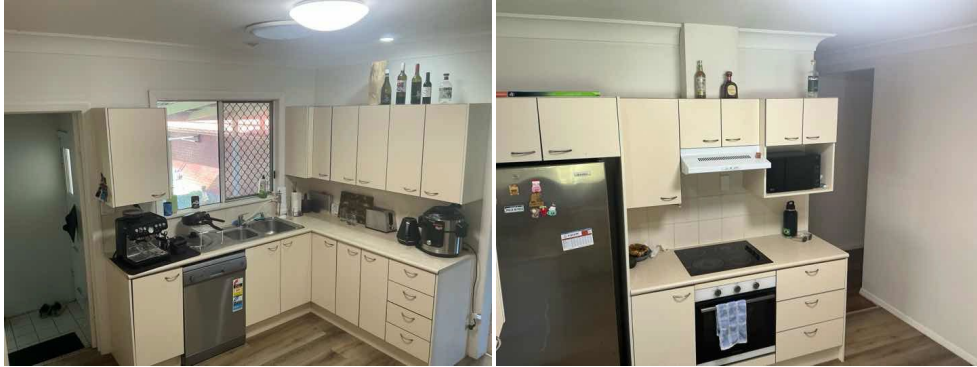
Of the visible areas, the general condition is serviceable or in reasonable condition for age of dwelling.

#5. Adjustment to cabinet doors required, in some instance hinges may need to be replaced.

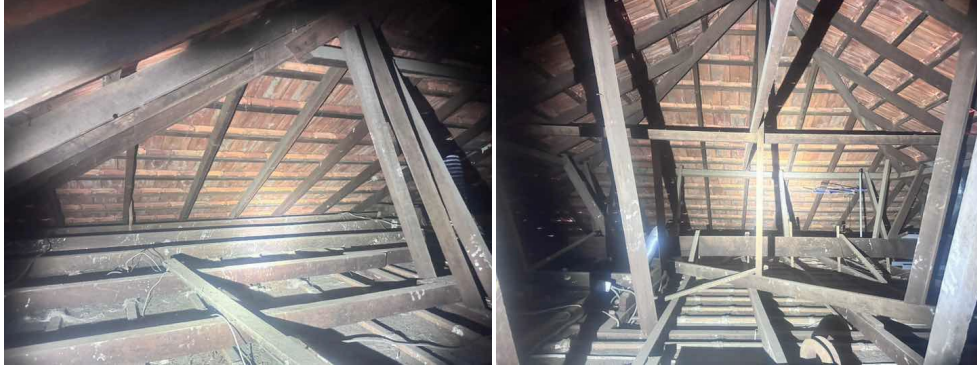
Visible sections of the roof void is in a serviceable condition for age of this dwelling.

#8. Age and decay visible to the locating lugs on the tiles. This can be common with aged terracotta and monitoring for change is required. Terracotta roof tiles require special care when walked on, and decay on these lugs makes this more important.

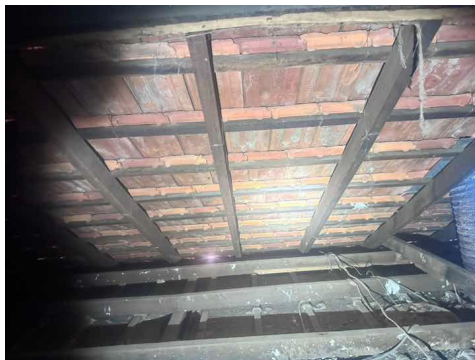
There is no sarking installed. Sarking is the layer of reflective film material installed during construction underneath the roofing material. It provides a moisture barrier and minimal insulation. The installation of sarking is not a building requirement.

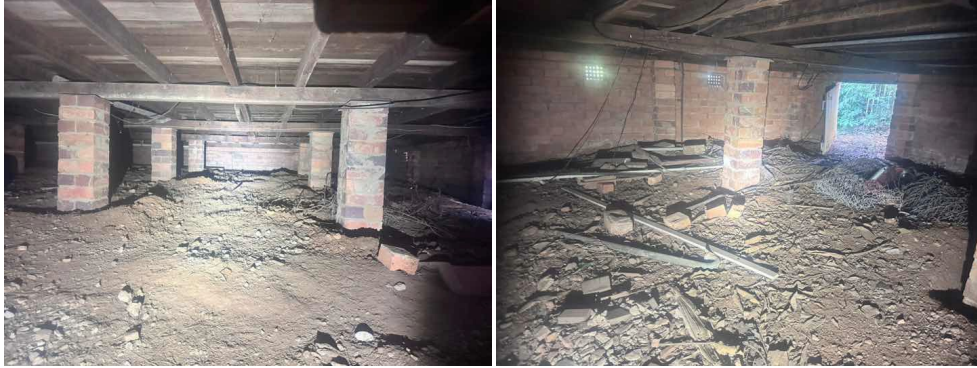
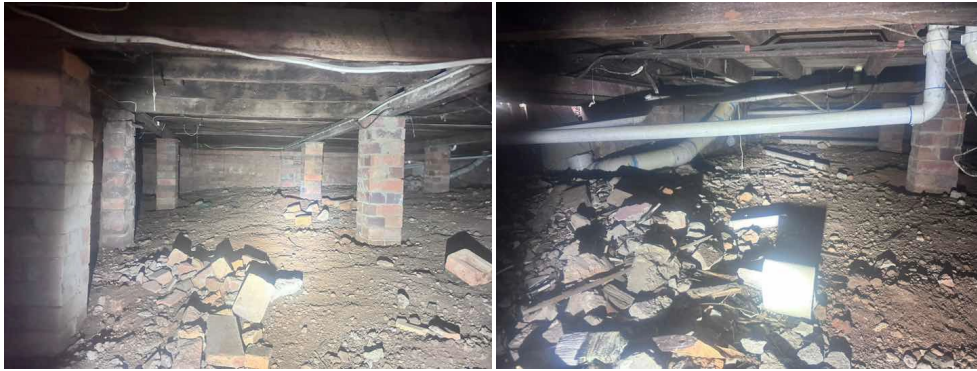
On inspection, defects were present that will require further assessing and recommendations by licensed and qualified trades persons, for example, a structural engineer, plumber, carpenter, electrician, plasterer may need to assess. Please read below for details.

#9. There is a split in the floor supporting joist below the bathroom.

This requires further support to prevent further damage and bathroom floor movement.

Contact a lic Builder/ Carpenter to assess and repair.

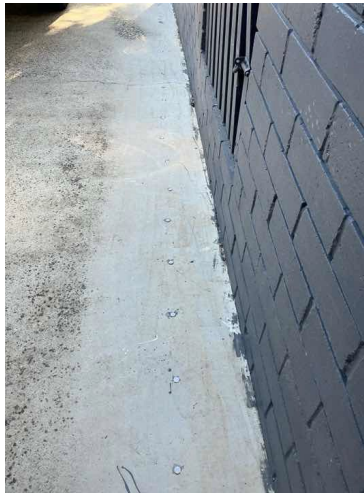
Yes, Drill Holes (Chemical Treatment) was seen at the property

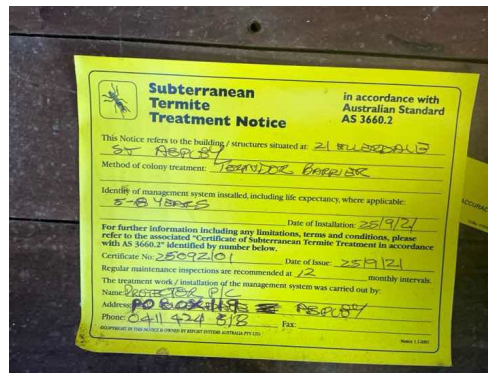
The durable notice is a permanent record of the previous treatment or termite barrier that has been carried out on a building.

We recommend that you read and understand this notice. Contact details should be clear. But regardless contact a licensed pest control technician to maintain the integrity of the barrier or treatment.
