# Seller disclosure statement

39 Victory Street, Zillmere QLD 4034

## Inspection Address

**39 Victory St, Zillmere, QLD**

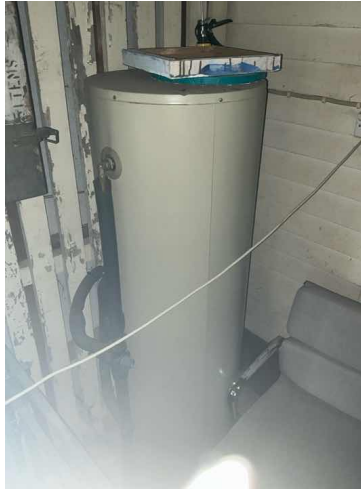
The hot water system appears to be in a serviceable condition. No specific tests other than running the hot water from a tap was carried out. No determination has been made as to the suitability or adequacy of the hot water system in relation to capacity or otherwise.

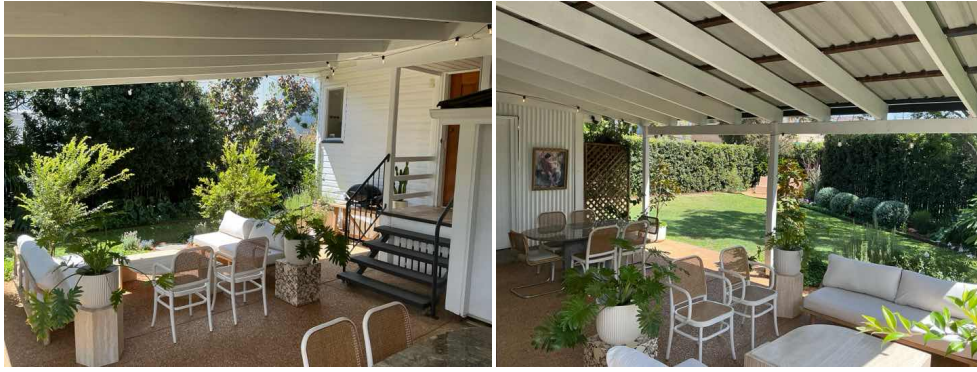
Visible sections of the Alfresco area are serviceable or in reasonable or condition for the age of this dwelling.

The connection of the pergola rafters to the main building fascia appear minimal. It cannot be determined the support behind the fascia that supports these connections. The rafter to fascia connections appear to be in a serviceable condition.

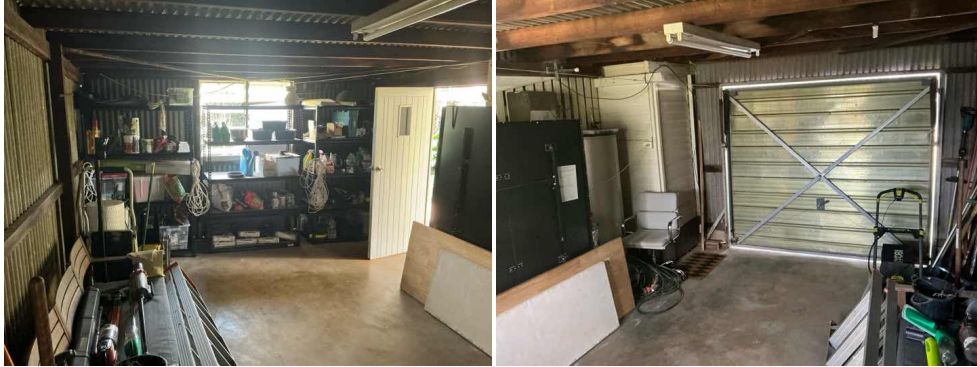
Of accessible and visible areas, the garaging is considered to be in a serviceable condition.

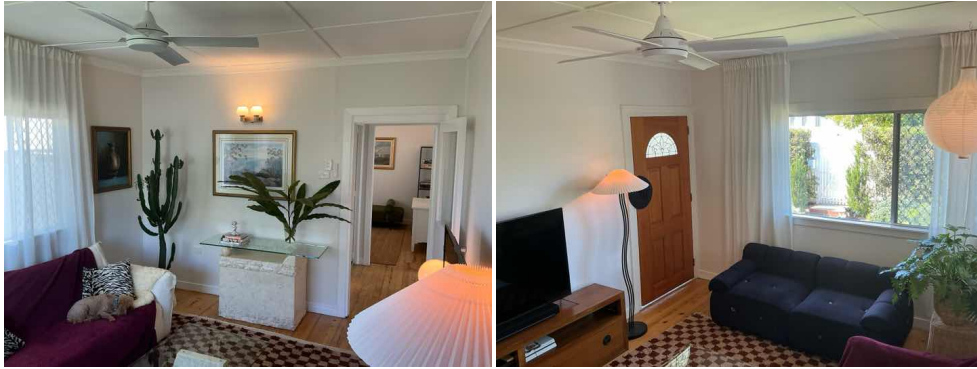
The lounge room is in serviceable condition with no notable structural defects sighted.

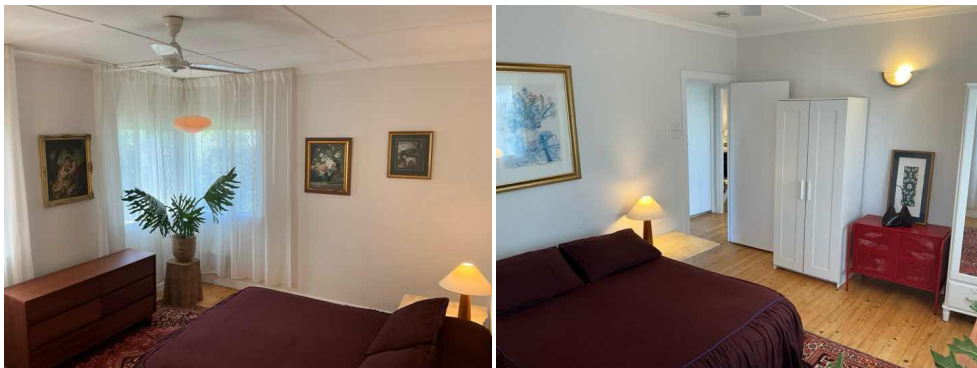
### Bedroom 1

This bedroom is in serviceable condition with no notable structural defects sighted.

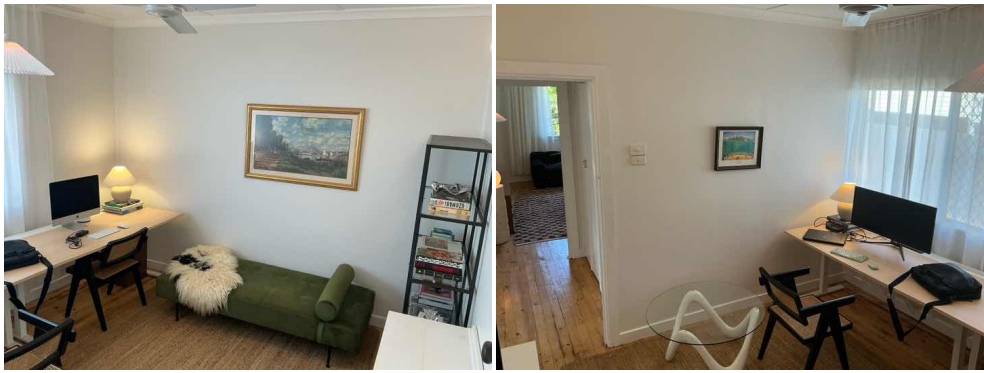
### Bedroom 2

This bedroom is in serviceable condition with no notable structural defects sighted.

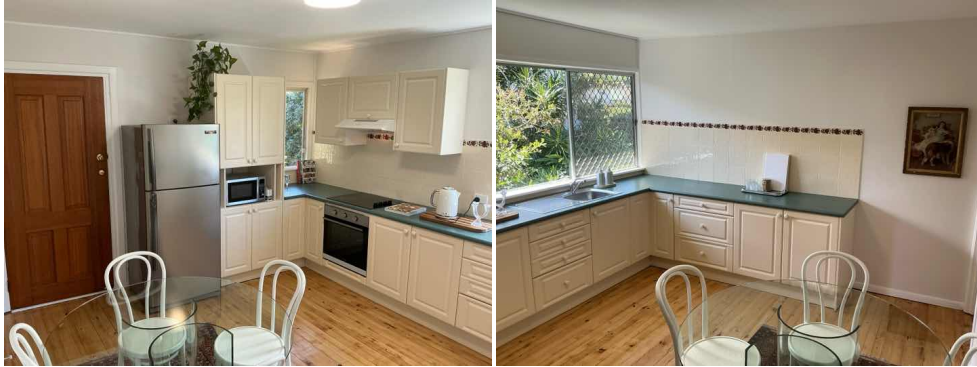
| Section | Location | Name | Comment |
|---|---|---|---|
| KITCHEN & LAUNDRY | Kitchen and Meals Area | Floor | #5. Decay noted to the timber floor. Historical timber decay, minor damage. |

Of the visible areas, the general condition is serviceable or in reasonable condition for age of dwelling.

#5. Decay noted to the timber floor. Historical timber decay, minor damage.

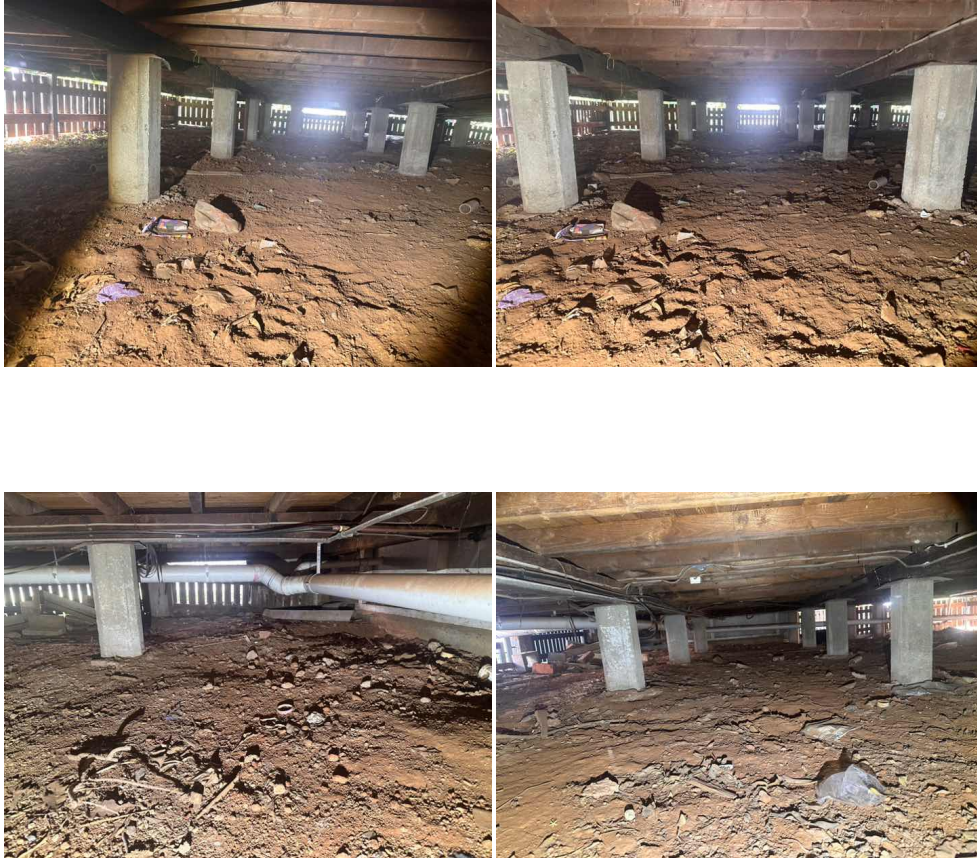
Of areas accessible and visible, the subfloor and components appeared to be in a serviceable condition.

Timber fungal decay evident to floor boards - Recommendations: A qualified carpenter should be engaged for advice and recommendations.

This appears aged staining and damage from previous leaking bathroom . No high moisture or water leak visible.
