Building and Timber Pest Inspection Report VR

Inspection Date: Tue, 28 Apr 2026

Property Address: 17 Benyon St, Wavell Heights QLD 4012,
Australia

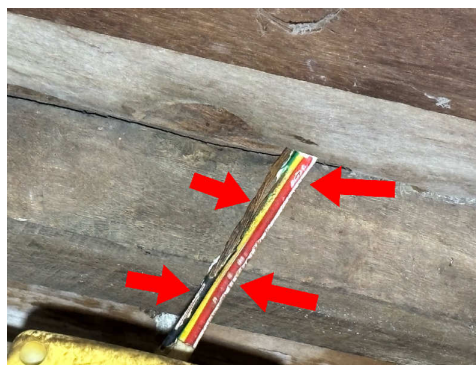
Finding: Subfloor - damaged electrical cable

Information: At the time of the inspection, it was noted that an electrical cable under the kitchen in the subfloor area has been damaged. The cables appear to have been chewed and as a result the active/live wire has been exposed.

This presents a safety hazard.

A licensed electrician must be engaged to replace the damaged wire. This must be done immediately.

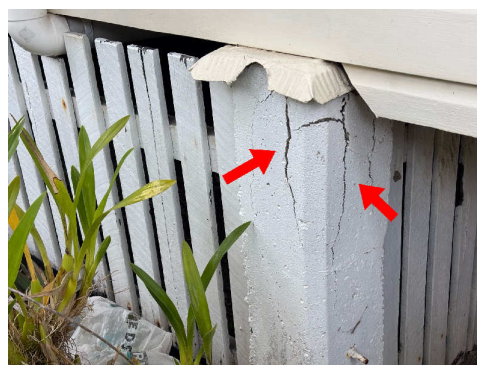
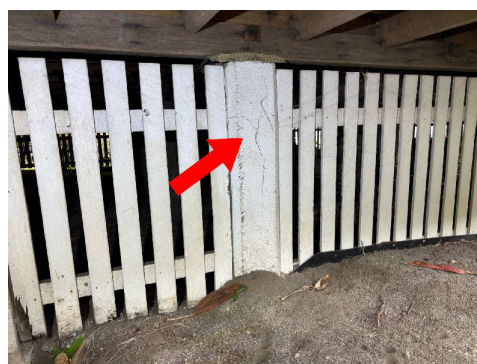
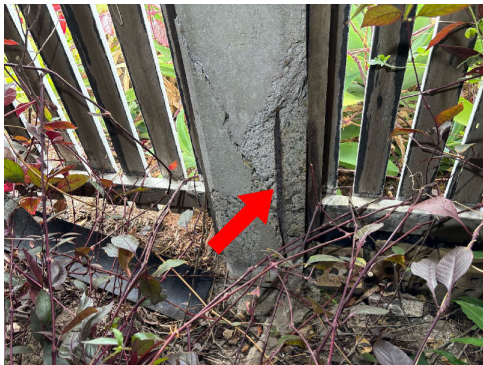
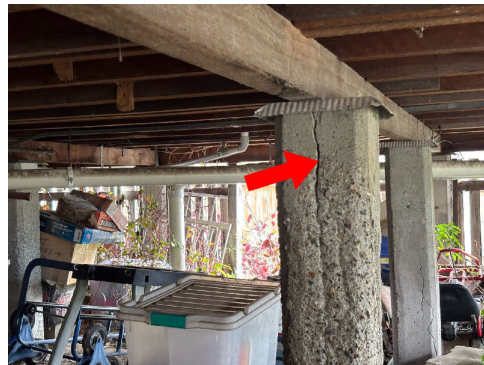
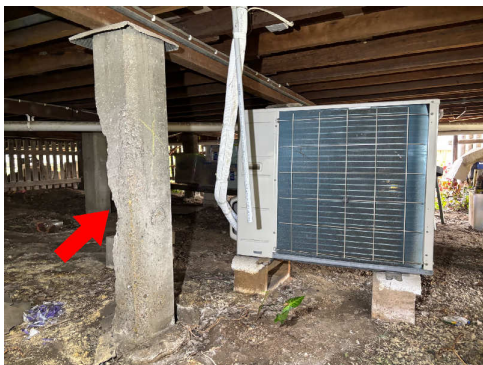
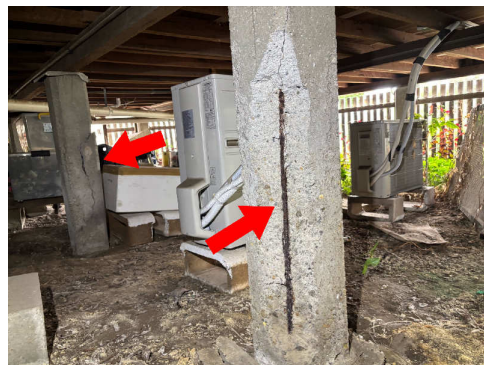
Finding 2.01

Finding: Concrete Stumps - Spalling

At the time of the inspection, it was noted that the majority of the concrete stumps to the subfloor structure were found to be affected by spalling, indicating that their structural integrity has been affected.

Spalling refers to concrete deterioration and threatens the building's supportive structure.

The cause of spalling can range from inferior quality concrete, improper concrete curing, chemical reactions to alkaline in the soil, or corrosion of steel reinforcement within the concrete, which is commonly known as concrete cancer.

The stumps are failing in their structural purpose, likely leading to a range of major and minor defects. Further damage to the stumps and structure may be imminent if left unattended.

An appointment with a registered builder specialising in re-stumping is required immediately to assess the condition of the concrete stumps and provide advice on remedial works. This defect should not be left unmanaged.

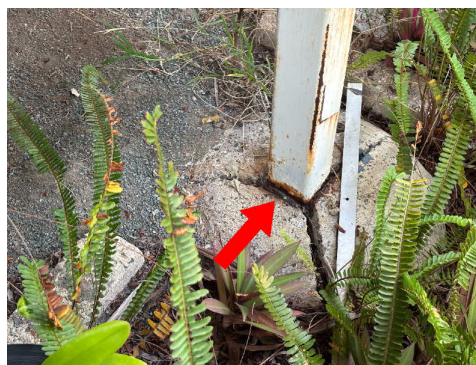
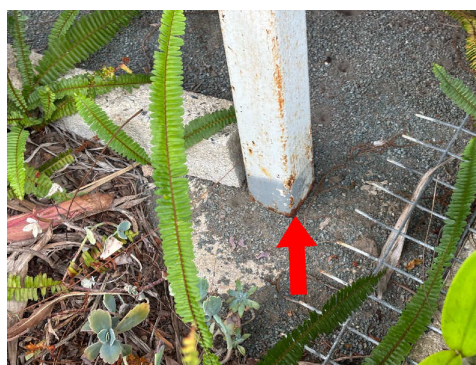
Finding 3.01

Finding: Entry deck - evidence of rust

Information: At the time of the inspection, it was noted that there was evidence of rusting to the steel posts supporting the entry deck. The front post has rusted to the extent of splitting the concrete at the base. The back post appears to have surface rust.

These steel posts need to be replaced. This has been noted as a minor defect due to the ease of access for replacement. If left on-addressed, this will become a major defect.

A licensed builder specialising in house re-stumping must be engaged to replace these two steel posts. This should be done as a matter of urgency.

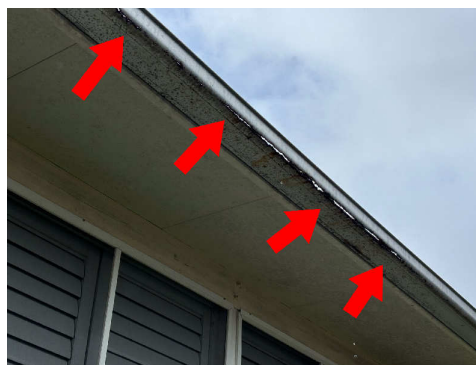
Finding 3.02

Finding: Gutters - rusting

Information: At the time of the inspection, it was noted that the gutter on the right hand side of the dwelling has rusted as such leaking in numerous areas. Gutters need to be in good working order to drain the roof properly.

If gutters are leaking , moisture may get to areas of the building that are meant to be keep dry. Damage to building elements may result of moisture ingress.

A licensed roof plumber should be appointed to inspect the gutters and advise on necessary rectification works. This should be done as a matter of urgency.

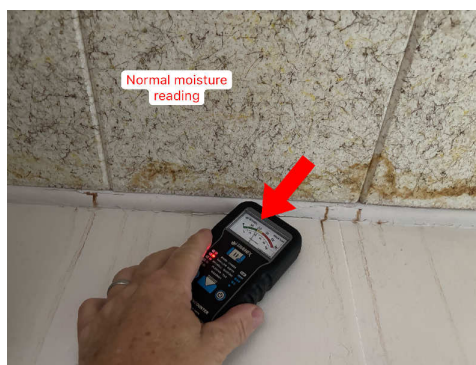
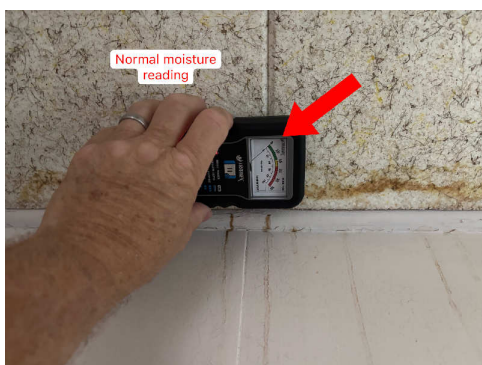
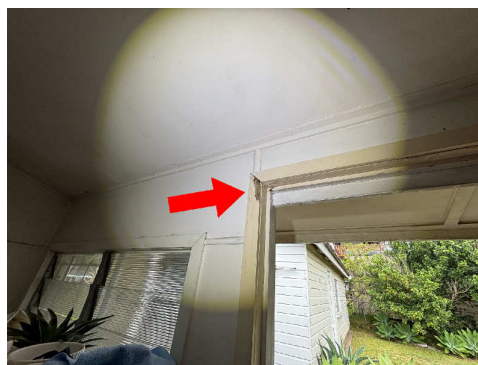
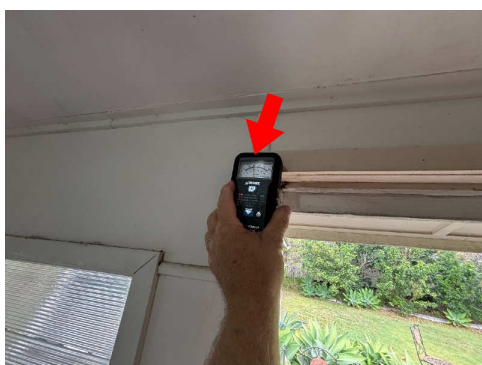
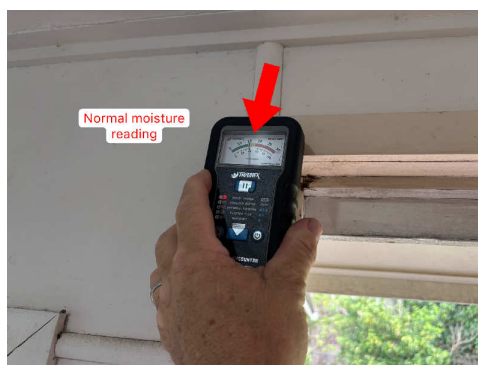
Finding 3.03

Information: At the time of the inspection, it was noted that there was evidence of moisture ingress in the laundry/toilet area. The moisture readings taken during the inspection, indicate that this is from an inactive leak. This may have occurred prior to the metal roof covering being replaced.

The client should monitor these areas for any change in appearance. A building maintenance professional or painting contractor could be engaged to repair the affected areas.

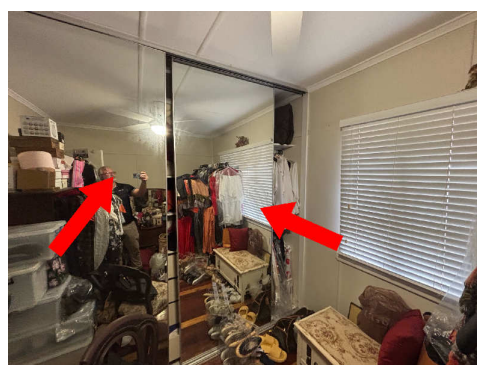
Finding: Bedroom 3 - wardrobe doors
 Information: At the time of the inspection, it was noted that the mirrored wardrobe doors in bedroom 3 were not able to be used as they are off their tracks.

This may be due to an issue with the rollers.

A building maintenance professional should be engaged to replace any affected rollers and place the wardrobe doors back on their tracks. This should be done as a short term priority.

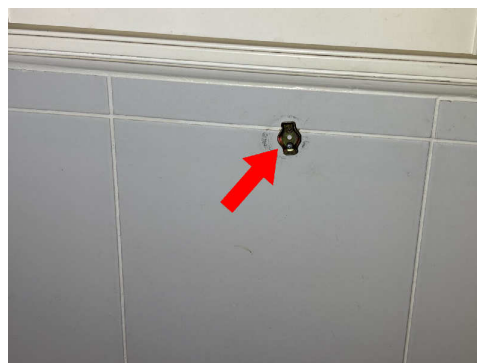
Finding 3.06

Information: At the time of the inspection, it was noted that the toilet roll holder in the bathroom was incomplete. The main part of the toilet roll holder was on the floor. This may be due to general wear and tear.

A building maintenance professional could be engaged to replace the parts or install a new toilet roll holder. This can be done at the clients discretion.

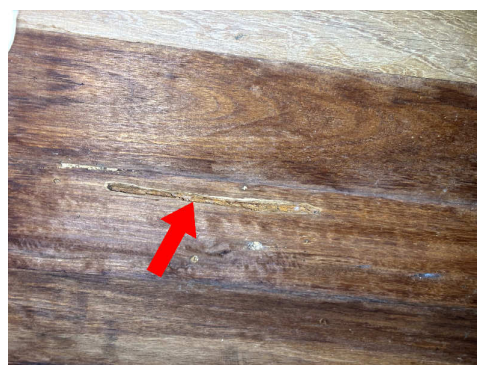
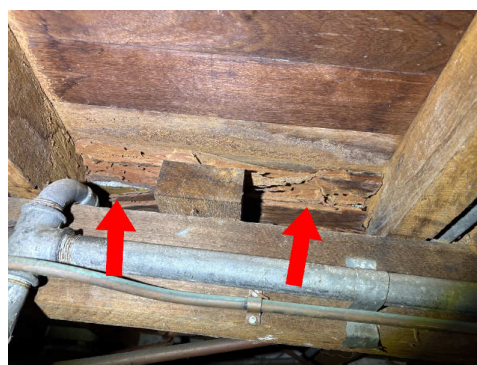
Finding: Evidence of termite damage

Information: At the time of the inspection, it was noted that there was termite damage to timber floorboards under the stove in the kitchen. No active termites were found in this area during the inspection.

It is strongly recommended that a chemical termite treatment system be installed to protect the dwelling.

It is advised that the area be visually inspected frequently to ensure that the condition of affected building materials does not worsen.

A building contractor may be appointed to provide a further invasive inspection if further damage is evident.

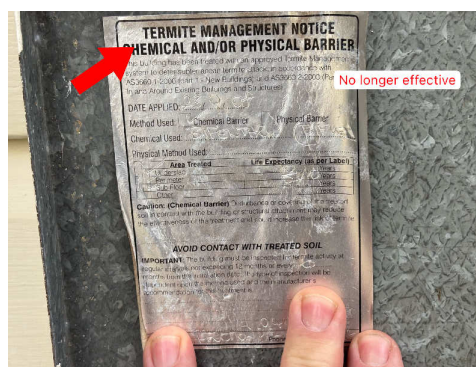
Finding 6.01

Information: At the time of the inspection, no evidence of a current chemical termite management system was found. There is a durable notice in the meter box showing a chemical treatment was carried out on the 23/09/2008 with an expected lifespan of 10 years for the underslab and perimeter and 5 years for the subfloor area. This treatment will no longer be effective. It is stated on the durable notice that termite inspections must be carried out every 6 months.

At the time of inspection, it appeared as though no termite management system has been installed, with no evidence to suggest preventative works taking place.

The client may consider gaining further advice from a pest controller as to the costs and procedures involved with this application. It is recommended that obtaining such advice be a short-term priority.

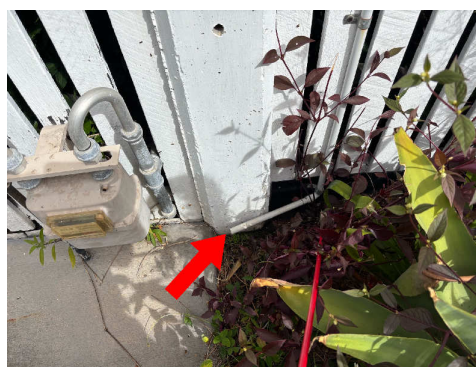
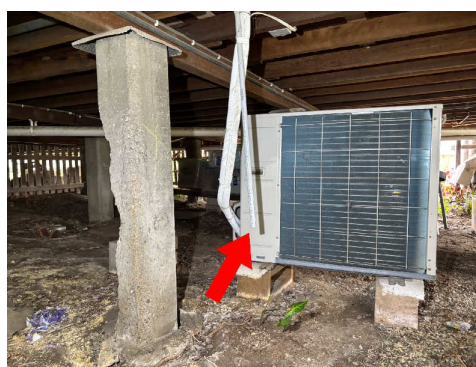
Finding 6.02

Building:	Main Building
Location:	All External Areas
Finding:	Air conditioner - Disconnected overflows

Information: At the time of the inspection, it was noted that the air conditioner drain overflows to all the units were not connected to the storm water drainage and as a result are draining next to the foundations of the dwelling.

Air conditioning overflows that are not connected to the storm water drainage and are draining near the foundation can create excessive moisture in the surrounding area.

Such leaking creates an environment which is conducive to an array of defects, including water damage to associated building elements and the attraction of termite or timber pest infestation.

It is highly recommended that a licensed plumber be appointed to connect the A/C overflow in order to prevent such an environment from being created. These minor works should be carried out as soon as possible.

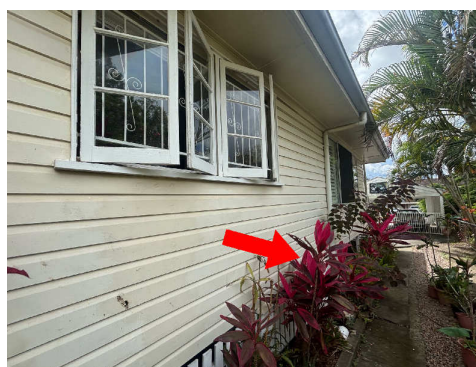
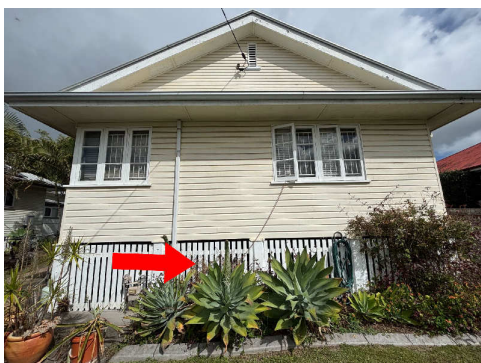
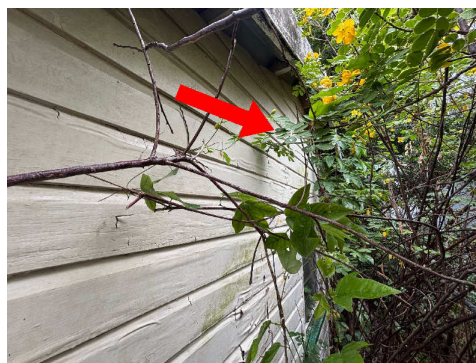
Finding 6.03

Information: At the time of the inspection, it was noted that there was vegetation touching the building and garage in several locations.

This creates a potential access point for termites to enter the building undetected. The vegetation hinders visual termite inspections. This is a conducive condition for termite activity.

The client is to ensure that the vegetation is trimmed back to prevent undetected termite entry to the building. This should be done as a matter of urgency.

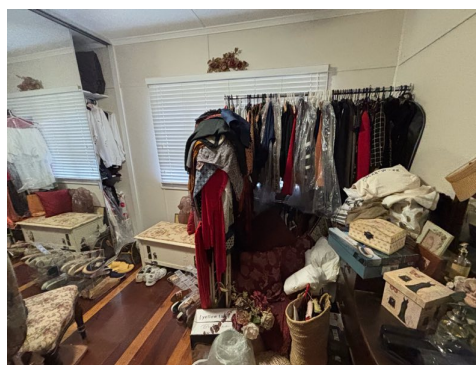
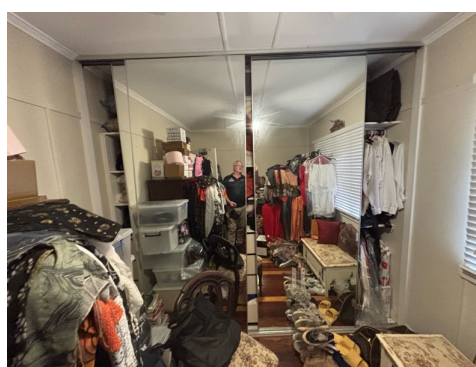
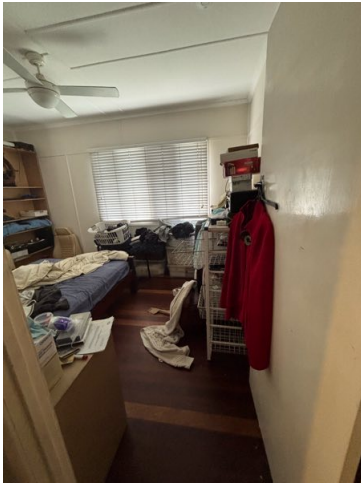
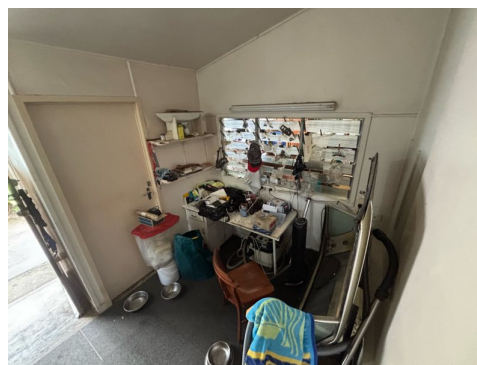
Finding: Obstructions and Limitations - Internal areas

Information: These photographs are an indication of the obstructions and limitations which impeded full inspection of the property of the internal areas at the time of inspection. These obstructions can hide an array of defects and should be removed to allow full inspection to be carried out. A re-inspection is recommended once the areas are made accessible.

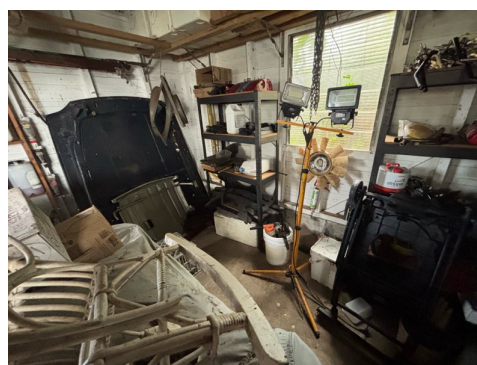
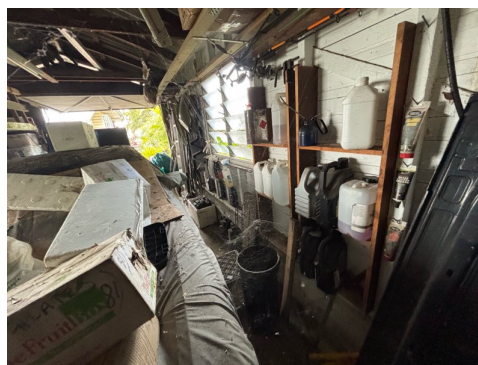
Finding: Obstructions and Limitations - External areas

Information: These photographs are an indication of the obstructions and limitations which impeded full inspection of the property of the external areas at the time of inspection. These obstructions can hide an array of defects and should be removed to allow full inspection to be carried out. A re-inspection is recommended once the areas are made accessible.
