Inspection Report

BPP Inspections

10 Centre St, Aspley, QLD

Pest And Building InsP-ection

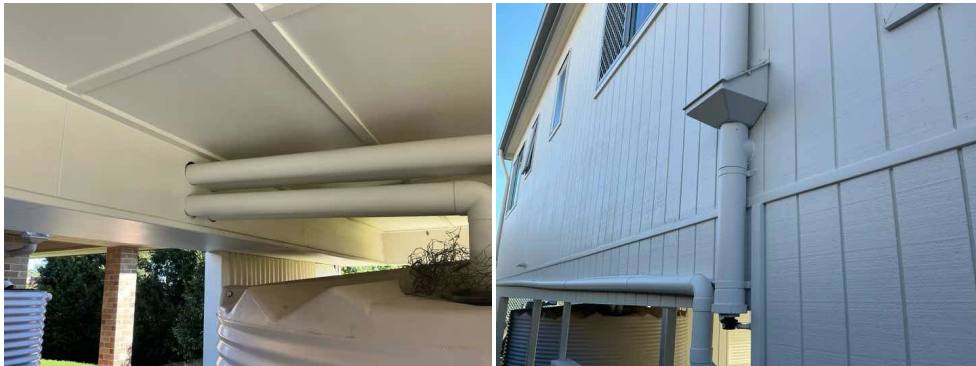
On visual inspection no apparent defects were noted to the down pipes and are considered serviceable, however no comment can be made with regard to blockages , connections to stormwater or functionality in the absence of rain. Note: Periodic maintenance checks should be carried out for rust penetrations and leaks.

The downpipes are concealed within the building and cannot be assessed.

Ensure leaf separators are clear and functional.

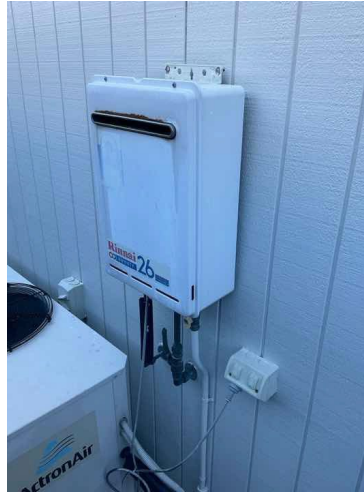
The hot water system appears to be in a serviceable condition. No specific tests other than running the hot water from a tap was carried out. No determination has been made as to the suitability or adequacy of the hot water system in relation to capacity or otherwise.

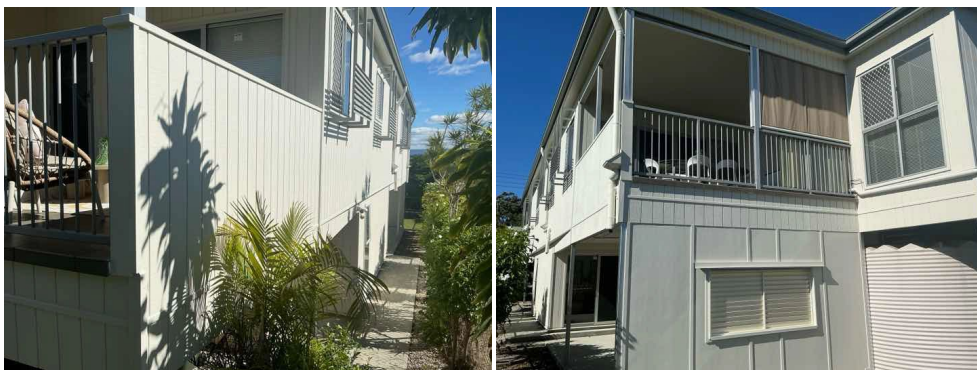
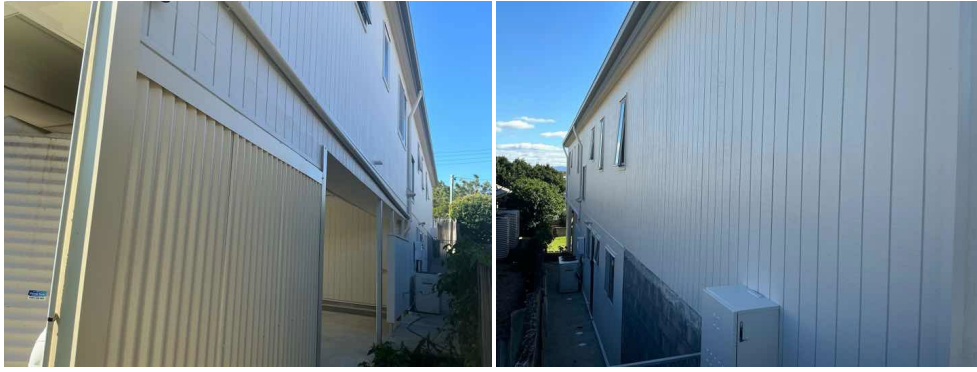
On visual inspection, the general condition of the exterior walls is serviceable for the age.

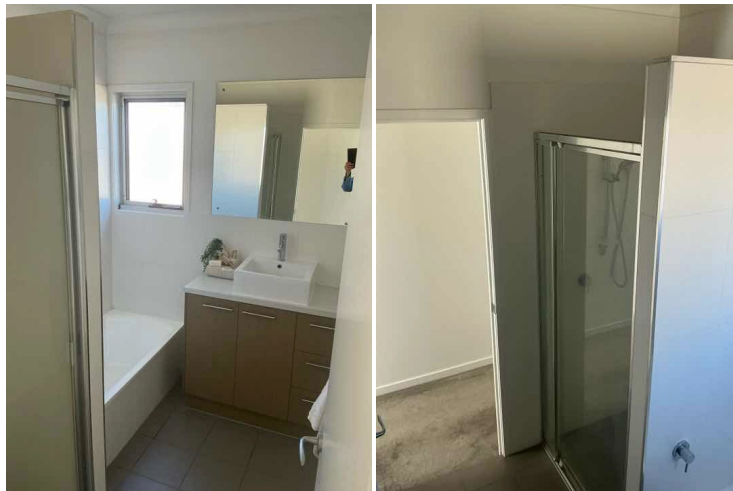
#4. Shower head is leaking. A qualified plumber should be engaged for advice and recommendations.
