**BRISBANE BUILDING  
& PEST INSPECTIONS**

# **Pre Purchase Building and Timber Pest Report**

Inspection Date: 19 Jun 2026

Property Address: 22 Gawain Road Bracken Ridge 4017

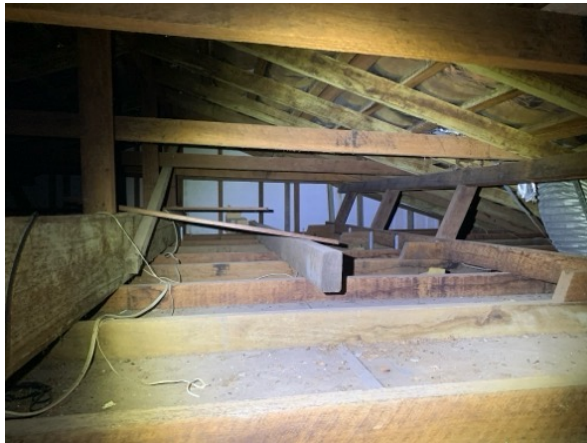
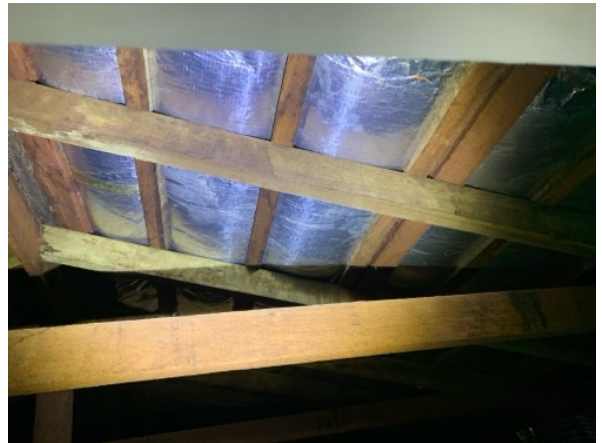
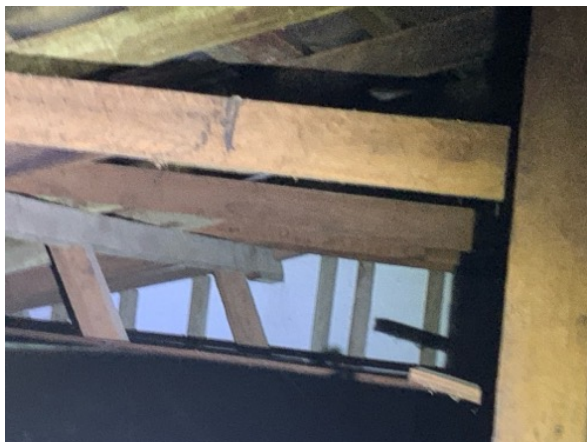
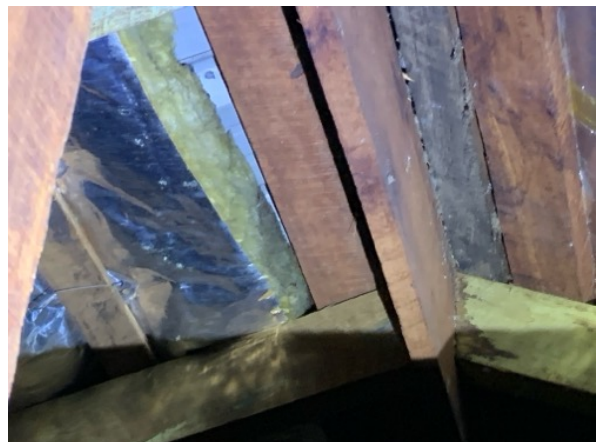
**Finding:** Additional Photos

Additional photos are provided for your general reference.
