# Seller disclosure statement

34 Ellerdale Street, Aspley QLD 4034

## Inspection Address

**34 Ellerdale St, Aspley, QLD**

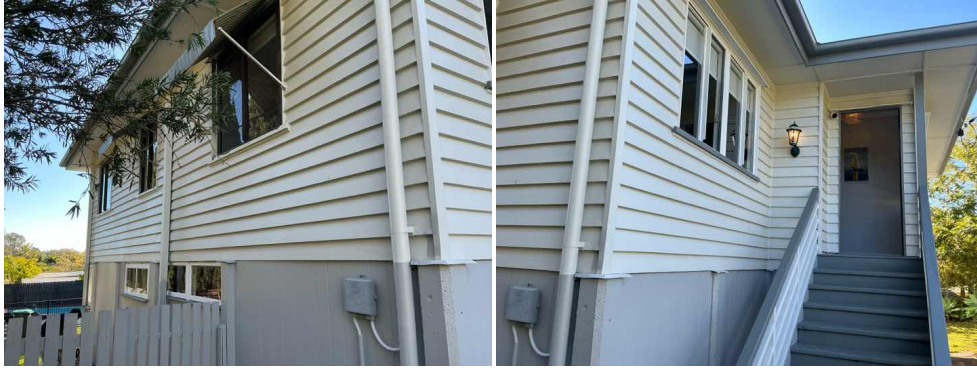
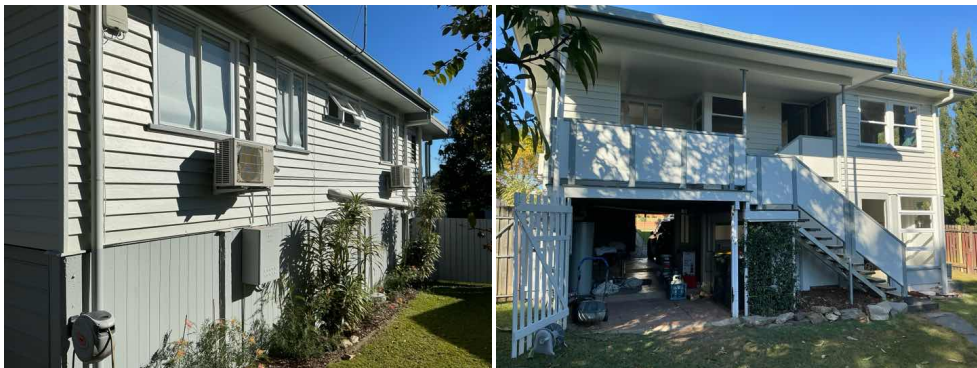
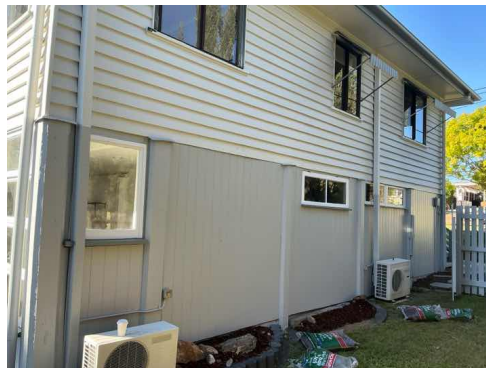
#### Exterior Wall Material

Weatherboard

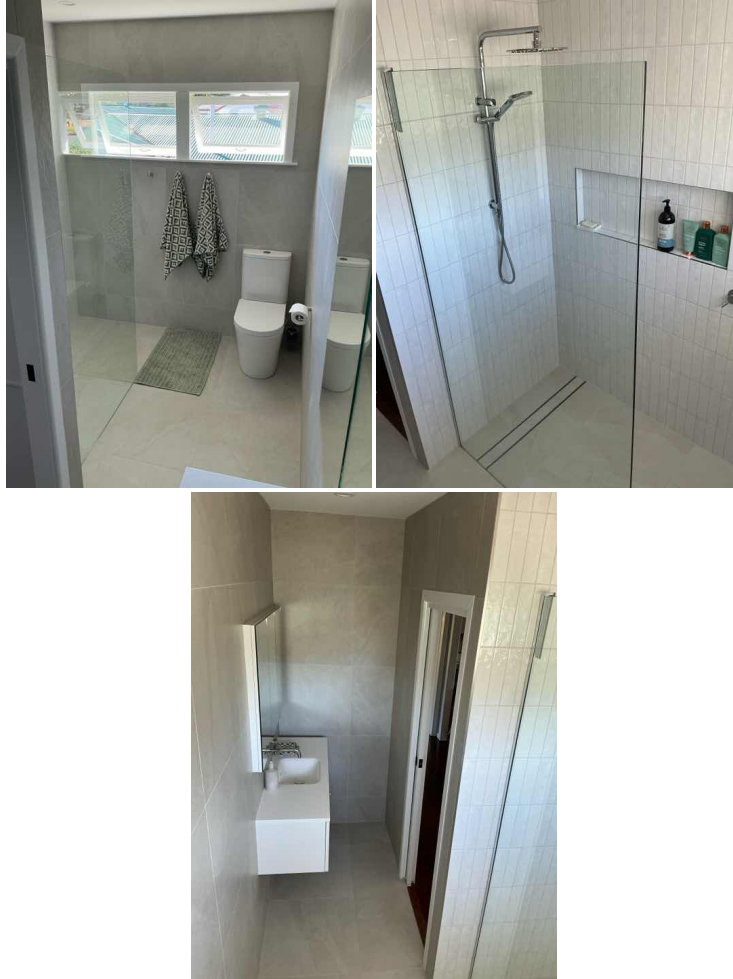
Hall

Of the visible areas, the general condition of this bathroom is serviceable or in reasonable condition for age of dwelling.
