Inspection Report

BPP Inspections

34 Ben Lomond St, Aspley, QLD

Pest And Building Inspection

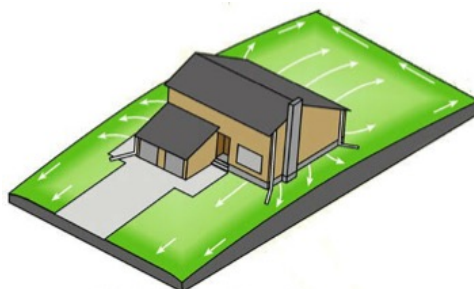
#1. The ground levels along the perimeter walls at the front of the home did not appear to fall away from the property walls sufficiently due to the natural landscape and contour. Recommendations: This will need to be assessed during a period of rainfall and if surface water appears to be entering the sub floor if applicable or ponding against the perimeter walls, engage a plumber or landscaper to assess and rectify as required. All drains should be regularly checked by a plumber and kept clean of debris to allow surface water to be carried away from the dwelling.

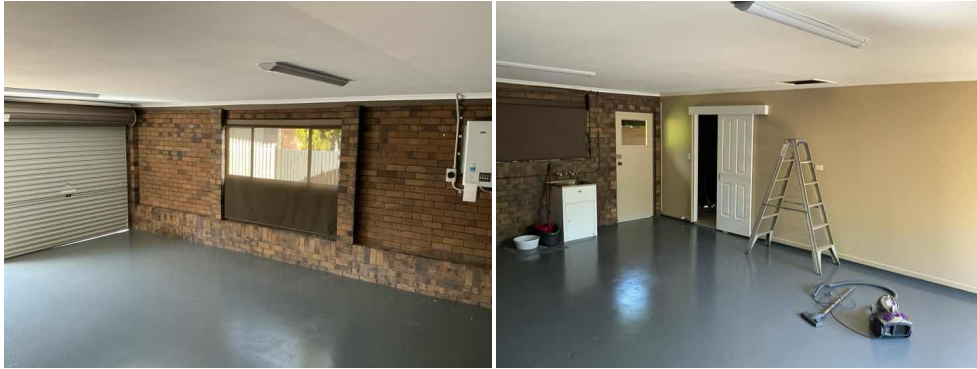
Ceiling Findings

#2. The plasterboard ceiling is aged and sagging between supports. Glue has released from its contact points leaving the sheeting supported mainly by its screw fixings. The ceiling requires an assessment by a lic plasterer to determine the process and costs involved with repair. Sagging ceilings have potential for collapse.

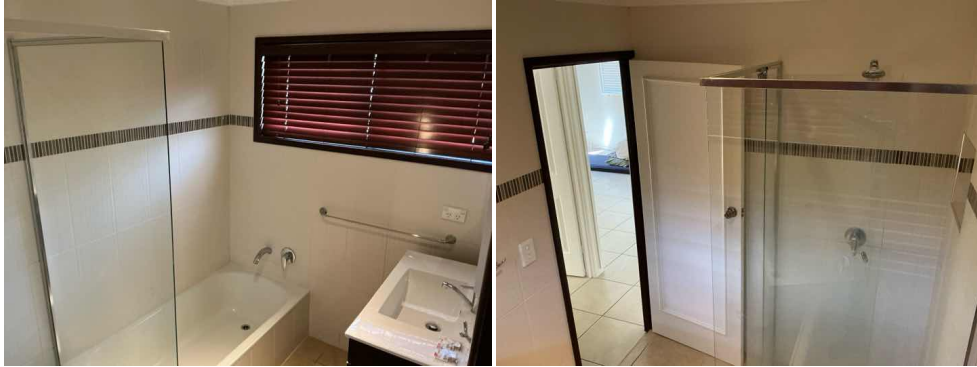
Hall

Of the visible areas, the general condition of this bathroom is serviceable or in reasonable condition for age of dwelling.

#4. The shower was run during the inspection. The building was unoccupied at the time of the inspection. This means that there was not a high level of moisture present to measure, as found in a shower in continual use. Evidence of defects were not visible, but the inspection for them is restrictive.

#5. Shower head is leaking. A qualified plumber should be engaged for advice and recommendations.
