Inspection Report

BPP Inspections

34 Ben Lomond St, Aspley, QLD

Pest And Building InsP-ection

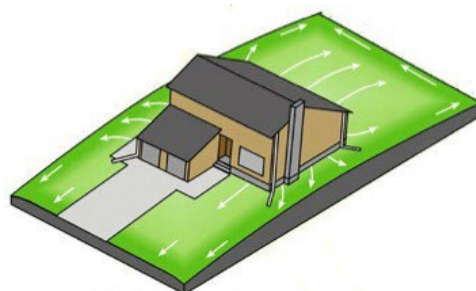
#1. The ground levels along the perimeter walls at the front of the home did not appear to fall away from the property walls sufficiently due to the natural landscape and contour. Recommendations: This will need to be assessed during a period of rainfall and if surface water appears to be entering the sub floor if applicable or ponding against the perimeter walls, engage a plumber or landscaper to assess and rectify as required. All drains should be regularly checked by a plumber and kept clean of debris to allow surface water to be carried away from the dwelling.

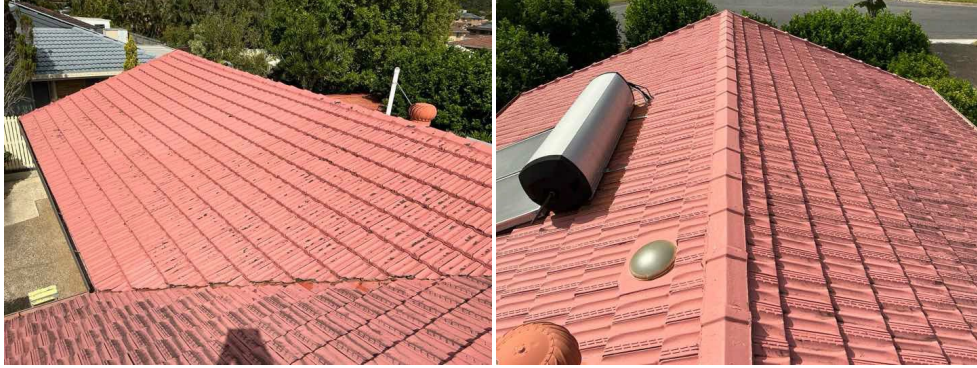
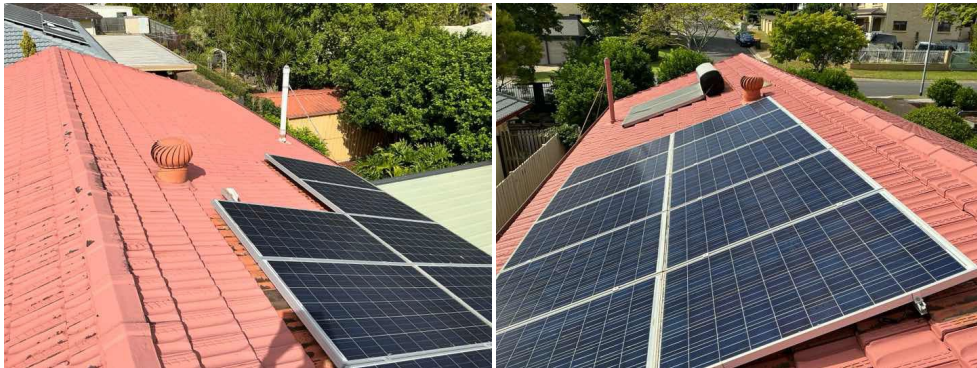
Roof Covering Type

Of the visible areas, the general condition of the roof is in serviceable condition for the age.

Repairs visible to cracked tiles. Change for complete tile , or regularly inspect tiles when cleaning roof/ gutter etc.

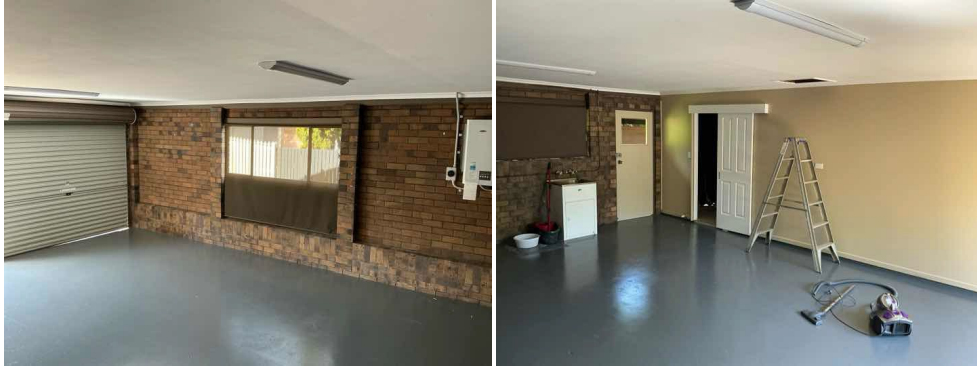
Of accessible and visible areas, the garaging is considered to be in a serviceable condition.

#3. The plasterboard ceiling is aged and sagging between supports. Glue has released from its contact points leaving the sheeting supported mainly by its screw fixings. The ceiling requires an assessment by a lic plasterer to determine the process and costs involved with repair. Sagging ceilings have potential for collapse.

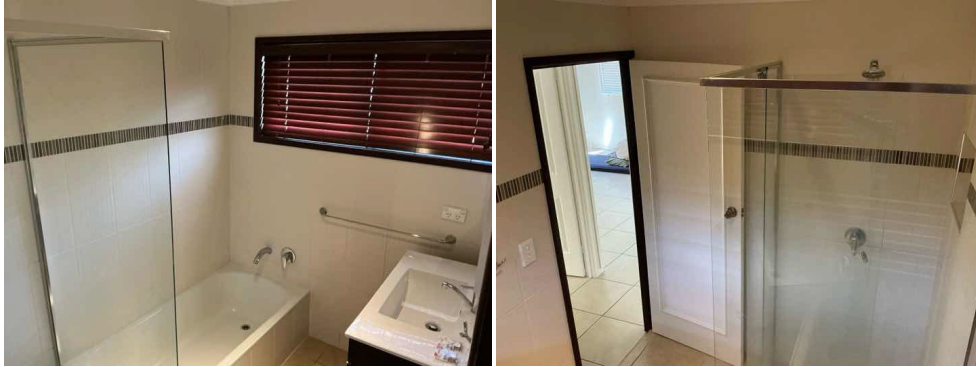
Hall

Of the visible areas, the general condition of this bathroom is serviceable or in reasonable condition for age of dwelling.

#6. Shower head is leaking. A qualified plumber should be engaged for advice and recommendations.
