Inspection Report

Inspection Address

39 Ironbark Place, Bridgeman Downs, QLD

Pest And Building InsP-ection

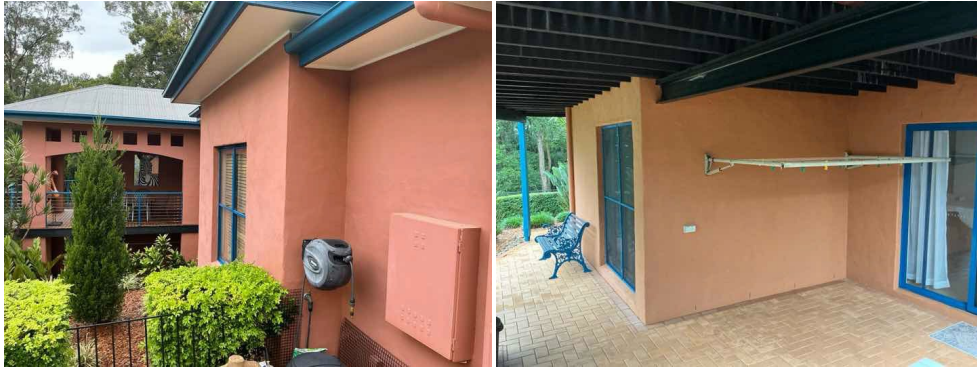
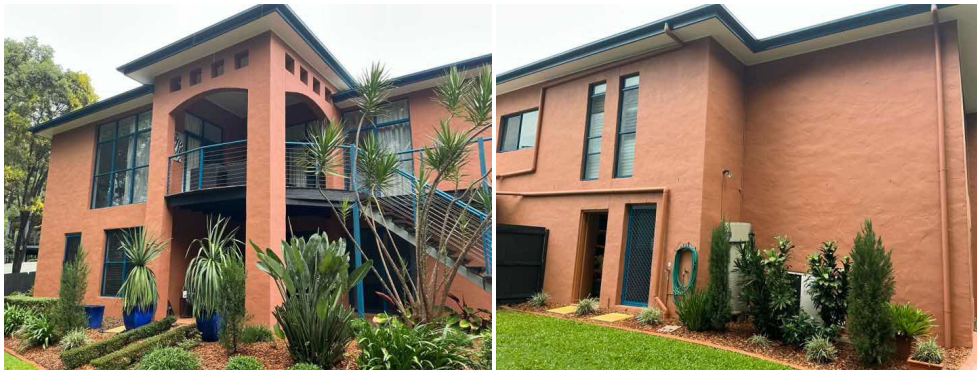
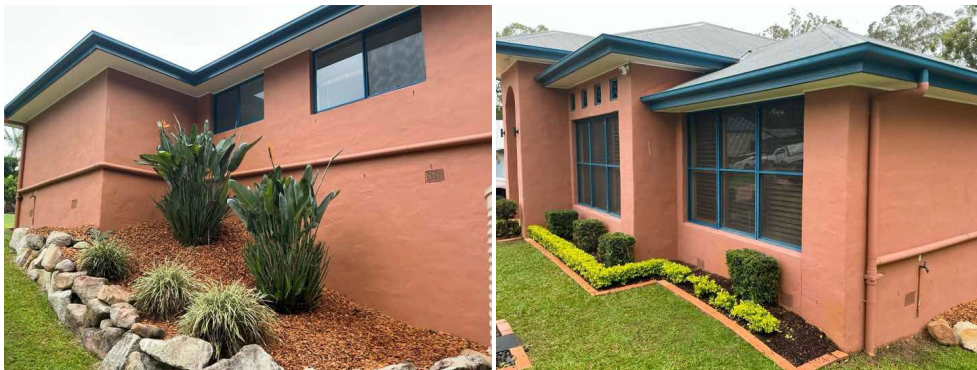
Exterior Wall Material

On visual inspection, the general condition of the exterior walls is serviceable for the age.

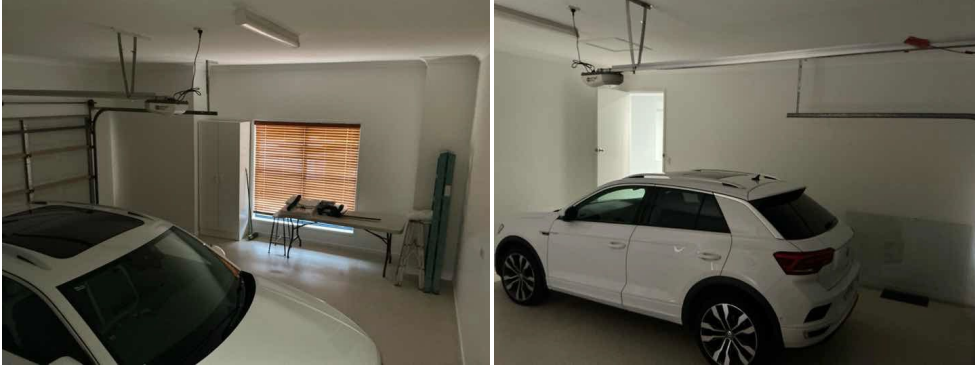
Of accessible and visible areas, the garaging is considered to be in a serviceable condition.

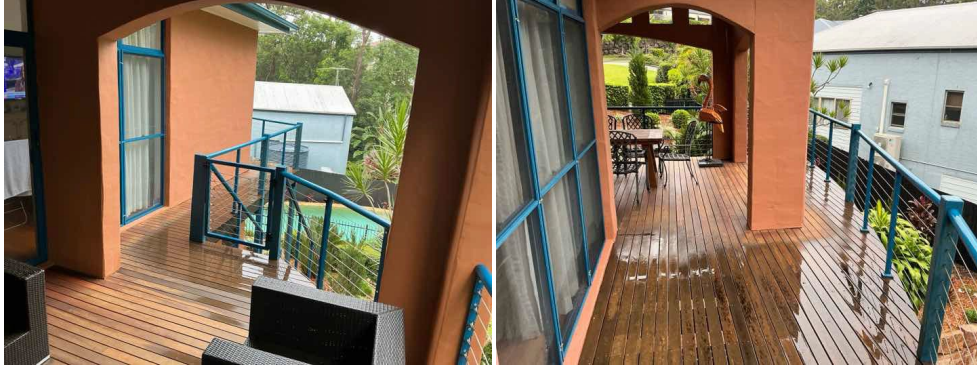
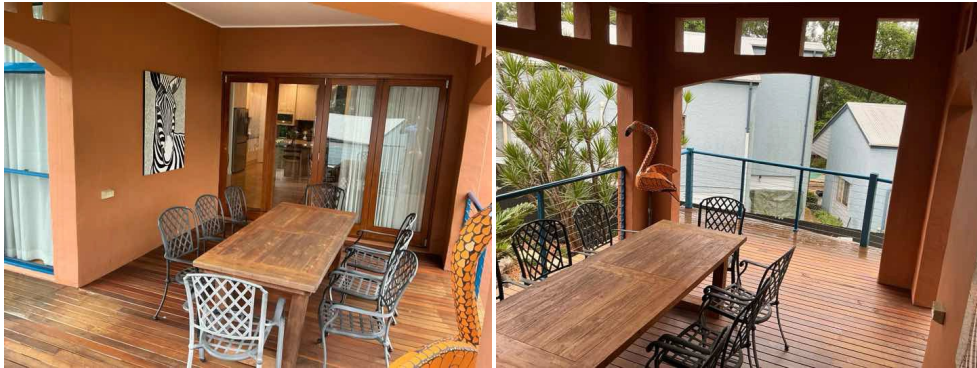
Deck Framework

Of areas visible, the decking appears to be in a serviceable condition.

#2. Additional timber support has been added to the deck floor joists. This is generally due to timber decay to the tops of the original floor joists. Inspection required annually to ensure all screwed and bolted fittings remain secure.

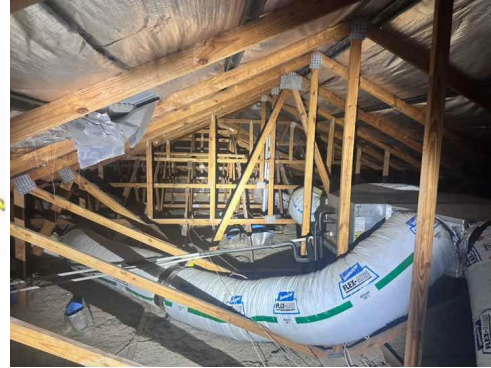
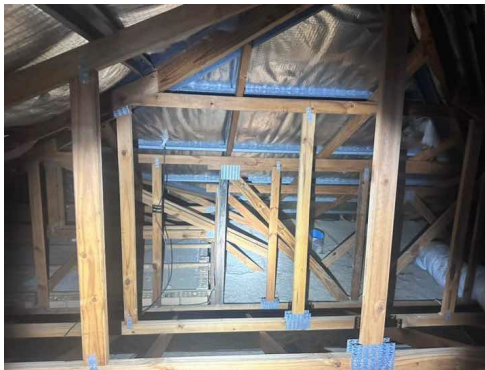
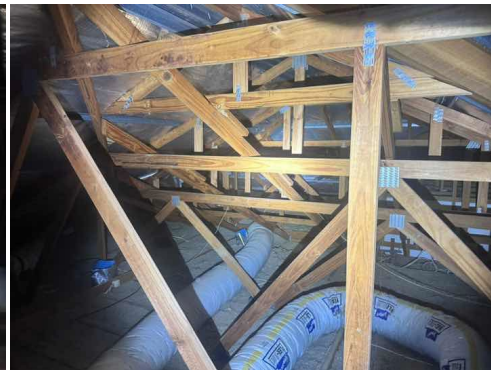
Roof Frame Type

The roof frame is a truss timber frame.

Visible sections of the roof void is in a serviceable condition for age of this dwelling.

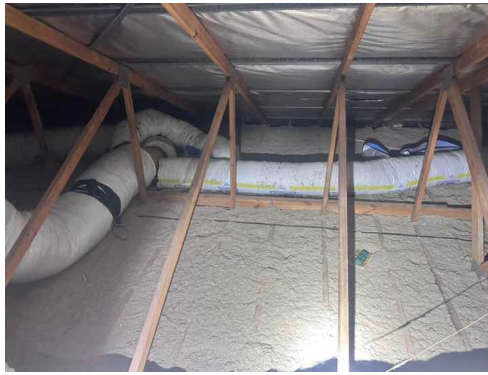
Type

The roof space is insulated with loose fill insulation.

Where visible and accessible, the insulation appears to be in a serviceable condition.

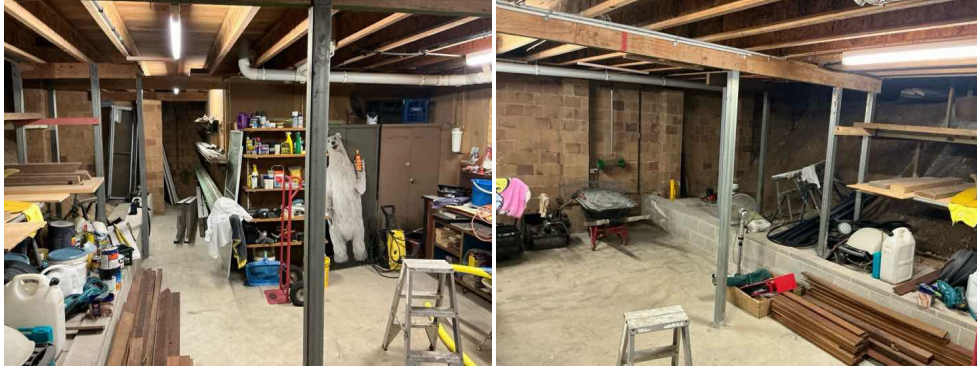
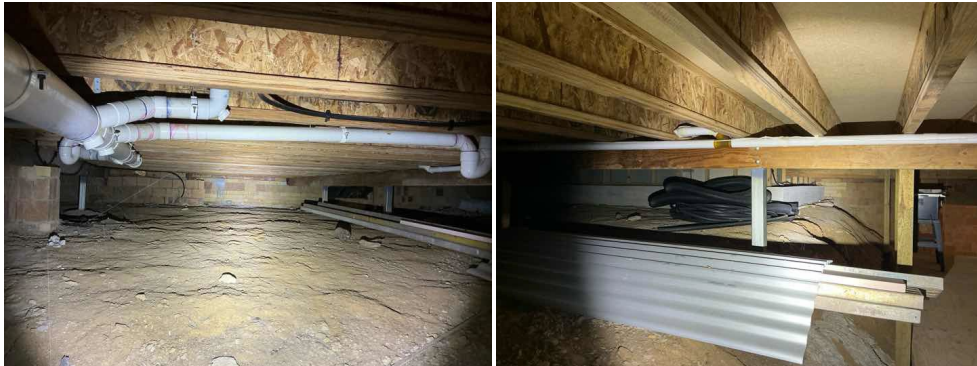
General Condition

Of areas accessible and visible, the subfloor and components appeared to be in a serviceable condition.

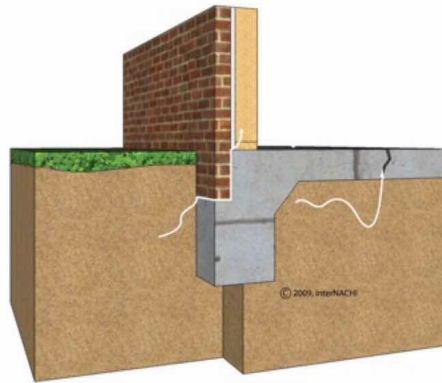
CONDUCTIVE CONDITIONS	5. Ant Capping and Termite Shields	The Termite Shields Appear To Be	#5. The termite shields (ant caps) are not installed. A chemical soil treatment is required to offer termite protection to the building. Contact a lic pest control technician. .
