Building and Timber Pest Inspection Report VR

Inspection Date: Thu, 28 May 2026

Property Address: 27 Tarm St, Wavell Heights QLD 4012,
Australia

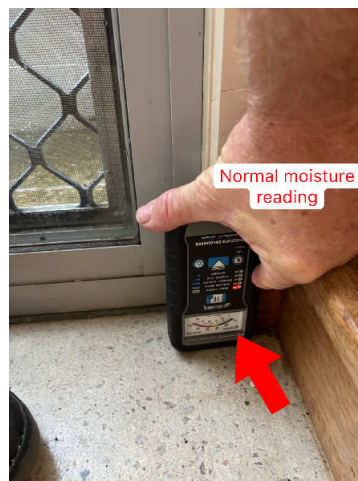
Finding: Door frames - evidence of moisture damage

Information: At the time of the inspection, there was evidence of moisture damage to a timber door frame in the front bedroom and a timber door frame in the kitchen area. The source of the moisture could not be determined.

If left unaddressed, further damage is likely to occur and may not be limited to the door frame.

A building maintenance professional or painting contractor should be engaged to repair the damaged timber door frames. This should be done as a short term priority.

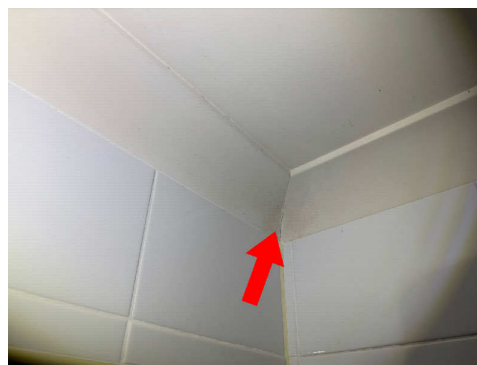
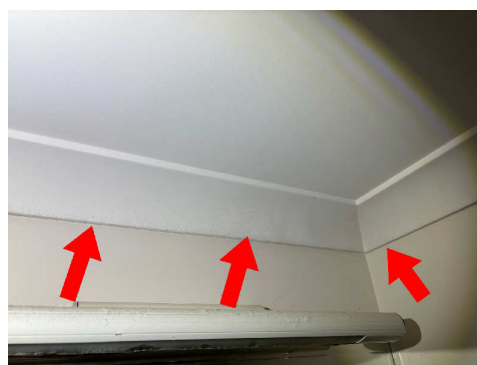
Generally, the client is advised to ensure that the general environment is free of moisture and humidity to aid in the prevention of mould formation and development. Any mould found during the inspection should be cleaned immediately by a cleaning contractor or the homeowner as applicable.

Please note that severely affected building elements may require replacement by a registered builder or qualified carpenter.

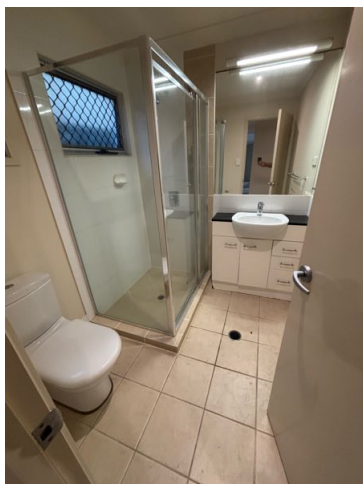
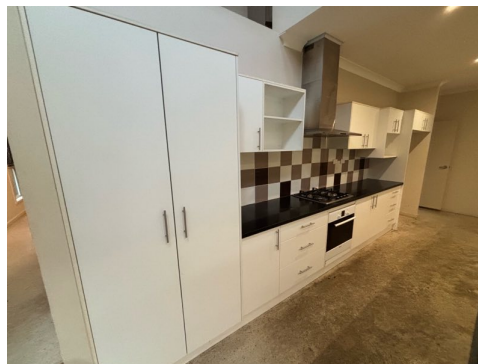
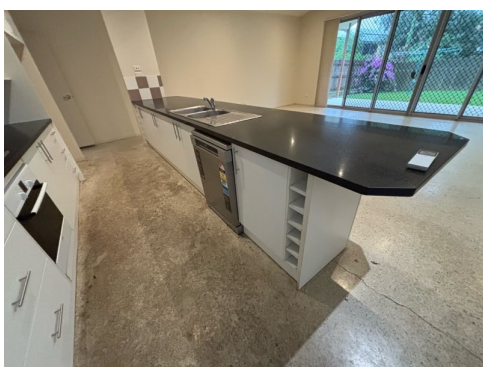
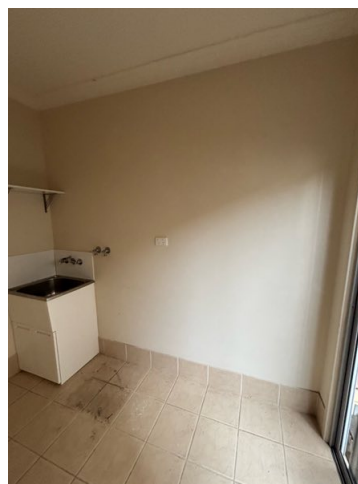
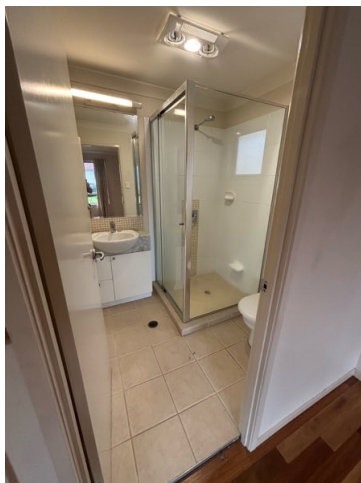
Finding: Obstructions and Limitations - Internal areas

Information: These photographs are an indication of the obstructions and limitations which impeded full inspection of the property of the internal areas at the time of inspection. These obstructions can hide an array of defects and should be removed to allow full inspection to be carried out. A re-inspection is recommended once the areas are made accessible.

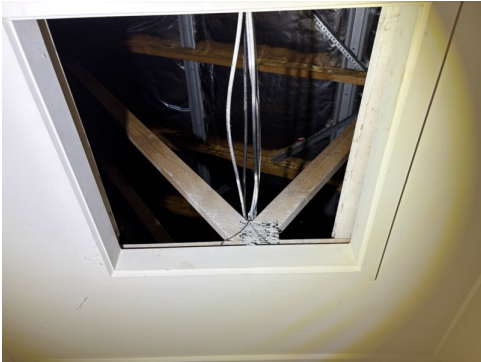
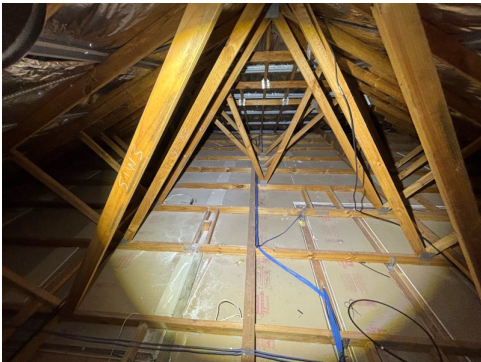
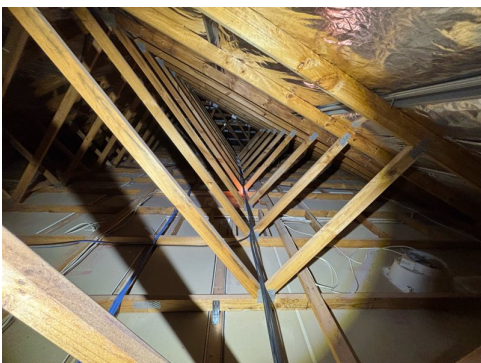
Finding: Obstructions and Limitations - Roof cavity

Information: These photographs are an indication of the obstructions and limitations which impeded full inspection of the property of the roof cavity at the time of inspection. These obstructions can hide an array of defects and should be removed to allow full inspection to be carried out. A re-inspection is recommended once the areas are made accessible.
