Building and Timber Pest Inspection Report VR

Inspection Date: Thu, 28 May 2026

Property Address: 27 Tarm St, Wavell Heights QLD 4012,
Australia

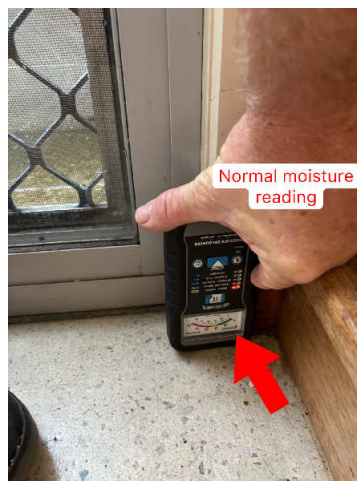
Information: At the time of the inspection, there was evidence of moisture damage to a timber door frame in the front bedroom and a timber door frame in the kitchen area. The source of the moisture could not be determined.

If left unaddressed, further damage is likely to occur and may not be limited to the door frame.

A building maintenance professional or painting contractor should be engaged to repair the damaged timber door frames. This should be done as a short term priority.

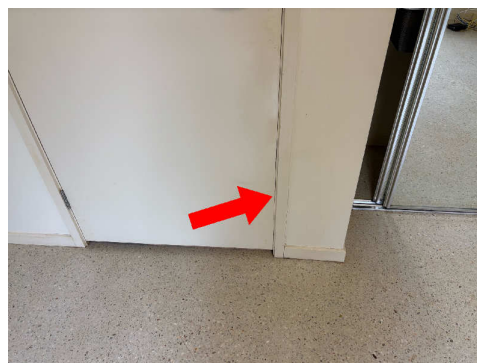
Information: At the time of the inspection, it was noted that the hinged door to the front downstairs bedroom was binding against the door jamb during normal operation. This appears to be general wear and tear.

For minor causes, a qualified carpenter or building maintenance professional should be appointed to perform minor rectification works at client discretion.

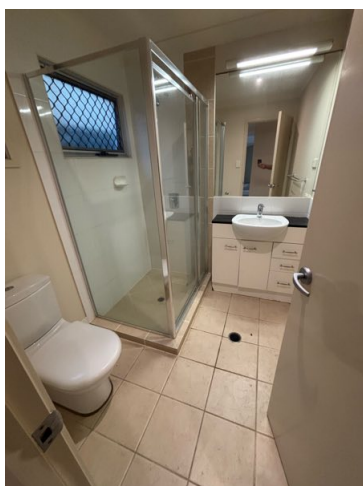
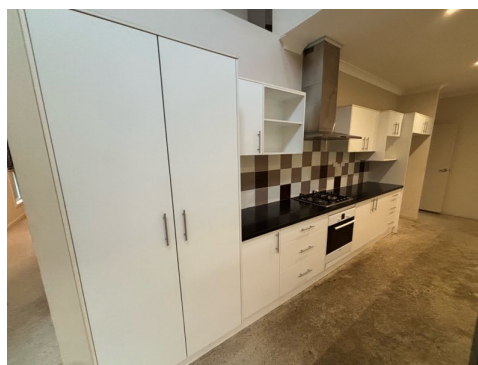
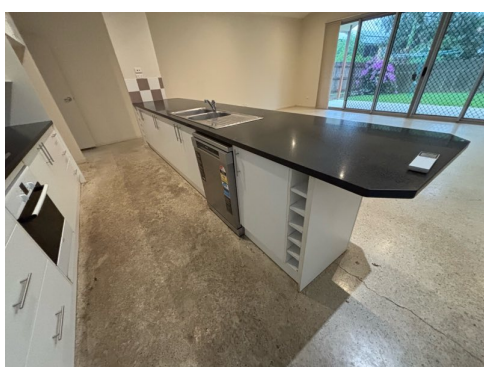
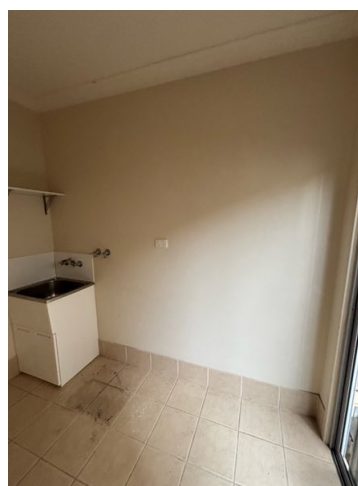
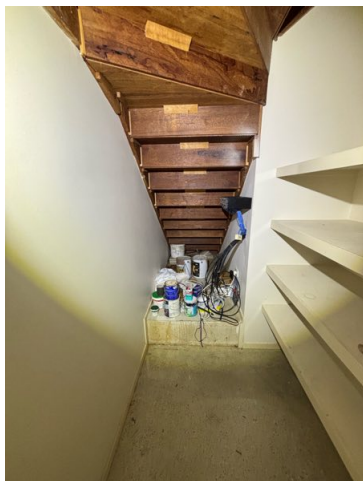
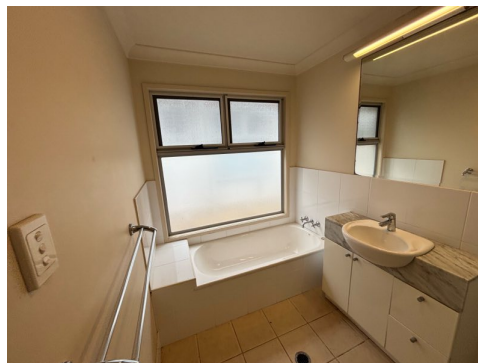
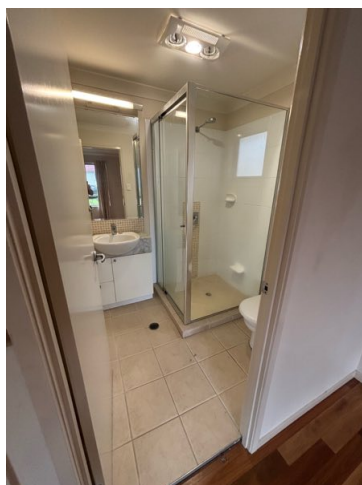
Finding: Obstructions and Limitations - Internal areas

Information: These photographs are an indication of the obstructions and limitations which impeded full inspection of the property of the internal areas at the time of inspection. These obstructions can hide an array of defects and should be removed to allow full inspection to be carried out. A re-inspection is recommended once the areas are made accessible.

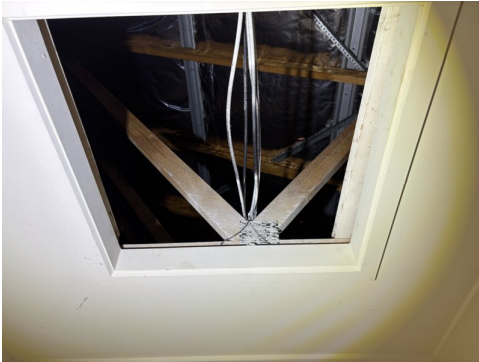
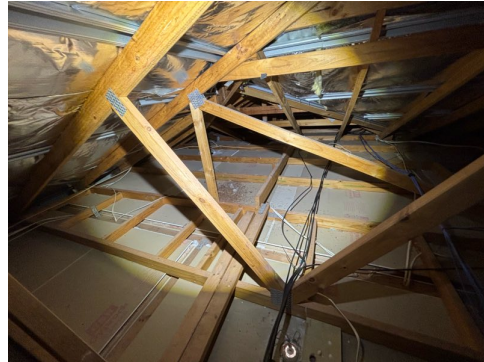
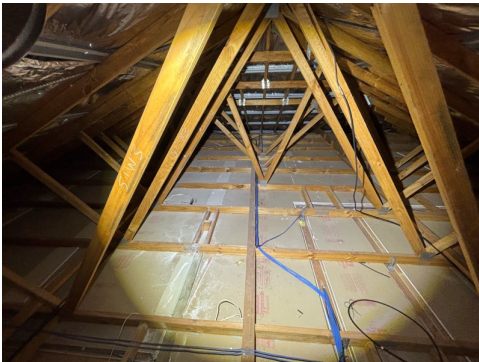
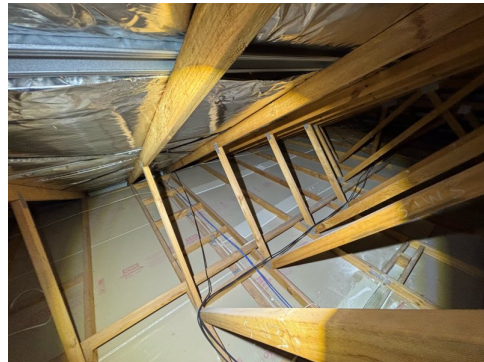
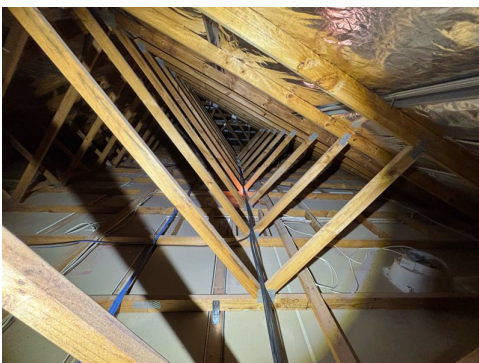
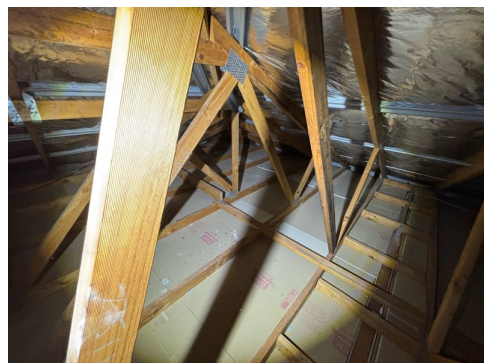
Finding: Obstructions and Limitations - Roof cavity

Information: These photographs are an indication of the obstructions and limitations which impeded full inspection of the property of the roof cavity at the time of inspection. These obstructions can hide an array of defects and should be removed to allow full inspection to be carried out. A re-inspection is recommended once the areas are made accessible.
