Pre-Purchase Building and Pest Inspection Report (PPBPIR)

16/15 Smith Road, Woodridge, QLD 4114

Monday, 29 July 2024

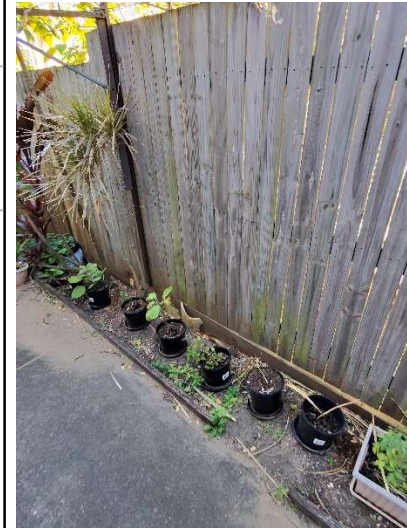
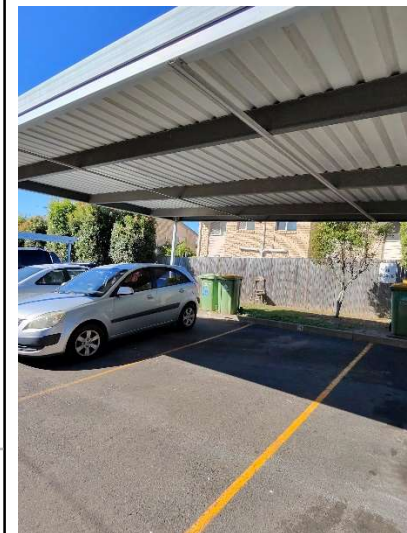
Earth-wood contact Note: Untreated or nondurable timbers in direct contact with the ground/soil produce a ready food source for termites. Also, susceptible timbers used in a hazardous environment are prone to fungal decay

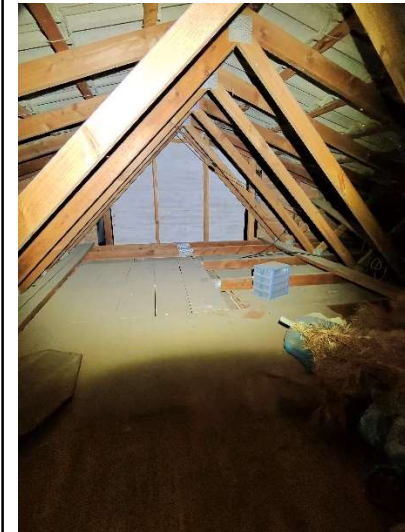
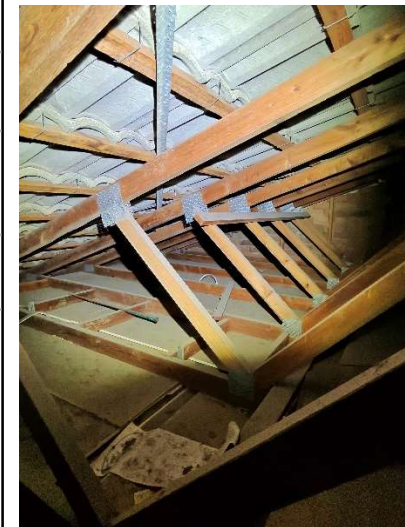
Check for evidence (Form 16) (or equivalent) to ensure the fire separation wall has been constructed in accordance with Australian Standard AS3600 requirements of an appropriate fire wall .

When access is restricted or no access is possible the installation of additional access points in the ceiling is recommended to enable a full inspection as inaccessible and restricted areas present high risk of undetected building defects.

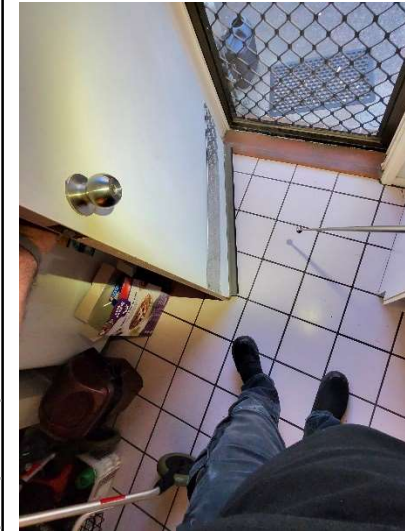
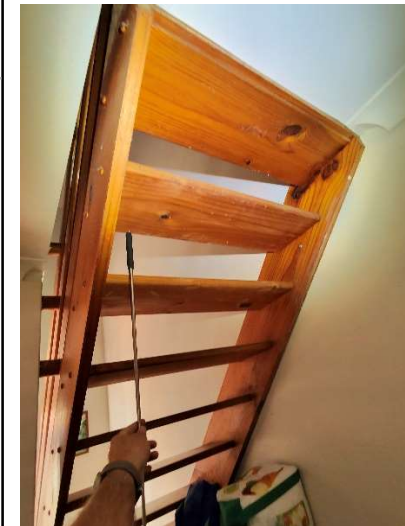
PAIN	GOOD TO FAIR
TIMBER	GOOD TO FAIR
<input checked="" type="checkbox"/>	Minor cracking of the plaster/cornice was observed. These cracks are caused by minor building movement and setting and do not represent a long-term structural problem. These cracks should be filled when next repainting.
<input type="checkbox"/>	Larger cracks should be taped before filling to provide additional strength to minimise the chance of re-occurrence
<input type="checkbox"/>	The joints at the rear and side of the kitchen sink, shower recesses, bathtub, vanities and laundry tub should be kept well sealed to prevent water penetration behind the Cabinets.
<input type="checkbox"/>	The use of power exhaust fans is recommended to expel the moist air from wet areas before it can affect the paint. Paint stress was observed in the wet areas of the building.
