# Inspection Report

## Coastal Building Inspections

**205 Dandaraga Road, MIRRABOOKA, NSW, 2264**

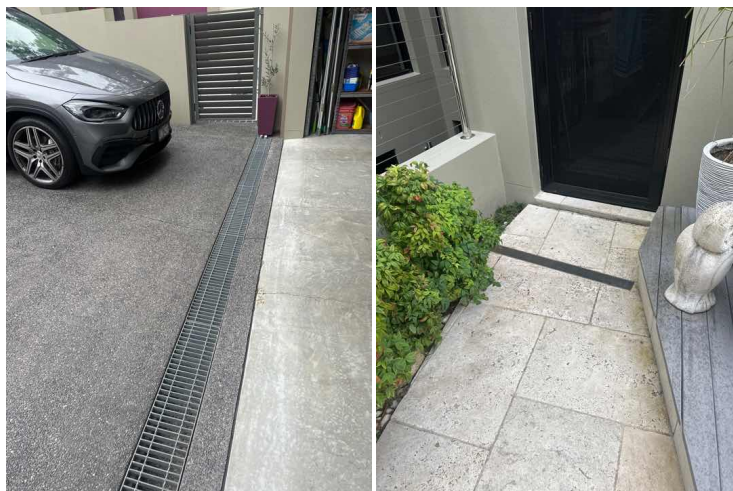
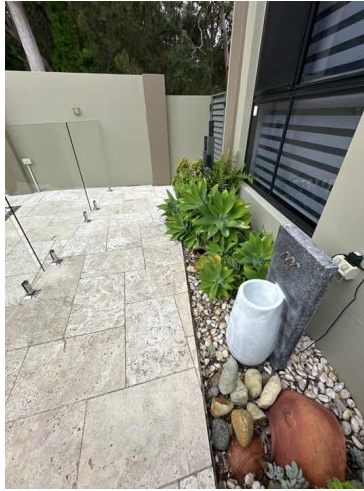
No evidence of slow or blocked drains at the time of inspections.

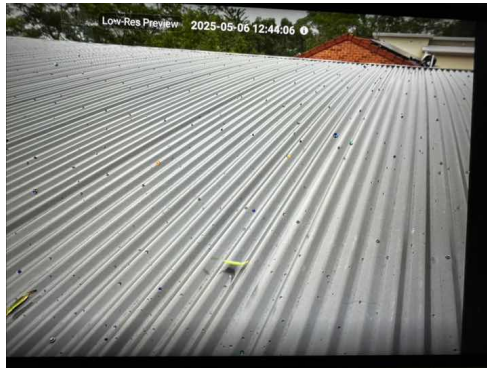
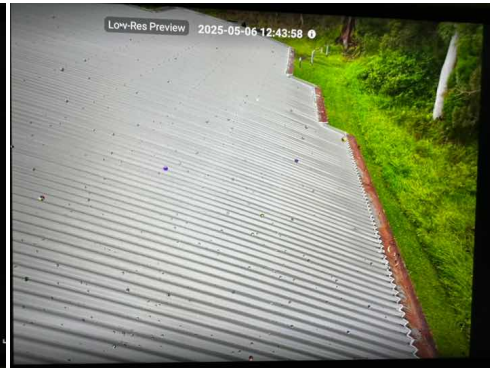
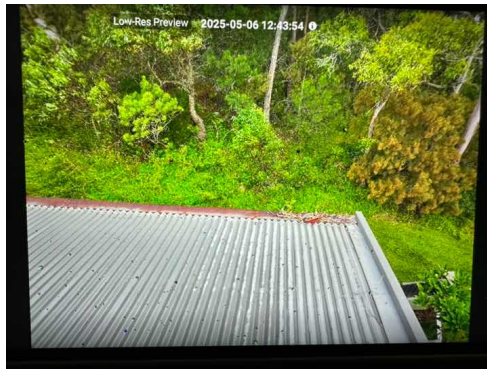
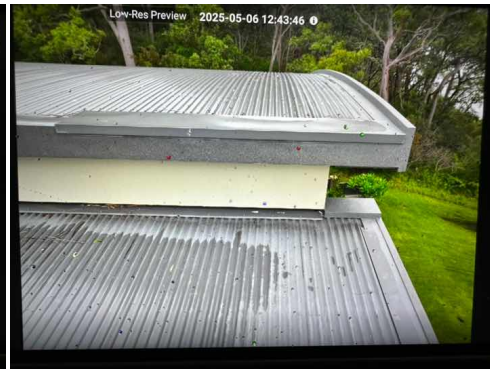
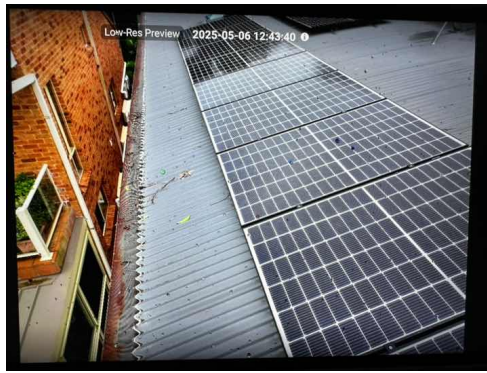
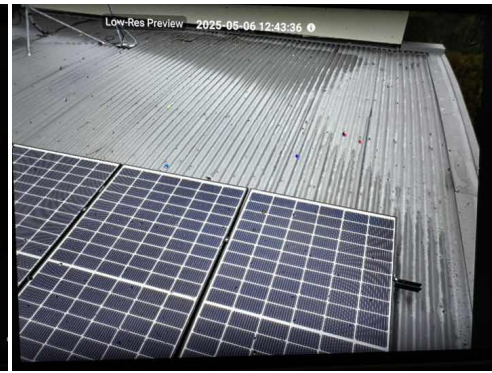
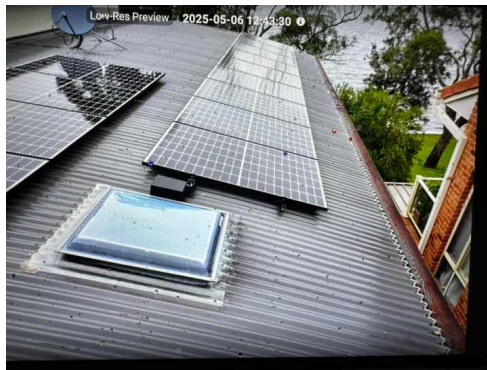
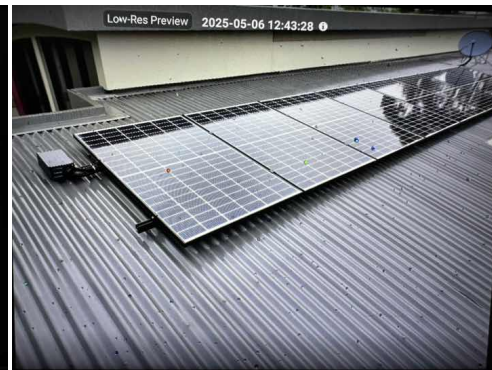
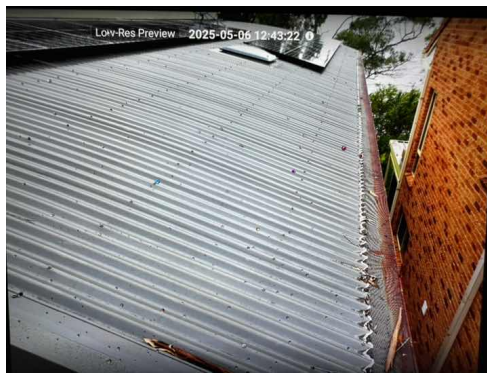
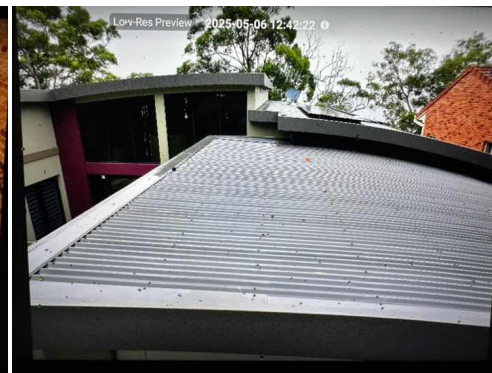
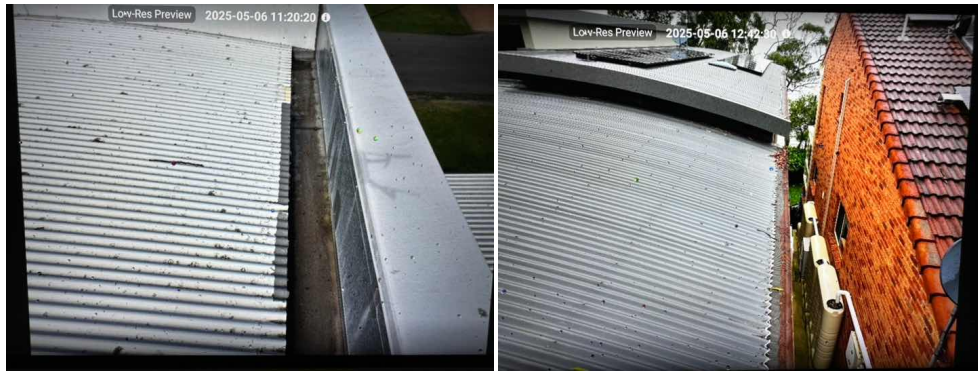
#### Roof Clad Condition

Visible section of The roof cladding appeared in a serviceable condition for the age of this dwelling. Annual maintenance inspection recommended.

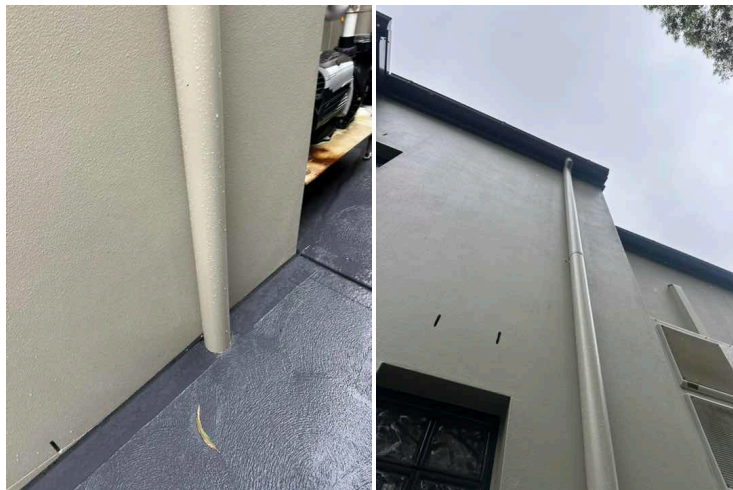
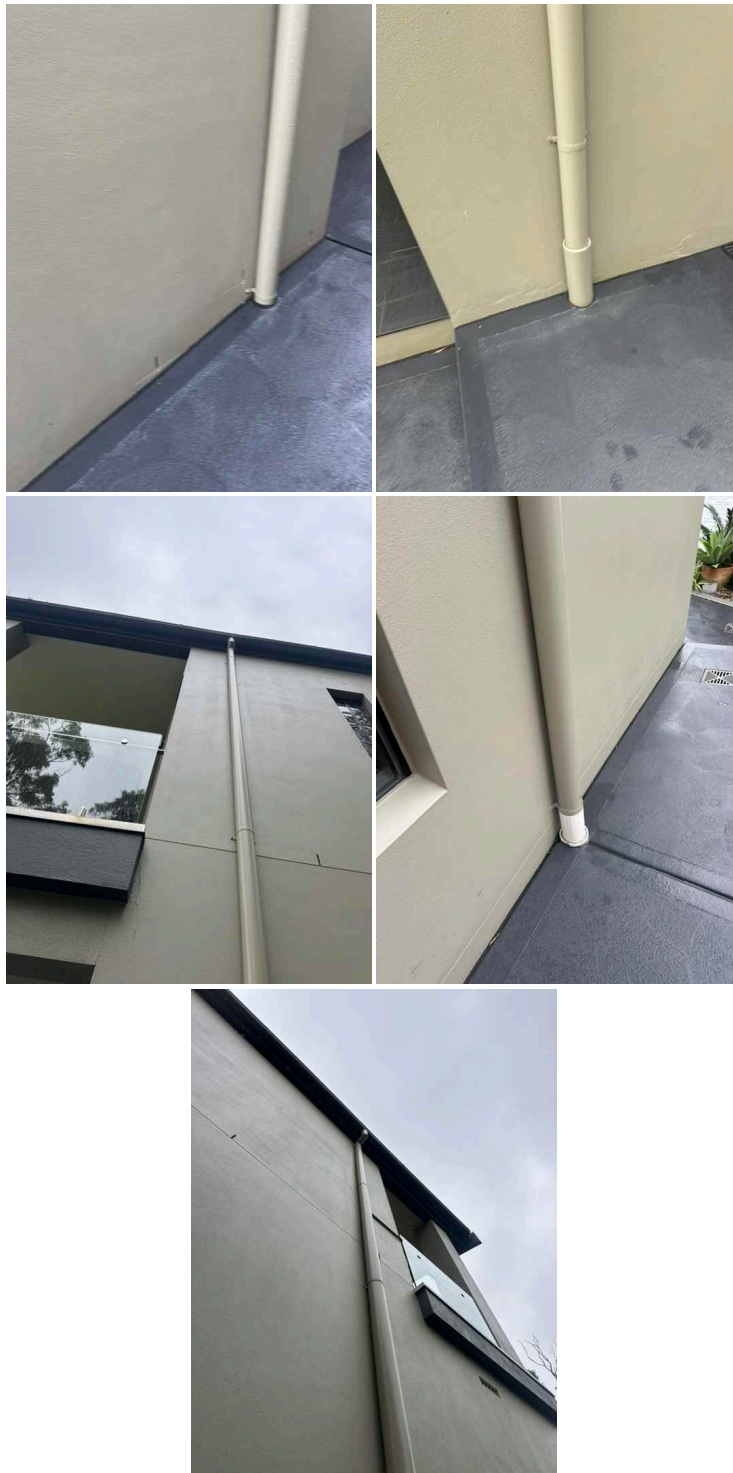
### **Down Pipe Findings**

On visual inspection no apparent defects were noted to the down pipes and are considered serviceable, however no comment can be made with regard to blockages, connections to stormwater or functionality in the absence of rain. Note: Periodic maintenance checks should be carried out for rust penetrations and leaks.

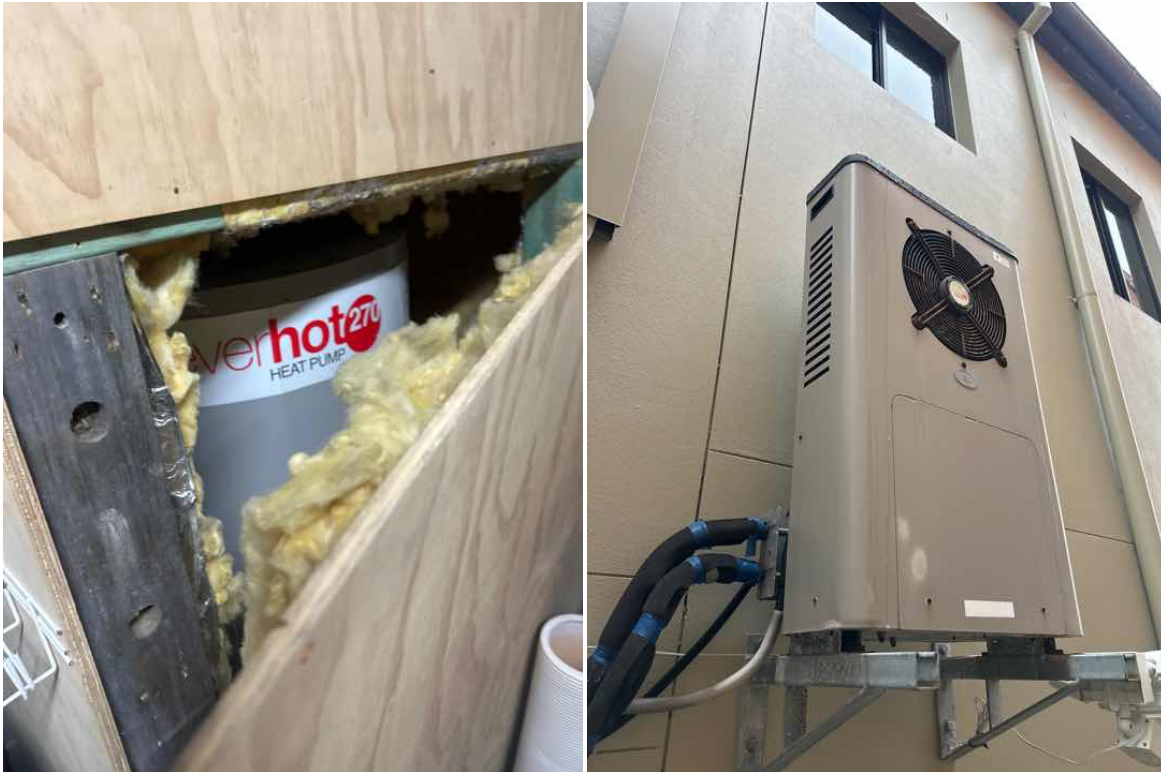
#### Hot Water Unit Findings

No access to hot water heater. No comment can be made.

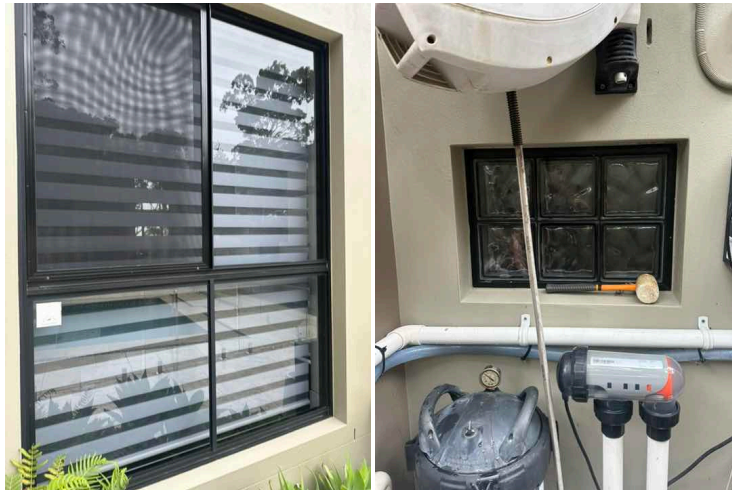
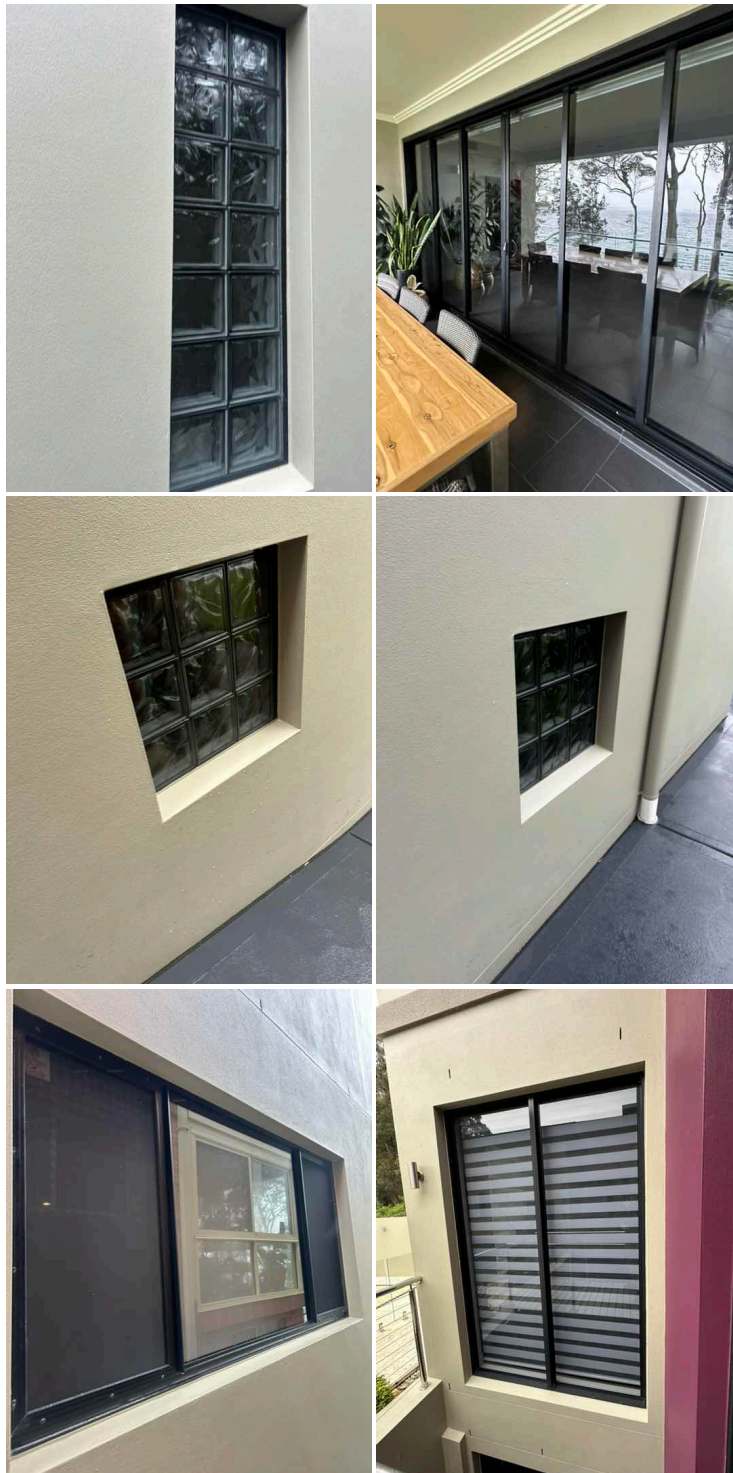
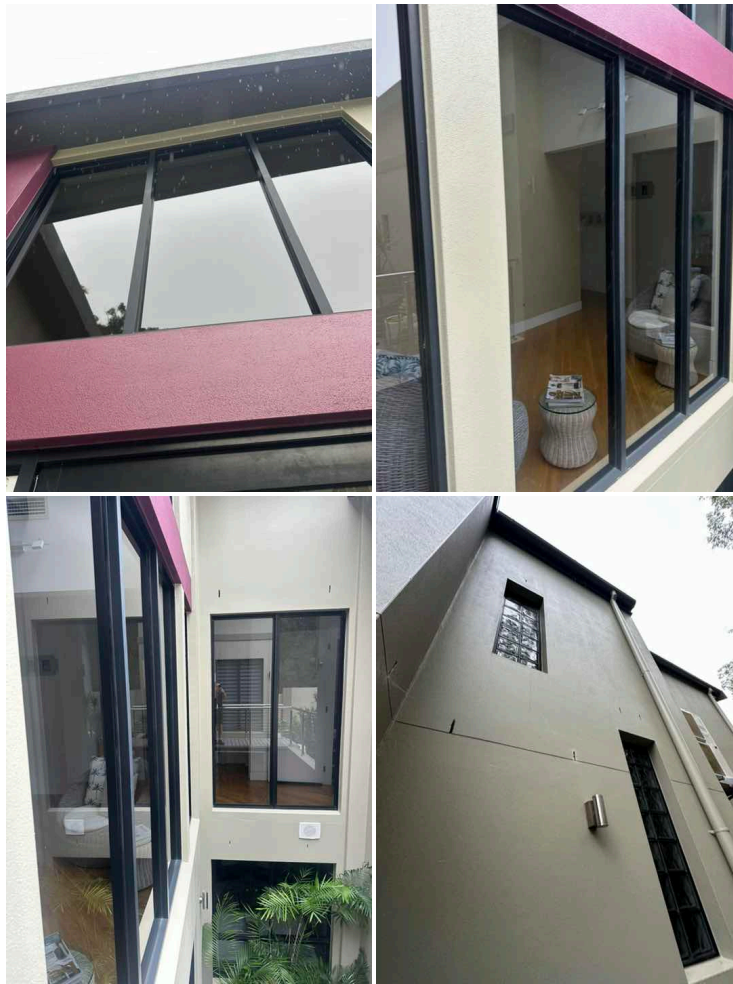
#### Overall Condition

On visual inspection, the general condition of the windows area is serviceable for the age.

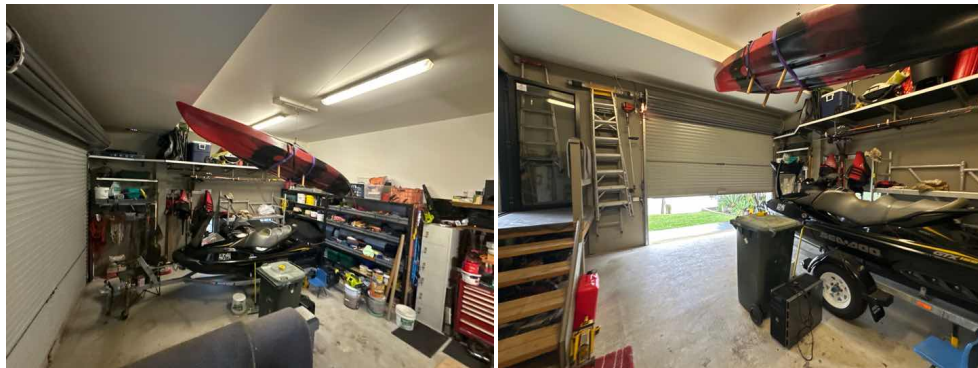
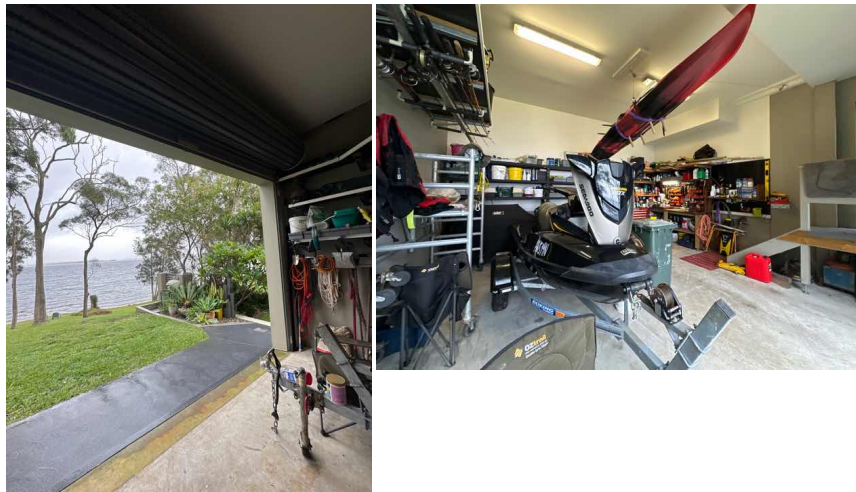
From the visible and accessible areas, the garage appears to be in a serviceable condition for the age of the property with no notable structural defects sighted.

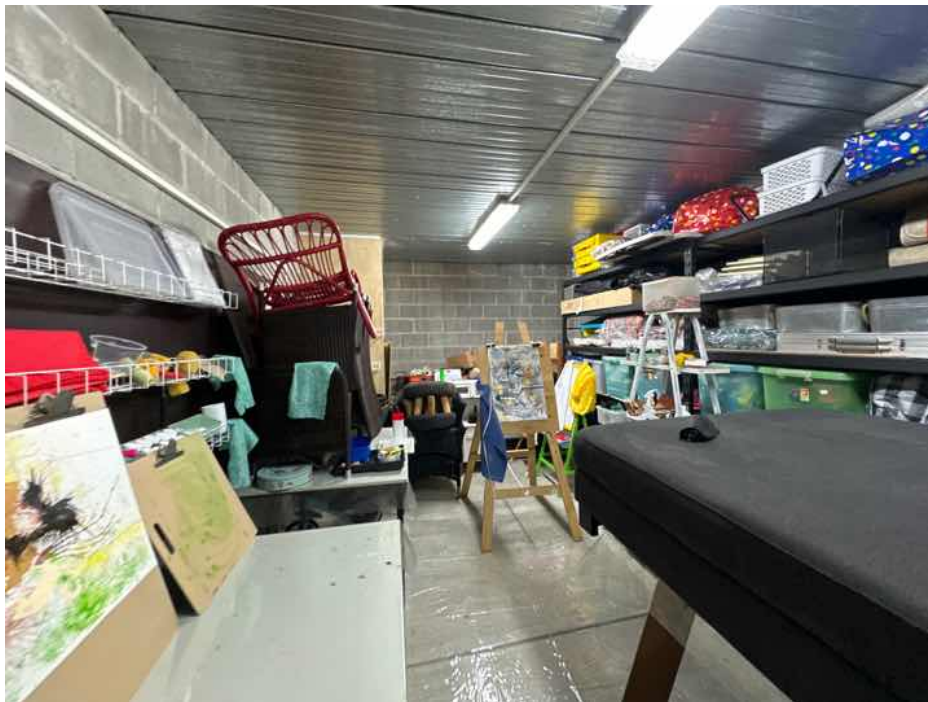
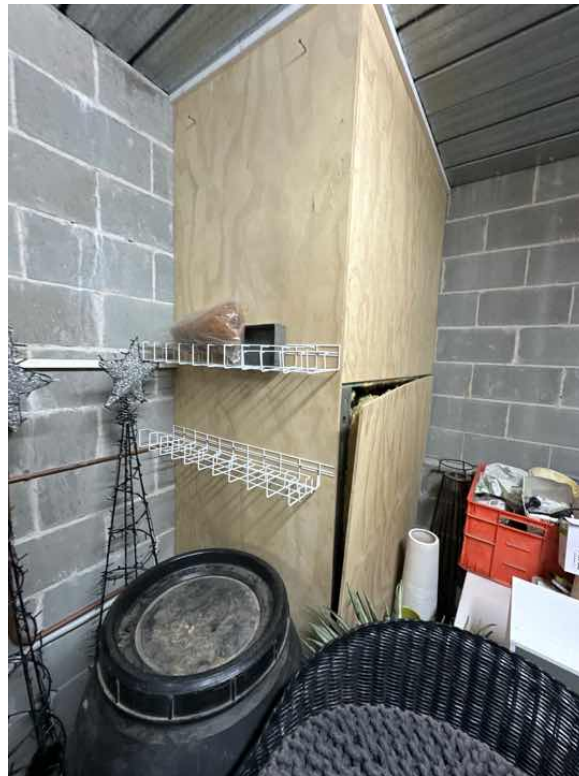
### **Storage below Garaging.**

From the visible and accessible areas, the garage appears to be in a serviceable condition for the age of the property with no notable structural defects sighted.

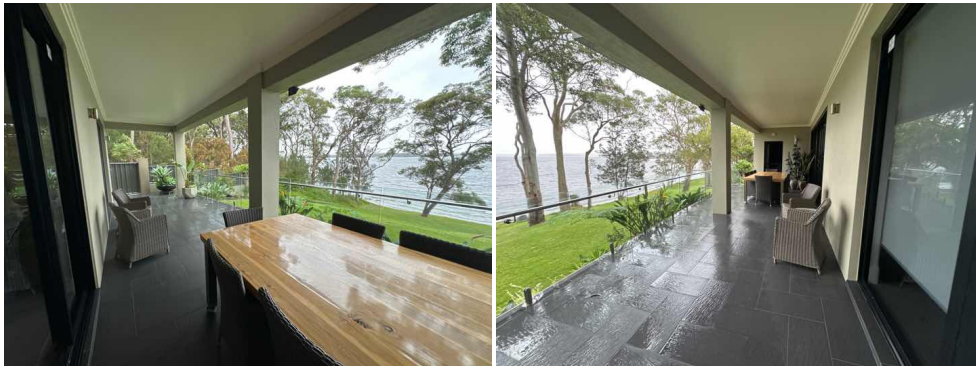
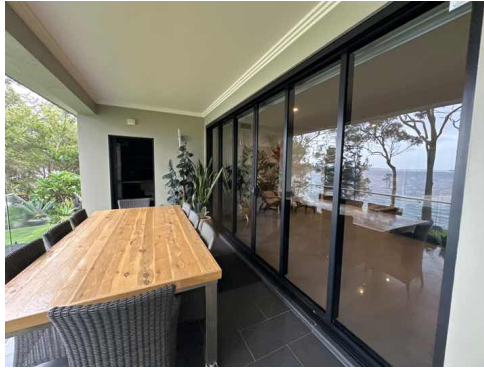
Though we are not structural engineers the balcony/s appear to be in a serviceable condition.

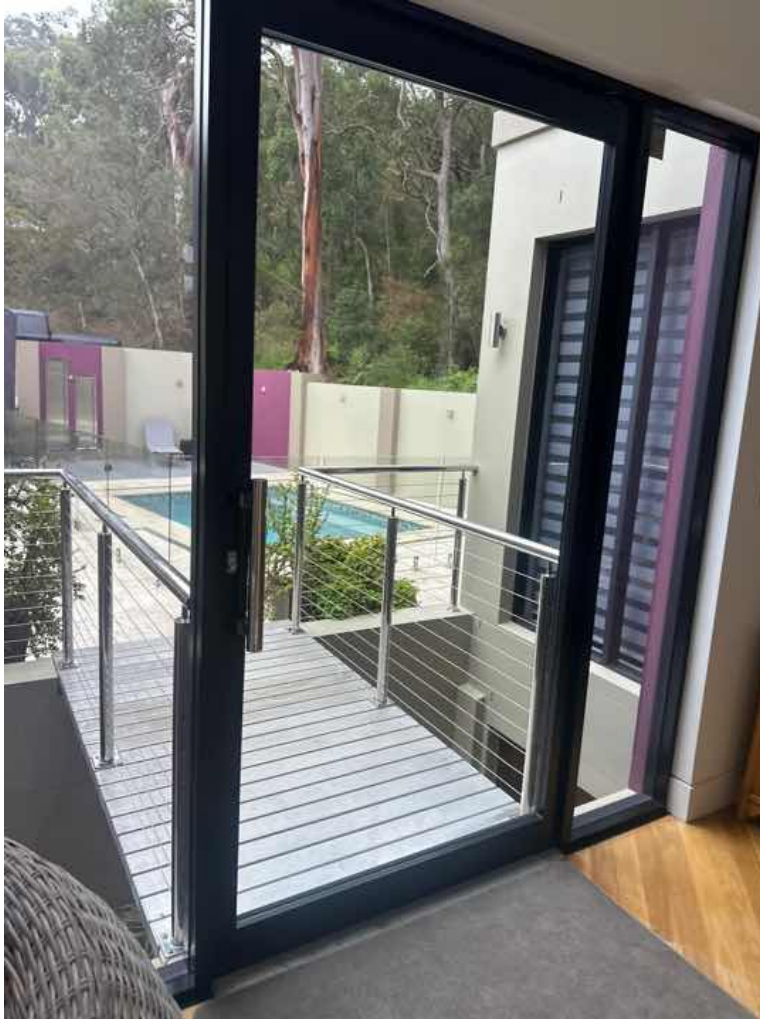
#### **Front Entry Doors**

The doors are in serviceable condition with no notable defects observed.

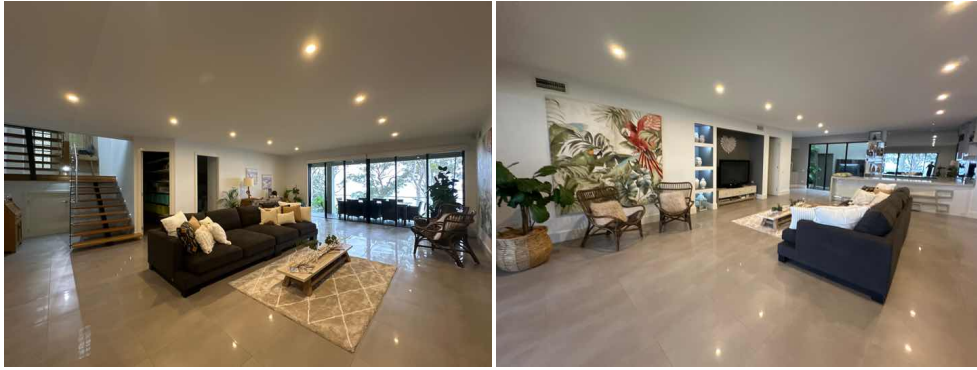
From the visible and accessible areas, the living and meals area appears to be in a serviceable condition for the age of the property with no notable structural defects sighted.

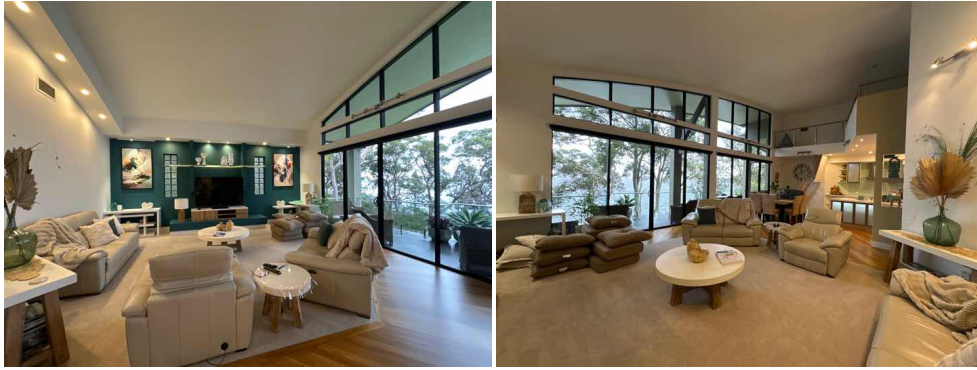
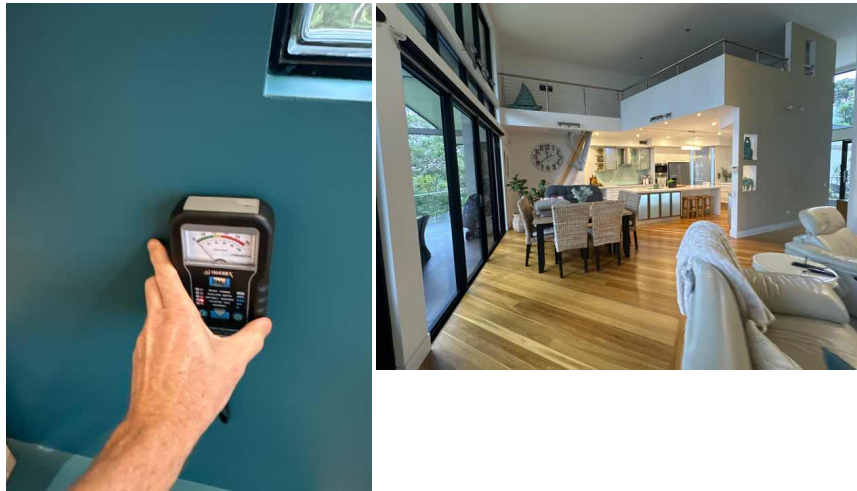
**Combo Lounge & Dining Room****Overall Condition**

From the visible and accessible areas, the lounge and dining room appears to be in a serviceable condition for the age of the property with no notable structural defects sighted.

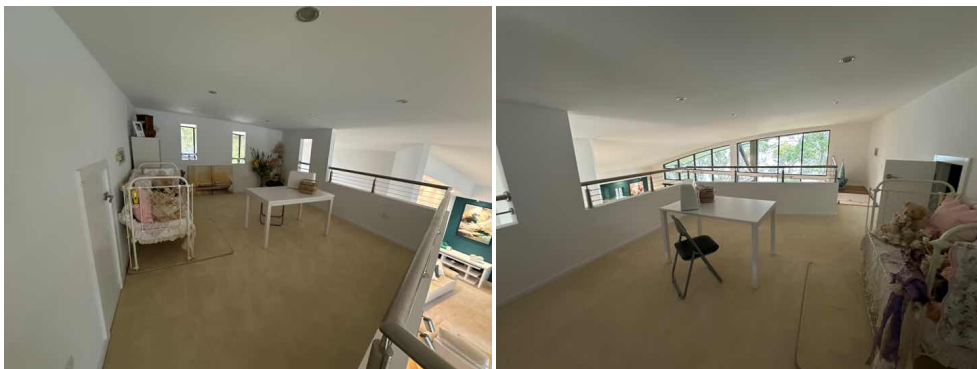
### Upstairs loft area

From the visible and accessible areas, the upstairs living room appears to be in a serviceable condition for the age of the property with no notable structural defects sighted.

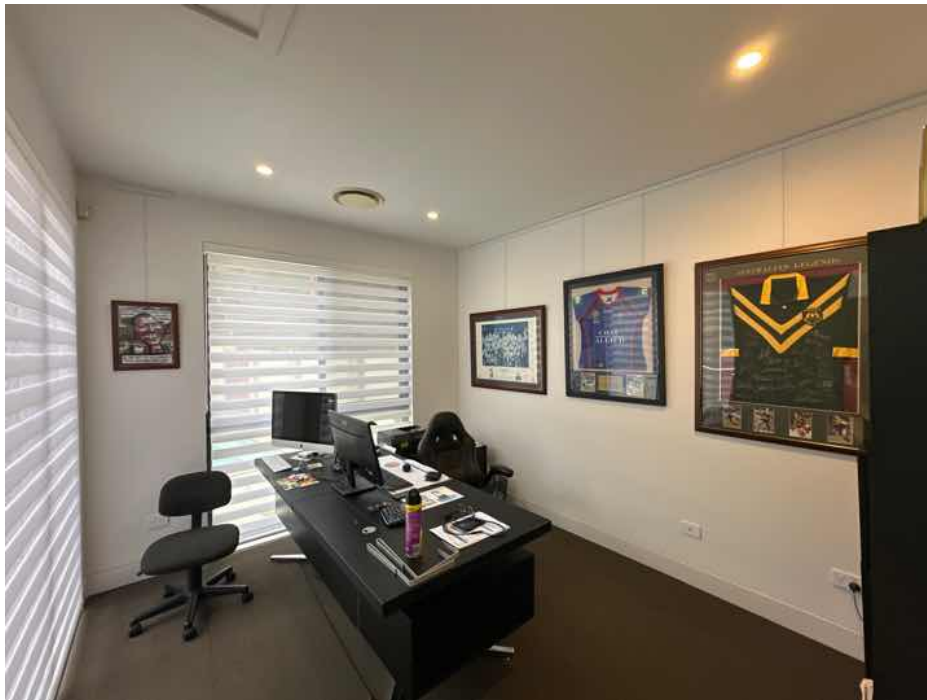
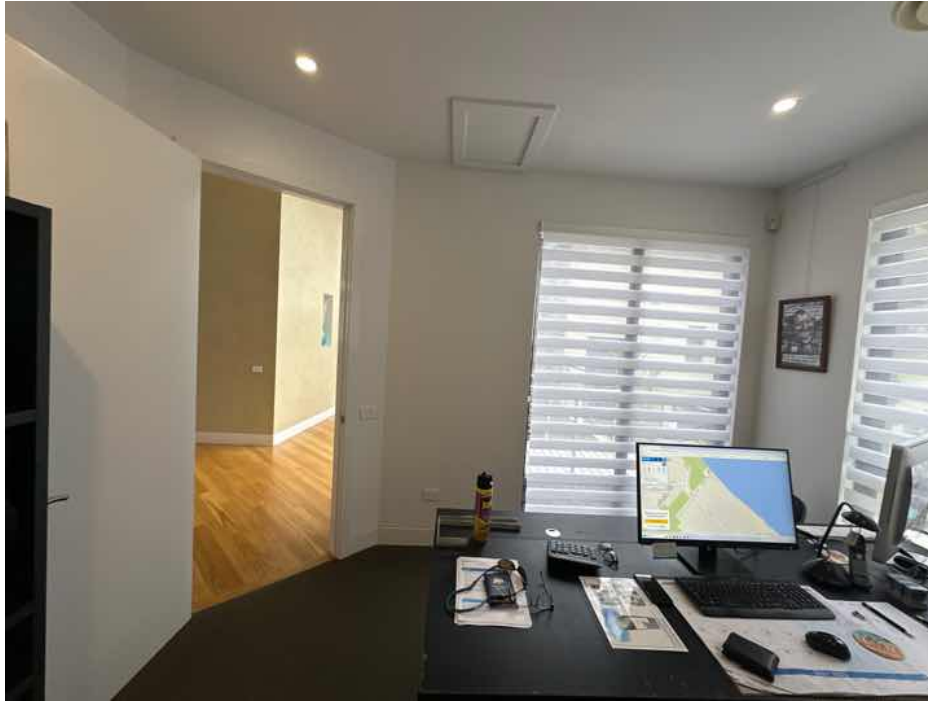
From the visible and accessible areas, the study/office appears to be in a serviceable condition for the age of the property with no notable structural defects sighted.

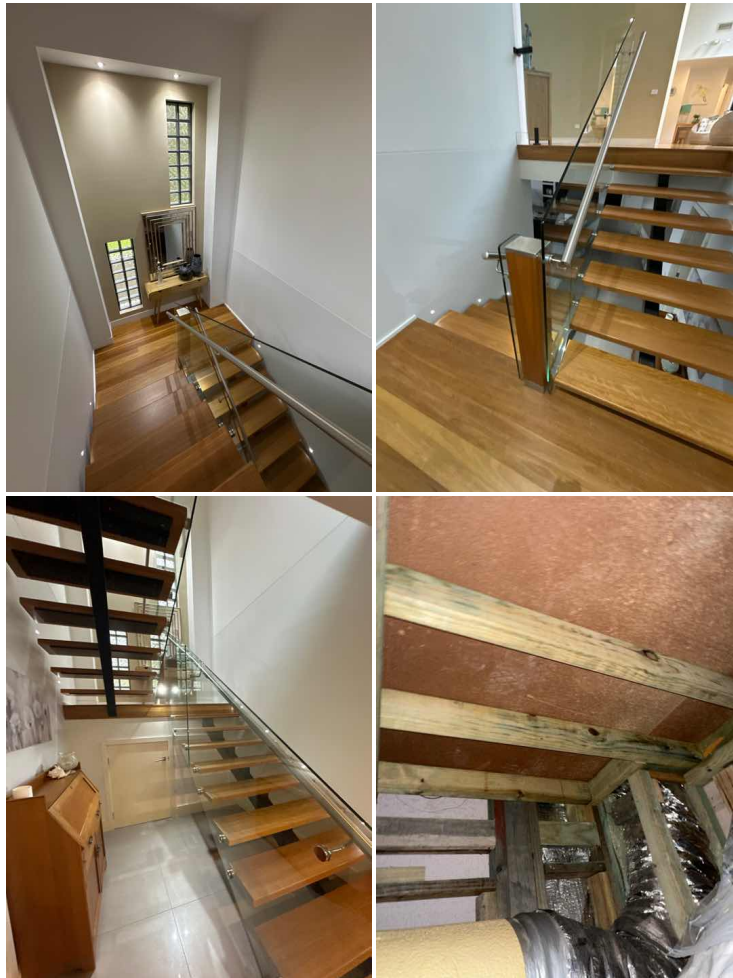
## **Internal Stair Case**

The internal stair case is in a serviceable condition for the age with no notable defects sighted.

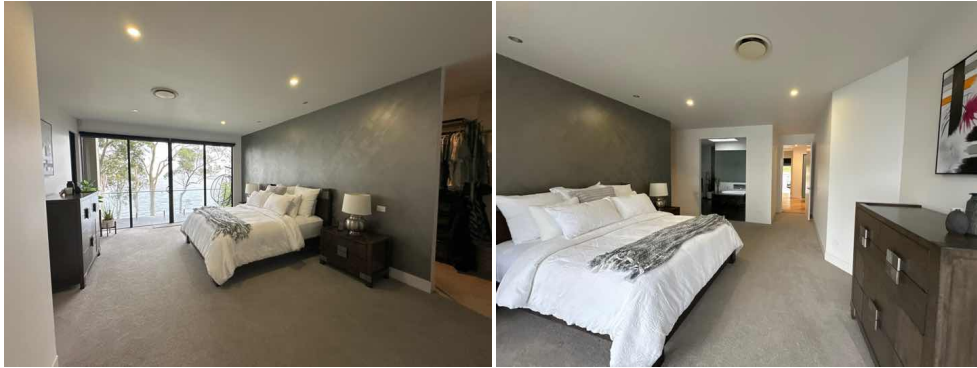
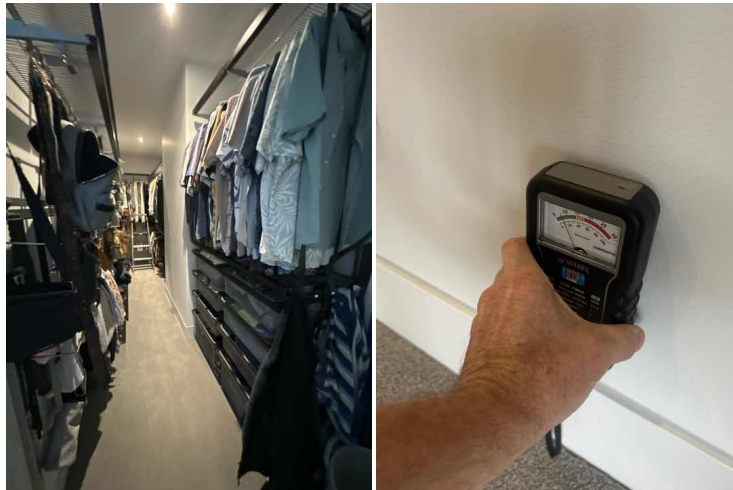
## **Bedroom 1**

This bedroom is in serviceable condition for the age with no notable structural defects sighted.

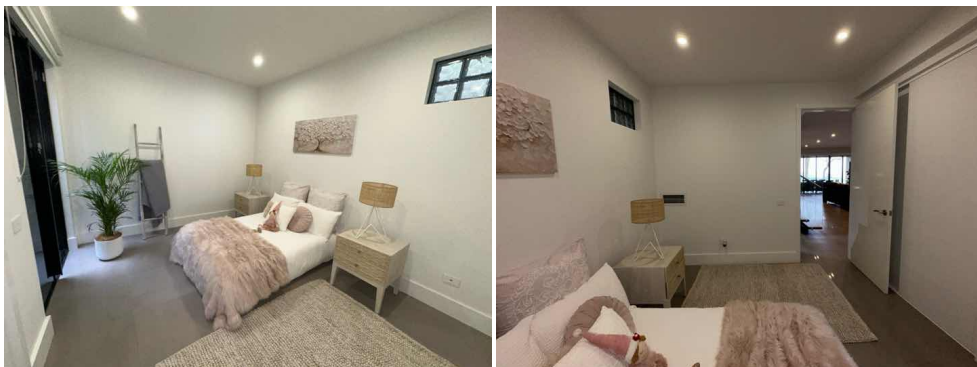
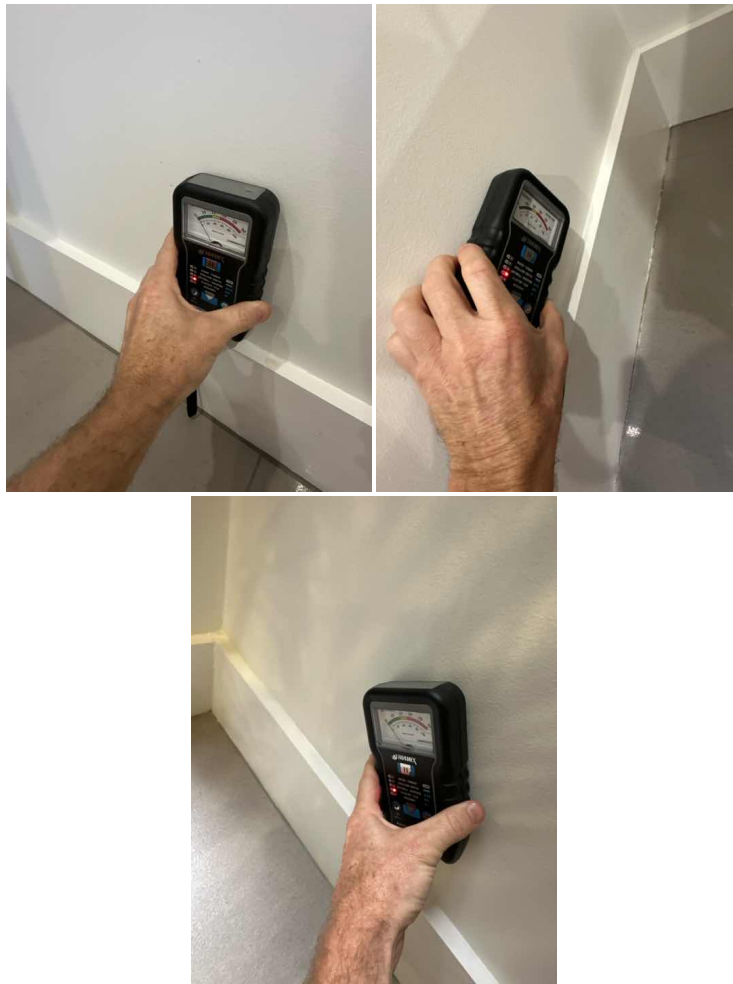
## **Bedroom 2**

This bedroom is in serviceable condition for the age with no notable structural defects sighted.

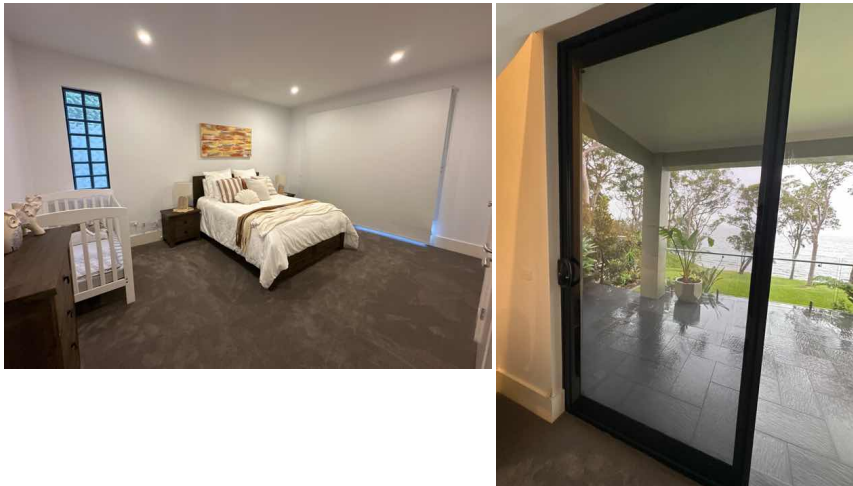
### **Bedroom 3**

This bedroom is in serviceable condition for the age with no notable structural defects sighted.

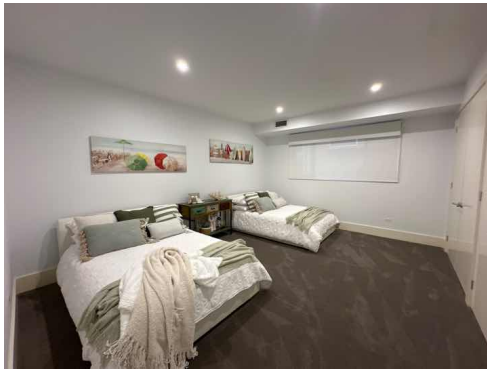
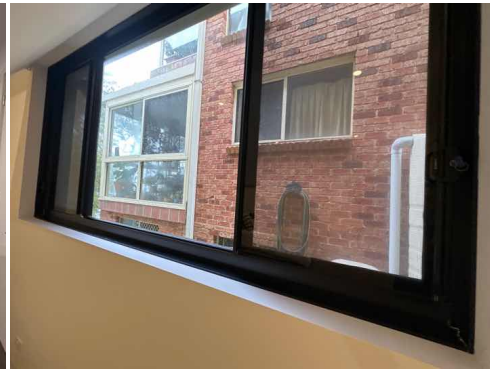
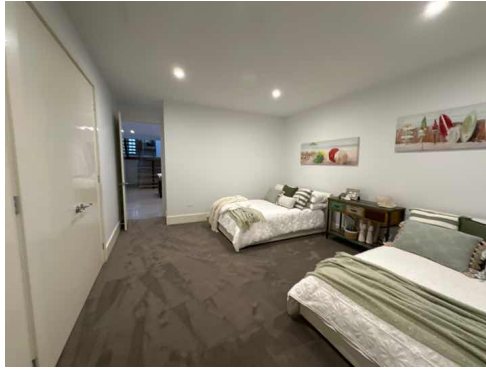
## **Bedroom 4**

This bedroom is in serviceable condition for the age with no notable structural defects sighted.

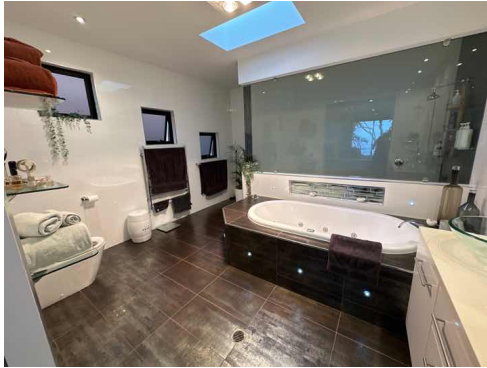
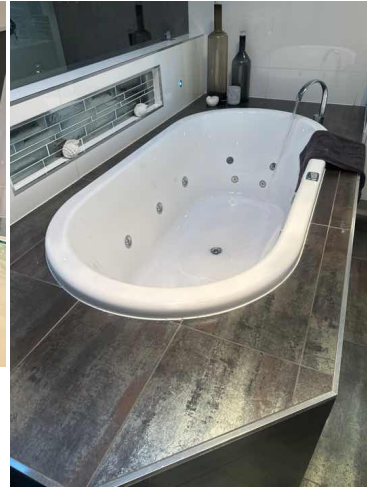
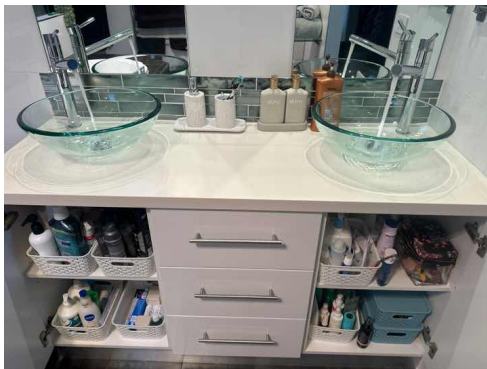
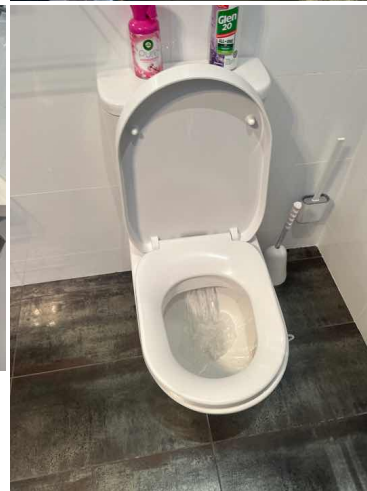
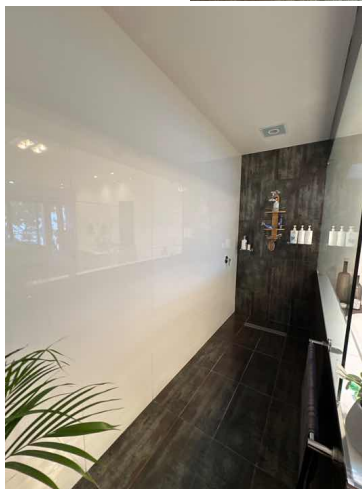
Of the visible areas, the general condition of this bathroom is serviceable or in reasonable condition for age of dwelling.

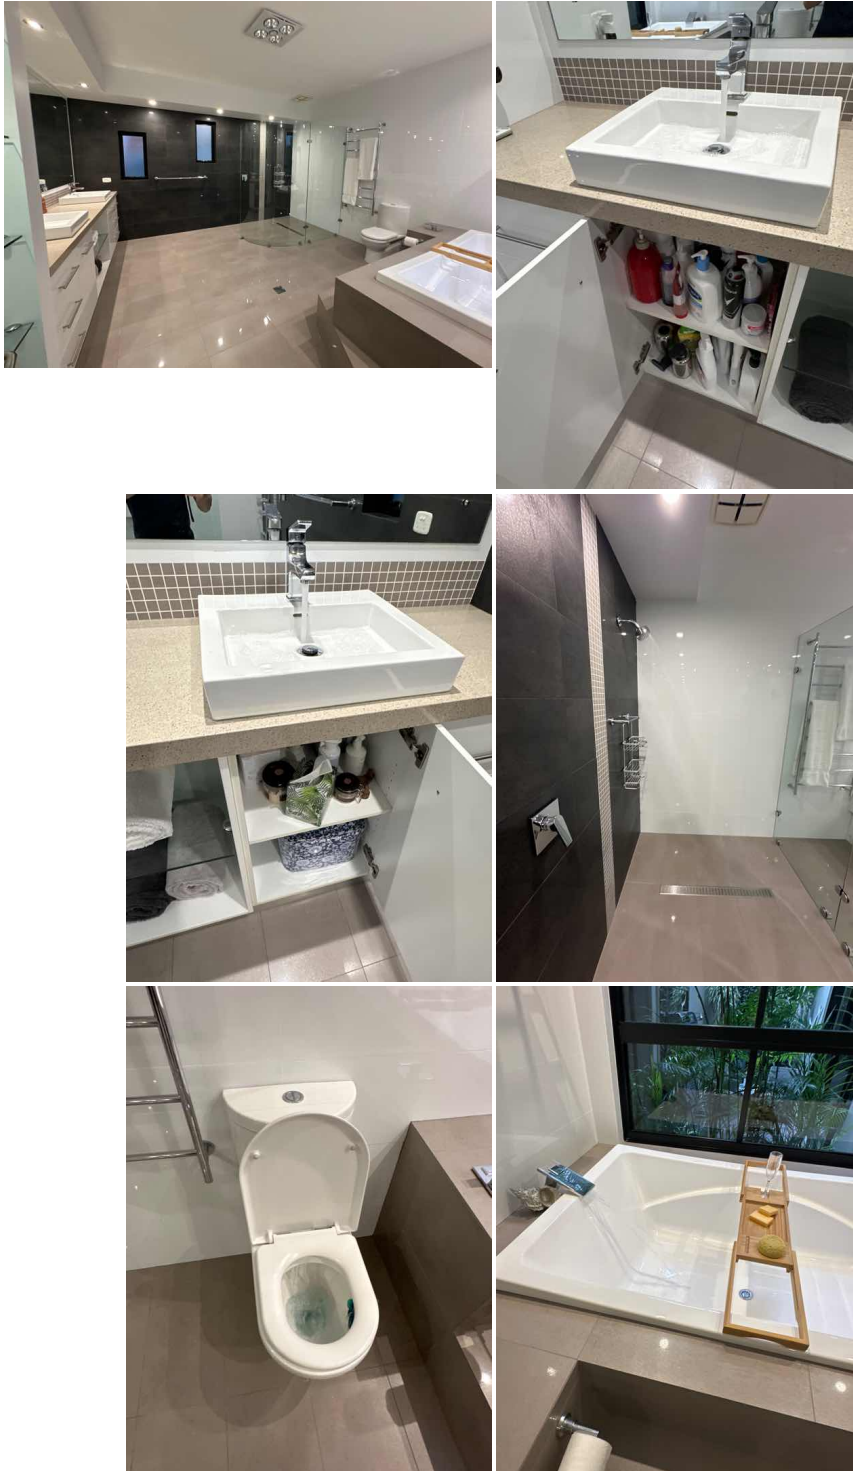
## **Bathroom 3**

Of the visible areas, the general condition of this bathroom is serviceable or in reasonable condition for age of dwelling.

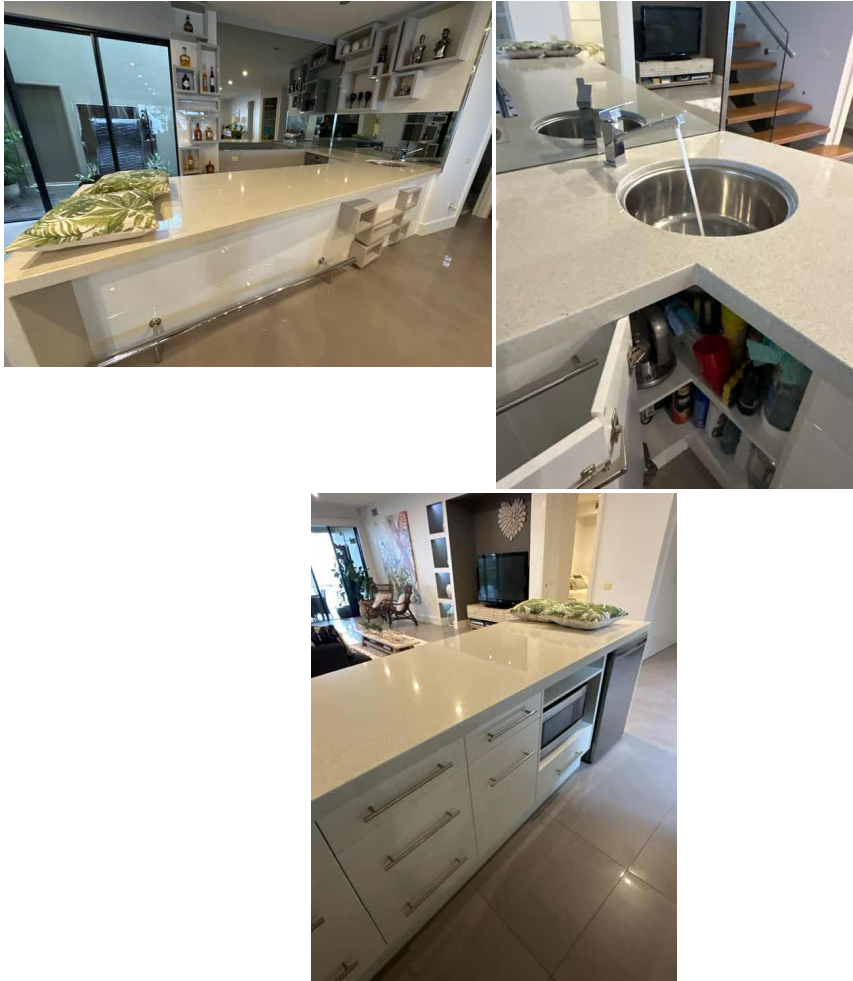
Of the visible areas, the general condition of the kitchen is serviceable or in reasonable condition for age of dwelling.

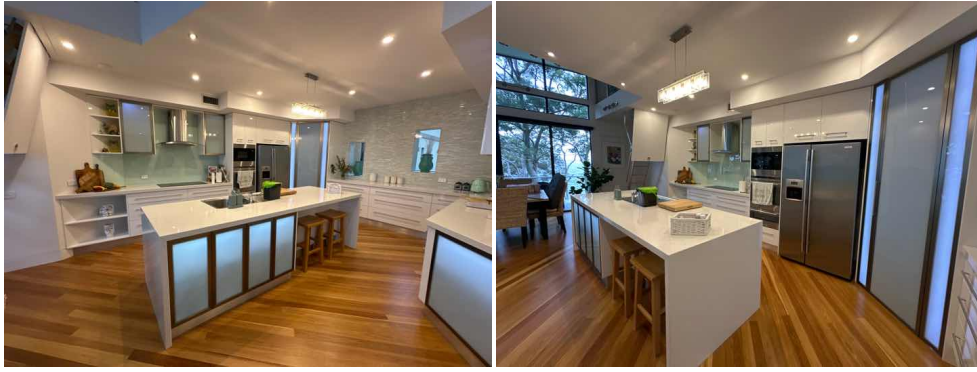
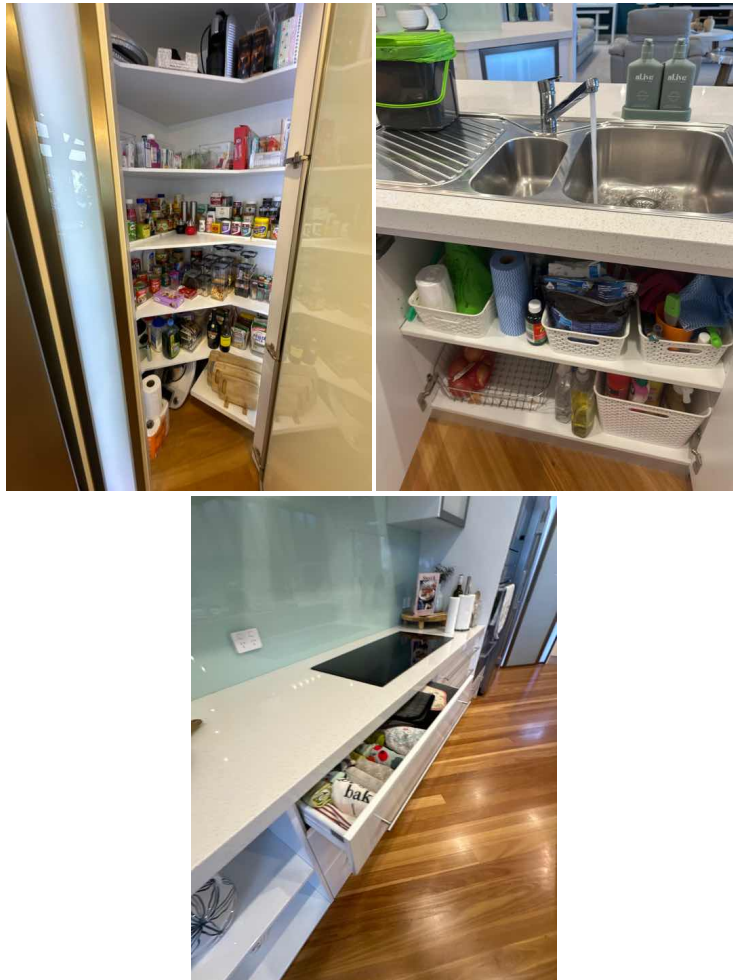
### Kitchen and Meals Area

Of the visible areas, the general condition of the kitchen is serviceable or in reasonable condition for age of dwelling.

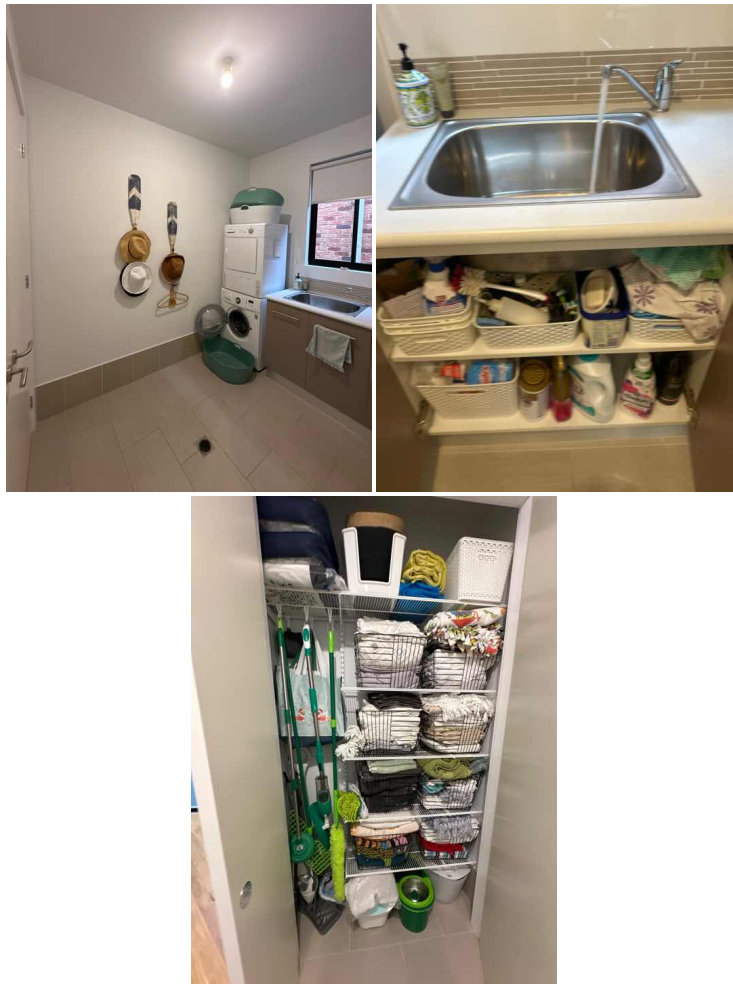
## **Laundry Findings**

Of the visible areas, the general condition of the laundry is serviceable.
