# Inspection Report

## Coastal Building Inspections

**205 Dandaraga Road, MIRRABOOKA, NSW, 2264**

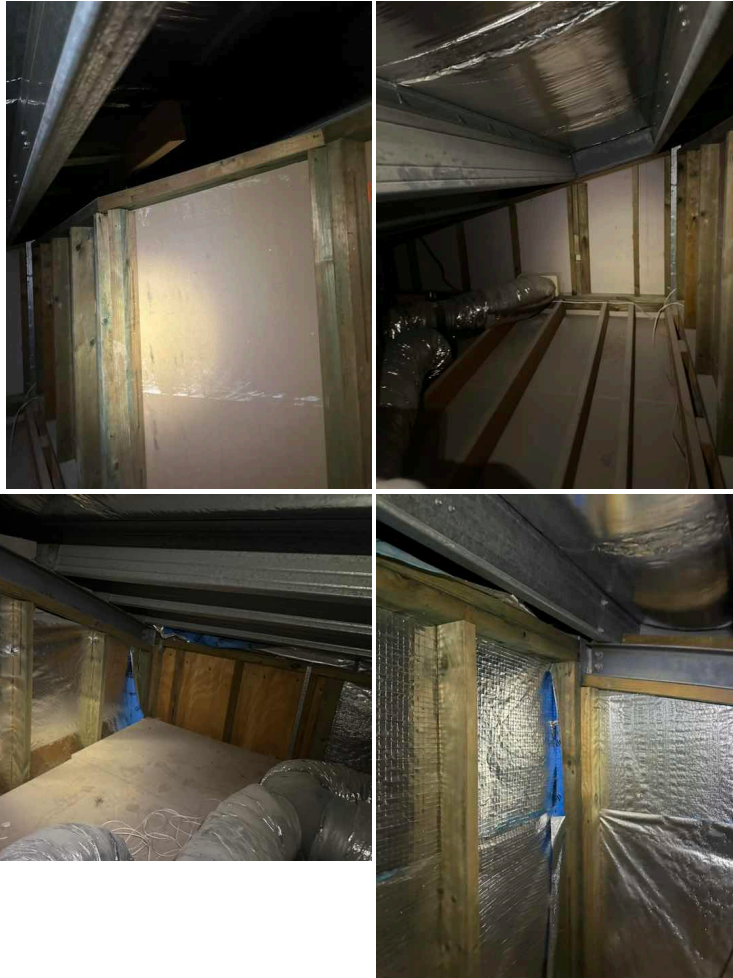
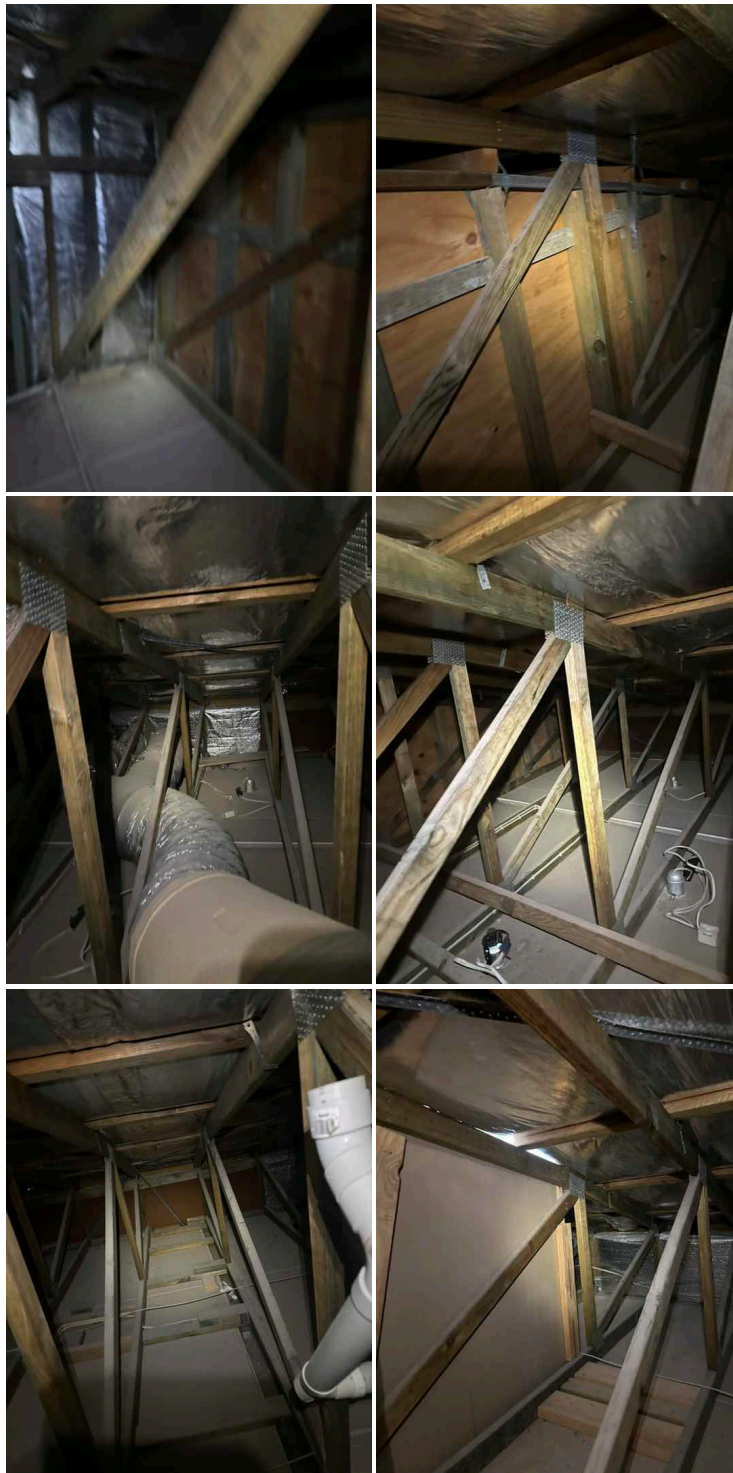
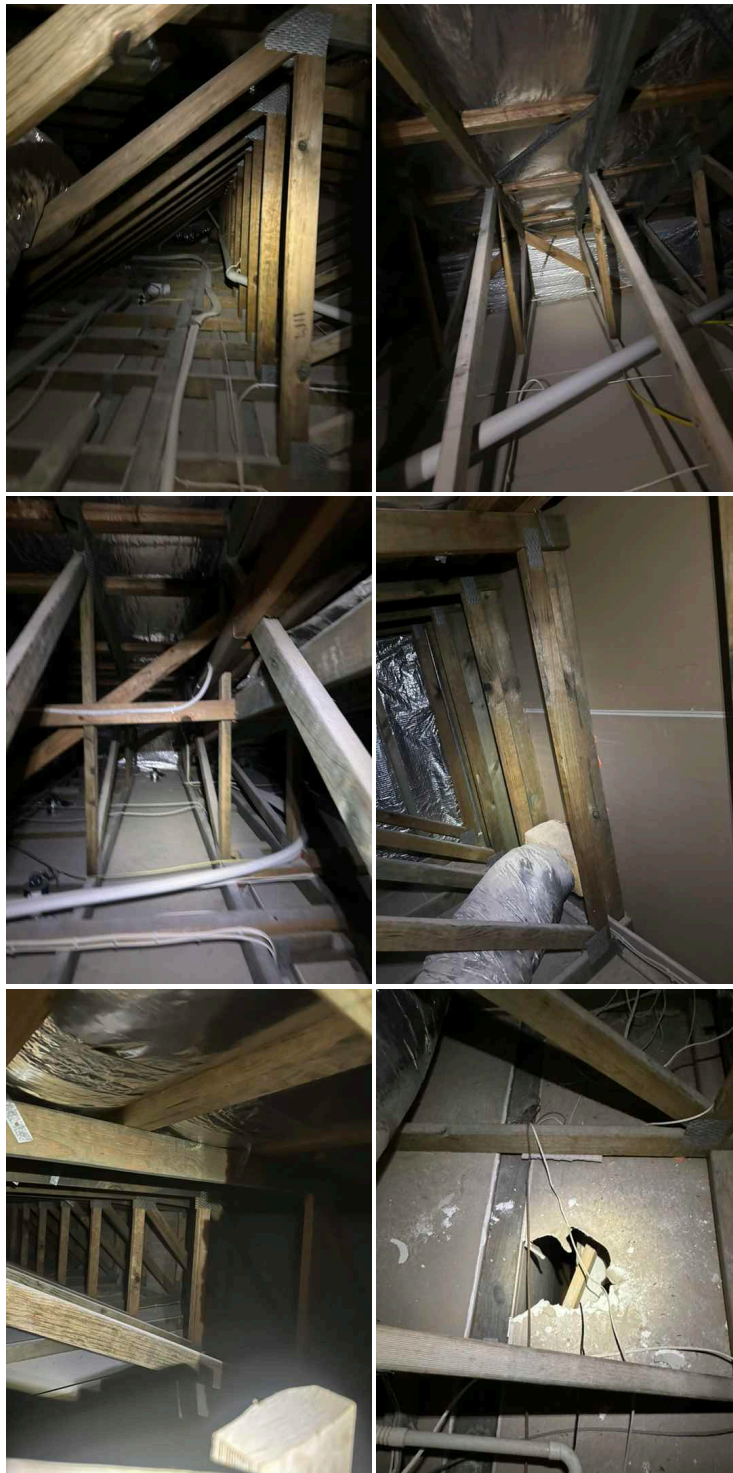
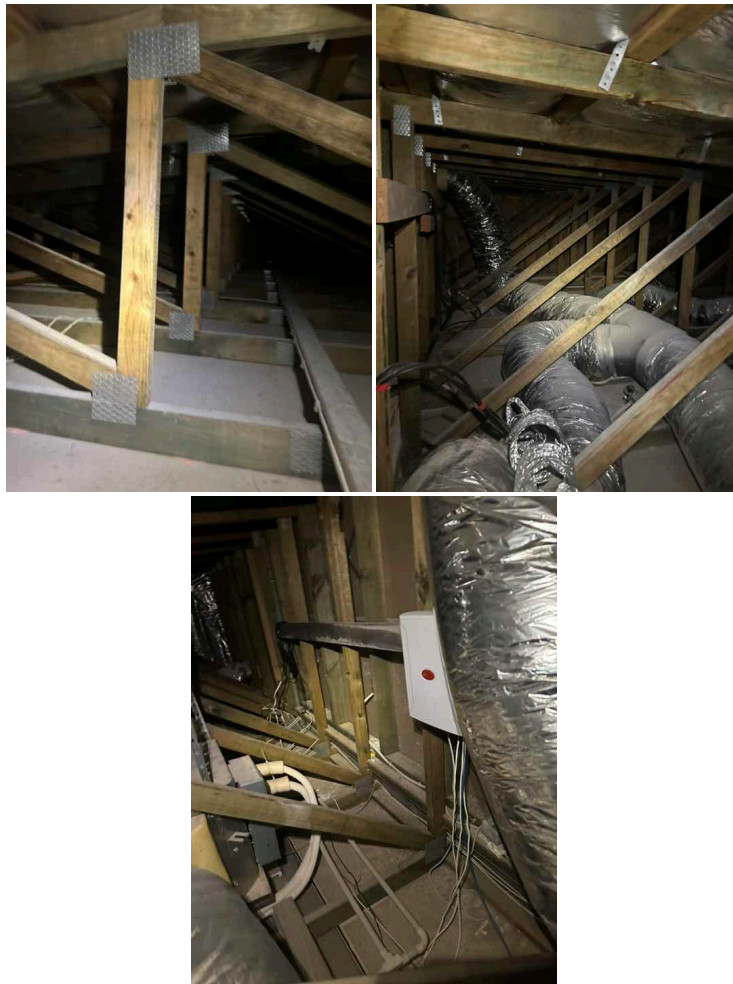
Visible sections of the roof void is in a serviceable condition for age of this dwelling.
