Building and Timber Pest Inspection Report

Inspection Date: Wed, 14 Aug 2024

Property Address: 33A Beecroft Rd, Beecroft NSW 2119,
Australia

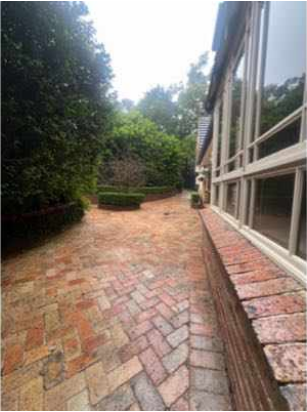
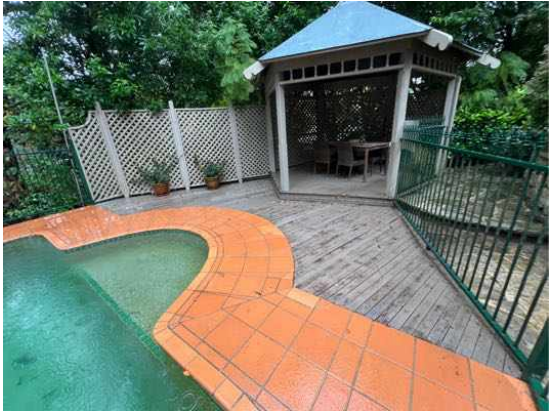
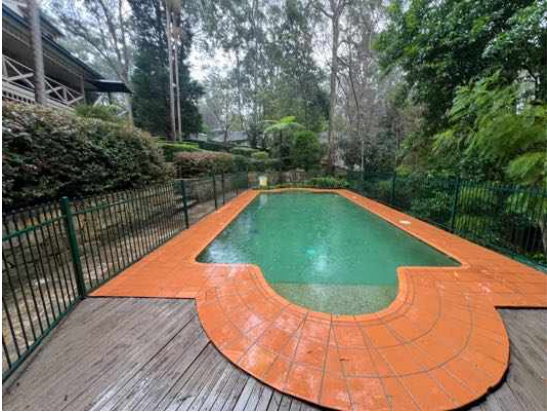
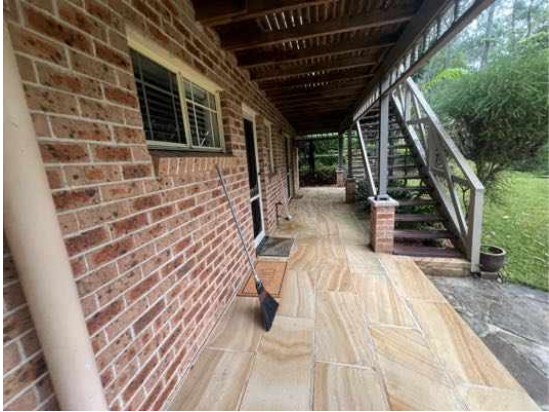
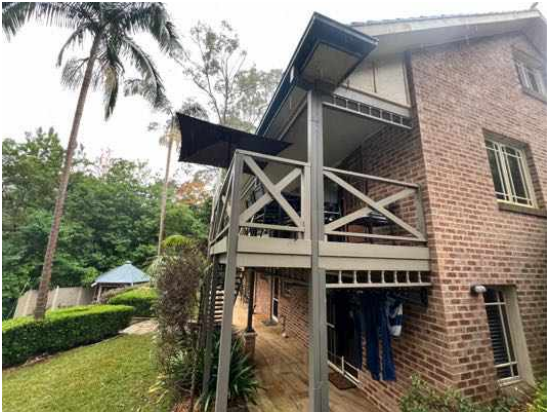
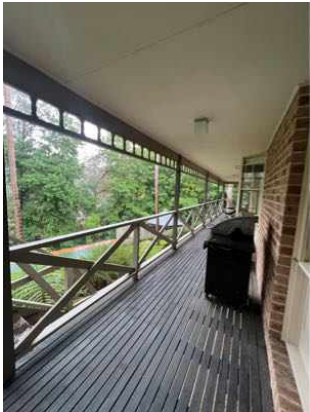
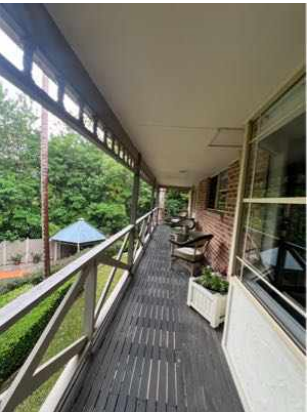
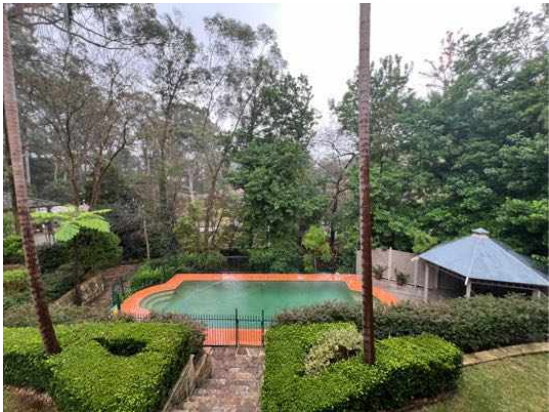
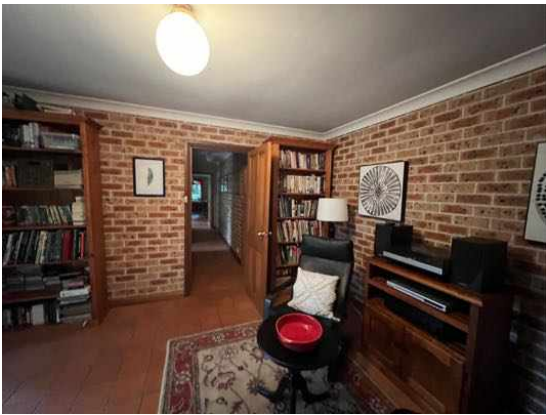
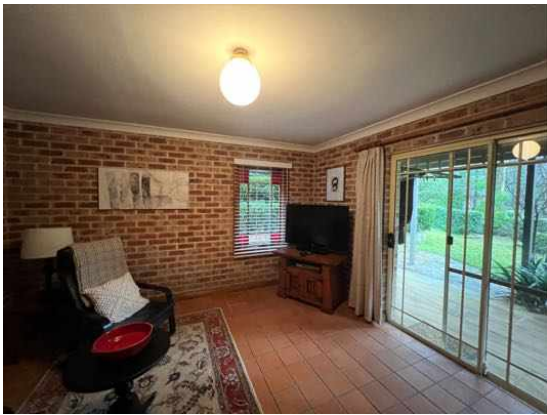
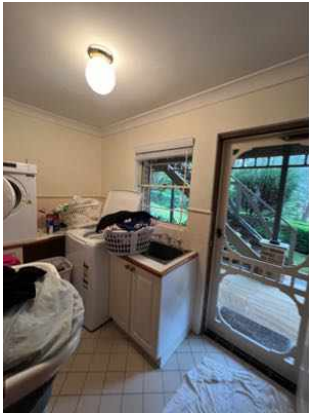
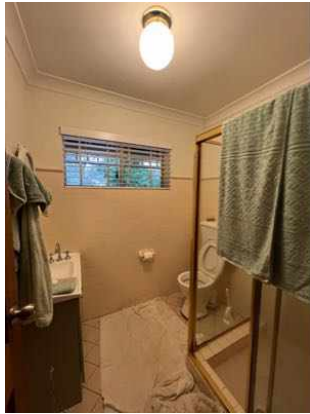
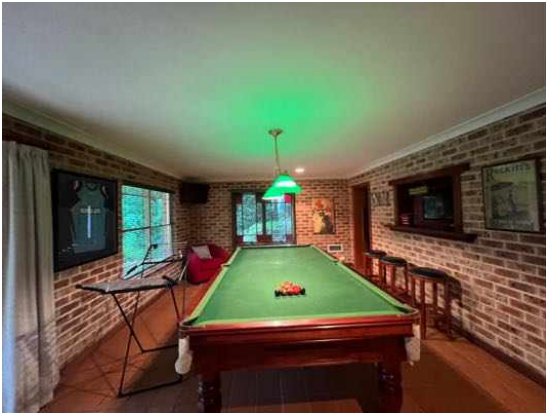
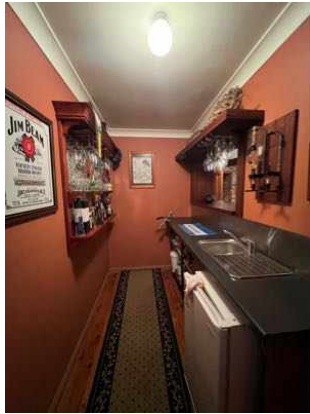
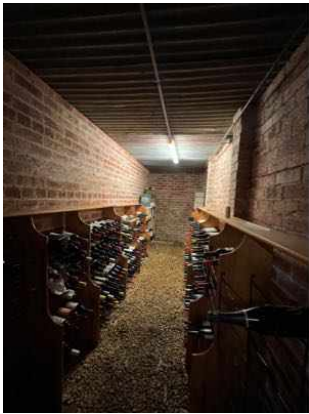
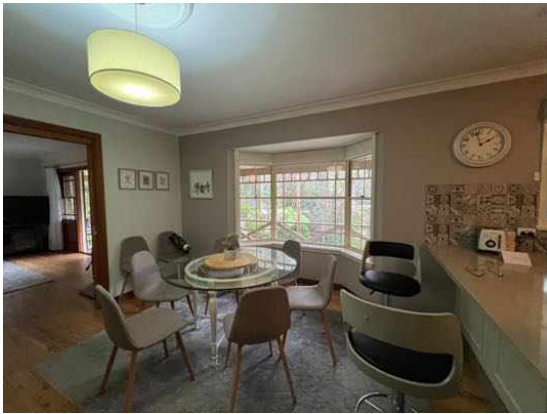
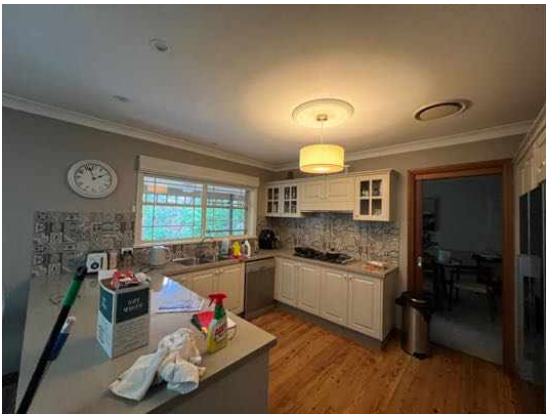
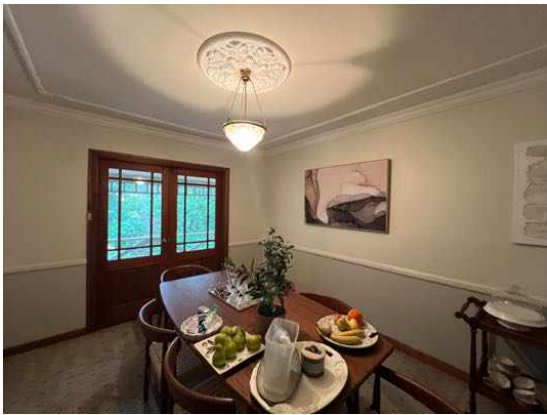
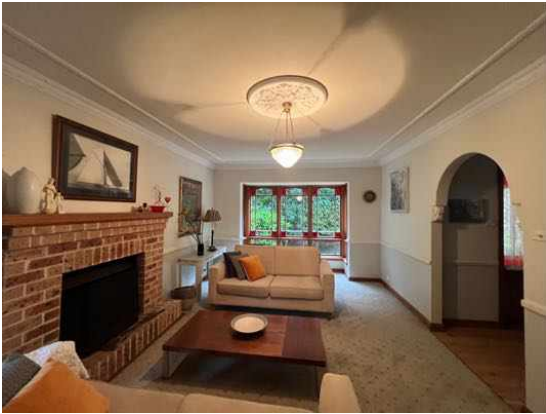
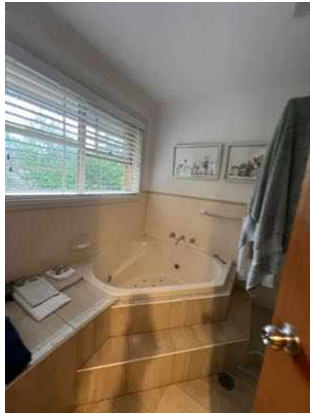
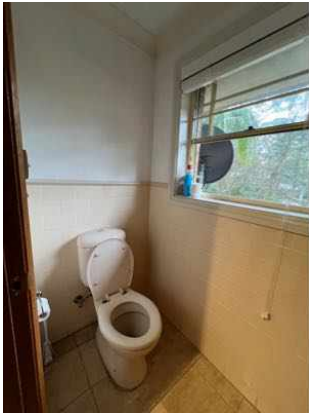
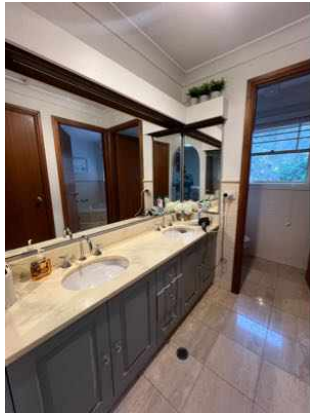
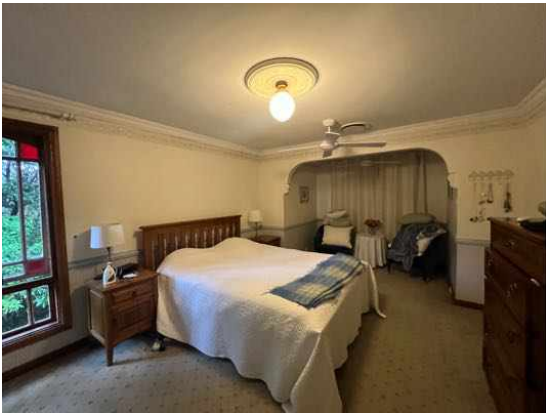
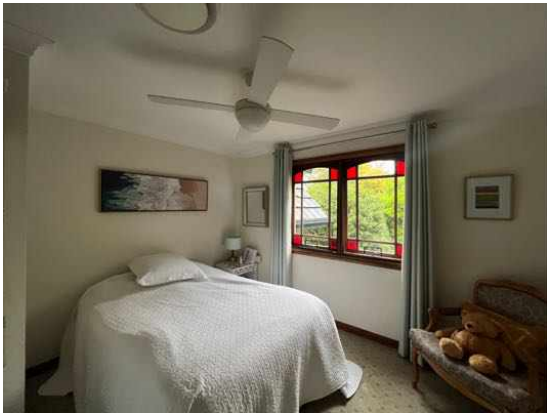
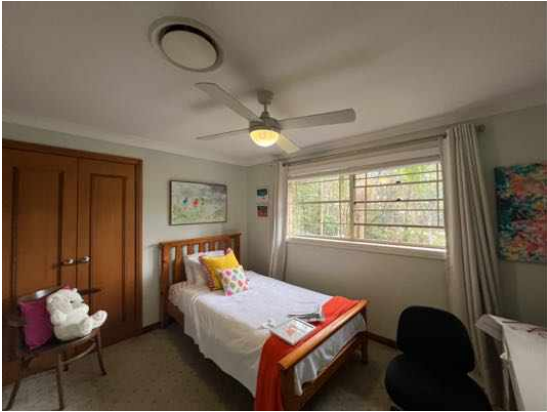
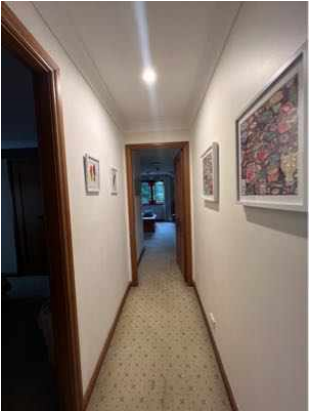
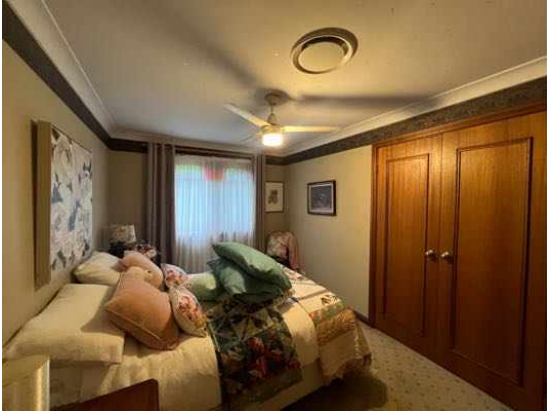
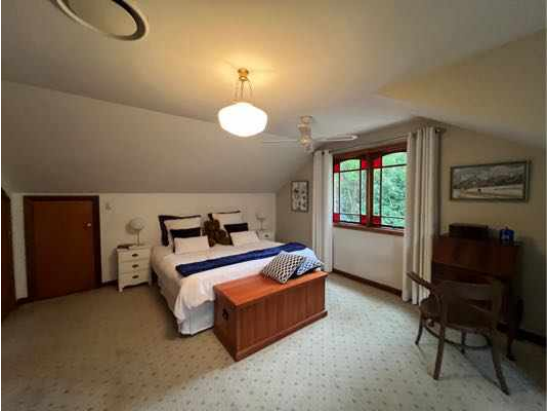
Building: Main Building
Location:
Finding: Additional Photos - Reference / Limitations
Information: These photos are for reference including some of the obstructions and limitations present.
