PRE-PURCHASE PROPERTY INSPECTION BUILDING REPORT

Visual Pre-Purchase Building Inspection Report.

6 RENNELL STREET KINGS PARK.

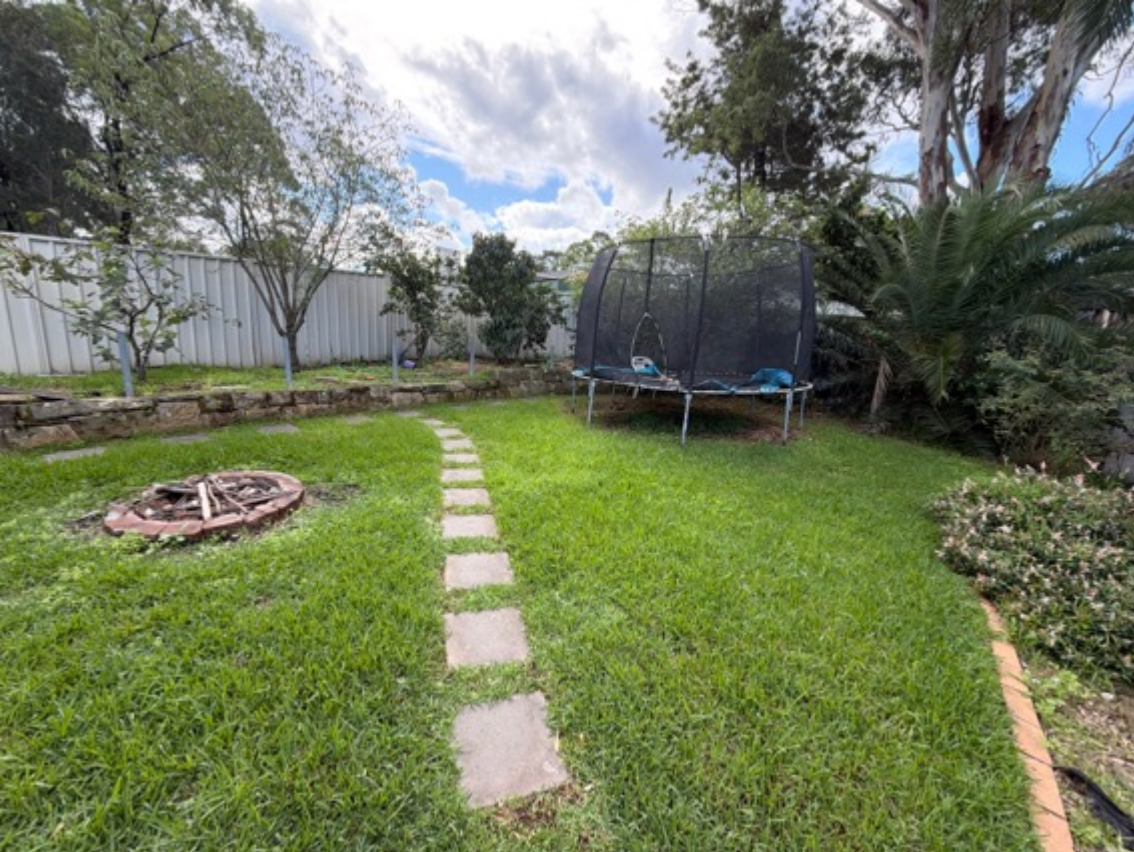
Site drainage / land overflow appears to function adequately with no signs of water laying at the time of inspection.

Rear yard example above.

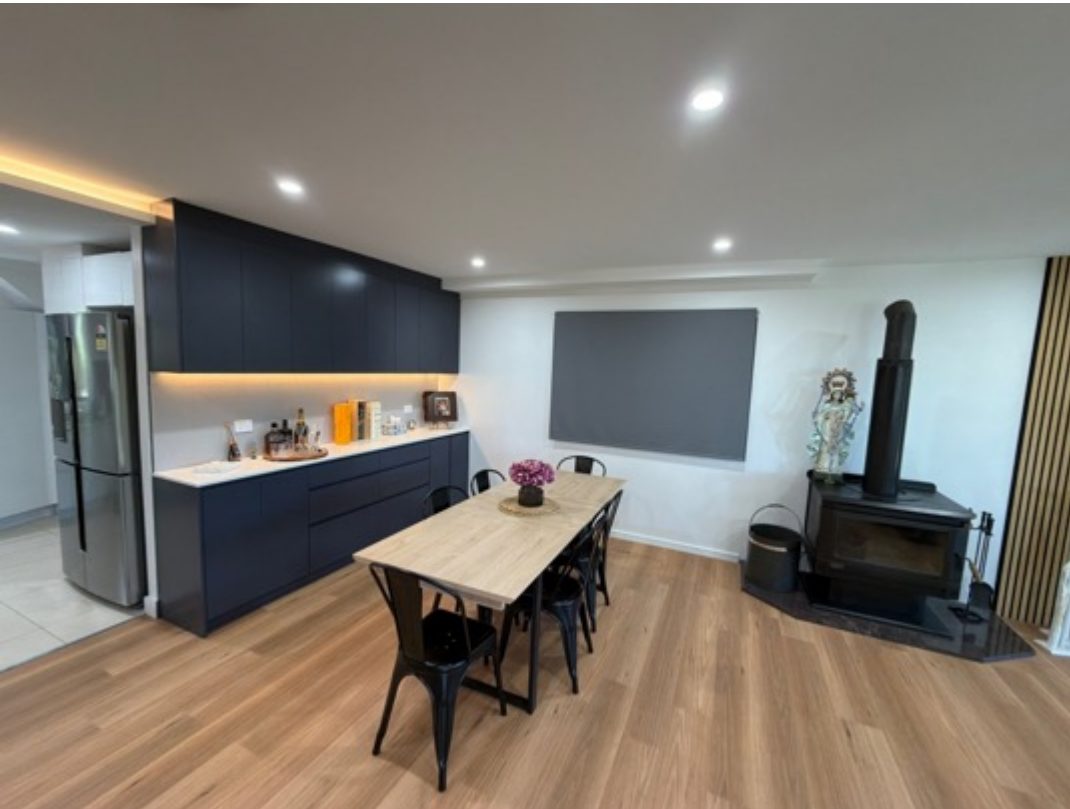
Interior living rooms present in satisfactory condition for the age.

Example dining area above.
