VISUAL BUILDING & PEST INSPECTION REPORT

Complies with Australian Standard 4349.1 & 4349.6

Inspected Property:
122 Livingstone Avenue, Pymble

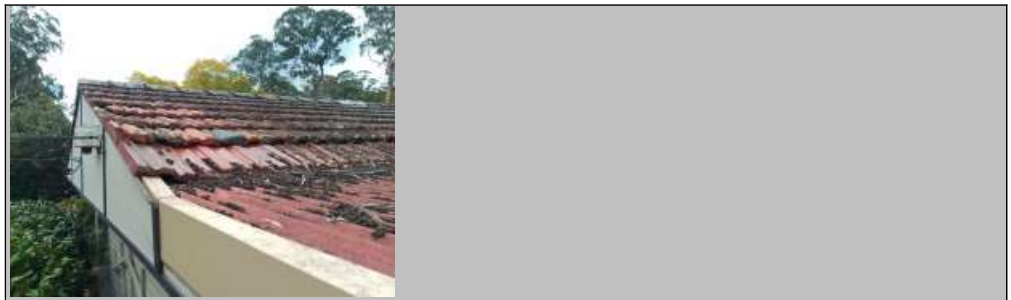
The overall condition of the roof coverings is fair. Areas of repairs are required. Mortar beds to the hip and ridge capping are cracked and require maintenance or re bedding and pointing in areas.

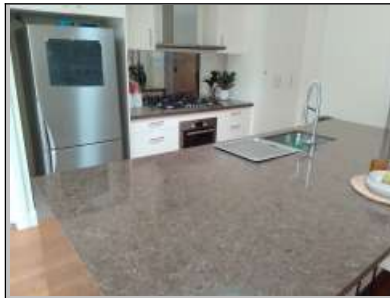
The condition of the fixtures is generally good, A glass splashback is located over the benchtop area. Glass appears to be in serviceable condition.

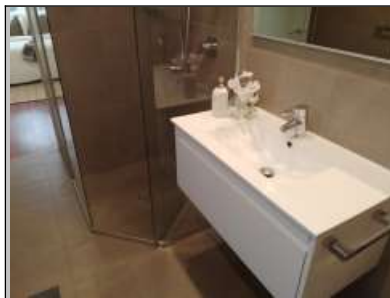
Adjacent to the laundry.

The shower recess was tested and there was no visible water penetration to surrounding areas. IMPORTANT NOTE: This test may not reveal water leaks until the shower is put into constant use and surrounding areas monitored over a period of time.

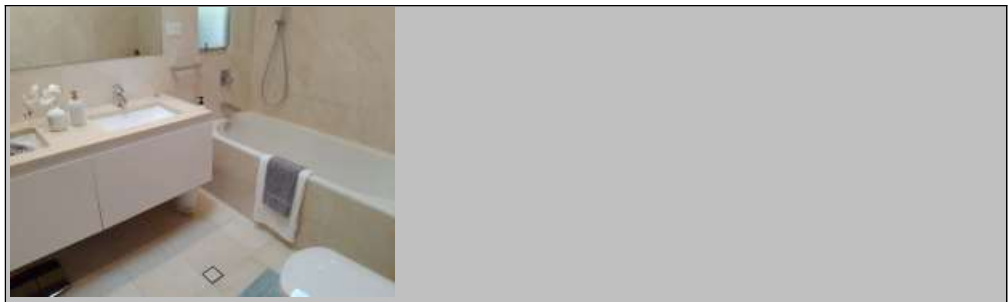
Adjacent to hall.

The shower recess was tested and there was no visible water penetration to surrounding areas. IMPORTANT NOTE: This test may not reveal water leaks until the shower is put into constant use and surrounding areas monitored over a period of time.

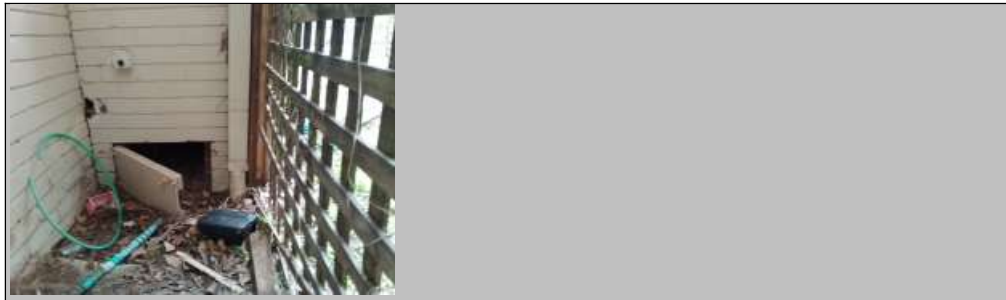
The entry point is too small to allow body access and accordingly no report on this area is submitted.

Damage and or defects may be present and not detected in areas where inspection was limited, obstructed or access was not gained. If restrictions are noted we STRONGLY recommend that access be gained to all inaccessible areas.
