Pre-Sale Building & Timber Pest Inspection Report

4 Golden Square Hendra 4011 Queensland Australia

10 Nov 2025

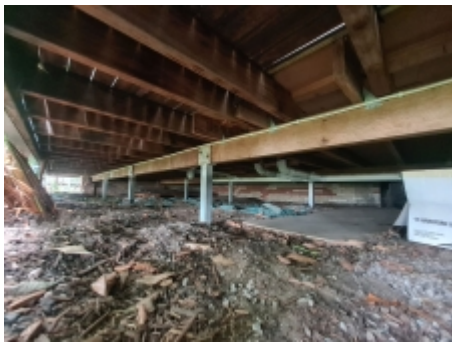
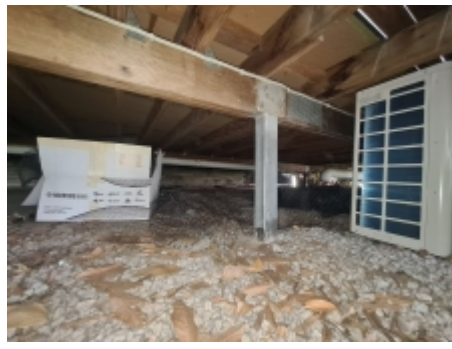
Subfloor Space

Defect Severity	Minor Defect
-----------------	--------------

Comment	Rusting to base of steel posts. Maintenance recommended
---------	---

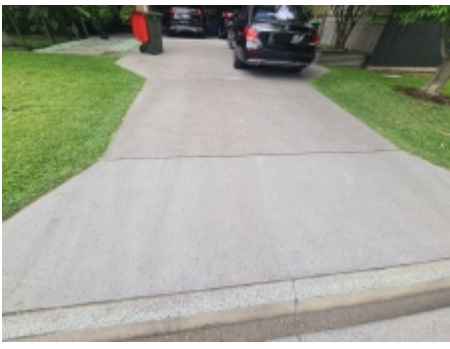
Site Area Photo

Defect Severity	Minor Defect
Comment	The concrete driveway has some visible cracking, this type of cracking is common with concrete driveways and considered cosmetic

This site should be monitored during heavy rainfall to confirm whether there are drainage issues that are not apparent at the time of inspection.
