# Pre-Sale Building & Timber Pest Inspection Report

29 Hatfield Street Banyo 4014 Queensland Australia

## Pre-Sale Building and Timber Pest Inspection - ASBIR Pre-Sale Building & Timber Pest Inspection Report

09 Jul 2026

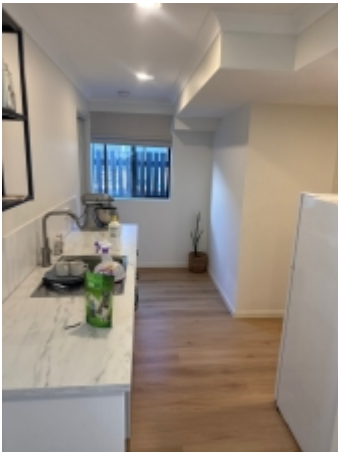
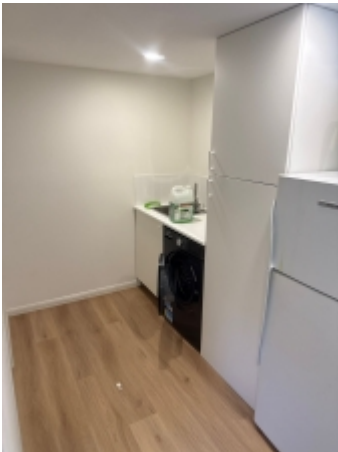
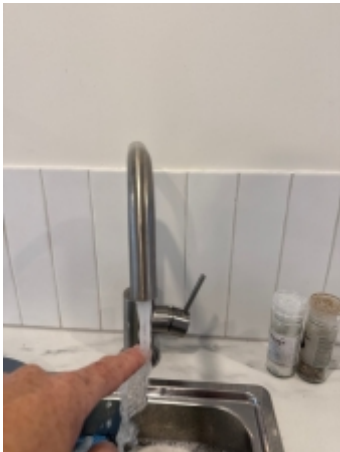
Downstairs Kitchen + Laundry

Comments Hot water is working

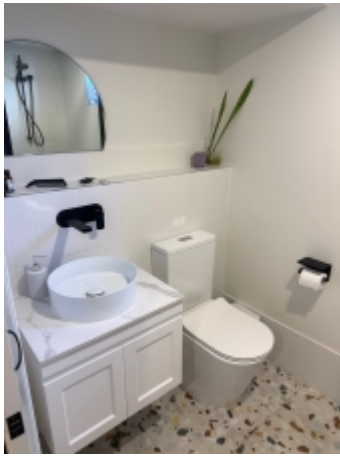
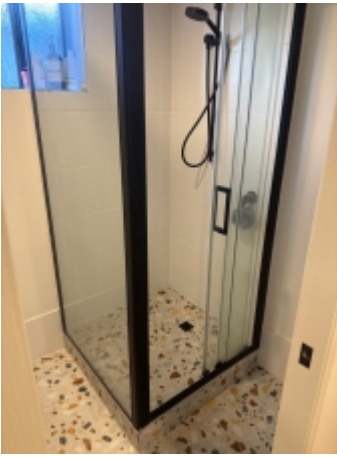
Downstairs Bathroom

**Room Defects**

| Defect Severity | Minor Defect |

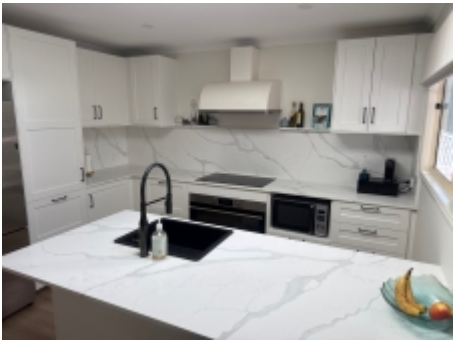
Upstairs Kitchen

Rangehood lights and fan working  
Dishwasher working  
Oven turned on and off

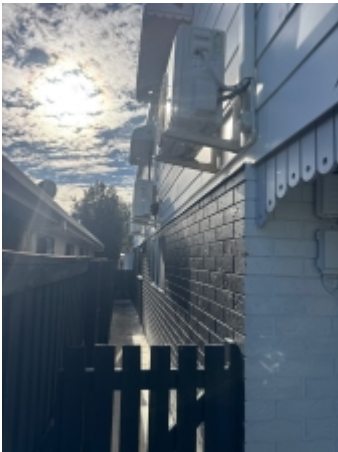
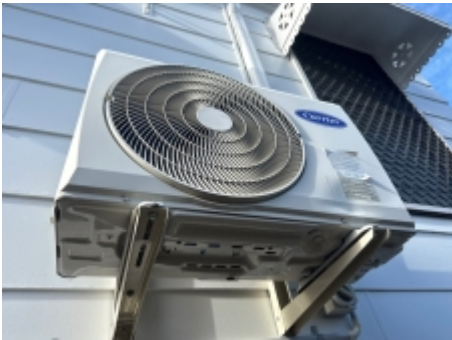
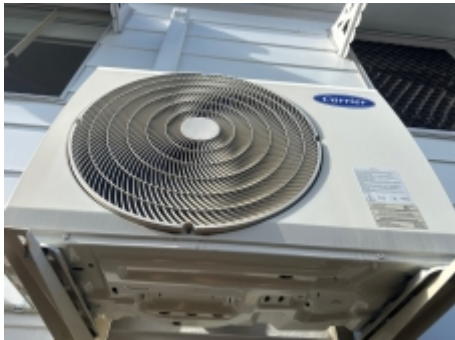
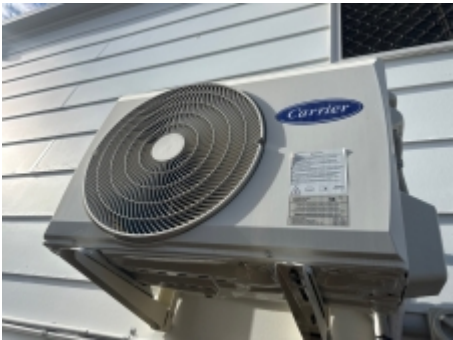
Left Side Elevation

| Comments | 3 AC units present |

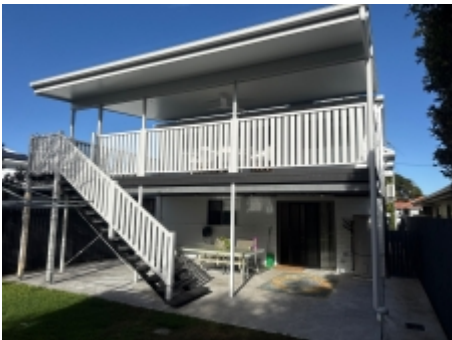
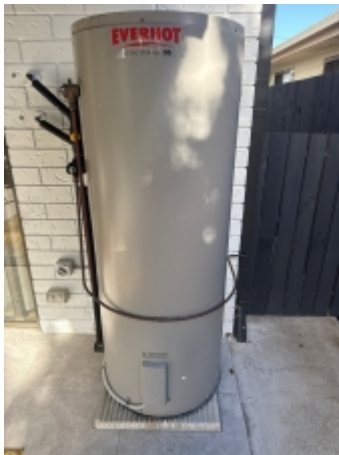
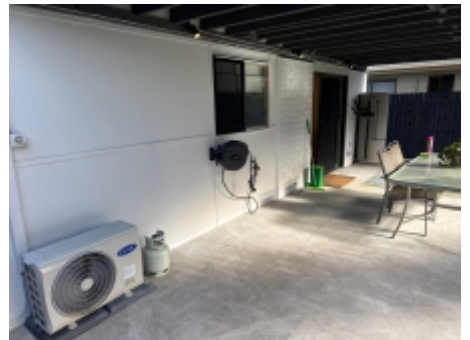
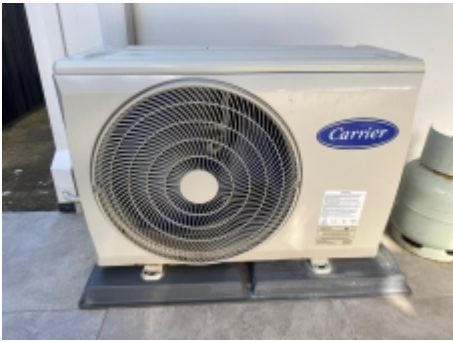
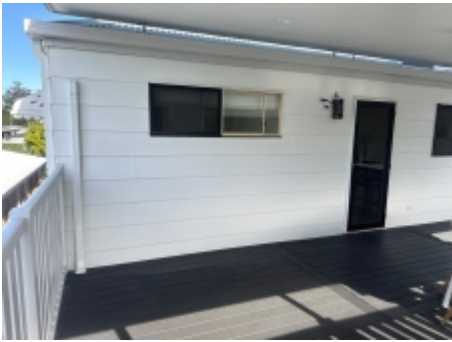
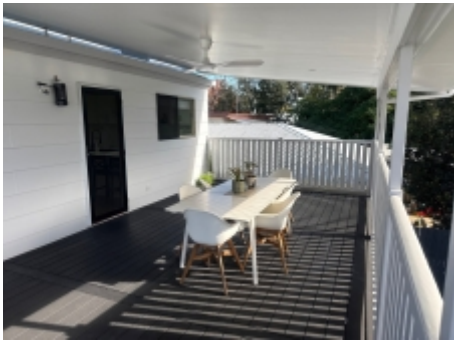
Rear Elevation

| Comments | 2023 hot water heater present<br>1 AC unit present |
| Comment | Rear stair case. Lowest stair tread is out of tolerance.<br>This is included in this report as this presents a potential trip hazard.<br>In accordance with the National Construction Code (NCC), stair risers in residential buildings must be between 115 mm and 190 mm in height, with a maximum variation of 5 mm within the same flight |

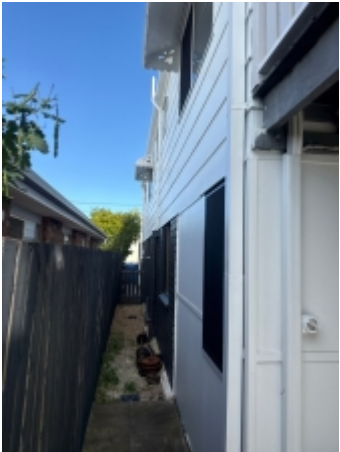
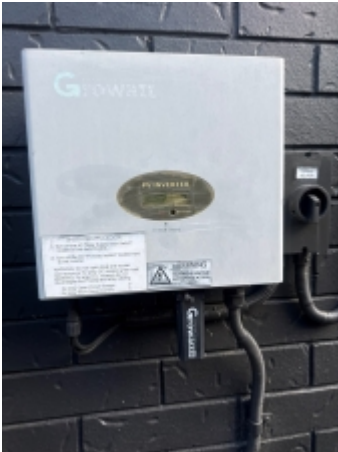
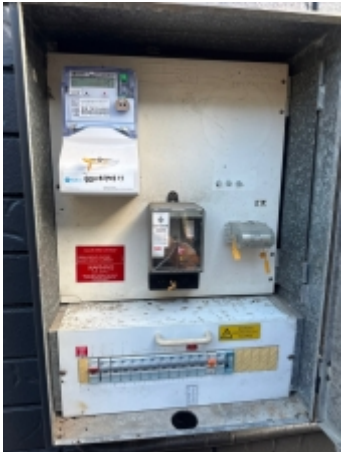
Right Side Elevation

| Comments | Solar inverter present - we are not electricians and do not test the system -<br>However a green light is displayed indicating normal function at present time. |

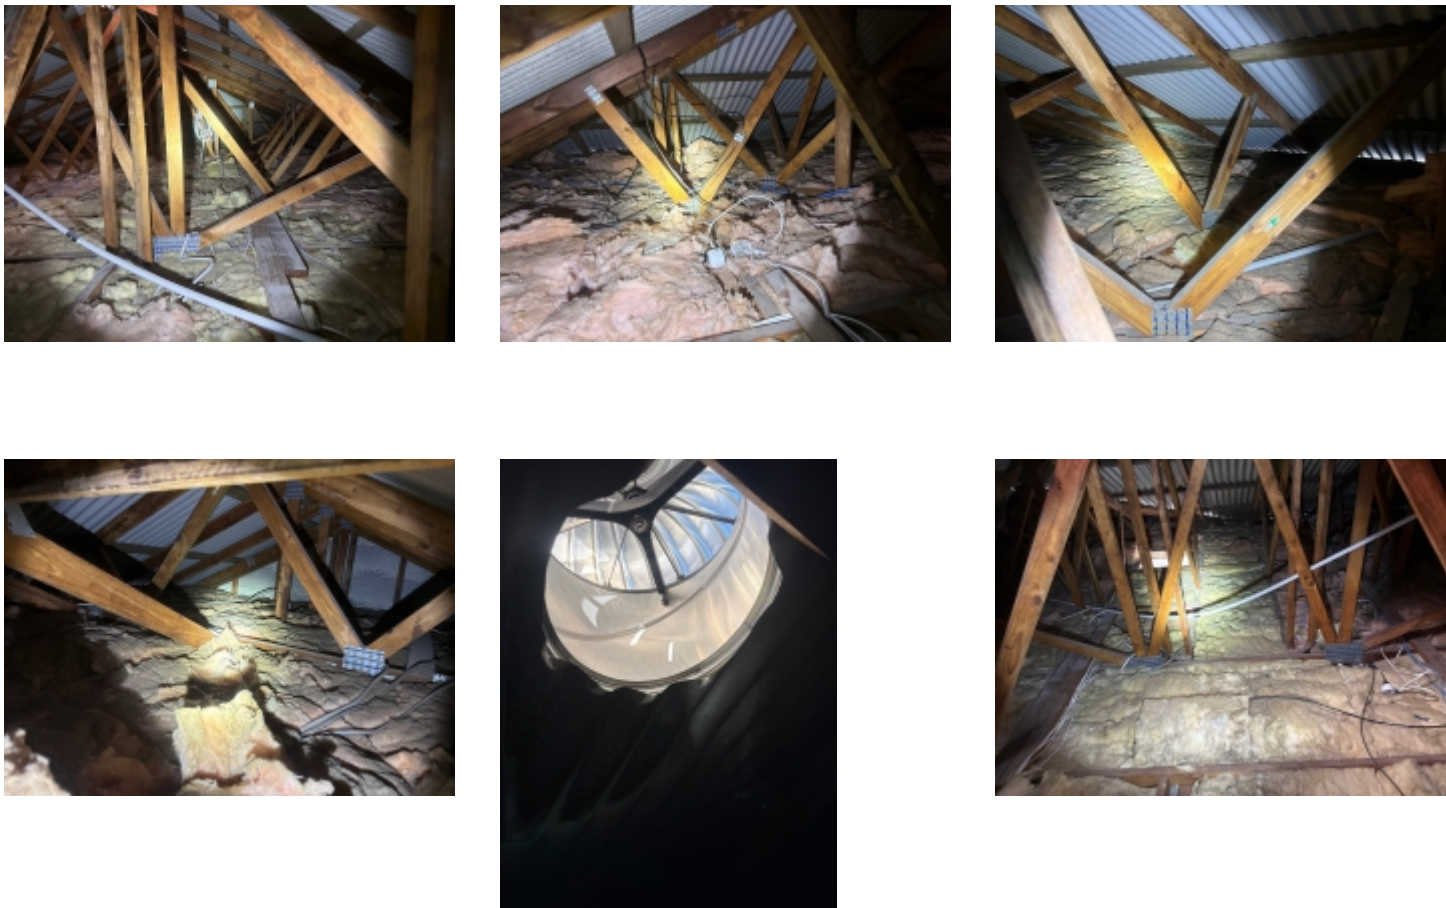
No defects found in the roof space at the time of the inspection

| Comments for Roof Space | Two whirlybirds are installed |
| The Following Observations Are Noted With The Roof Space | Insulation is present |

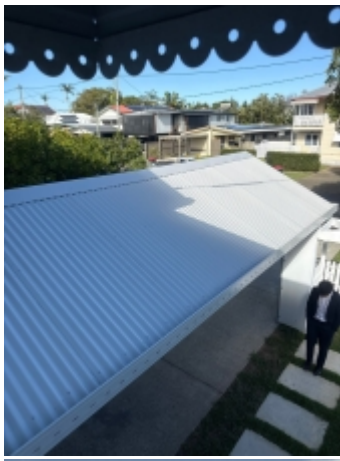
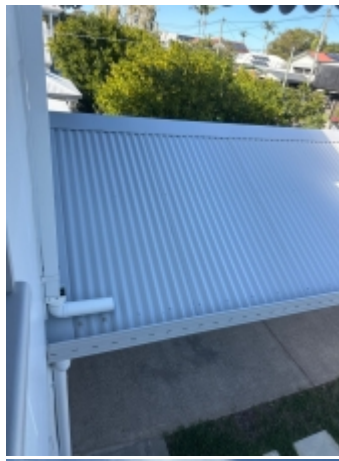
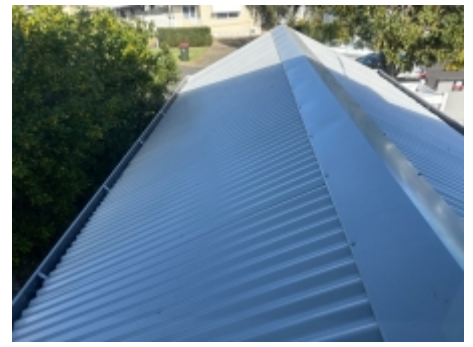
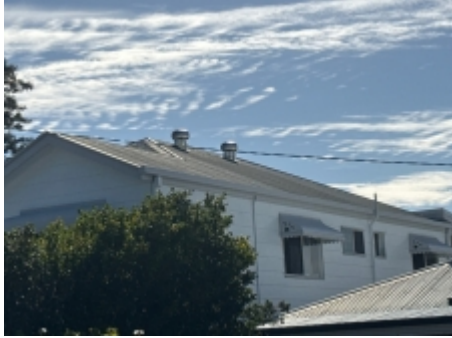
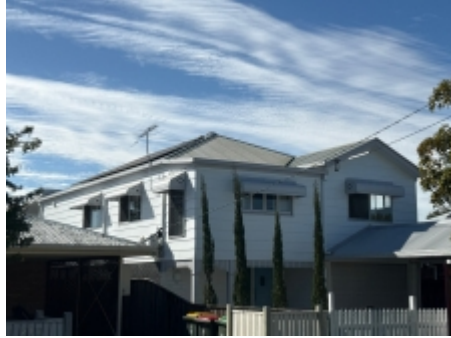
Roof was viewed ground only due to height restrictions

No defects found on the roof exterior at the time of the inspection

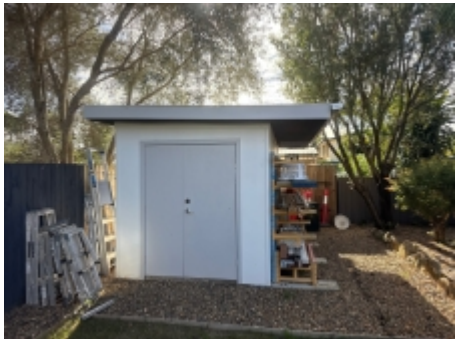
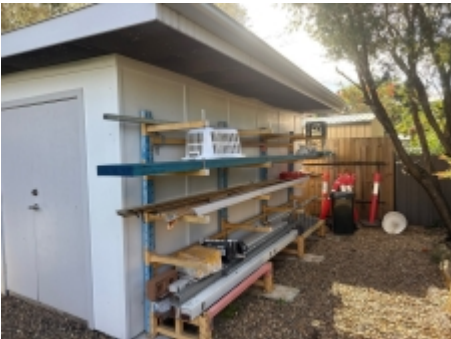
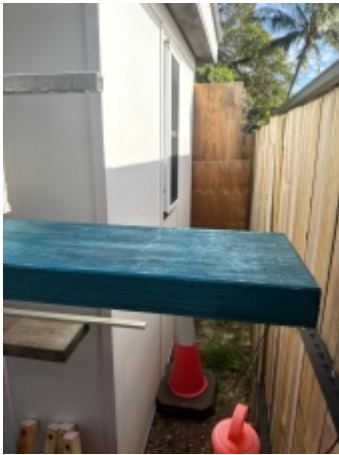
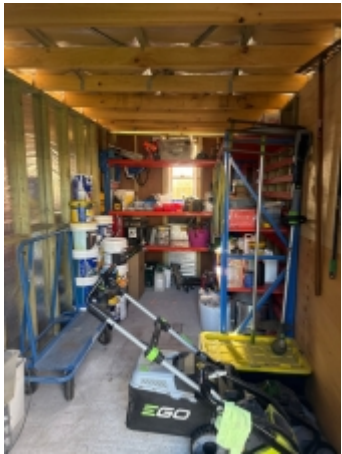
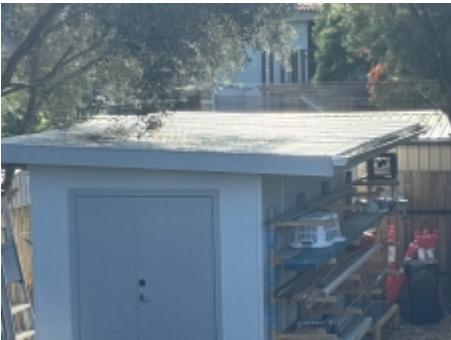
Garden Shed

| Site Drainage Appears To Be: | Adequate |

This site should be monitored during heavy rainfall to confirm whether there are drainage issues that are not apparent at the time of inspection.
