Pre-Sale Building & Timber Pest Inspection Report

34 Blaikie Street Hendra 4011 Queensland Australia

16 Mar 2026

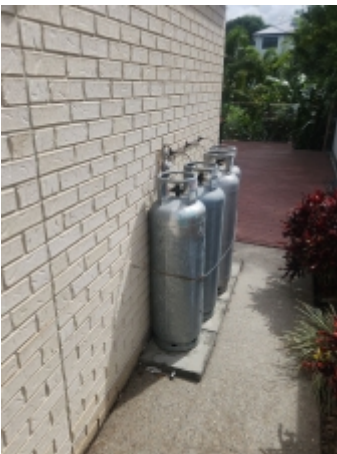
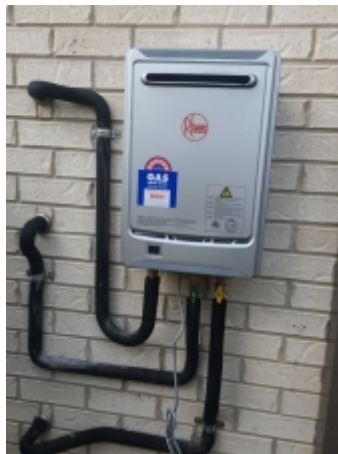
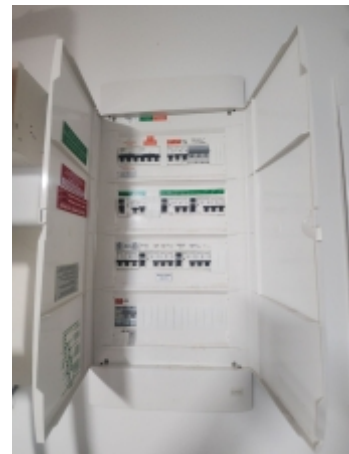
General Exterior & Services

Comments	LPG gas connection present. A safety switch has been installed, A gas hot water system was present. A safety switch has been installed,
----------	--

Defect Severity	Minor Defect
-----------------	--------------

Comment	The external render is cracking in places; this is appearance cracking
---------	--

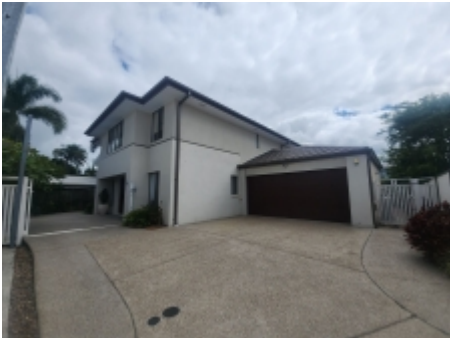
Front Elevation

Defect Severity	Minor Defect
-----------------	--------------

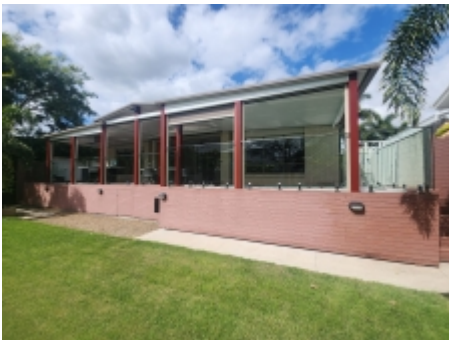
Rear Elevation

Defect Severity

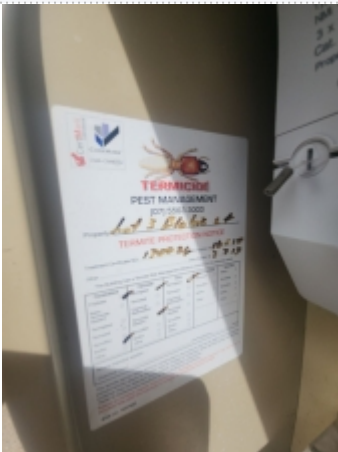
Was evidence of a previous treatment located? (this may include drill holes, dusting or baiting) No

Additional Comments: Physical barrier at construction.
