Pre-Sale Building & Timber Pest Inspection Report

75 Nellie Street Nundah 4012 Queensland Australia

06 Mar 2026

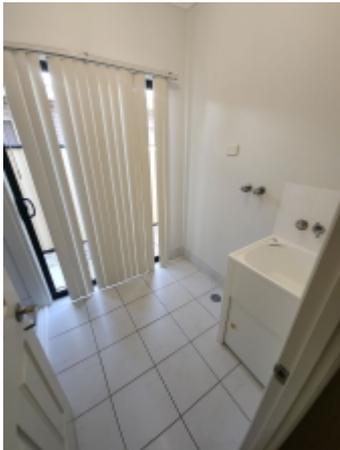
Laundry

Minor Defect

Some cracked tiles were noted to the floor area; this is considered a cosmetic issue

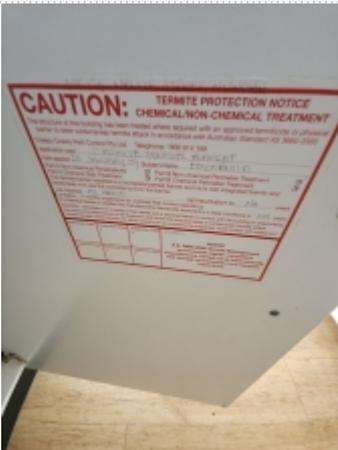
EVIDENCE OF A POSSIBLE PREVIOUS TREATMENT

A notice indicates that the property may have been treated during construction in respect to non-chemical protection against subterranean termite attack.
