# Pre-Sale Building & Timber Pest Inspection Report

41 Oxford Street Hamilton 4007 Queensland Australia

## Pre-Sale Building and Timber Pest Inspection - ASBIR Pre-Sale Building & Timber Pest Inspection Report

21 May 2026

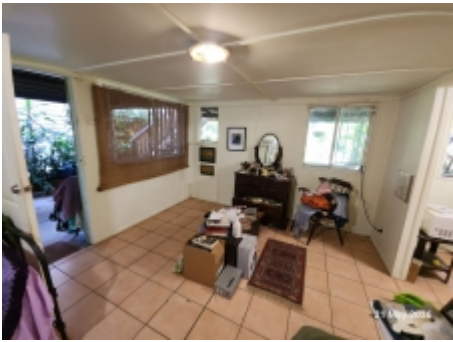
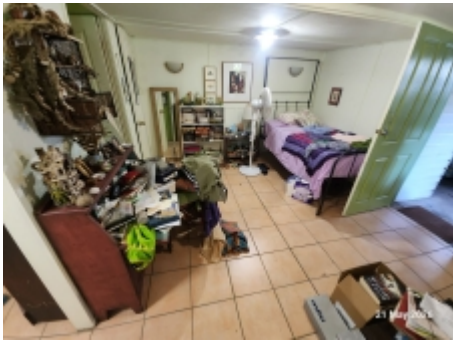
Downstairs Living / Bedroom

| Comment | Some cracked and drummy tiles were noted to the floor area. |

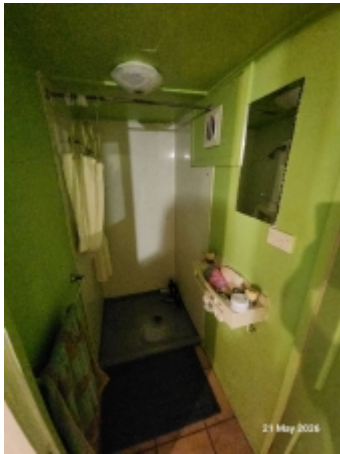
Bathroom 2

| Comment | Wet rot decay present to the timber skirtings |

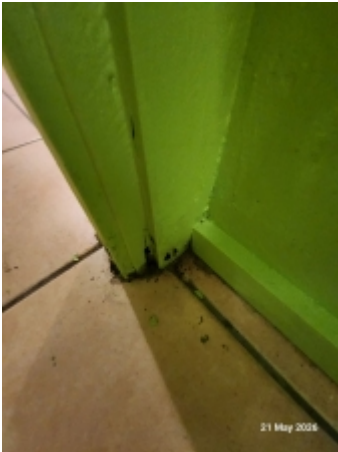
Evidence of what appears to be a termite attack was noted to the architraves. Replacement of the damaged timber is required. The full extent of timber replacement and/or repair can not necessarily be determined during this visual inspection as damage or activity may exist in concealed or inaccessible areas

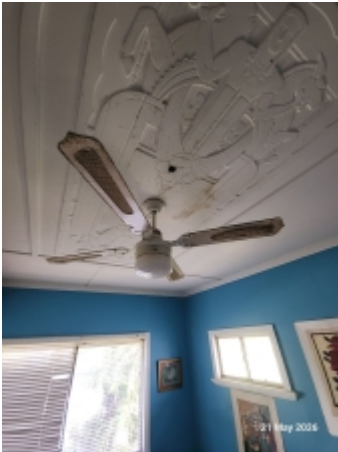
Evidence is noted of past water penetration through the ceiling. The cause of this should be further investigated and rectified.

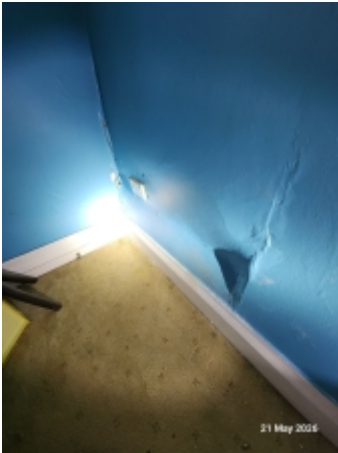
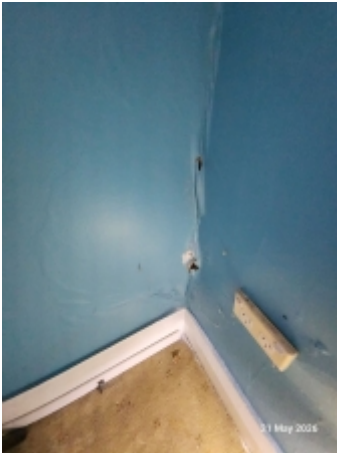
The wall sheeting appears warped and damaged. Repairs are required. Further investigation is recommended to determine the cause and extent of the issue

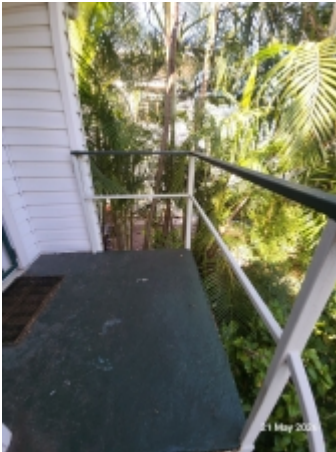
In Queensland, you are not retroactively required to upgrade a balustrade that was built to the standards in place at the time of construction, even if those standards are no longer current. However, if you are undertaking renovations that affect the balustrade or if it's deemed unsafe, upgrades may be required.

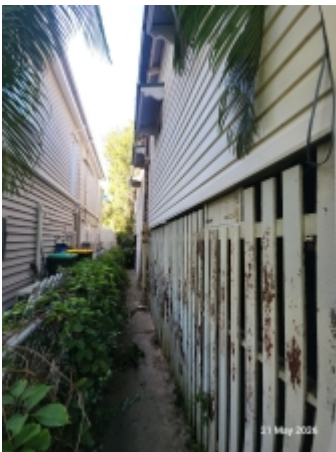
Deterioration was noted to the paintwork to the external surfaces;

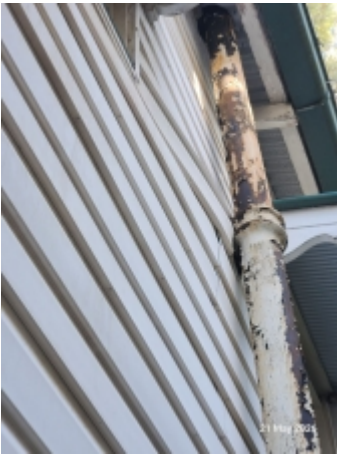
A hole is present in the external cladding. Repairs are recommended. Cladding appears bowed in sections. The cause of this should be further investigated and rectified.

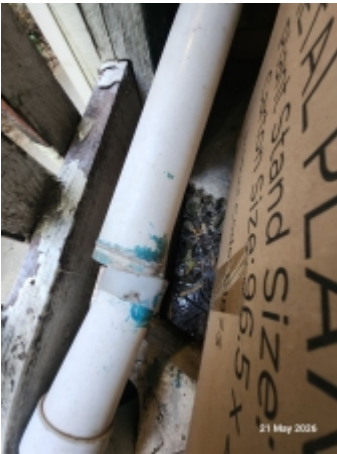
The plumbing to the sink is leaking and the discharge pipe to the sewer is no longer connected. This is considered a major defect. A Licensed plumber should be called to make a further evaluation and repairs or rectification as needed.

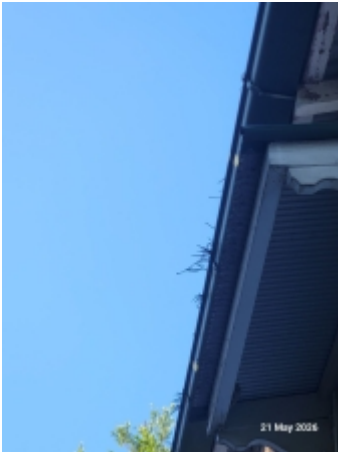
| Comment | Gutters contain leaves and debris; it is recommended that the gutters be cleaned out |

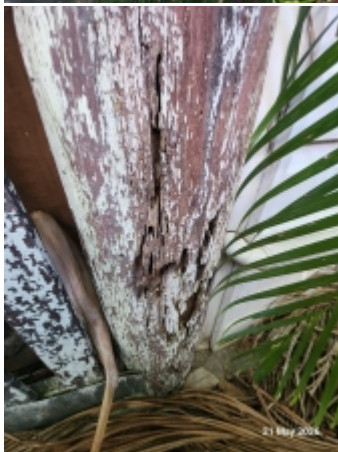
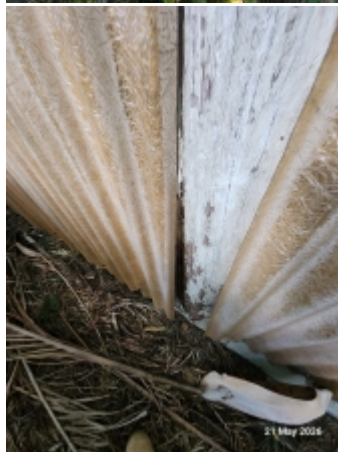
Details & Location:

Tree to front elevation.  
Right elevation house stumps.  
Ground floor toilet architraves and door jamb.  
Bathroom 2 architraves and door jamb.

A more invasive inspection is highly recommended to be carried out. This is outside the Scope of our Agreement for this Inspection.

It is strongly recommended that the full extent of any such activity and damage be fully understood through the engagement of a Licenced Builder, Structural Engineer or appropriately qualified expert.

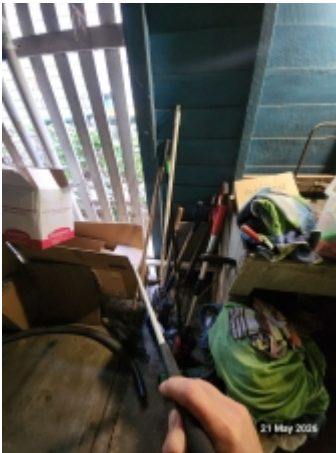
Laundry sink.

If leaks are detected, it is recommended that a suitably qualified plumber or builder is engaged to rectify as soon as possible.

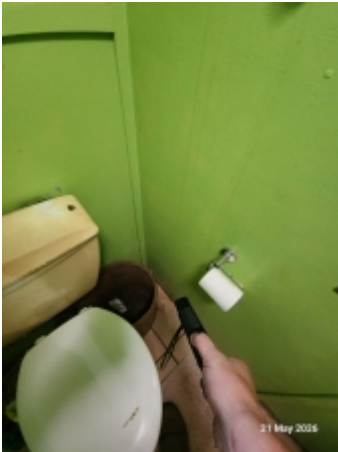
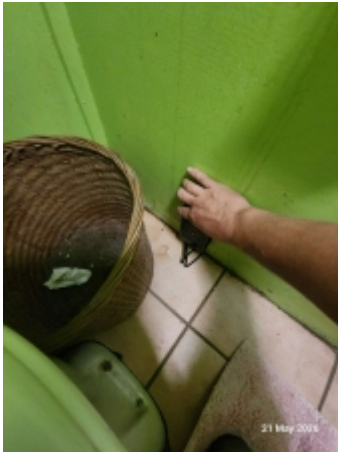
Back of shower wall bathroom 2

If high moisture or thermal levels have been reported, it is important to ensure further expert advice is obtained in order to determine the reason, extent of any damage caused and estimated cost of rectification as areas with high moisture are more prone to Timber Pest attack.

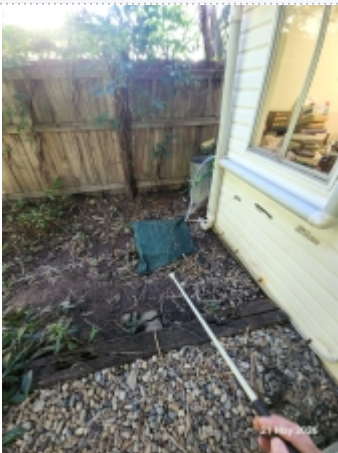
| We claim no expertise in plumbing and drainage, however it appears that site drainage is generally: | Inadequate |

| Details & Recommendations: | A drainage expert should be engaged to asses drainage around the property, including the rear elevation. |

Where site drainage is deemed inadequate, remedial action should be undertaken by an engineer, plumber, drainer or licensed builder.
