Pre-Sale Building & Timber Pest Inspection Report

43 Clarke Street Hendra 4011 Queensland Australia

04 Jul 2025

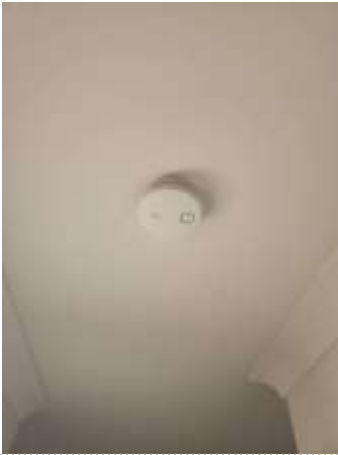
Smoke Alarms

Smoke alarms installed but not tested.

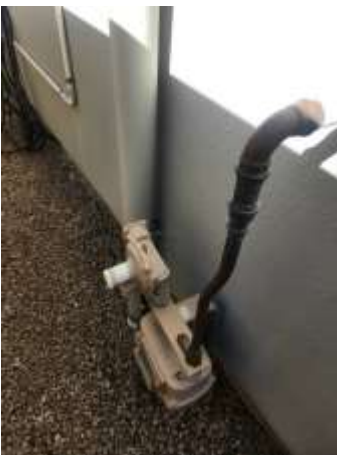
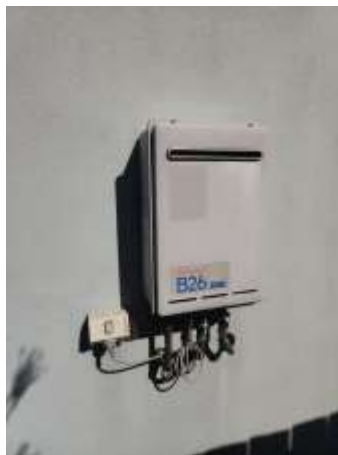
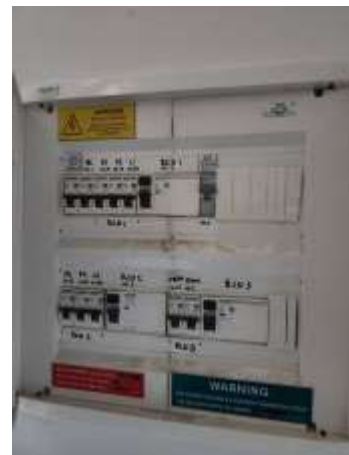
General Exterior & Services

Gas mains present.
Gas hot water system present.
A safety switch has been installed, but not tested.
